HIGHWAY RESEARCH RECORD

Number 5

*Continuously-Reinforced Concrete
Pavement
4 Reports*

Determining and Evaluating Stresses of an In-Service Continuously-Reinforced Concrete Pavement

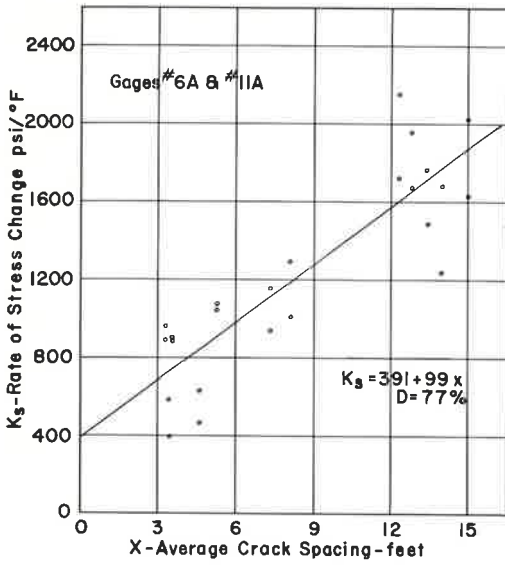
Figure 18. K_s in terms of average crack spacing, 0.5 percent.

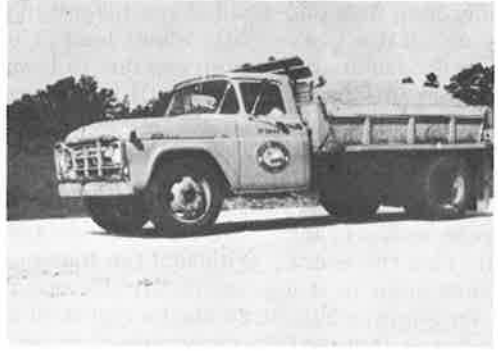
Figure 24. Vehicle used in wheel load tests.

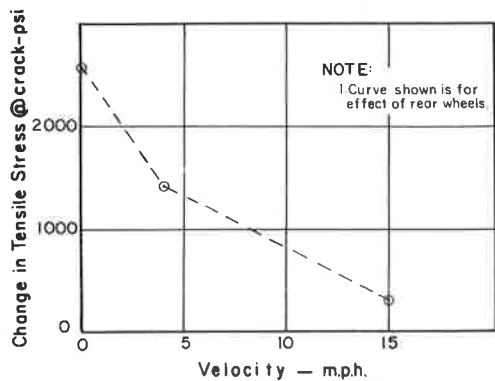
Figure 27. Effect of velocity of load on steel stresses at a crack, NBL (0.5 percent.)

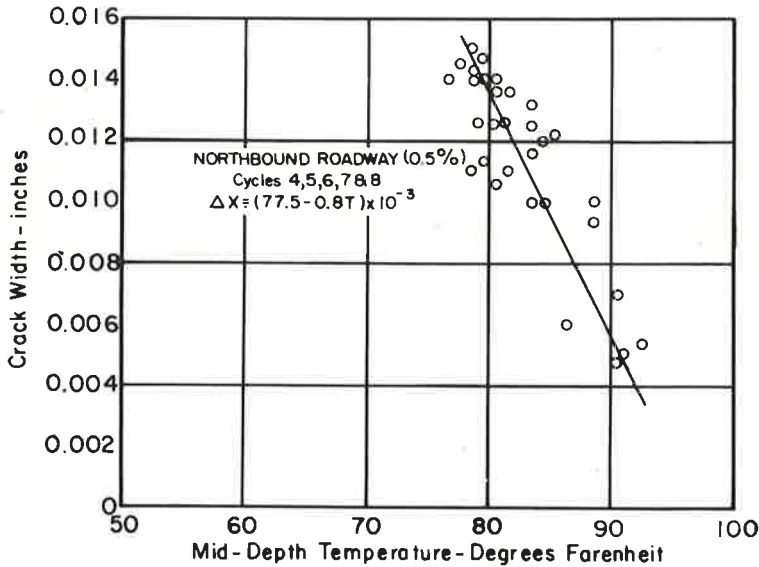
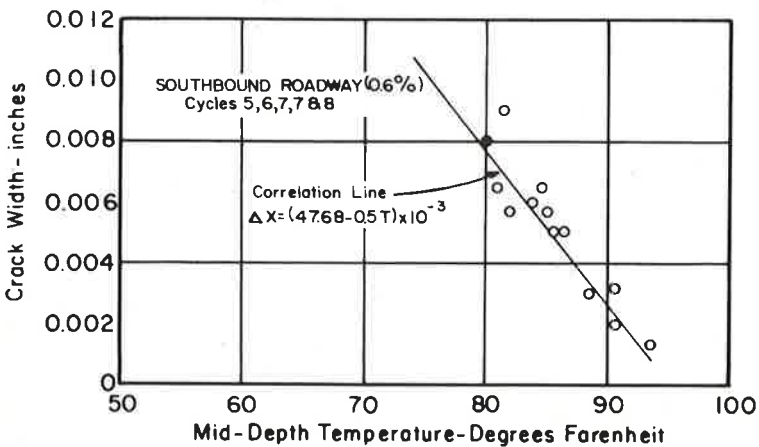
Figure 28. Relationship between crack width and middepth temperature for preformed crack in each roadway.

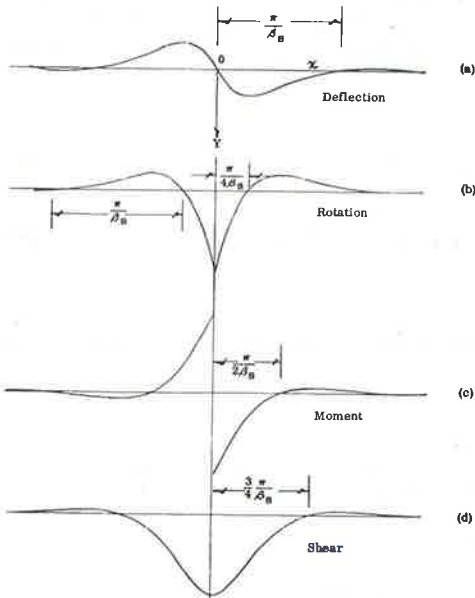
Figure 16. Response of infinite beam on elastic foundation due to transverse movement applied at $x = 0$.

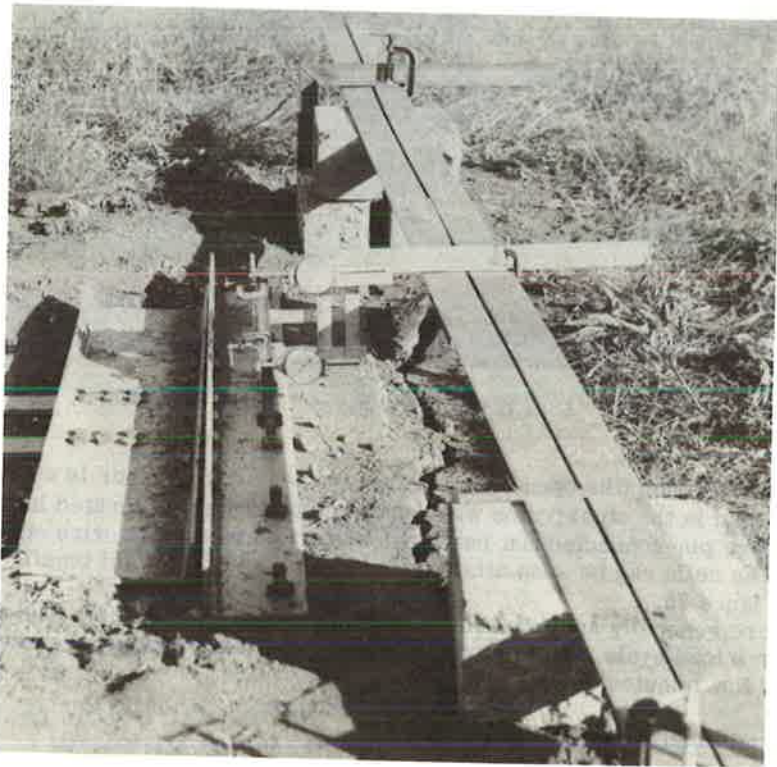
Figure 28. Micrometers in position for measuring horizontal translation and rotation.

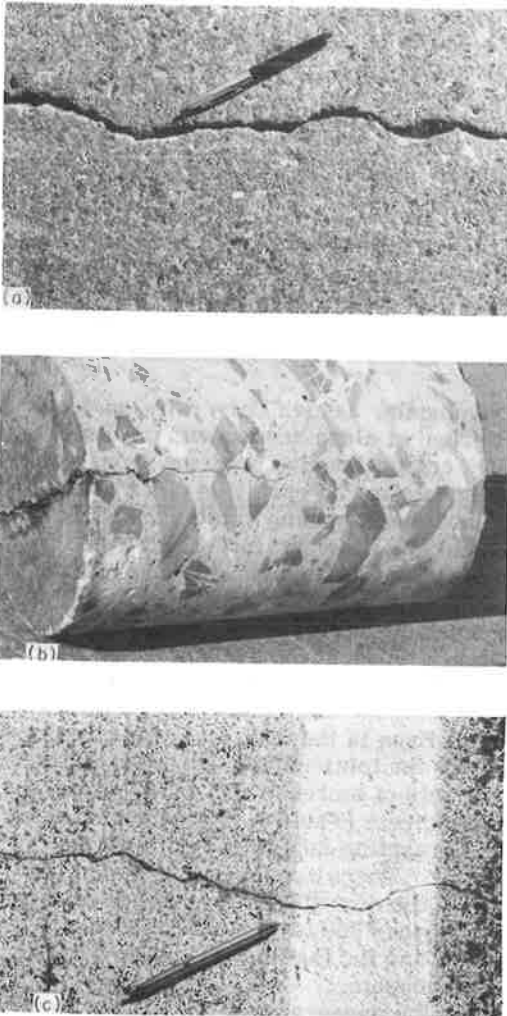
Figure 3. Typical crack on York pavement: (a) spalled appearance at surface, (b) core removed directly over crack, (c) appearance of crack at edge of pavement.

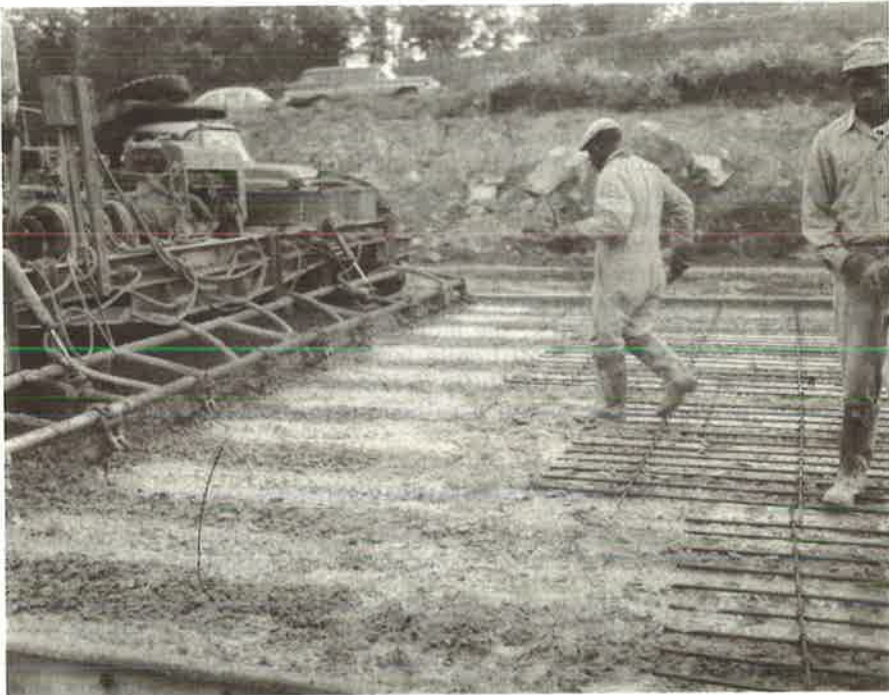
Figure 8. Pavement construction showing internal vibration of concrete, and staggered ends of bar mats.

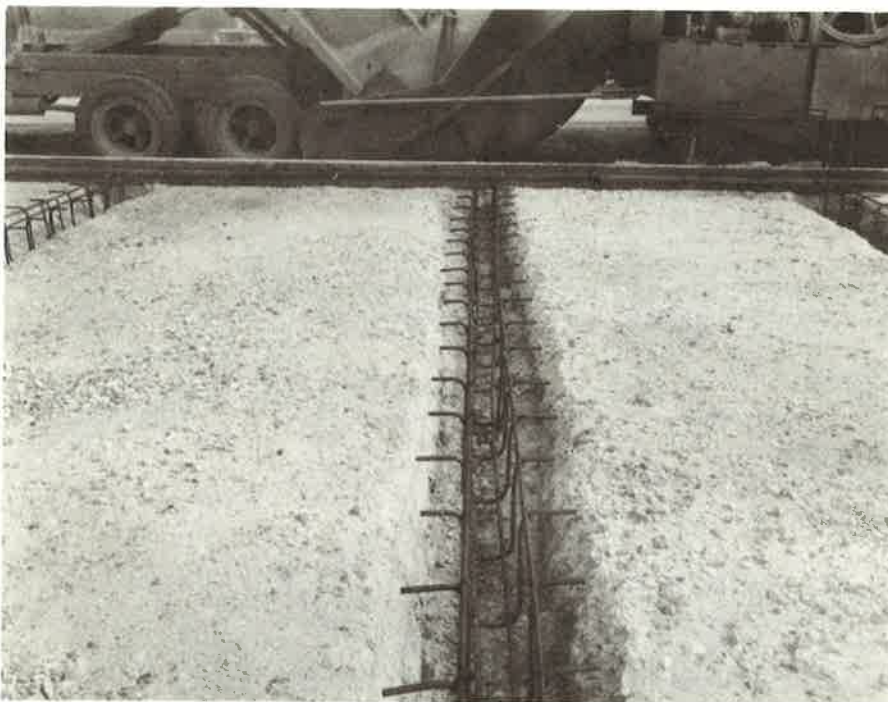
Figure 9. Details of reinforcing steel cage in end restraint lugs.

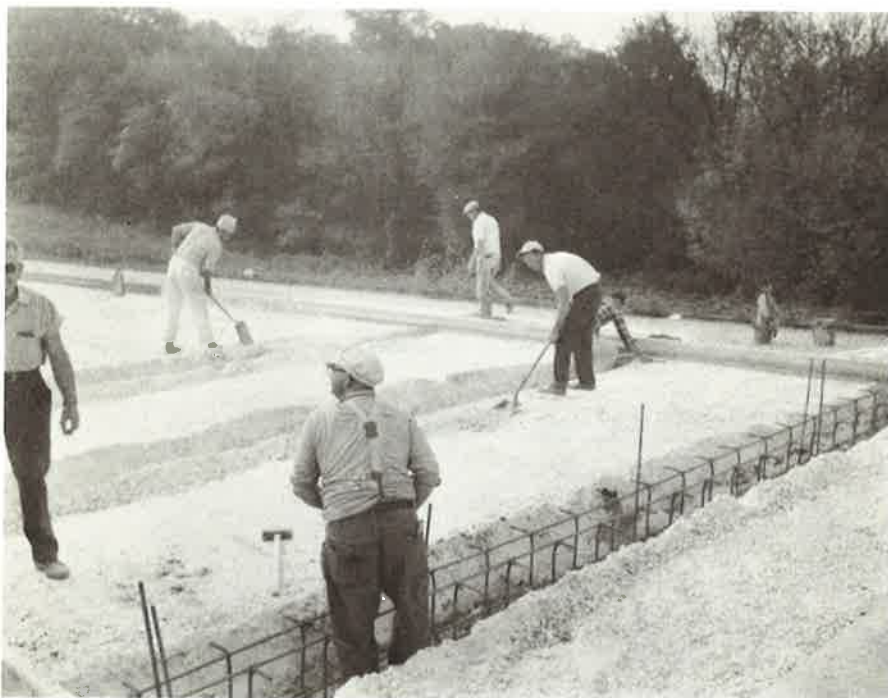
Figure 10. Placing reinforcing steel and trimming subbase at end restraint lugs.

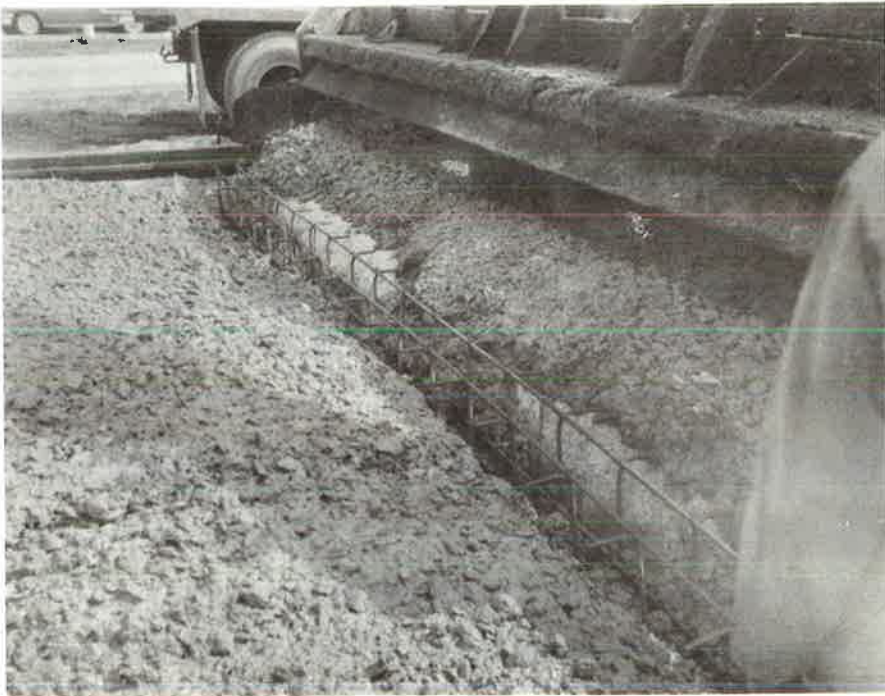
Figure 12. Concrete pouring in vicinity of end restraint lug.
