Alkali-Silica and Alkali-Carbonate Reactivity Of Some Aggregates from South Dakota, Kansas, and Missouri

KATHARINE MATHER, ALAN D. BUCK, and WILBUR I. LUKE, Geologists,
Concrete Division, U. S. Army Engineer Waterways Experiment Station,
Jackson, Mississippi

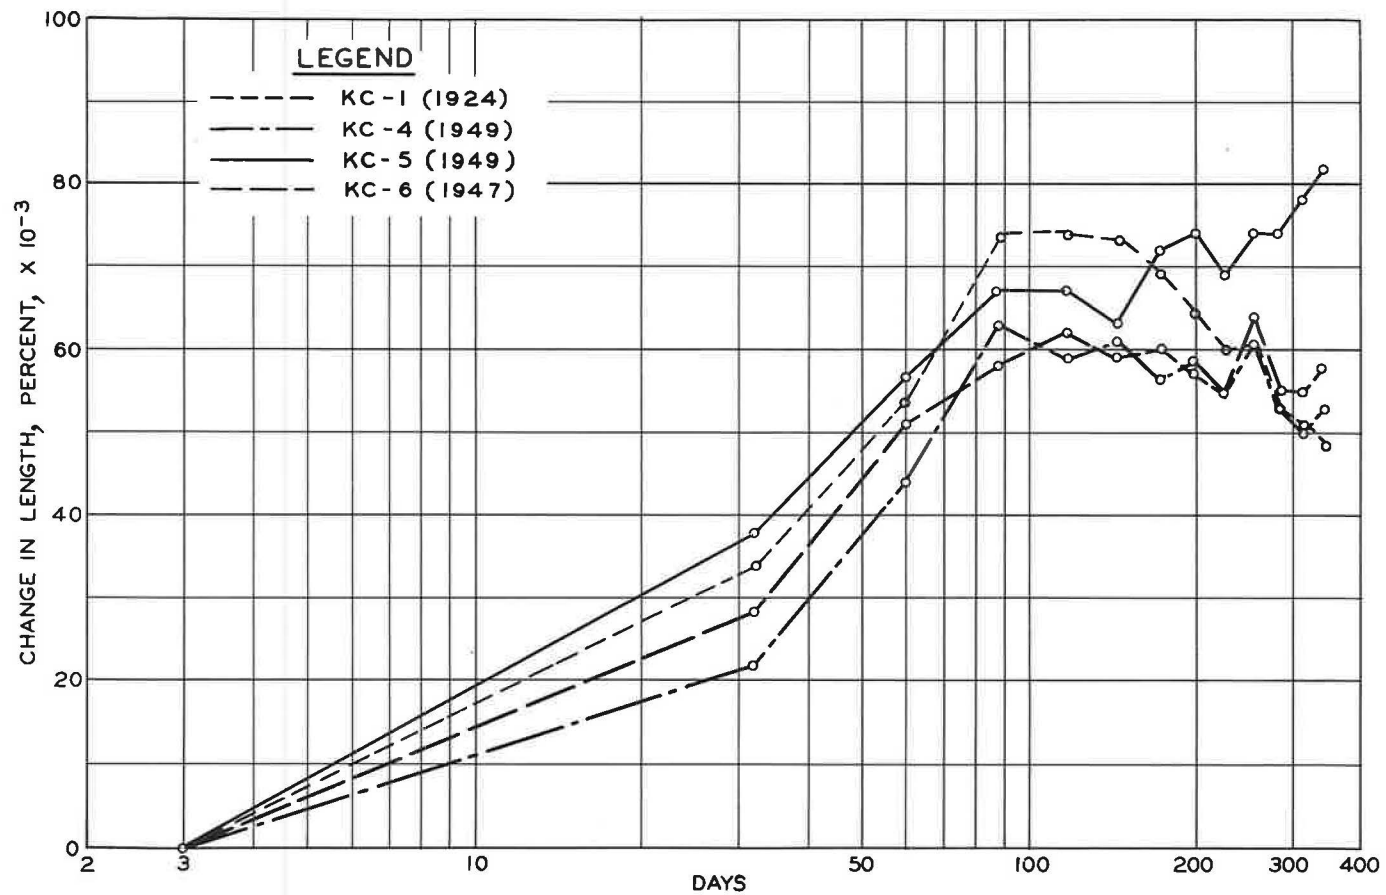
Figure 1. Expansion, during storage over water at 25 ± 2 C, of sawed concrete prisms from a pavement at Scandia (KC-1) and from office building and garage at Harlan County Dam.

Table 5 contains the results of X-ray examinations of the cement paste concentrates. Table 6 and Figures 1 and 2 show the length-changes of concrete prisms exposed at high humidity, and Table 7 and Figures 3, 4 and 5 show the length changes of prisms exposed to a Conrow cycle. All of the descriptions of carbonate coarse aggregates from the cores are grouped in Table 8.

One surface of the prism stored over water (Table 6, Fig. 1) was part of the original surface of the pavement; several white gel spots formed on it. A small gel-filled crack was noted next to a limestone coarse aggregate particle on another surface. No gel appeared on the prism subjected to the Conrow cycle (Table 7, Fig. 3). The gel spots formed on the first prism substantiated the presence in the concrete of ingredients capable of alkali-silica reaction in environments favoring the reaction.

No signs of alkali-silica reaction gel were found on the prisms stored at high humidity or those subjected to a Conrow cycle (Tables 6, 7; Figs. 1, 4). The comparison between the behavior of the prism from KC-4 and that from KC-5 in storage at high humidity (Fig. 1) indicated that KC-4 represented concrete that had probably exhibited some of its reactive potential in the structure. The pattern on the outer surface on the north wall of the building (Fig. 8) may represent the result of such expansion. The south wall of the building was not patterned like the north wall; KC-5, from the south wall, retained its expansive potential and exhibited it in the higher expansion it developed and retained in storage over water.

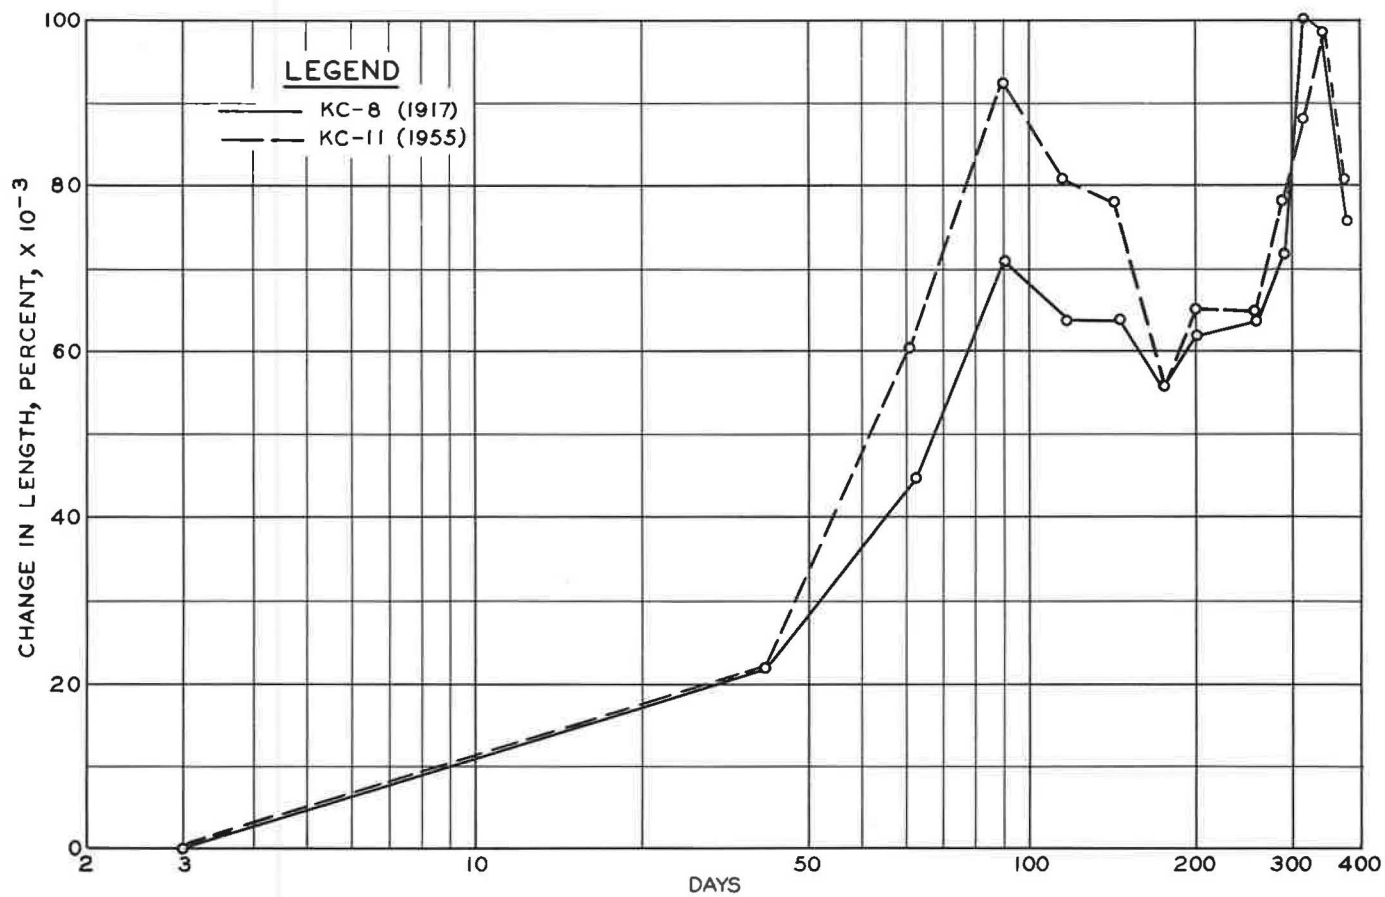
Figure 2. Expansion, during storage over water at 25 ± 2 C, of sawed concrete prisms from two structures at Fort Riley, Kan.

sections made from the same or adjacent areas of the concrete. No gel or secondary calcite was found on the prism stored at high humidity (Fig. 2); some white gel was found on the surfaces and in mortar adjoining some of the lighter gray calcareous chert particles in the prism subjected to the Conrow cycle (Fig. 5).

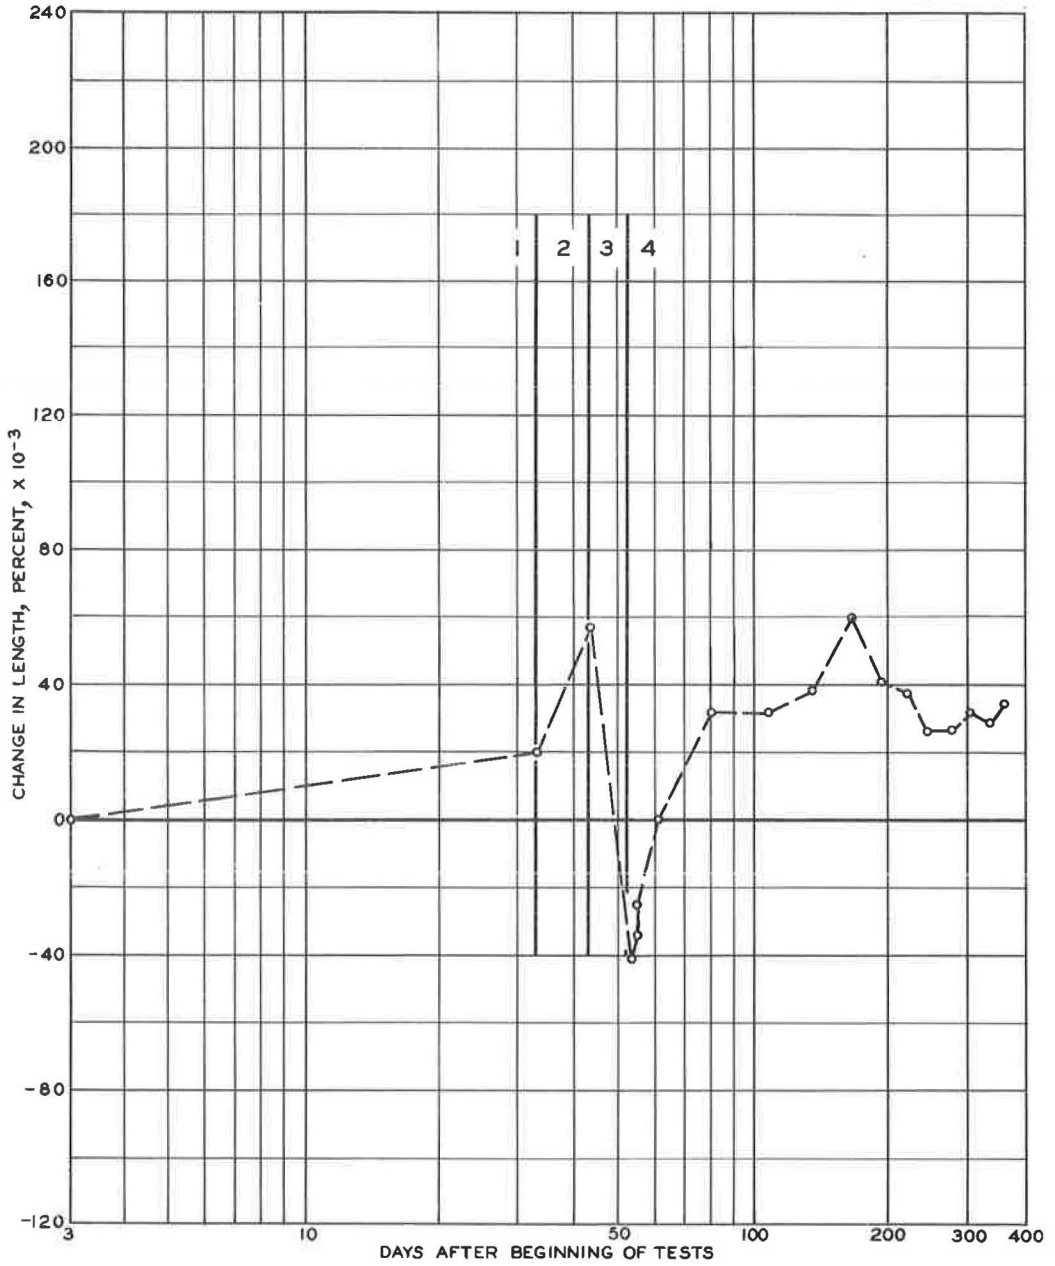
Figure 3. Effect of Conrow cycle on sawed concrete prisms from a structure at Scandia, Kan.

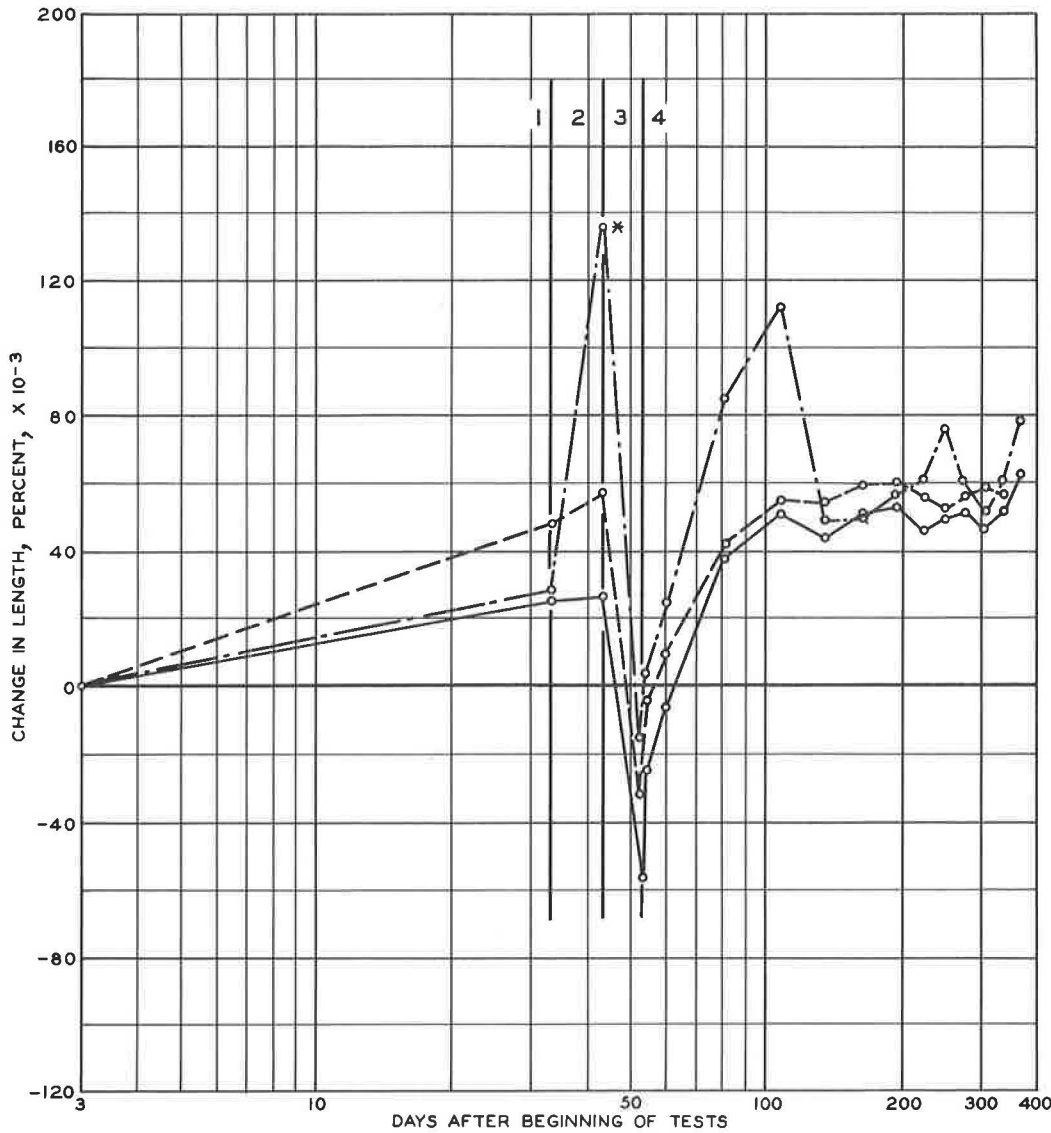
Figure 4. Effect of Conrow cycle on sawed concrete prisms from Harlan County Dam, Neb.

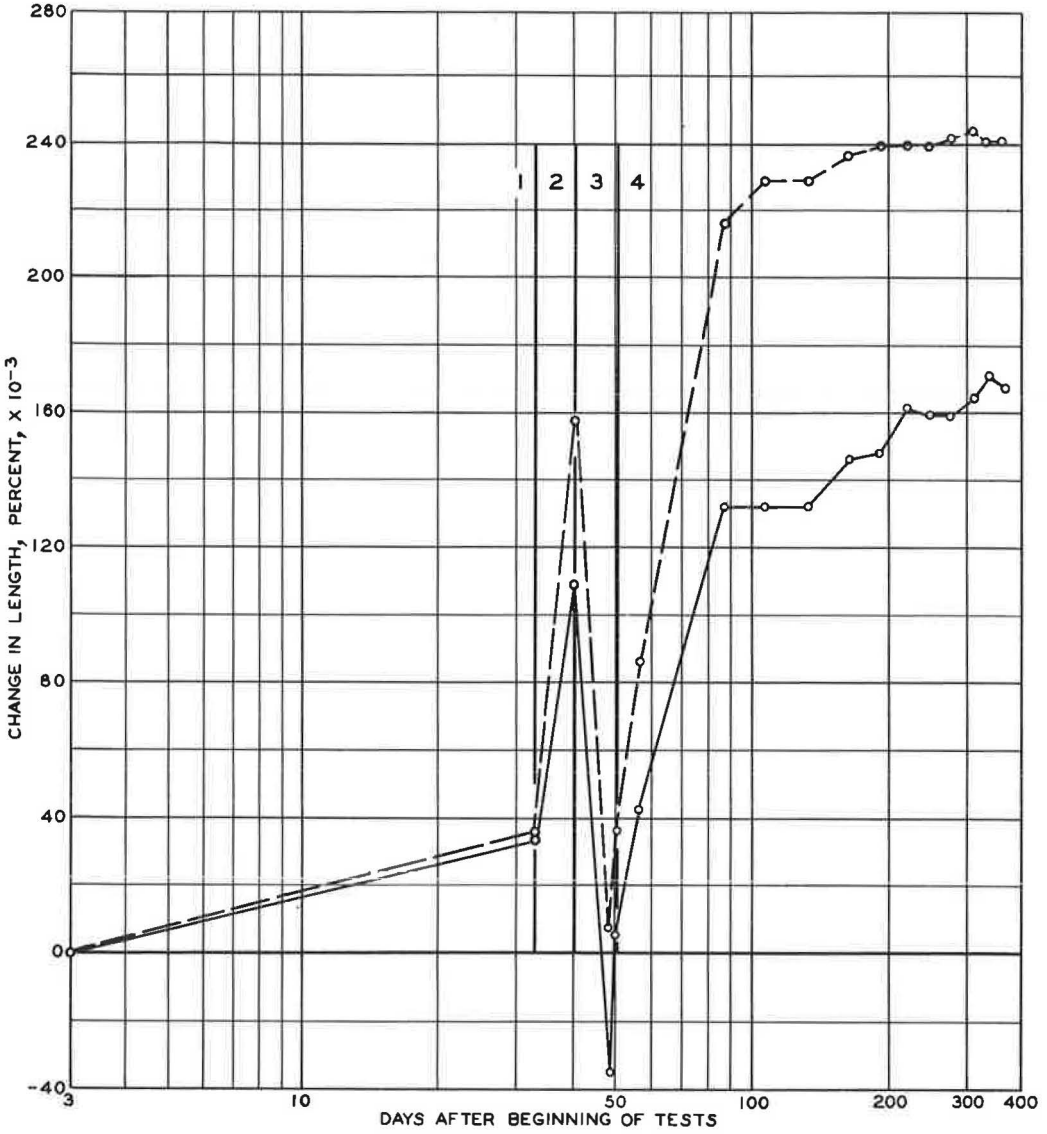
Figure 5. Effect of Conrow cycle on sawed concrete prisms from two structures at Fort Riley, Kan.

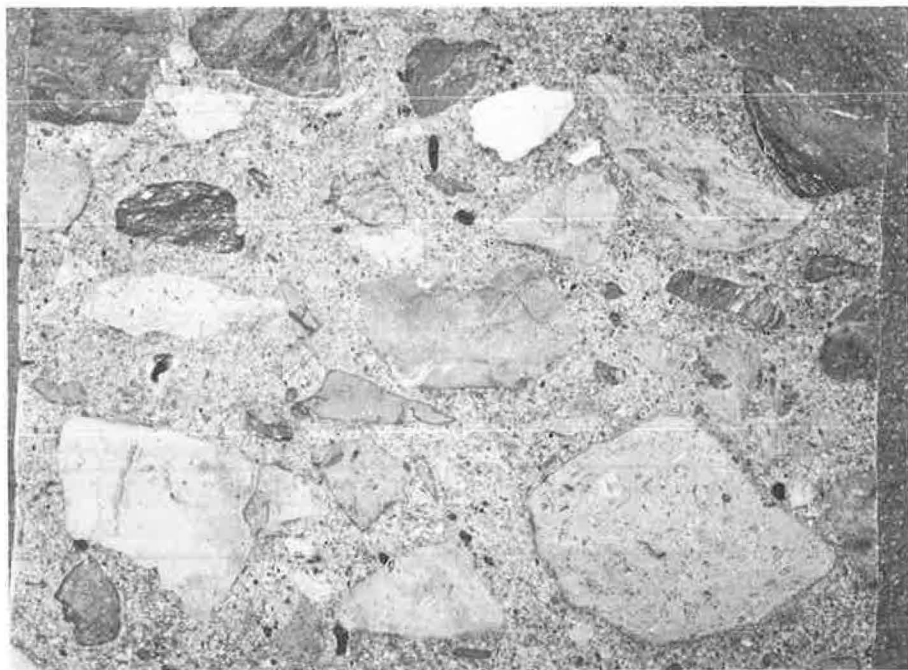
Figure 6. KC-1, sawed surface, three-quarter size. Note dark rims around most of limestone coarse aggregate particles and darker staining of mortar around large limestone particle in lower right corner.

widest at the coarse aggregate-mortar interface, dwindling into the surrounding mortar (Fig. 6). X-ray examination of the dark shells and discolored mortar did not show any brucite ($\text{Mg}(\text{OH})_2$) and little dolomite was present in the interiors of the rimmed coarse aggregate. A slice of the concrete etched with hydrochloric acid by the procedure of Lemish et al. (8) revealed thin rims, just inside the surfaces of some coarse aggregate particles, less soluble than the surfaces or the interiors (Fig. 7). Two counts of one sawed surface were made at low magnification to determine whether there was any association between the rim phenomena and any evidence of distress. Results of the first count of a 6- by 6½-in. sawed surface parallel to the axis of the core are given in Table 9 and results of the second count are given in Table 10. Chi square, calculated as 49.586 with 2 degrees of freedom, corresponds to a probability less than 0.01 of this degree of association between size and rims arising by chance, showing that rims were more abundant on larger pieces of coarse aggregate. Qualitatively, rims were also more abundant on two darker lithologic varieties which together amounted to one-quarter of the whole coarse aggregate. Rims were least abundant on the commonest lithologic variety in the aggregate (Table 8).

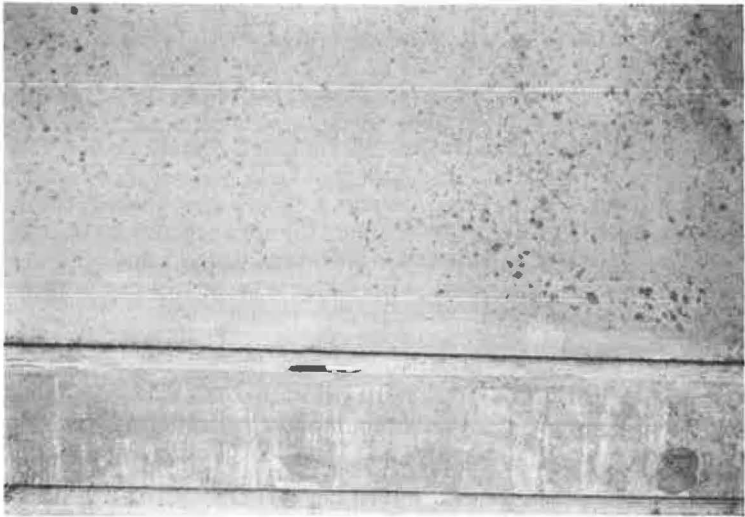
Figure 8. North wall of administration building, Harlan County Dam, Harlan County, Neb., showing mottling of concrete. The ball-point pen is 5 1/8 in. long. KC-4 was drilled to left of field shown.

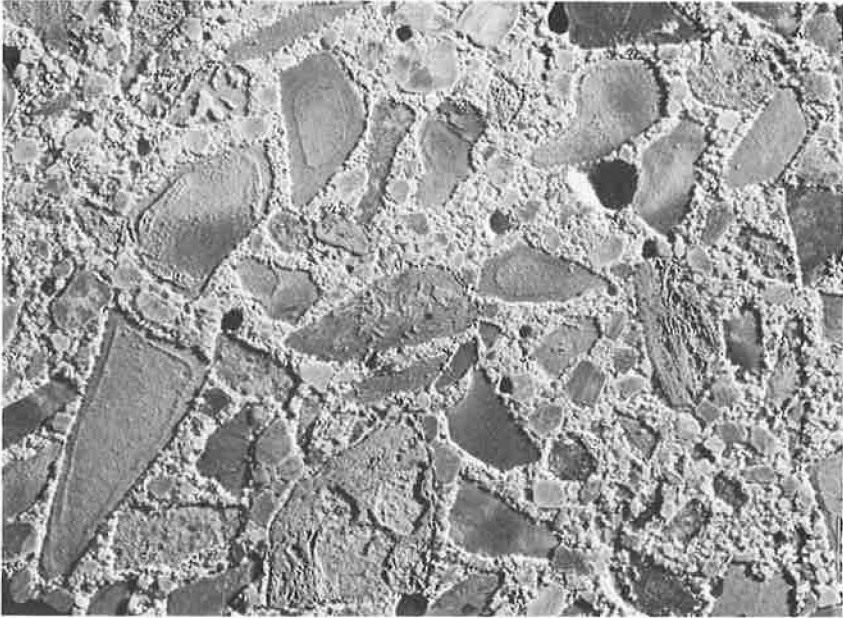
Figure 9. KC-4, sawed surface, $\times 1\frac{1}{2}$, etched in 3N hydrochloric acid. Limestone particles were etched deeper than rest of surface and are therefore at lower elevations than rest of surface. An excellent example of the Lemish rims that developed on many of these particles is shown in the large, wedge-shaped particle in lower left. Others are present.

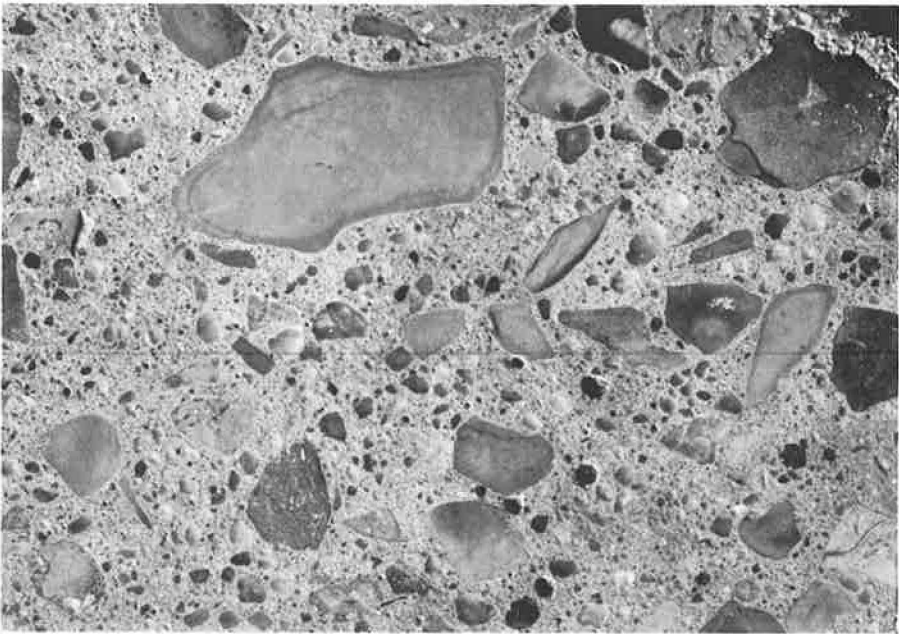
Figure 10. KC-5, sawed surface, $\times 1\frac{1}{2}$. Concrete in KC-4 and -5 was made from same aggregate and cement combinations; therefore, limestone particles in both exhibit the same type of rims. Compare with Figures 9 and 11.

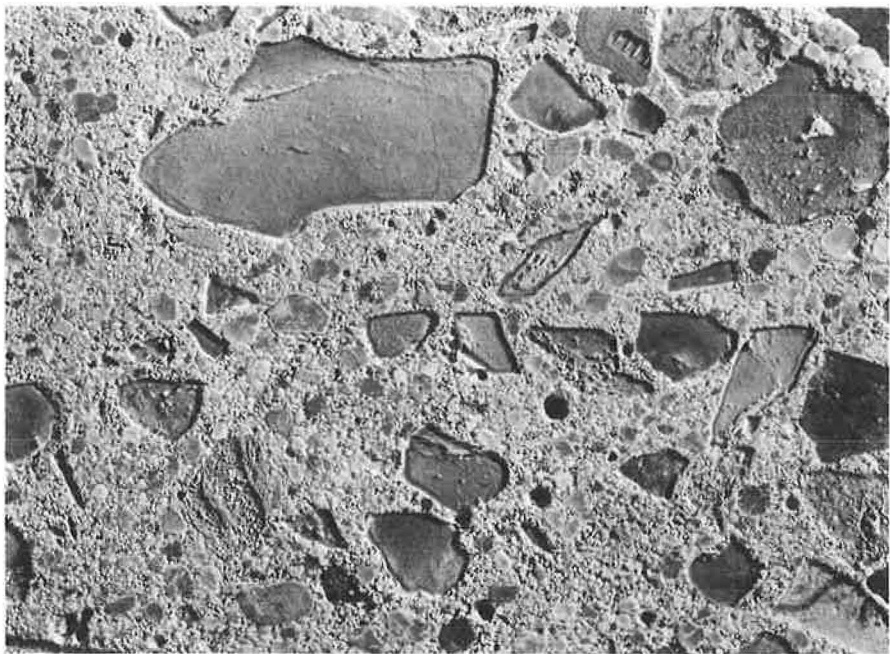
Figure 11. KC-5, sawed surface, $\times 1\frac{1}{2}$, etched with 3N hydrochloric acid (same surface as Fig. 10). Note that particles in this photograph displaying Lemish rims are, in most cases, same particles that had dark surface rims in Figure 10.

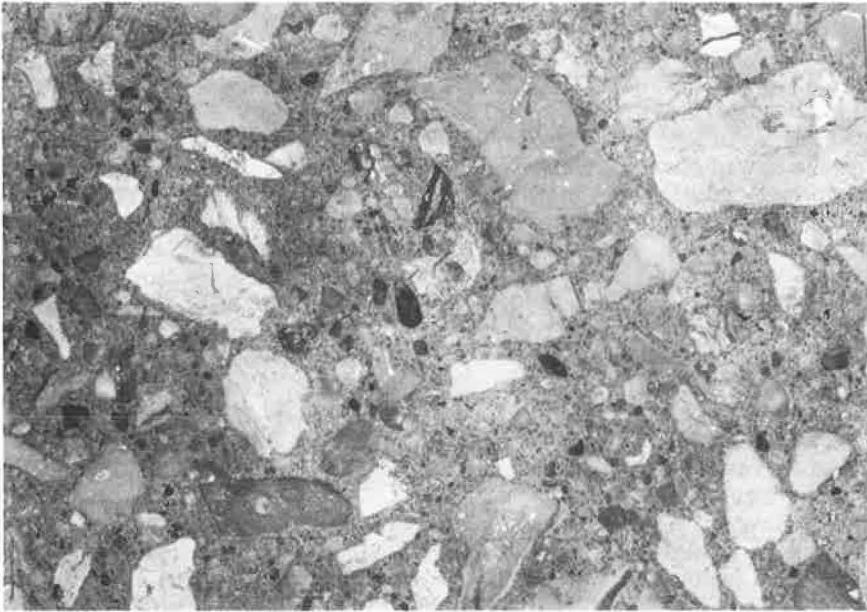
Figure 12. KC-6, sawed surface, $\times 1\frac{1}{2}$. Narrow rims are present in paste at paste-aggregate contacts of most of lighter coarse aggregate particles, although rims are not readily apparent from this photograph.

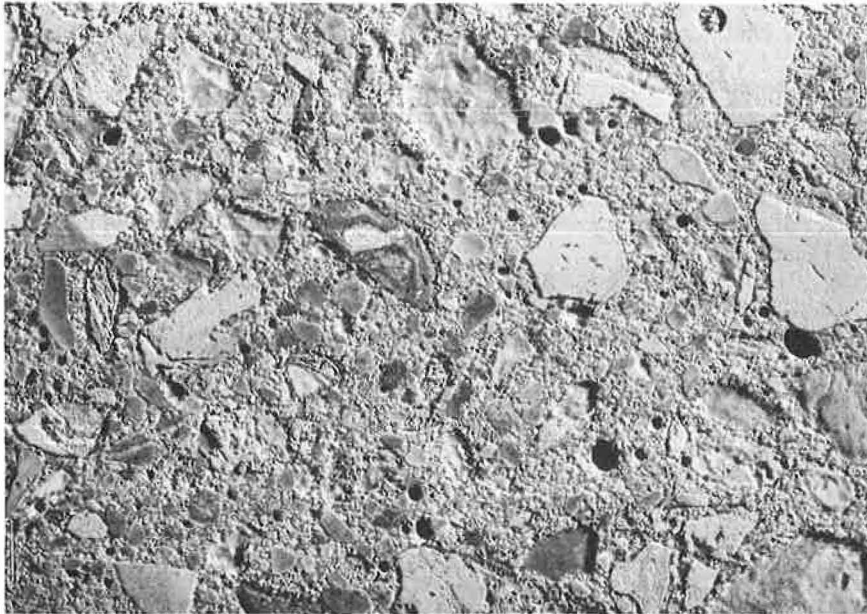
Figure 13. KC-6, sawed surface, $\times 1\frac{1}{2}$, etched with 3N hydrochloric acid. Light colored, spongy-textured, cherty particles were more resistant to acid attack and are therefore in relief above etched concrete surface. Limestone particles, being less resistant, are in negative relief.

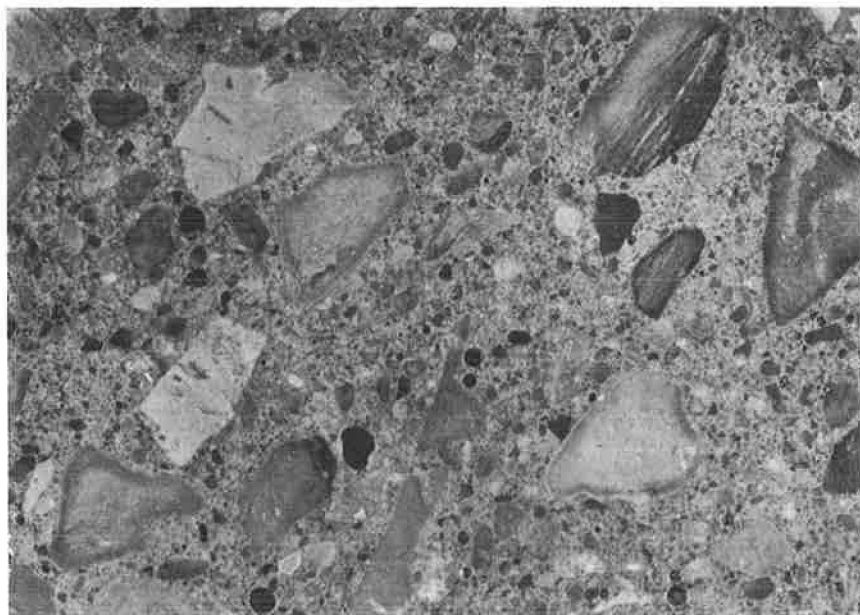
Figure 14. KC-7, sawed surface, $\times 11\frac{1}{2}$. Lighter colored coarse aggregate particles with rims in mortar immediately surrounding particles are composed of chert and cherty limestone. Darker particles with internal rims are composed of fairly pure limestone.

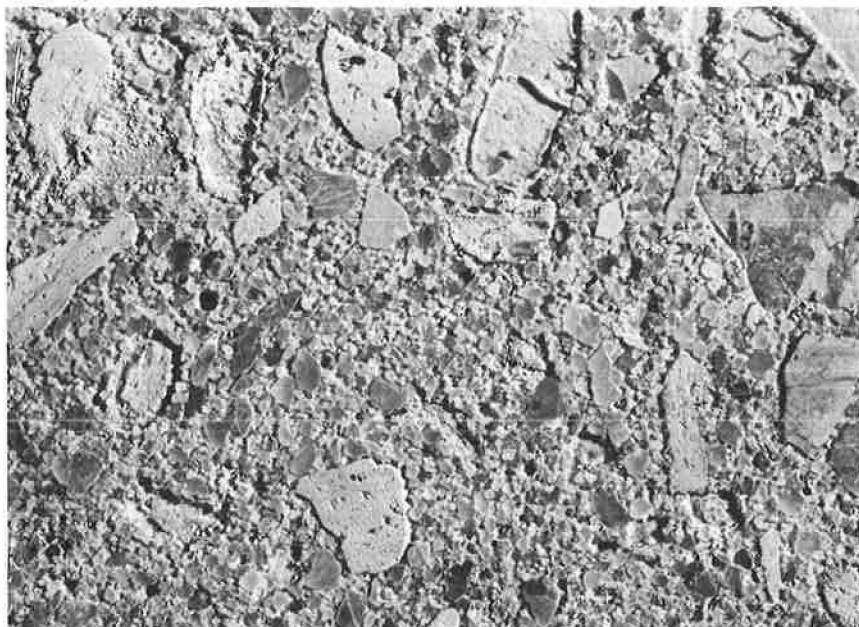
Figure 15. KC-7, sawed surface, $\times 11\frac{1}{2}$, etched with 3N hydrochloric acid. Rims that were present in mortar surrounding cherty particles were destroyed by the acid etch. Rims are present in two limestone particles in upper part of photograph.

The etched surfaces of the rimmed limestone particles contained thin rims, at or just inside the aggregate-mortar interfaces (Fig. 15) that were less soluble than the interiors of the particles. Why the limestone particles in KC-7 had rims and those in KC-6 did not is not known. The possibilities include:

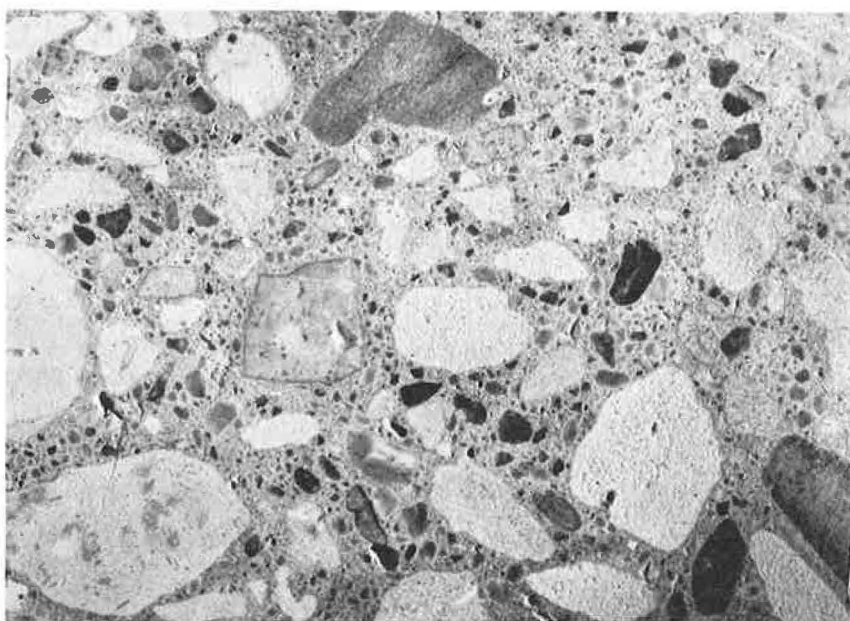
Figure 16. KC-8, sawed surface, $\times 1\frac{1}{2}$. Particles with dark, narrow reactions rims are composed of chalcedonic chert. Rest of particles, some of which are surrounded by vague rims, are of limestone composition.

Sawed and etched surfaces of slices of the core are shown in Figures 16 and 17. Figure 16, the unetched surface, shows the dark internal rims associated with the cherty particles, and shows less clearly vague rims in the mortar surrounding some of the limestone particles. Hydrochloric acid etching destroyed the rims in the chert completely. The mortar bordering the cherty particles was not etched as deeply as mortar in other areas, probably indicating that the mortar around the alkali-silica reactive particles was enriched with alkali-silica gel. The rims that developed on etched surfaces of some limestone particles in KC-1, -4, -5, and -7 were not present on limestone particles in this core; the etched surfaces of the particles were generally smooth and evenly etched.

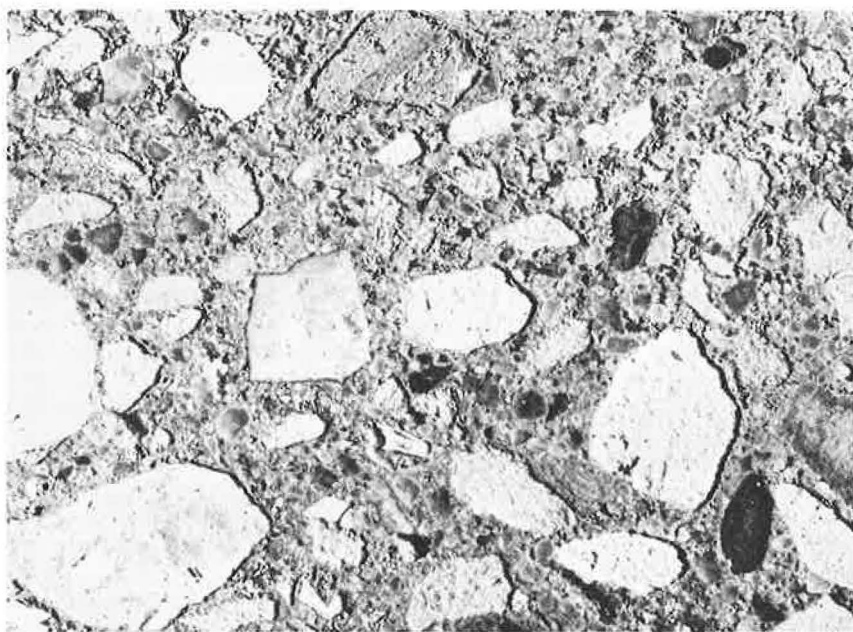
Figure 17. KC-8, sawed surface, $\times 1\frac{1}{2}$, etched with 3N hydrochloric acid. This is same surface as shown in Figure 18. Limestone particles were heavily etched by acid, whereas the chert particle, located just to left of center, was unaffected.

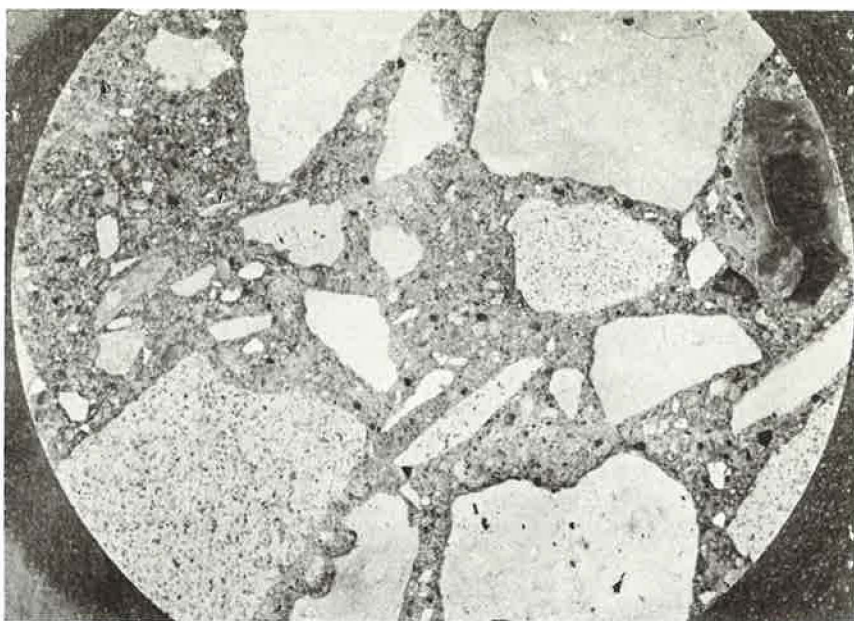
Figure 18. KC-9, sawed surface, three-quarter size. Reddish-brown carbonated rims associated with some of the limestone particles are illustrated by dark mortar rim around large limestone particle in lower right. Others are present but are less distinct. Dark particle in upper extreme right is chalcedonic chert.

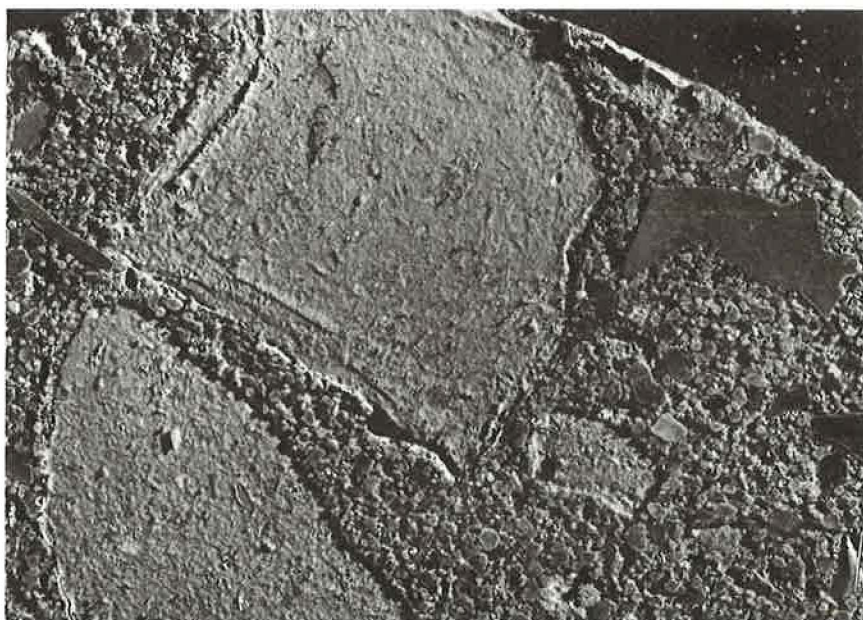
Figure 19. KC-9, sawed surface, $\times \frac{1}{2}$, etched with 3N hydrochloric acid. Large limestone particle in center contains a shell of less soluble material along two sides of particle, a slight distance inside aggregate-mortar contact. Chert particles were unaffected by acid.

Examination of the core as received, and of slices sawed from it, indicated that little reaction had taken place. No gel or obviously reacted particles were found. The chert particles were not conspicuously rimmed as in core KC-8; some of the larger limestone particles were partially rimmed by darker reddish-brown mortar borders that blended within short distances into the normal gray mortar of the rest of the core. The discolorations in the mortar were somewhat like those around some of the limestone particles in KC-1, but those in KC-9 were not as conspicuous. At low magnification a few hairline cracks were observed on sawed surfaces; the cracks appeared to originate in large coarse aggregate particles, and extended out into the mortar, running around and through other coarse aggregate particles, before fading out. The cracks were not lined with reaction products. They are believed to have been present in the concrete core before sawing. The coarse aggregate ranged from about $2\frac{1}{2}$ -in. maximum size down into sand sizes, with most of the larger particles larger than $1\frac{1}{2}$ in. About one-half of a surface sawed normal to the length of the core contained four or five coarse aggregate particles (Figs. 18 and 19). Hydrochloric acid etching destroyed rims in the mortar surrounding the limestone particles, and revealed rims similar to those in KC-1, -4, -5, and -7 on several of the limestone particles (Fig. 19).

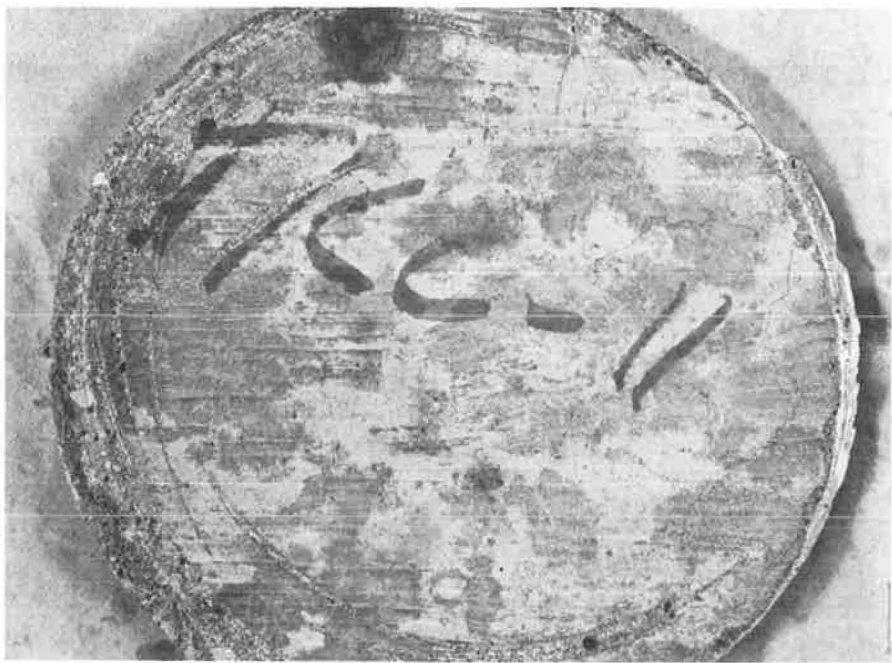
Figure 20. KC-11, finished wall surface, three-quarter size. Mottled appearance of surface is due to poor bond between wood-formed surface and rubbed on cement paste. Light areas are rubbed cement still adhering to original surface. Impression of wood form is apparent. Irregular dark lines are penciled traces of fine shrinkage cracks.

The finished surface of the core, representing the outer surface of the wall, was mottled light gray and olive-gray (Fig. 20). The mottling was caused by variations in bond between the wood-formed surface and a cement paste rendering put on to improve the appearance of the wall. Part of the rendering adhered and part did not adhere to

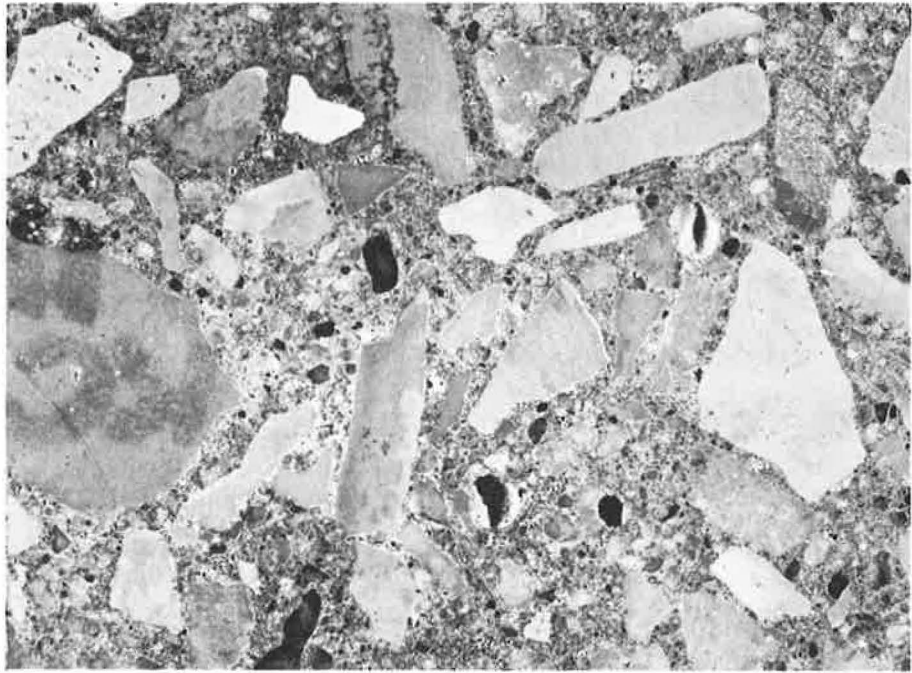
Figure 21. KC-11, sawed surface, $\times 1\frac{1}{2}$. No coarse aggregate particles are rimmed. One rimmed opaline siltstone particle is located just beneath tabular limestone particle in upper right. Dark areas in large air voids are shadows caused by crosslighting.

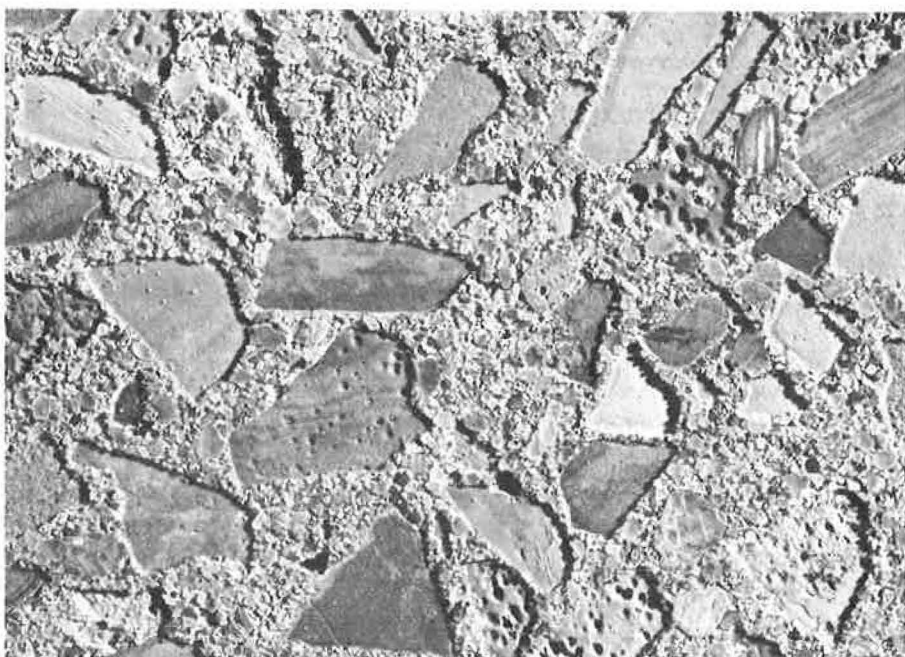
Figure 22. KC-11, sawed surface, $\times 1\frac{1}{2}$, etched with 3N hydrochloric acid. Acid made a smooth, even etch on most particles. Pocked appearance of some particles is due to dissolved-out fossils. All coarse aggregate particles are in negative relief.
