A Study of the Feasibility of Using Roadside Radio Communications for Traffic Control and Driver Information

DONALD O. COVAULT and ROBERT W. BOWES

Respectively, Professor and Graduate Research Assistant,
School of Civil Engineering, Georgia Institute of Technology

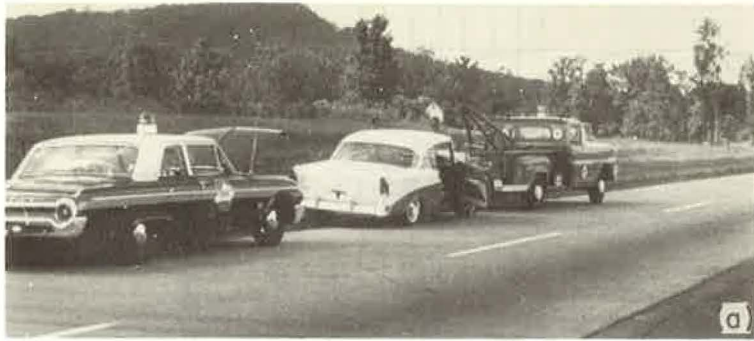
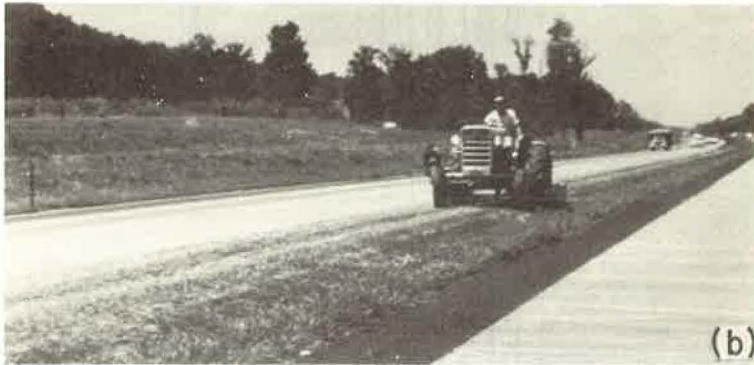
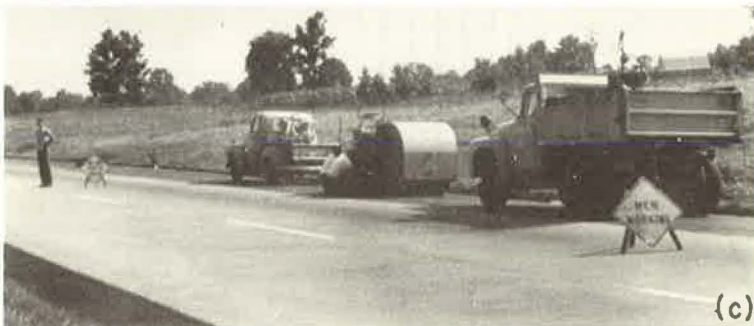
Figure 7. Activity area: (a) accident scene—Experiment 1; (b) mowing scene—Experiment 2; and (c) patching scene—Experiment 3.

Experiment 1.—Experiment 1, dealing with an accident scene, was conducted on July 23 and August 1, 1963. To simulate actual conditions, a tow truck, wrecked vehicle and a State Police cruiser were positioned in the median lane of the toll road. A State Police Officer was available to direct traffic through the area should any congestion develop. The only other warning devices used were the red flashing lights on the police vehicle and the wrecker. Figure 7a shows the accident scene.

The Kentucky State Highway Department supplied several trucks and the necessary personnel to realistically execute the work (Fig. 7). Half lane 1 was blocked in the activity area. A flagman and typical maintenance signing, visible to the approaching drivers while they were still in the grid of the camera at location 3, was used.
