HIGHWAY RESEARCH RECORD

Number 60

Rigid Pavement Design
1963
10 Reports

HIGHWAY RESEARCH RECORD 60 RIGID PAVEMENT DESIGN: 1963

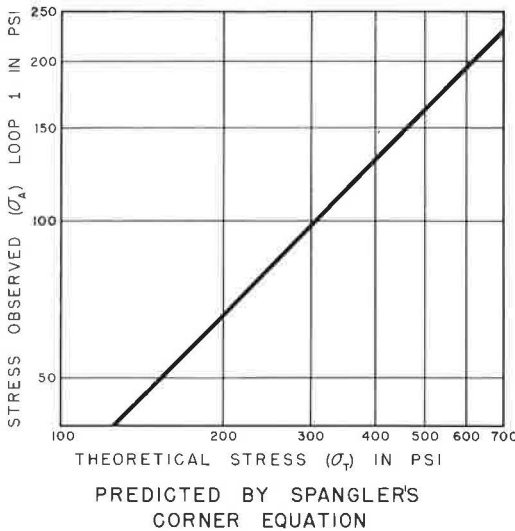
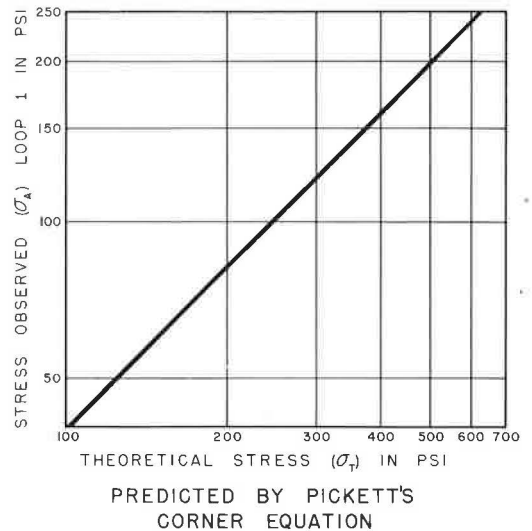
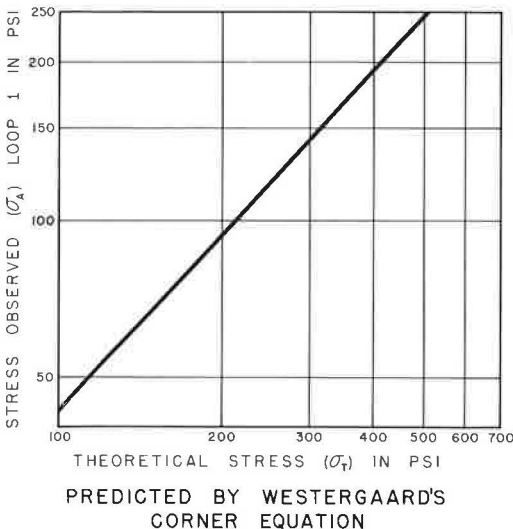
EQUATION FOR PREDICTING CORNER STRESS
OBSERVED AT THE AASHO ROAD TEST IN
TERMS OF A THEORETICAL STRESS:

σ_A = STRESSES OBSERVED LOOP 1 - AASHO ROAD TEST
 σ_T = THEORETICAL STRESSES
 A & B = CORRELATION CONSTANTS
 r^2 = CORRELATION COEFFICIENT

Figure 1. Theoretical stresses compared with observed stresses on Loop 1, AASHO Road Test.

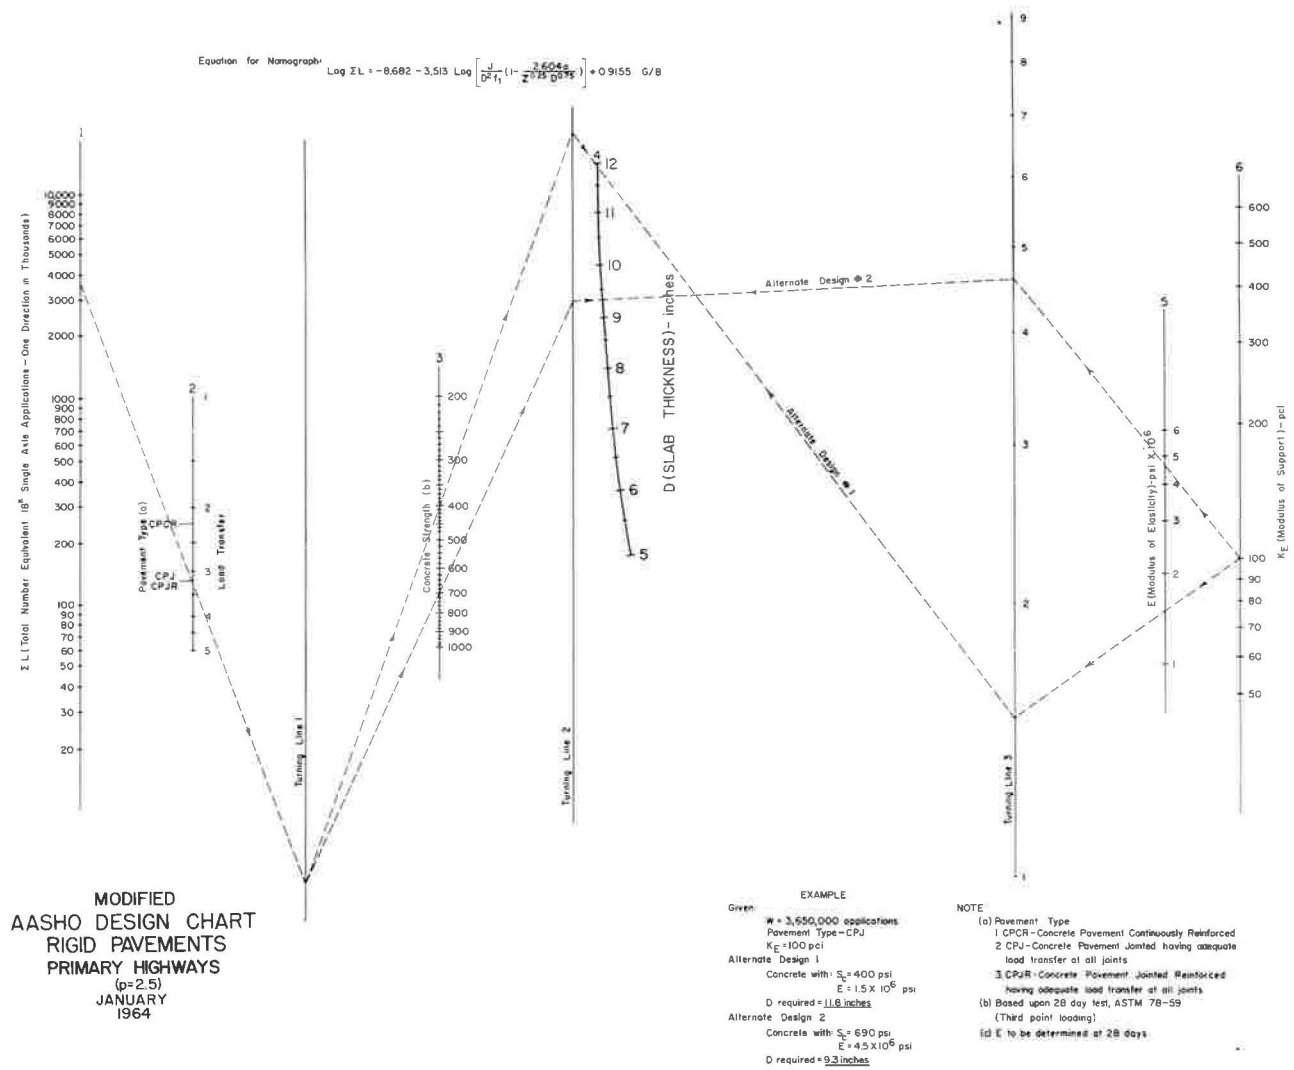
Figure 3. Rigid pavement design nomograph.

Use of the Nomograph.—The examples on the chart show how typical design problems may be handled. Certain information is normally fixed by the conditions at the site or by arbitrary choice.

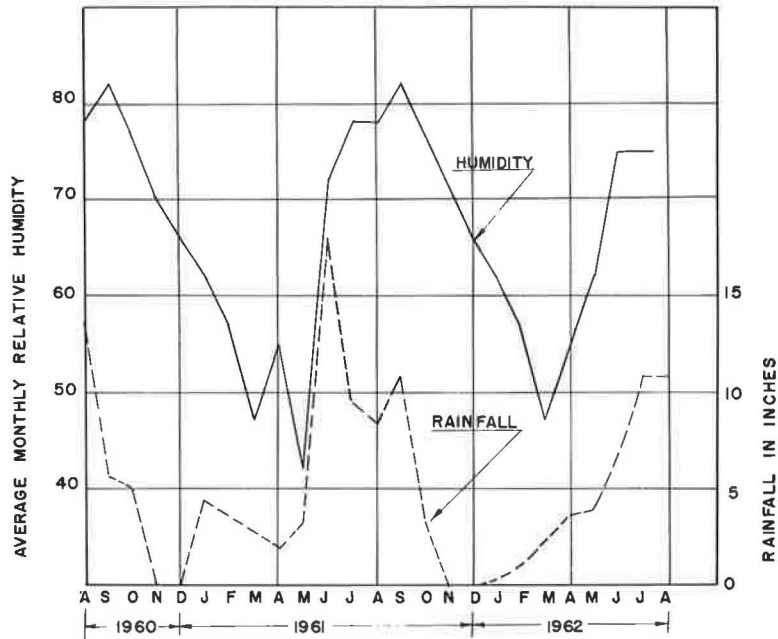
Figure 2. Annual variations in relative humidity and rainfall.

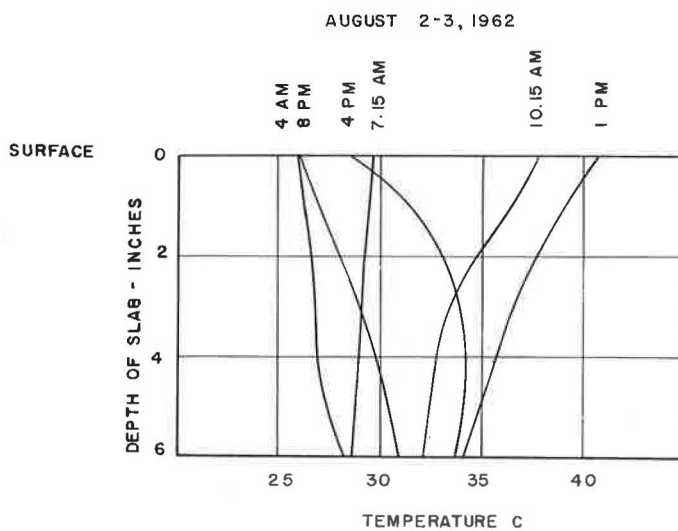
Figure 14. Variation of temperature with depths at various times.

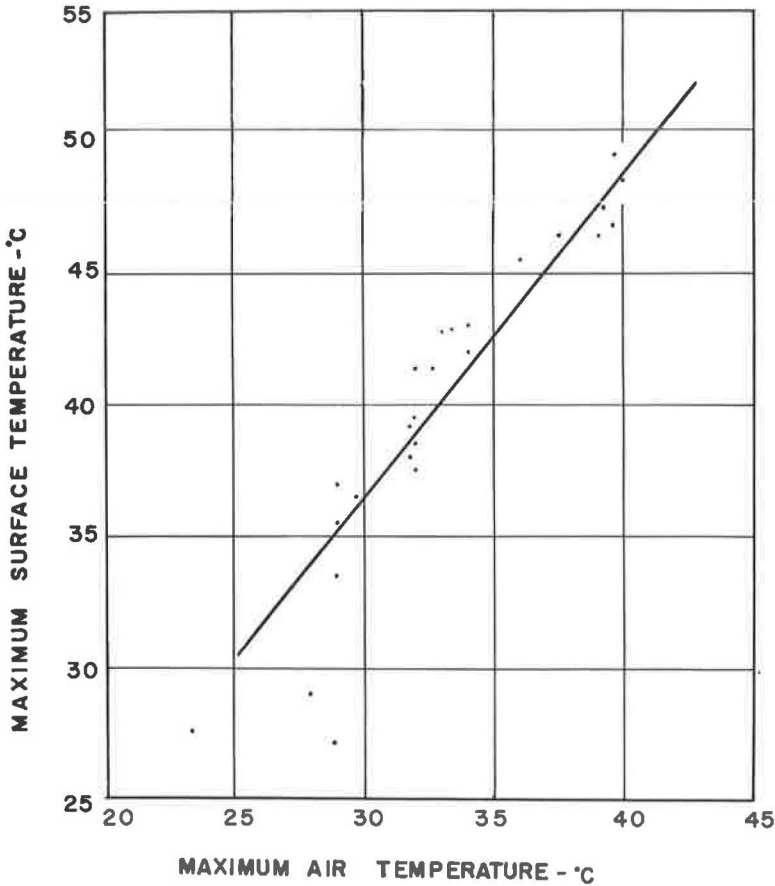
Figure 15. Maximum surface temperature vs maximum air temperature.

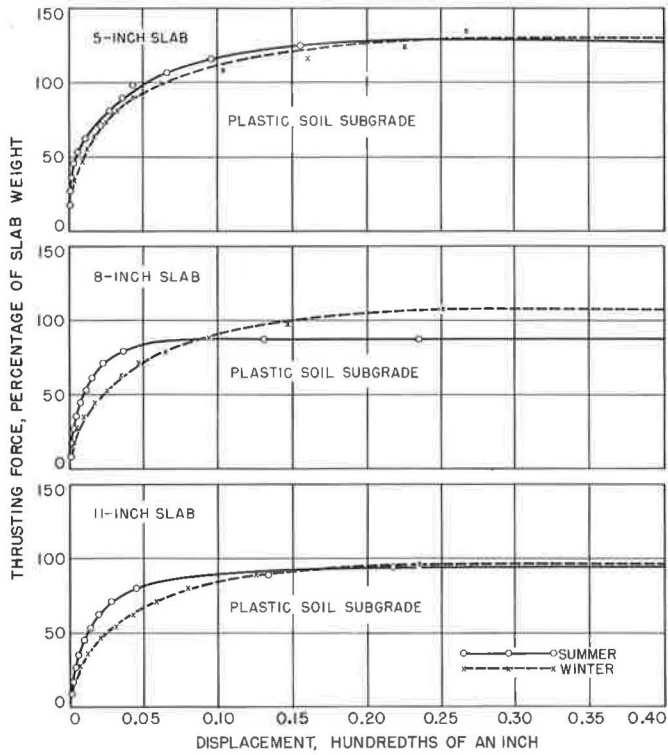
Figure 6. Force-displacement curves for concrete slabs on plastic soil.

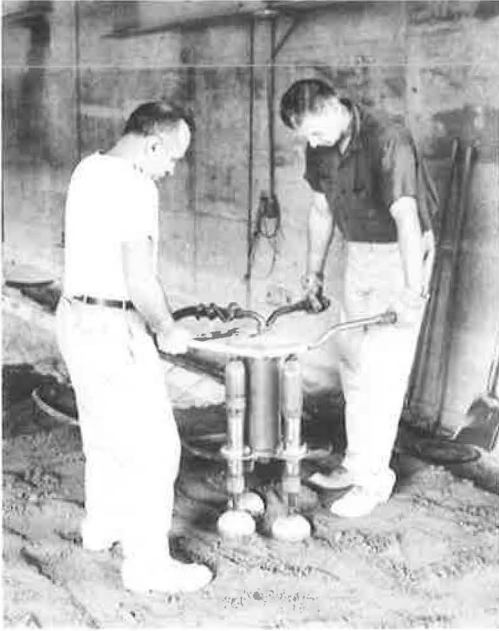
Figure 2. Consolidation of subbase with mechanical tamper.

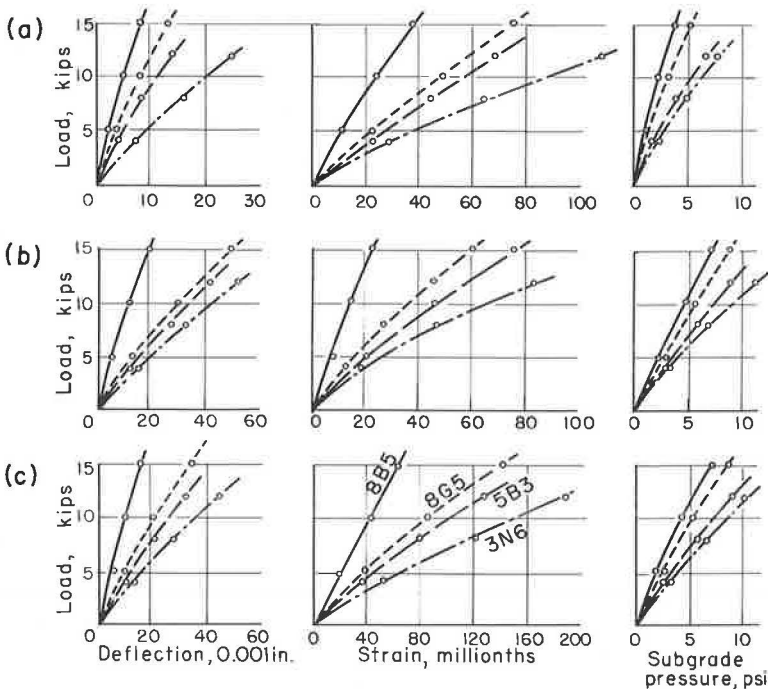
Figure 9. Representative data: (a) interior, (b) joint corner, and (c) free edge (8B5 and 8G5, doweled; 5B3 and 3N6, undoweled).

Relative Response of Test Pavements to Load. —The deflection, strain, and pressure responses to 9-kip loads at interior and free edge positions on all combinations are shown in Figure 10. The ability to support loads is an inverse function of these measurements, therefore low magnitudes indicate high load capacity. The order of increasing magnitude of deflection, strain, and pressure is not always the same; but if the 8-in. slab on 5-in. gravel is ignored, the order is well established for combinations of

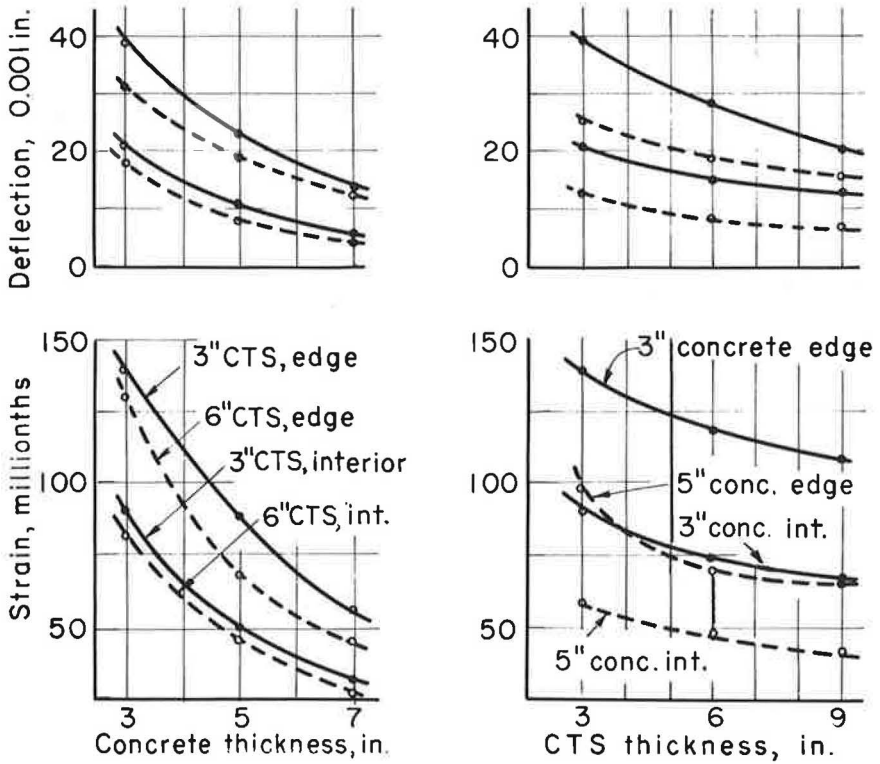
Figure 15. Influence of layer thickness.

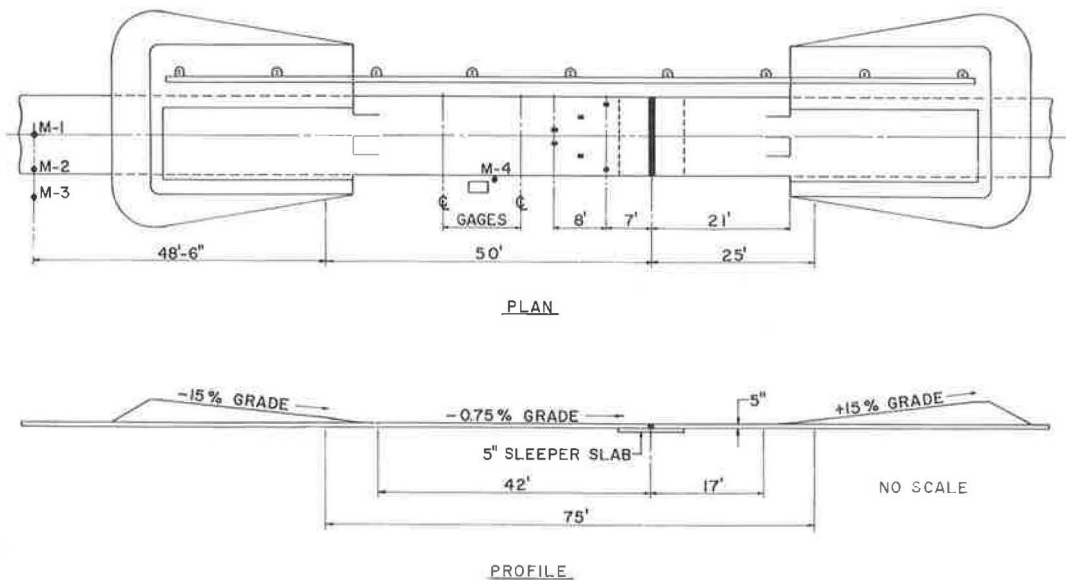
Figure 1. Test strip.

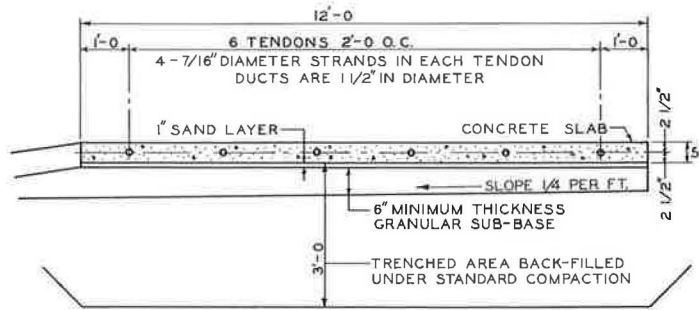
Figure 2. Typical site cross-section.

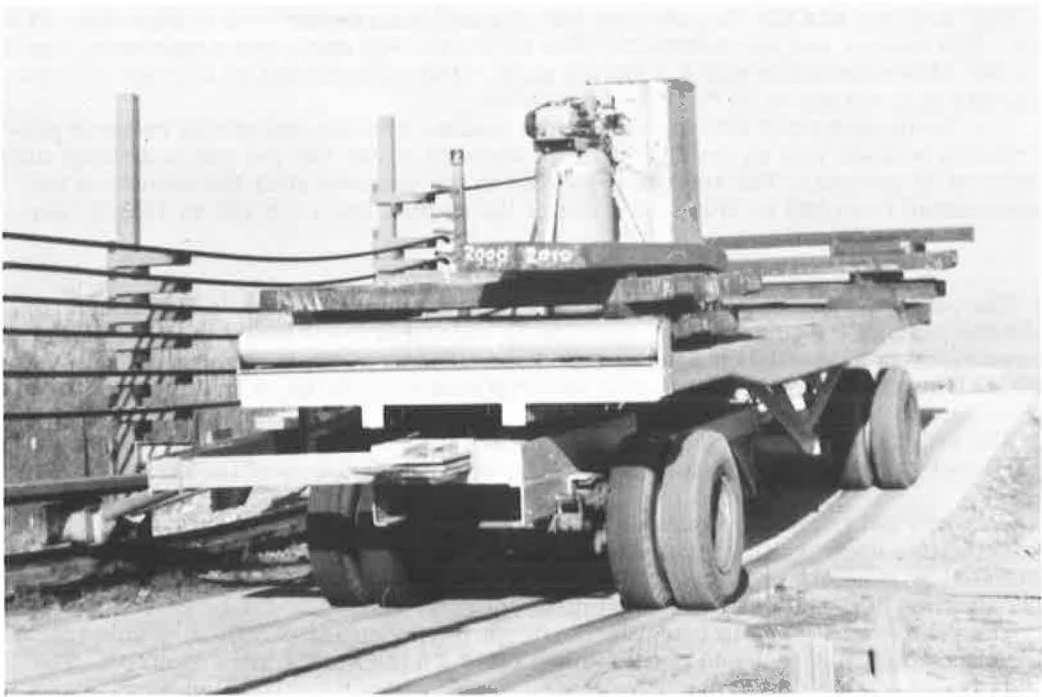
Figure 4. Assembled vehicle in operation.

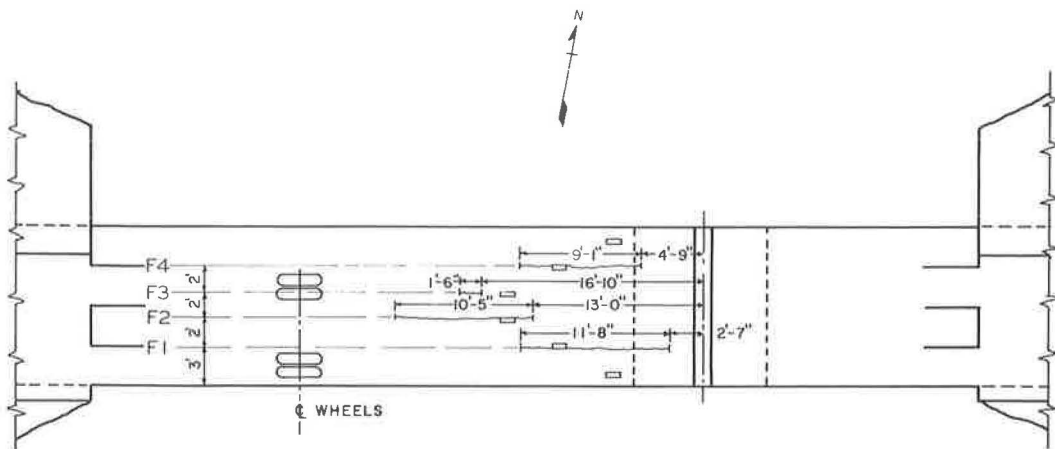
Figure 22. Longitudinal cracks, Aug. 22, 1962.

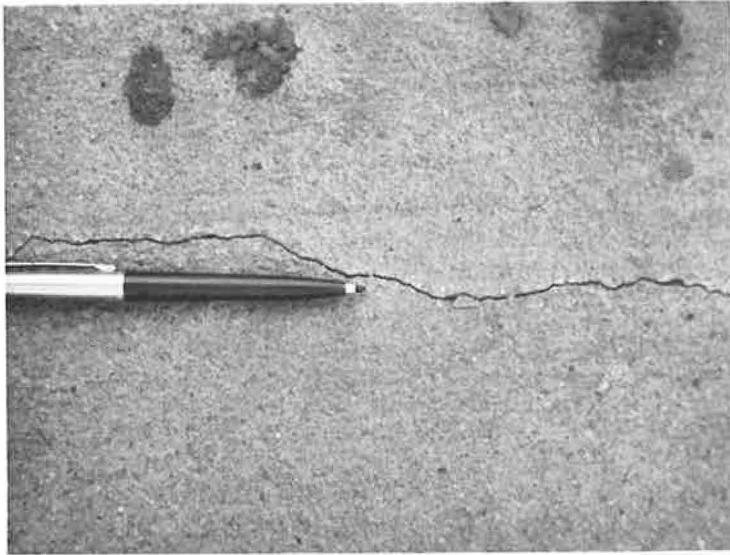
Figure 24. Longitudinal crack at F-2.

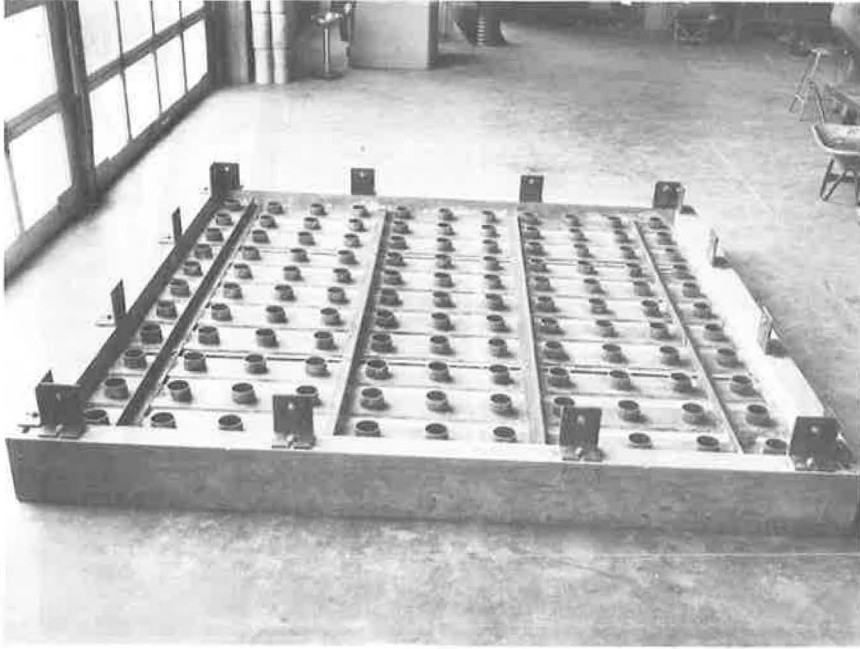
Figure 2. Concrete box before coil spring placement.

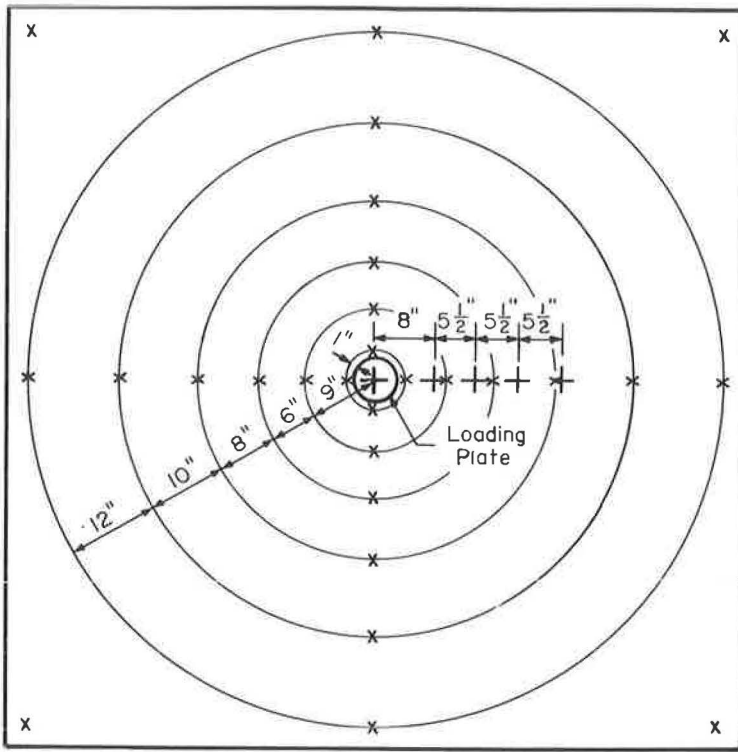
— Top Surface Strain Gage Location
 X Deflection Dial Location
 Figure 5. Typical instrumentation plan.

The deflection pattern of each slab was determined by twenty-eight 0.001-in. dial indicators attached to a wooden bridge that rested on the machine platen. Deflection measurements were noted at each load increment.

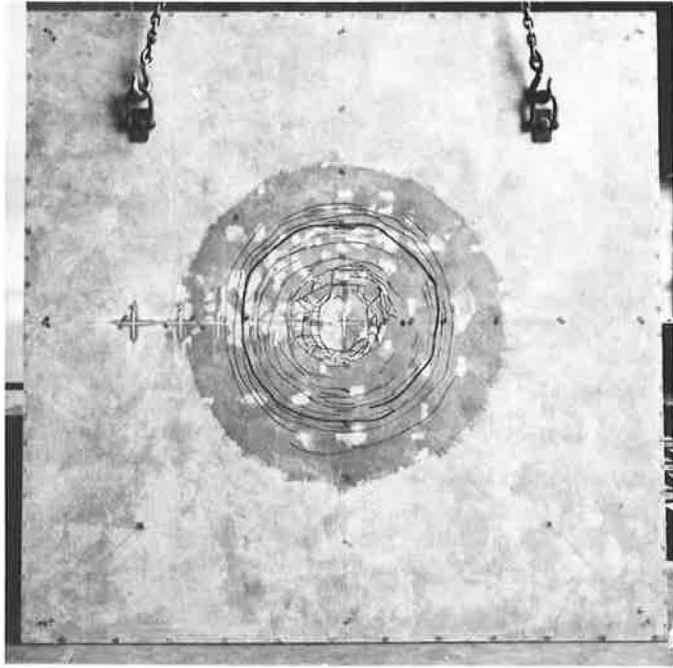
Figure 6. Top surface cracking after test of Slab 2.

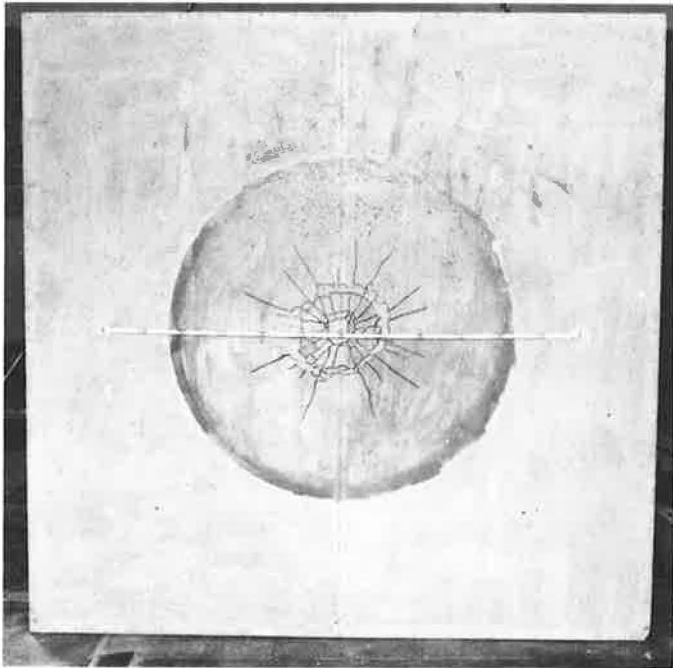
Figure 7. Bottom surface cracking after test of Slab 2.

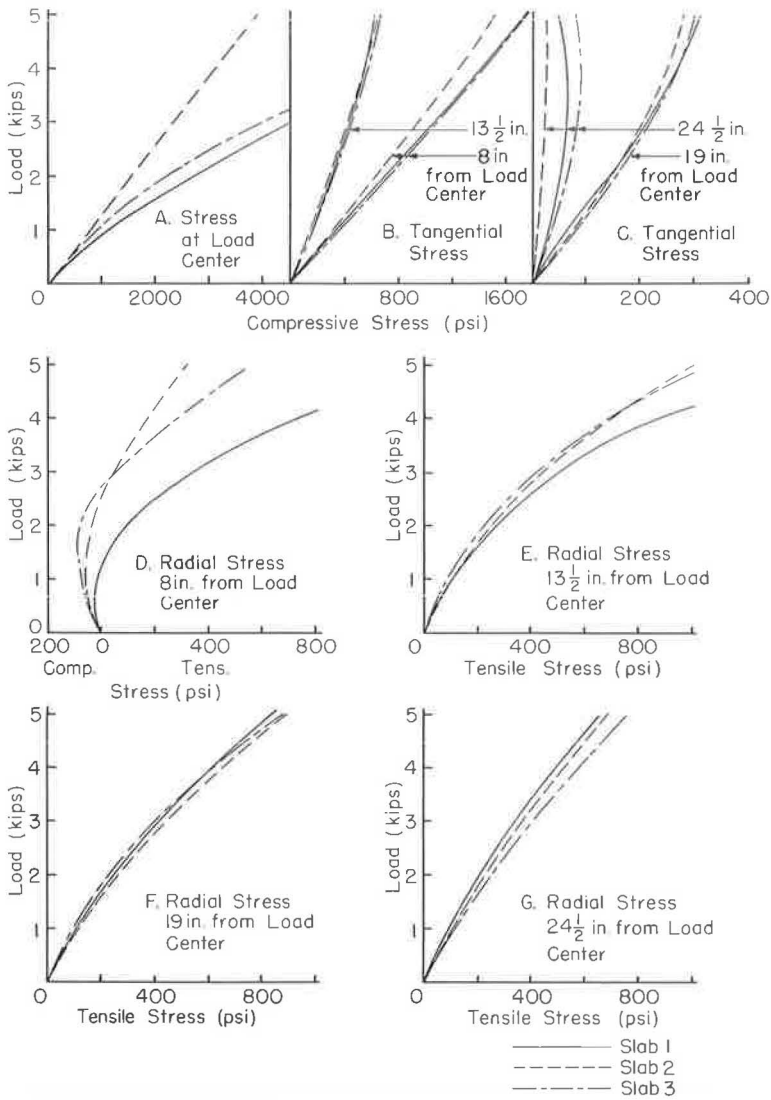
Figure 8. Top surface stresses.

Assuming the neutral axis to be at the mid-depth of the slab, top surface compressive stresses at the load center (Fig. 8A) were used to determine bottom surface crack-

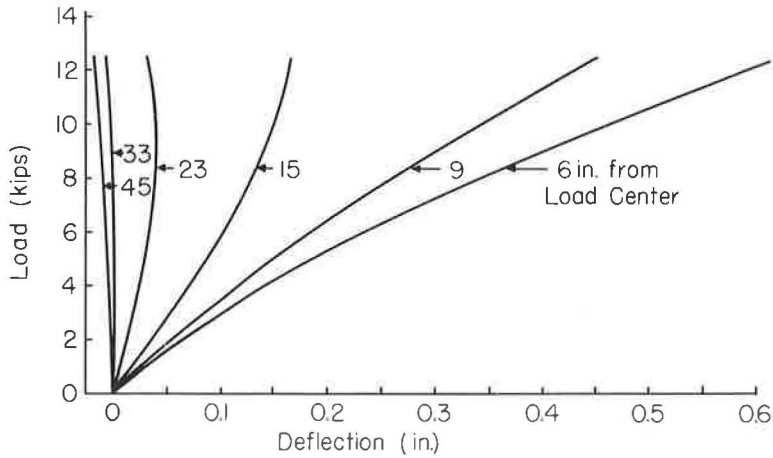
Figure 9. Deflection of Slab 2.

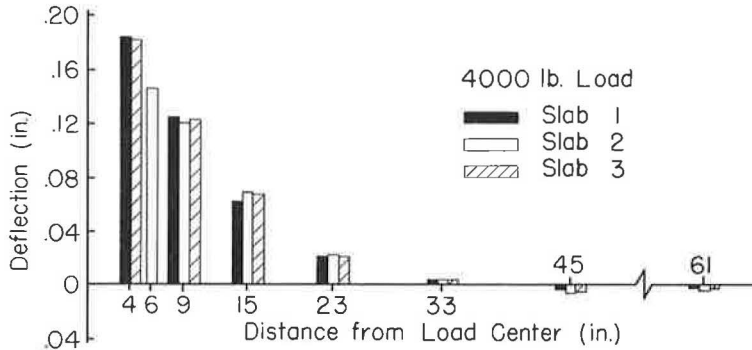
Figure 10. Comparison of slab deflections.

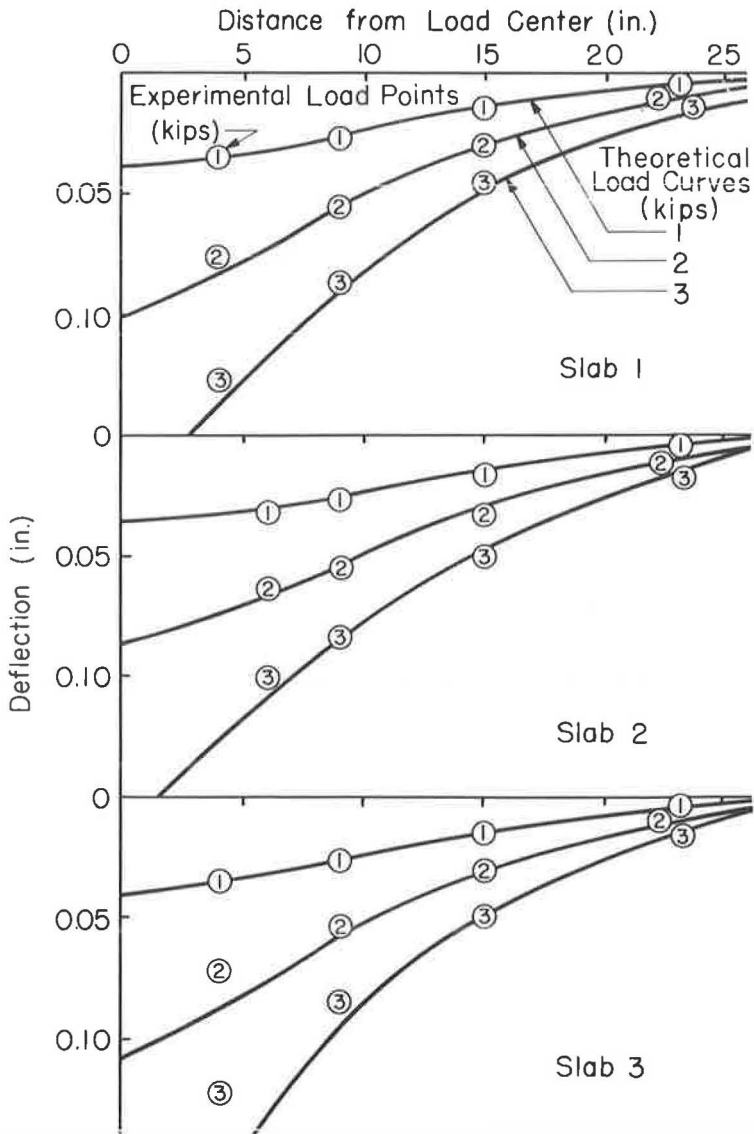
Figure 11. Comparison of experimental and theoretical deflections.

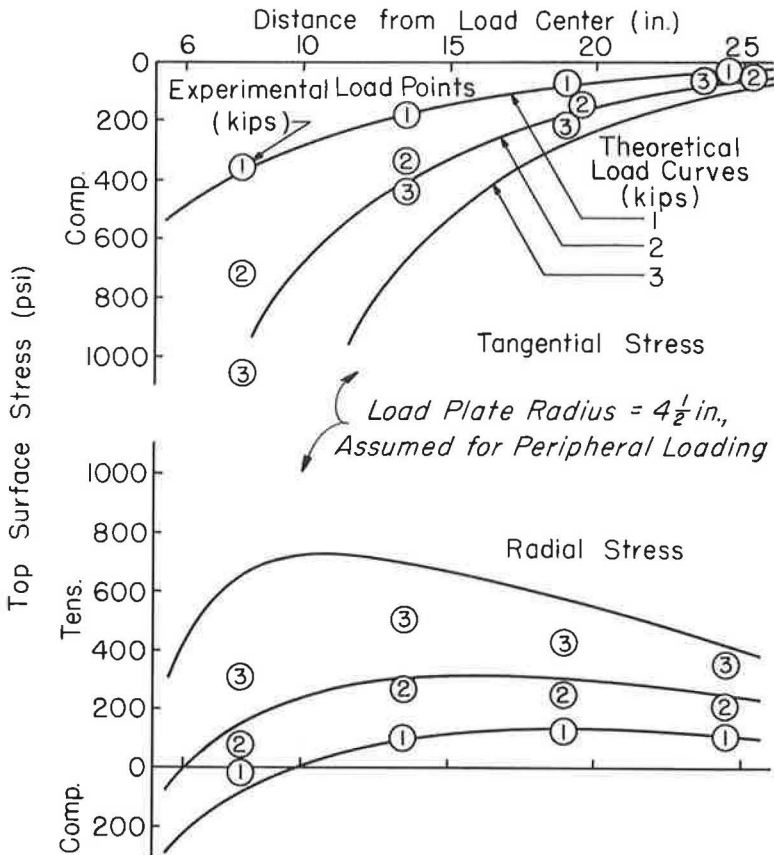
Figure 14. Comparison of experimental and theoretical stresses of Slab 1.

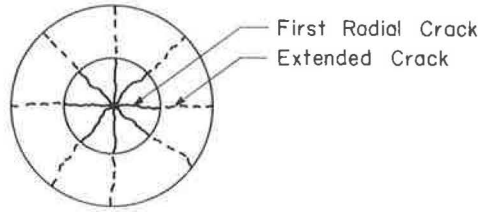
A. Assumed Bottom Surface Crack Pattern

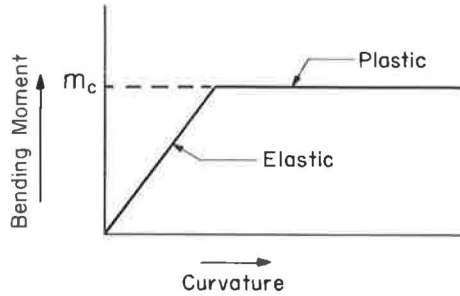
B. Assumed Moment-Curvature Relationship

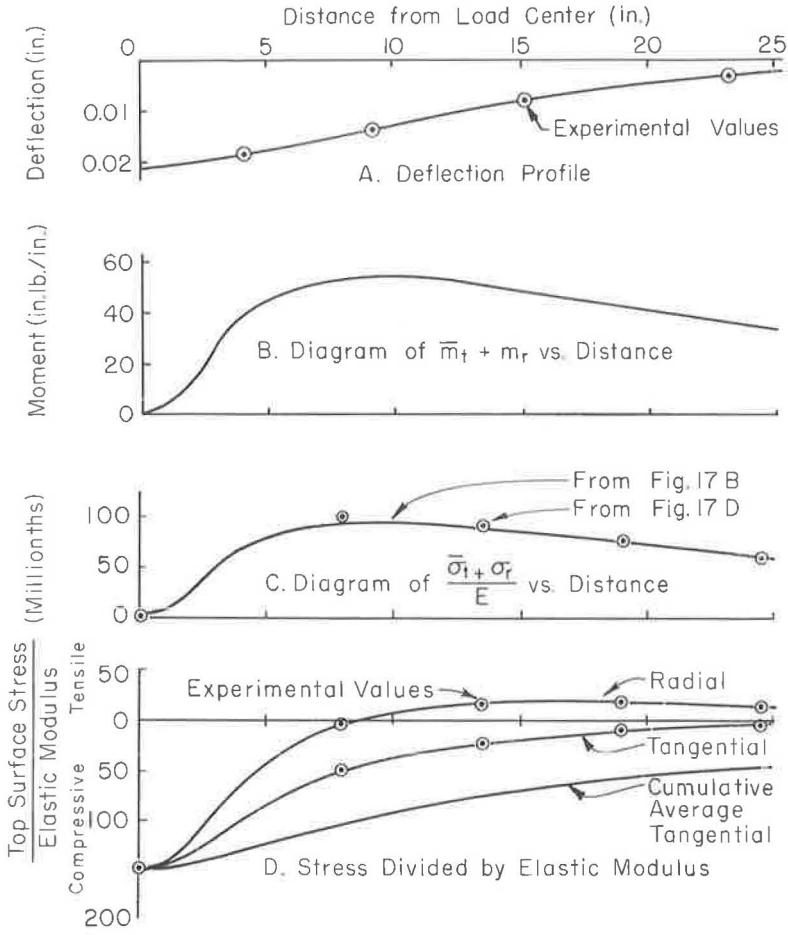
Figure 17. Diagrams for 500-lb load on Slab 1.

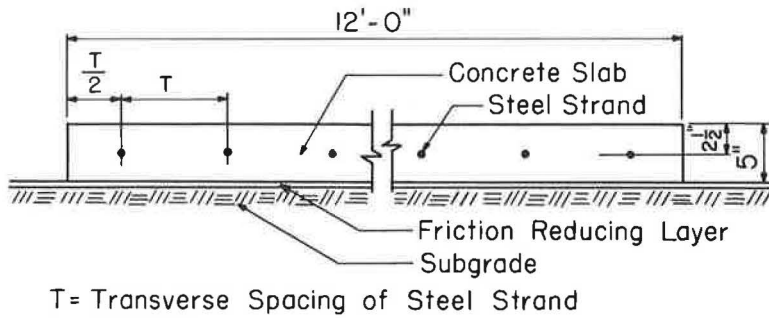
Transverse Section (All Slabs)

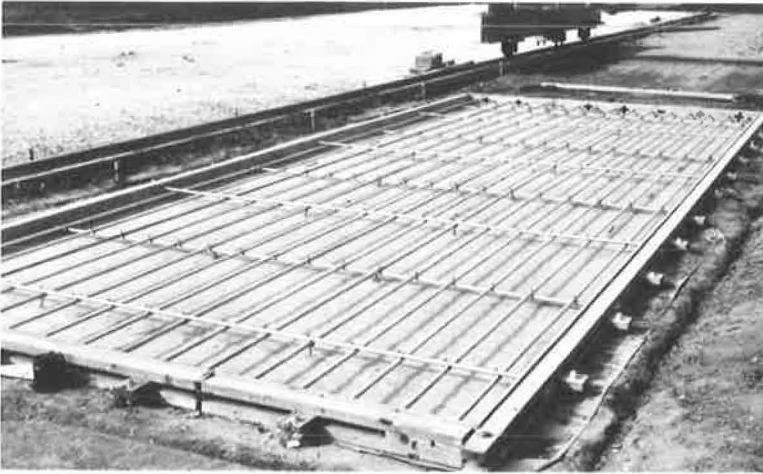
Figure 2. Grid of flexible conduit prepared for slab with two-way prestress.

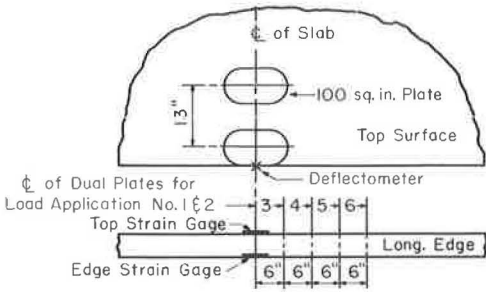
Figure 4. Bottom cracking load positions and instrumentation.

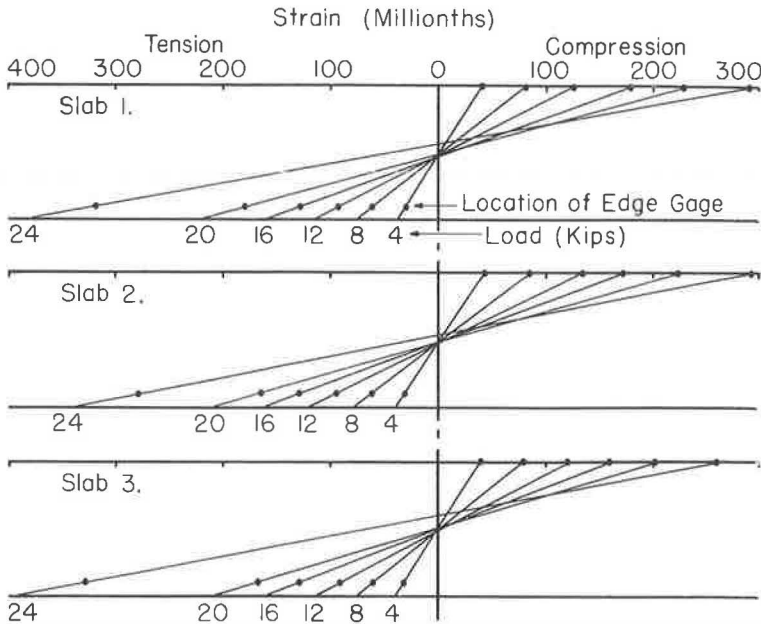
Figure 5. Edge strain diagrams.

Initial Loadings. — The data obtained from the initial edge load tests on the three slabs are shown in Figures 5 through 7. The slabs were uncracked at the time of loading. Figure 5 shows the strains measured by the gage on the top surface and the gage on the vertical edge near the bottom surface of each slab. A linear strain distribution was assumed, and straight lines connecting these measured strains passed through zero strain near the mid-depth of the slabs before bottom surface cracking occurred. After cracking there were larger strain changes per unit load; the strains measured near the bottom surface increased more than the top surface strains, and the locations of zero strain occurred above the mid-depth of the slabs. The true bottom surface cracking loads were difficult to determine but were estimated at 18,000 lb for Slab 1 and 20,000 lb for Slabs 2 and 3. The additional longitudinal prestress resulted in an increase in the load causing bottom surface cracks that extended in a generally transverse direction inward from the edge.

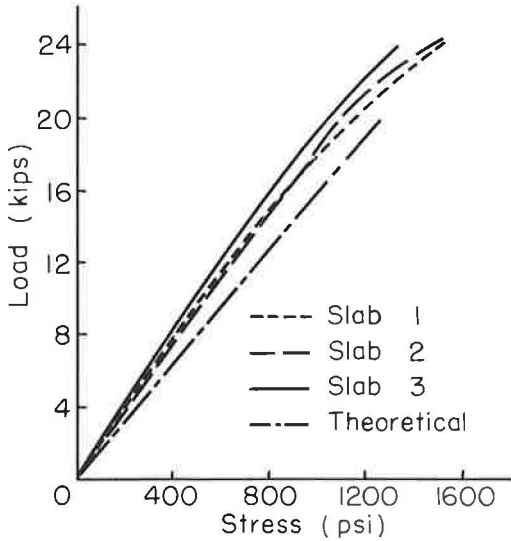
Figure 6. Top surface compressive edge stresses.

Top surface longitudinal edge stresses at the load were computed by multiplying the measured compressive strains by the concrete elastic modulus using a value of 5 million psi. These stresses are shown in Figure 6 with the corresponding edge deflections shown in Figure 7. These figures indicate that the compressive stress and deflection at the edge were nearly proportional to the applied load before bottom surface cracking occurred. Values computed by methods based on the elastic theory are also shown on these figures. For this purpose, influence charts (5) were used with a value of 140 pci for the subgrade modulus, 5 million psi for the concrete elastic modulus, and 0.15 for Poisson's ratio. The load test compressive stresses and deflections averaged 16 per-

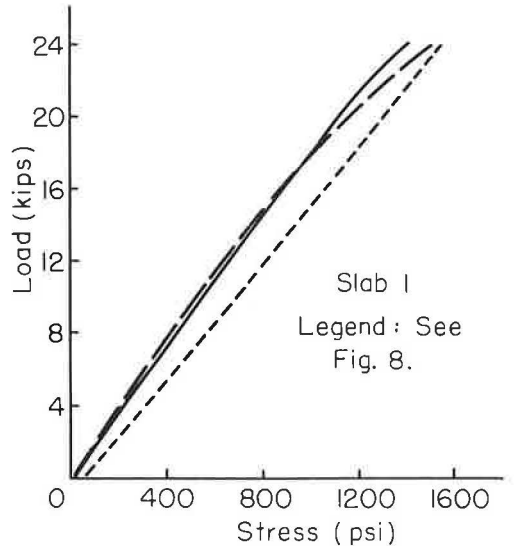
Figure 9. Top surface compressive edge stresses.

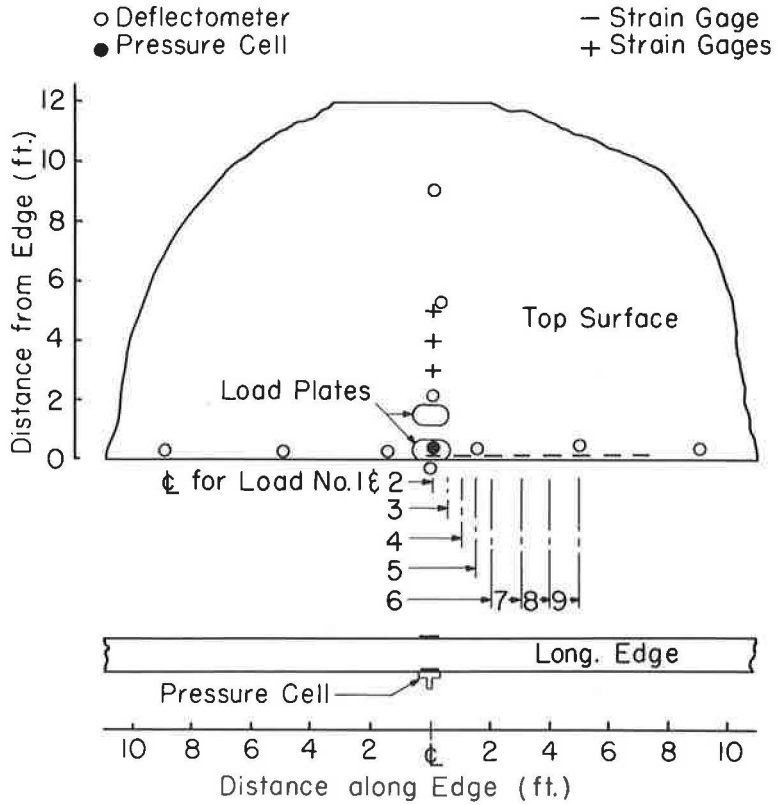
Figure 10. Top surface cracking load positions and instrumentation.

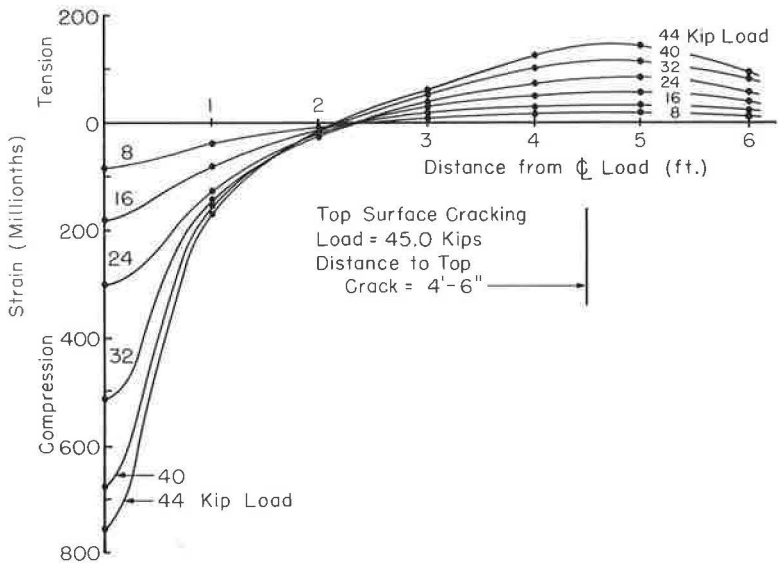
Figure 11. Distribution of top surface strains along edge of Slab 1.

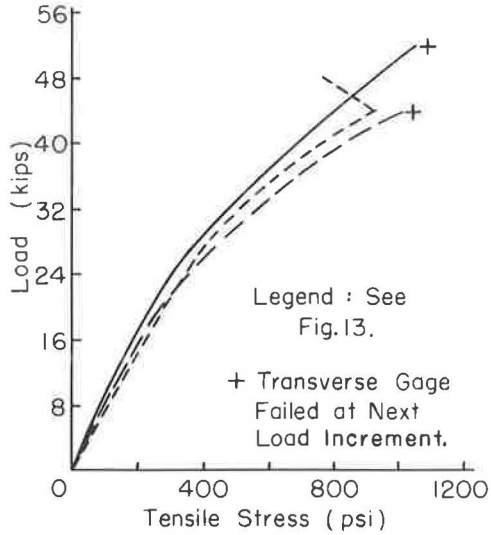
Figure 14. Maximum top transverse tension inward from edge.

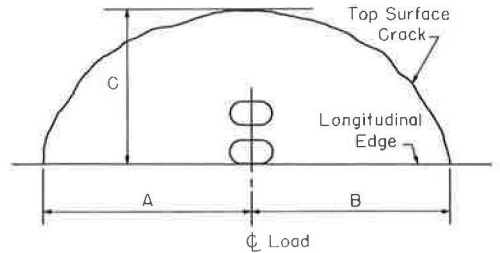
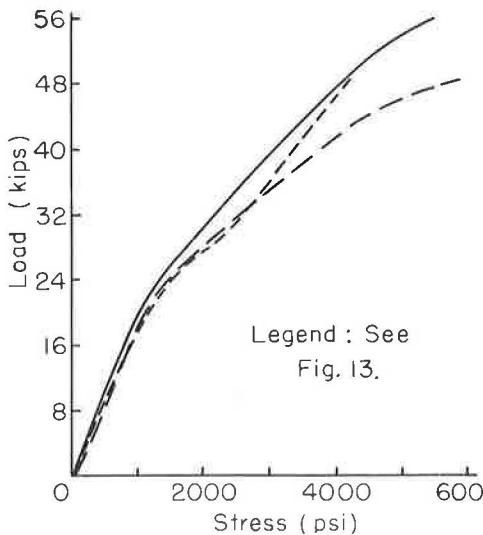
Figure 15. Top surface longitudinal compressive edge stress at load.

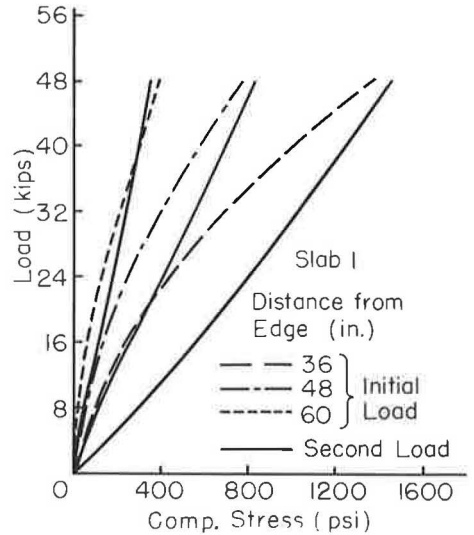
Figure 23. Top surface longitudinal compressive stress inward from edge.

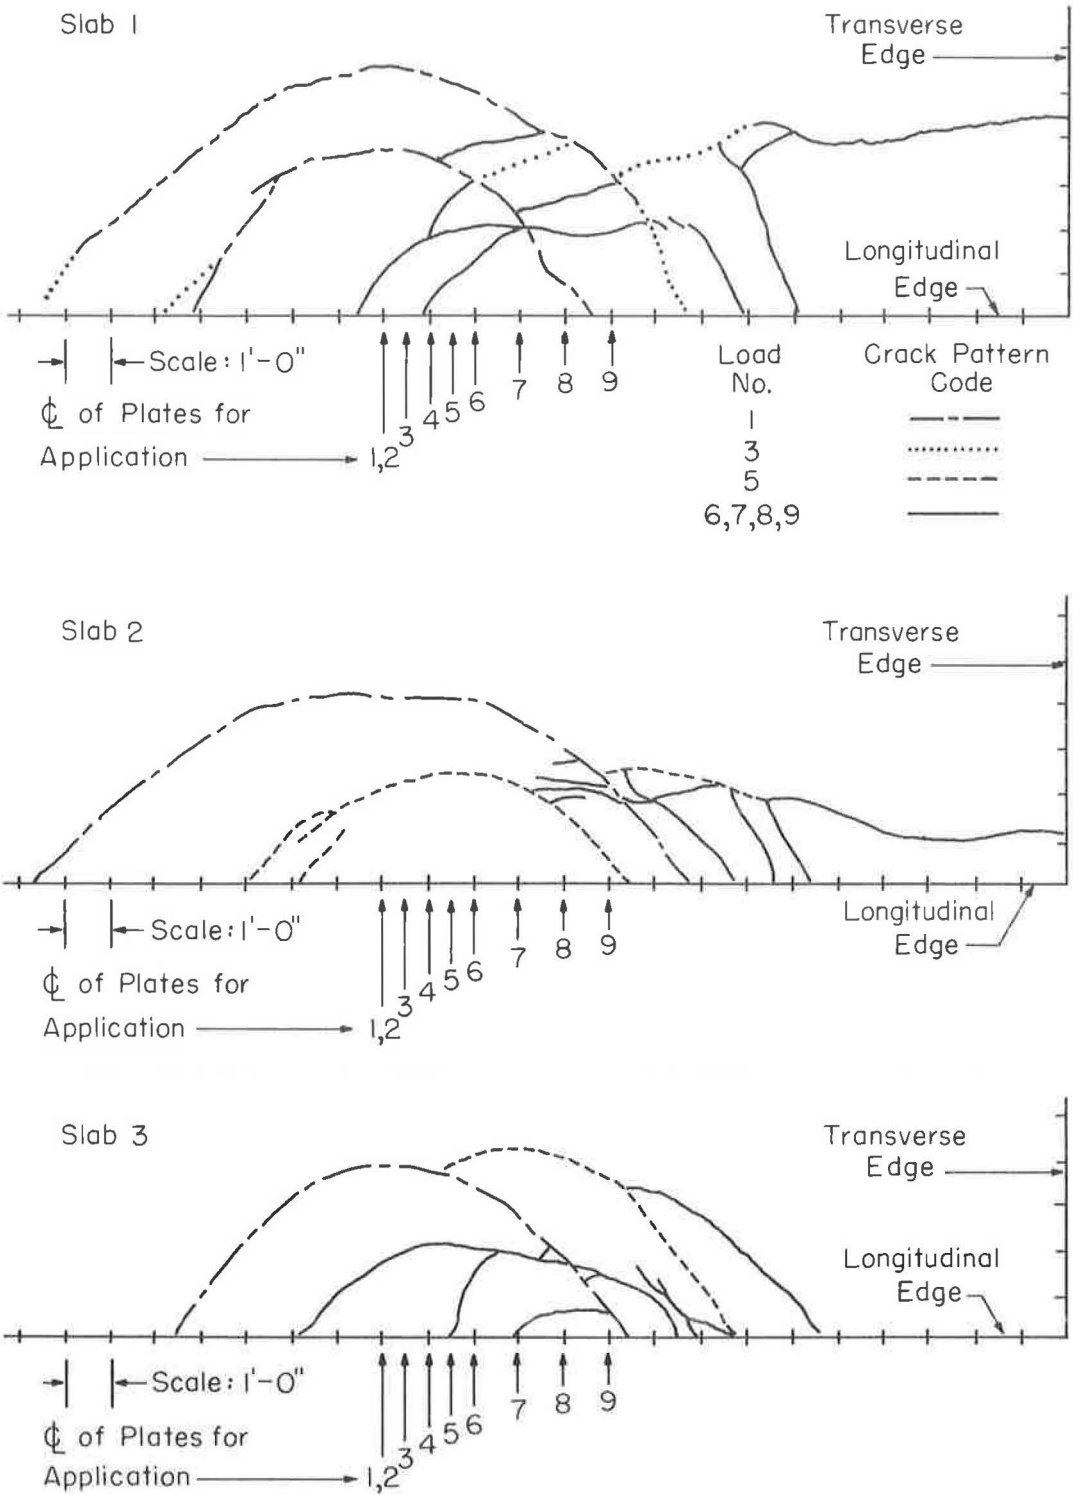
Figure 24. Top surface crack patterns for edge load tests.

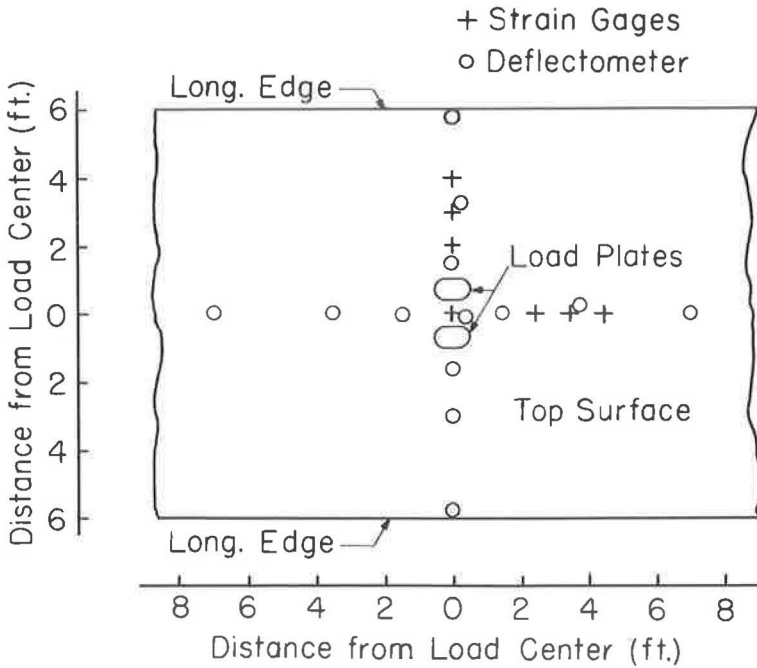
Figure 25. Interior load instrumentation plan.

Static loads were also applied at an interior location of each slab. The dual loading plates were positioned midway between the longitudinal slab edges at a minimum distance of 8 ft from a transverse edge. The load was increased in 4-kip increments until either top surface cracks appeared or the loading equipment's safe limit was reached. At each increment measurements were made to determine the longitudinal and trans-

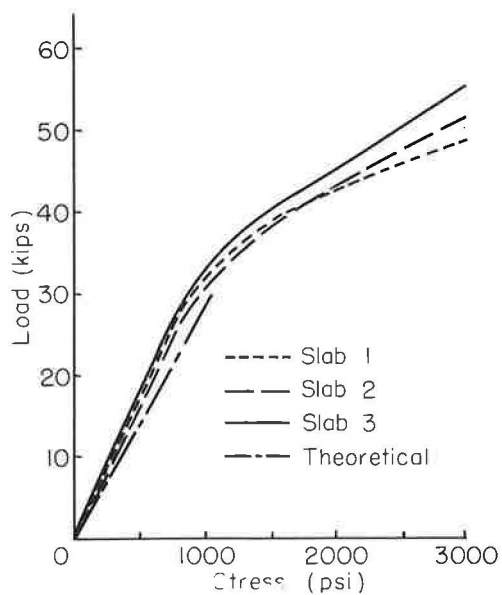
Figure 26. Top surface longitudinal compressive stress at load.

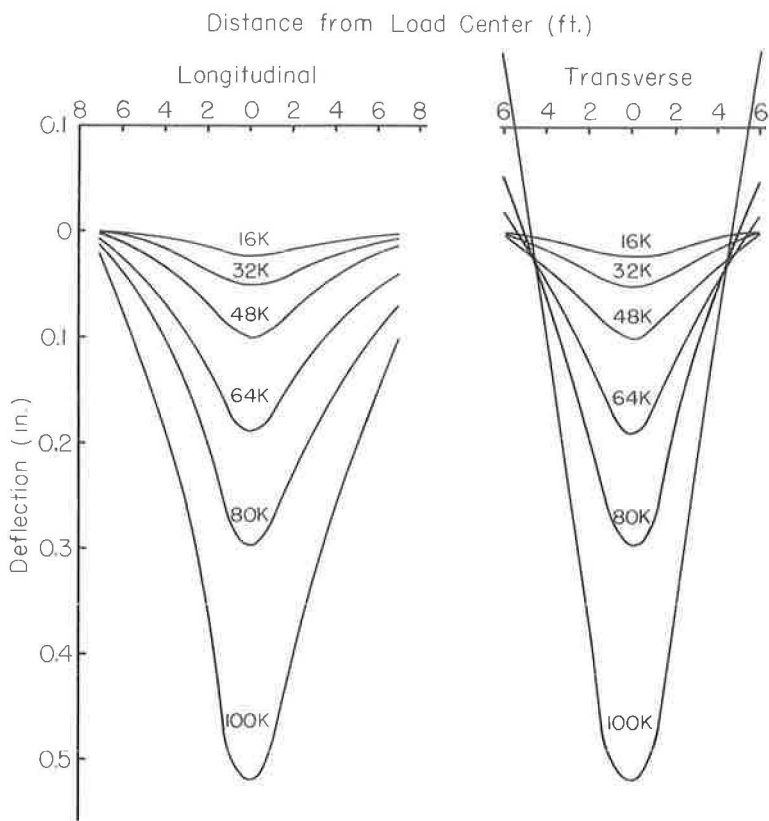
Figure 30. Deflection profiles, interior load, Slab 3.
