HIGHWAY RESEARCH RECORD

Number 60

Rigid Pavement Design
1963
10 Reports

HIGHWAY RESEARCH RECORD 60 RIGID PAVEMENT DESIGN: 1963

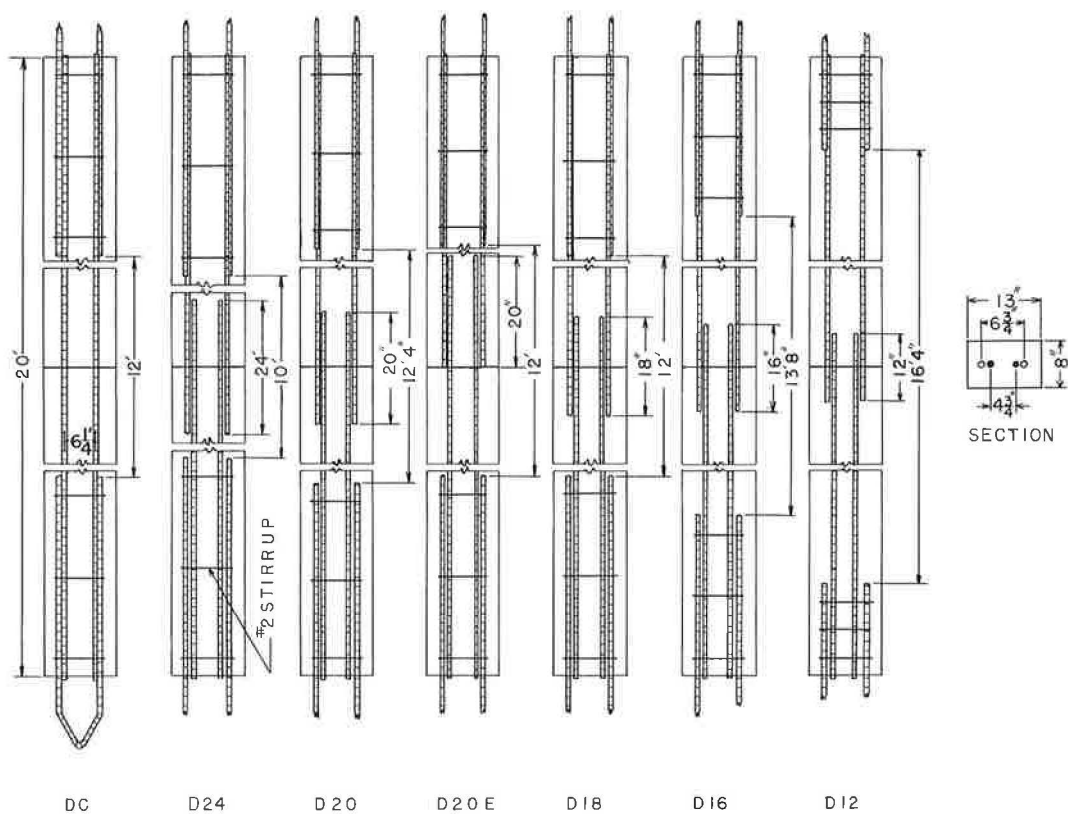
Figure 1. Deformed-bar specimens, series D.

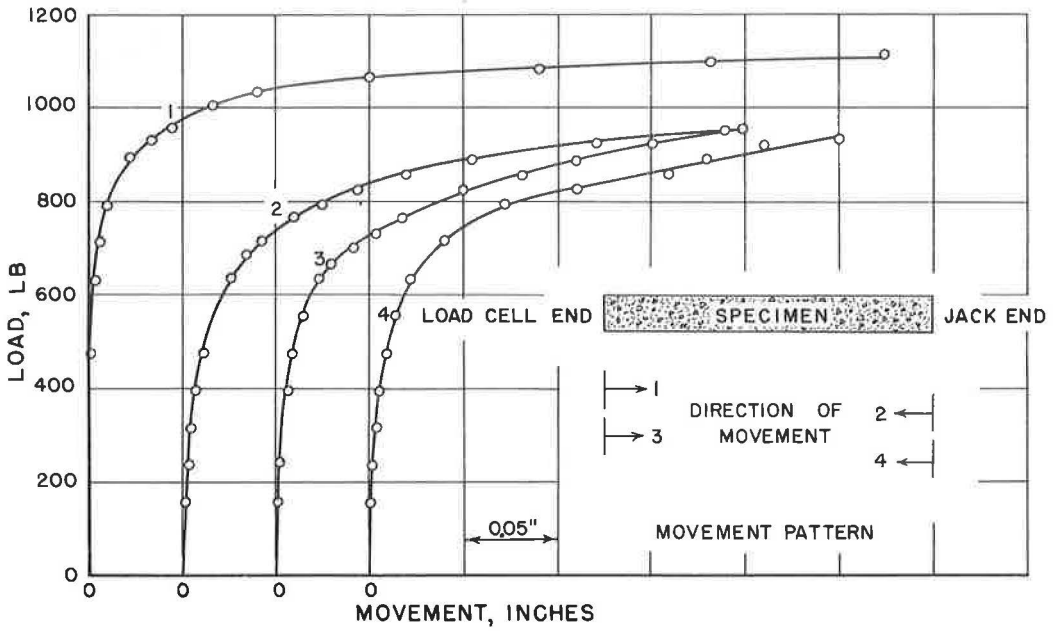
Figure 6. Frictional resistance, specimen D16-14.

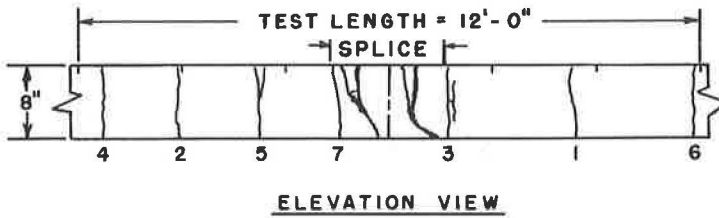
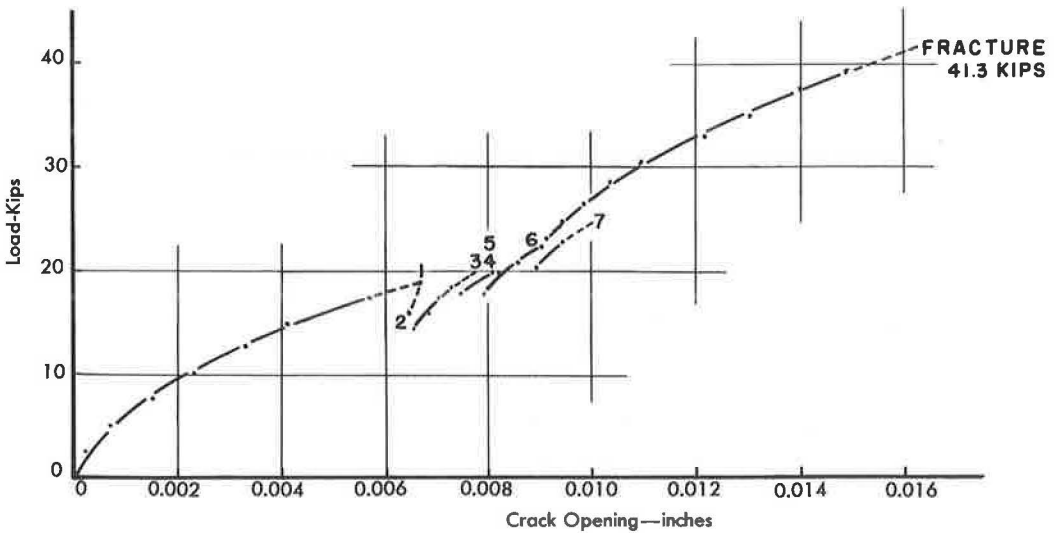
Figure 11. Test record, specimen WWF26-1.

Specimen WWF26-1 (Fig. 11) is typical of stronger welded-wire fabric splices. The first transverse crack (1) formed at 18.5 kips (steel stress 31.4 ksi). As the load dropped to 15.7 kips and the preformed crack closed a little, a second transverse crack (2) formed. Five additional transverse cracks formed at loads between 14.1 to 24.4 kips and preformed crack openings 0.0065 to 0.01 in. Beyond this stage, both preformed and transverse cracks continued to open but no additional cracks occurred prior to fracture of the splice at 41.25 kips (steel stress 70.0 ksi). The fracture was

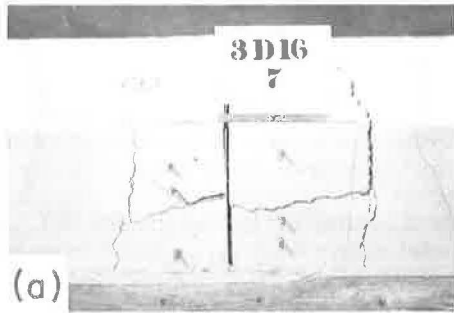
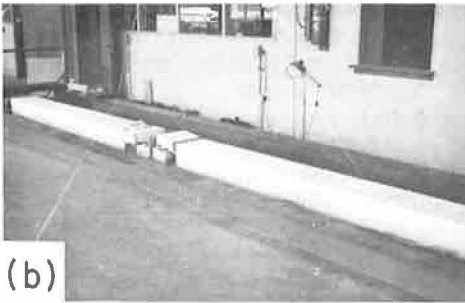
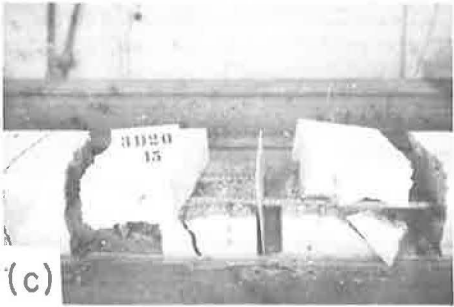
Figure 12. Fracture patterns: (a) specimen D16-7, (b) D20-15, and (c) D20-15.

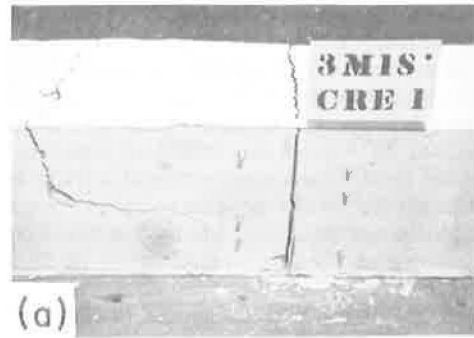
Figure 13. Fracture patterns: (a) specimen WWF18E-1 and (b) WWF26-1.

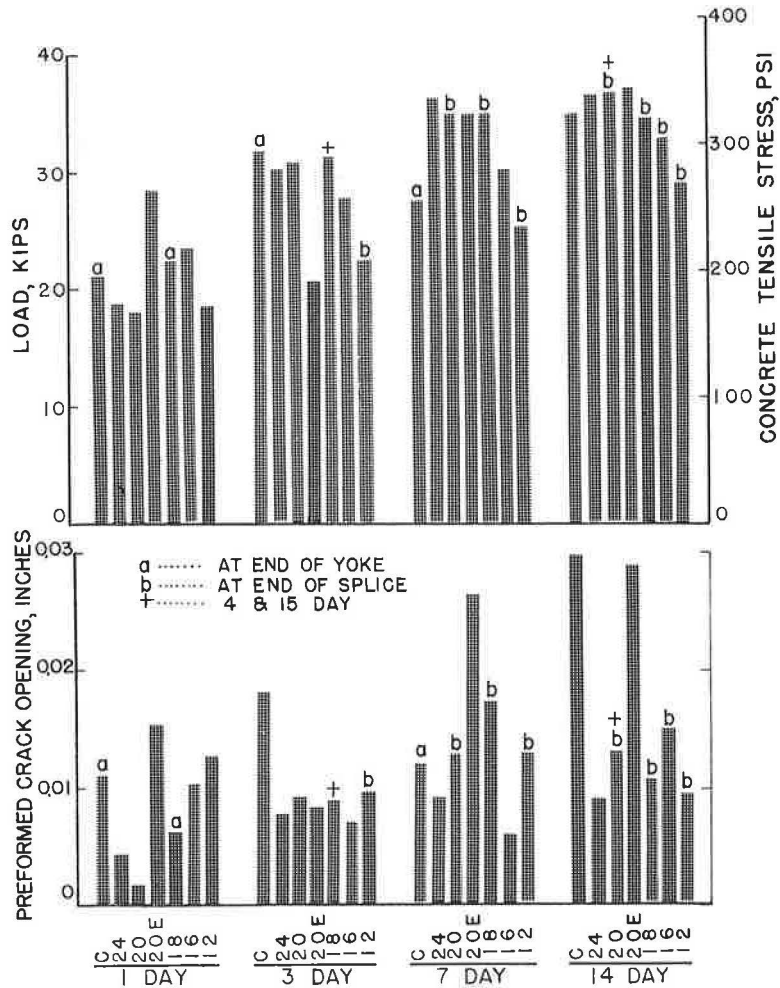
Figure 14. First transverse cracks, series D.

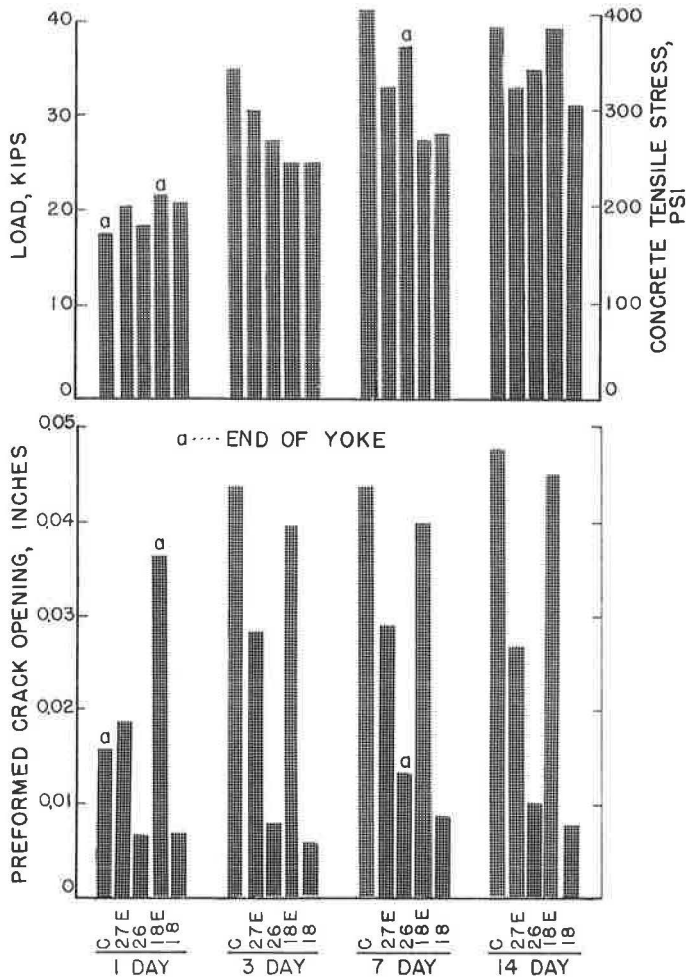
Figure 15. First transverse cracks, series WWF.

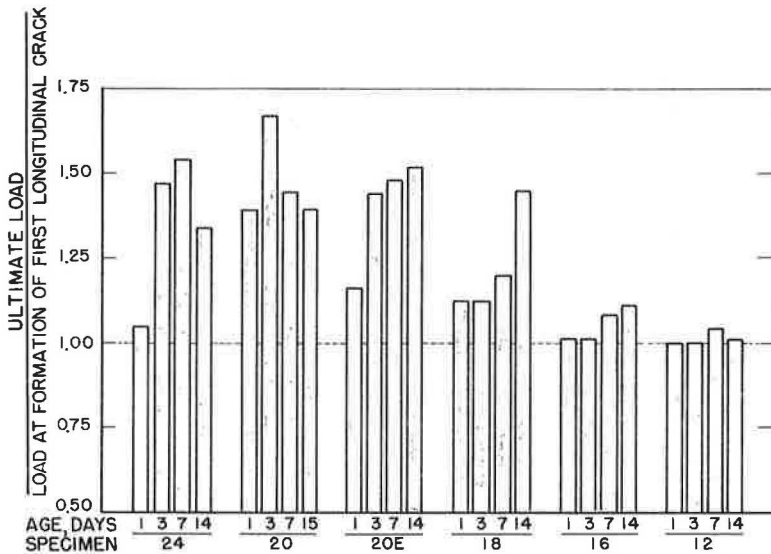
Figure 17. First longitudinal crack at the preformed crack, series D.

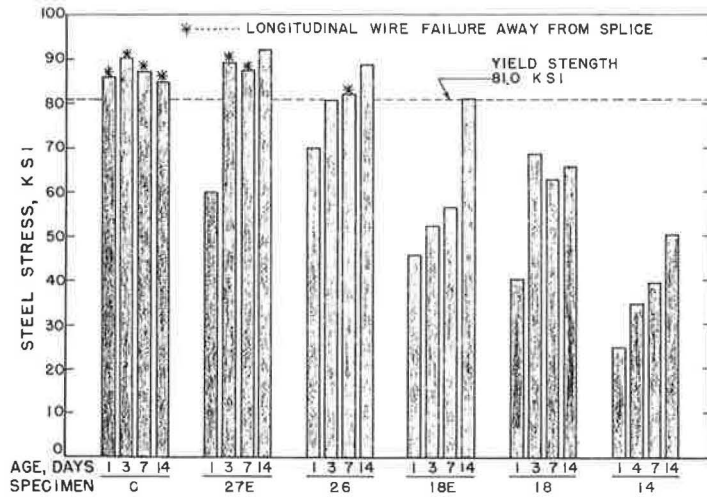
Figure 18. Ultimate strengths, series D.

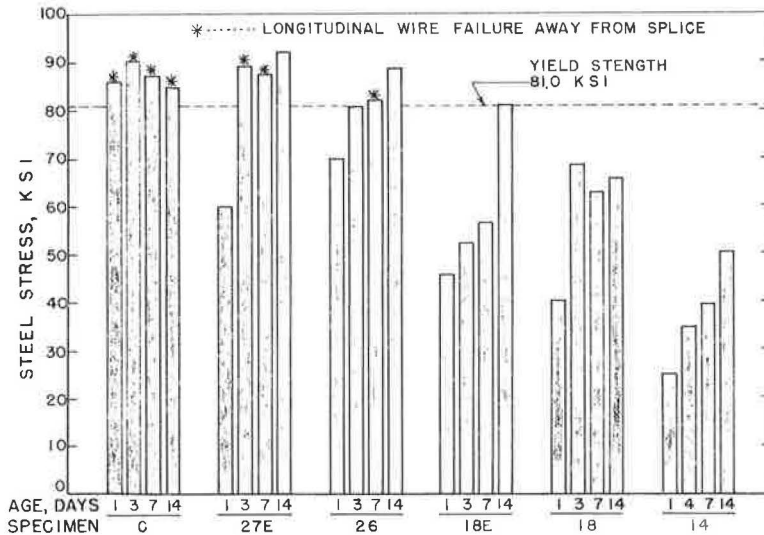
Figure 19. Ultimate strengths, series WWF.

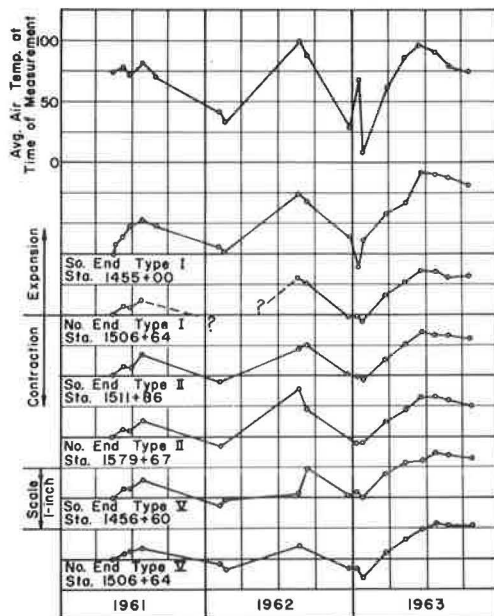
Figure 5. Measured longitudinal movements of various pavement ends (De Soto County).

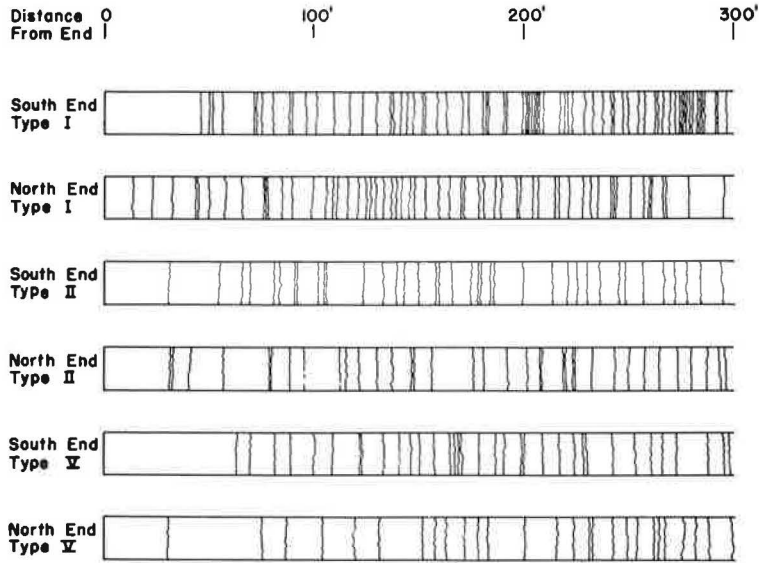
Figure 6. Crack pattern for first 300 ft for various pavement ends (De Soto County).

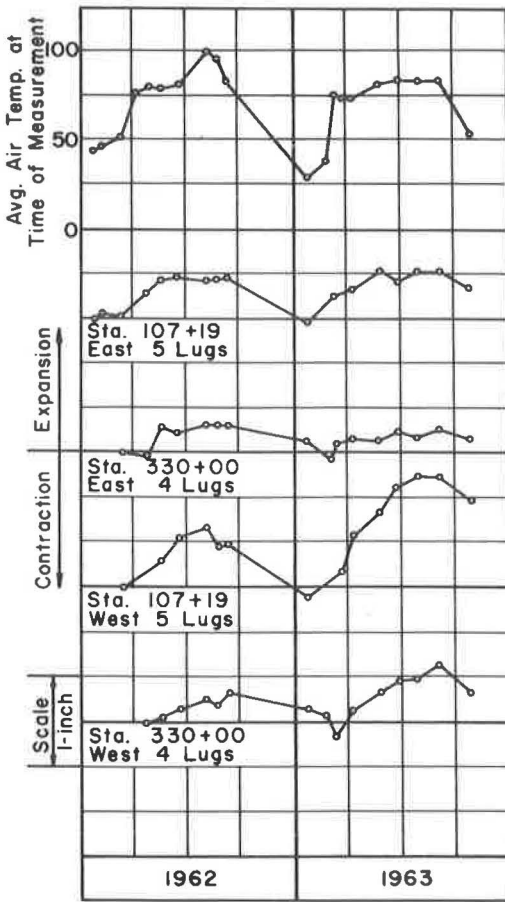
Figure 11. Measured longitudinal movements of pavement ends (Jones County).

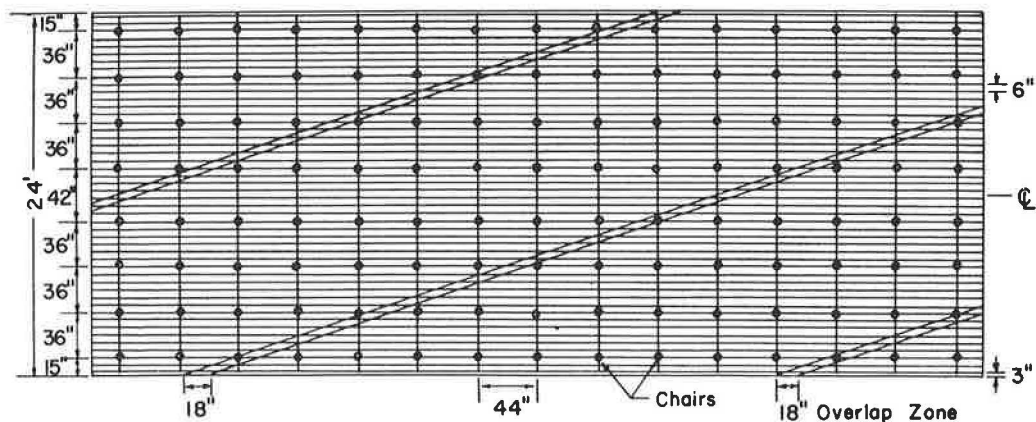
LONGITUDINAL STEEL - No. 5 x 40' Billet Steel A 432 - 48 Deformed Bars for 24' Width Provides 0.646% of Cross Sectional Area

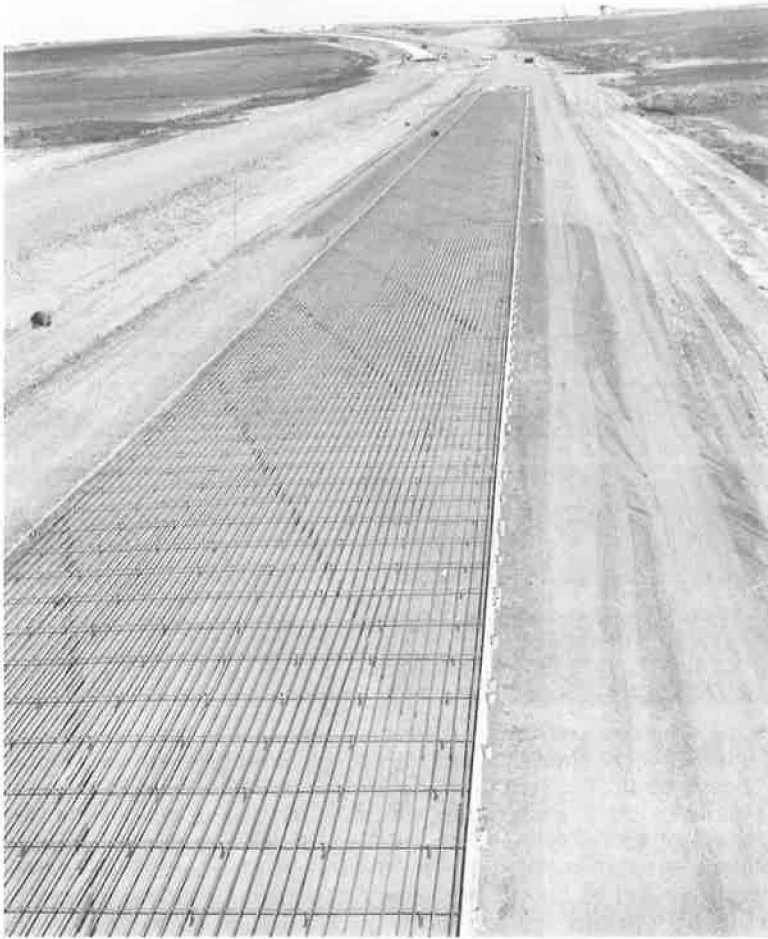
Figure 14. Reinforcing steel in place.
