Chemical Deicing of Aircraft Runways

W. P. CONRARDY

Air Force Materials Laboratory, Wright-Patterson Air Force Base, Ohio

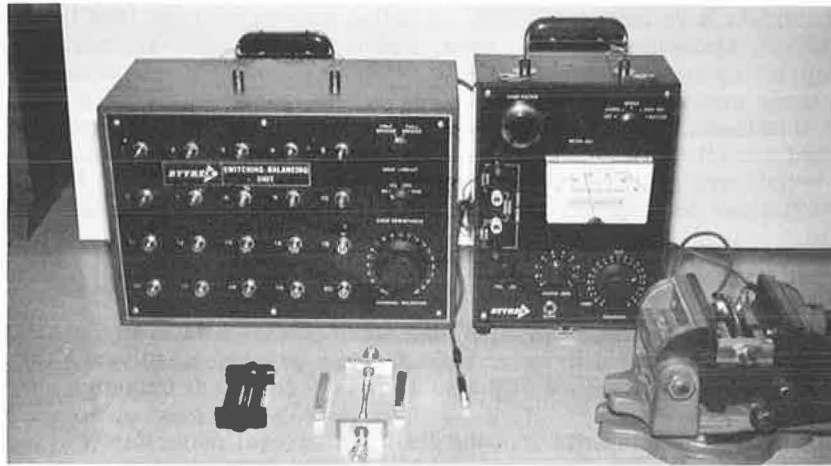
Figure 1. Test specimen, fixture and strain gage instruments used for loading specimen.

Procedure.—2014-T6 aluminum alloy machined specimens cut from the longitudinal direction were used. The specimen, its fixture, a jig vise used for applying stress to the specimen fixture and strain gage instruments are shown in Figure 1. Each specimen was loaded to 80 percent of yield strength, determined by averaging data from three stress-strain curves for each specimen. After loading, each specimen and fixture was completely painted with stop-off lacquer except for the gage length of the specimen. Salt solution concentrations were arbitrarily selected at saturation for 32 F.

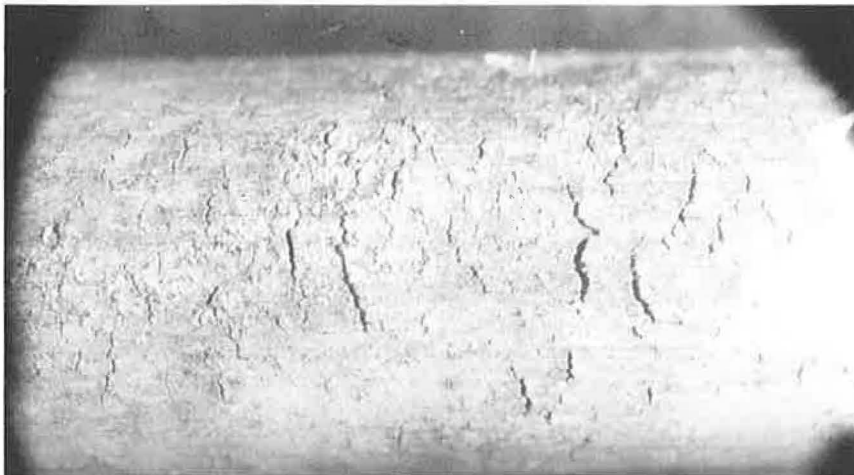
Figure 2. Specimen corroded by exposure to NaCl solution and pulled.

amount as indicated by the elongation data. A distinctive corrosion pattern was produced by each type of salt solution. A comparison of these surfaces shows that the specimen exposed to NaCl (Fig. 2) was appreciably more corroded than the specimens exposed to either CaCl_2 (Fig. 3) or urea (Fig. 4) solutions.

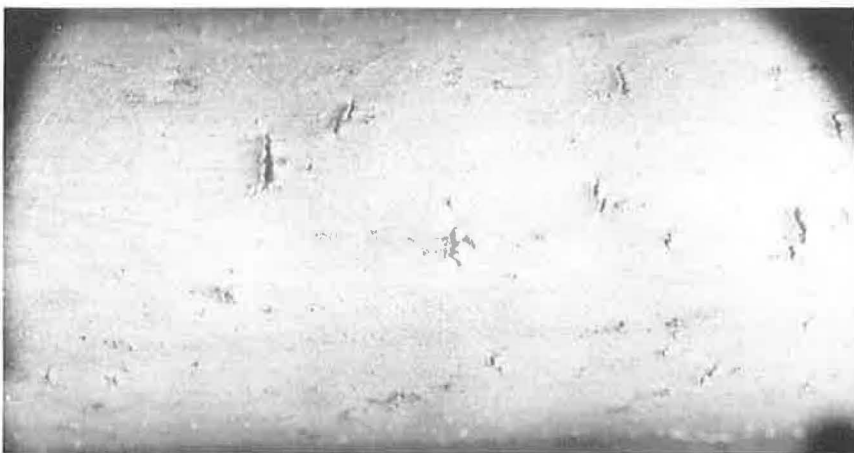
Figure 3. Specimen corroded by exposure to CaCl_2 and pulled.

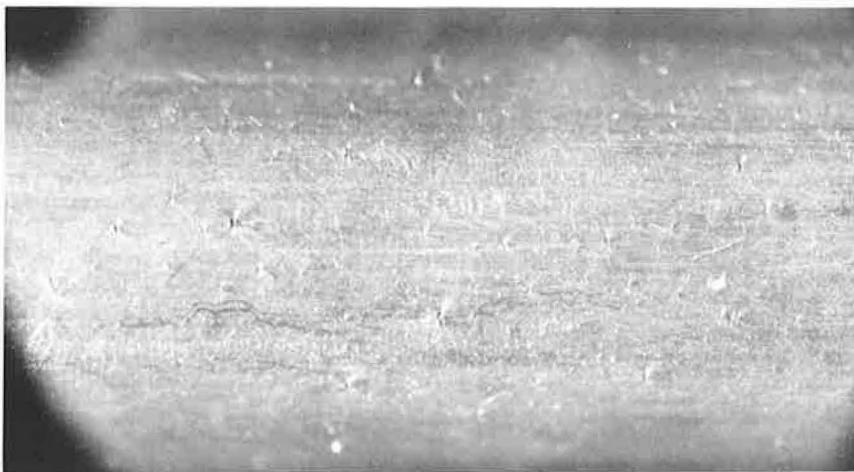
Figure 4. Specimen corroded by exposure to urea solution and pulled.

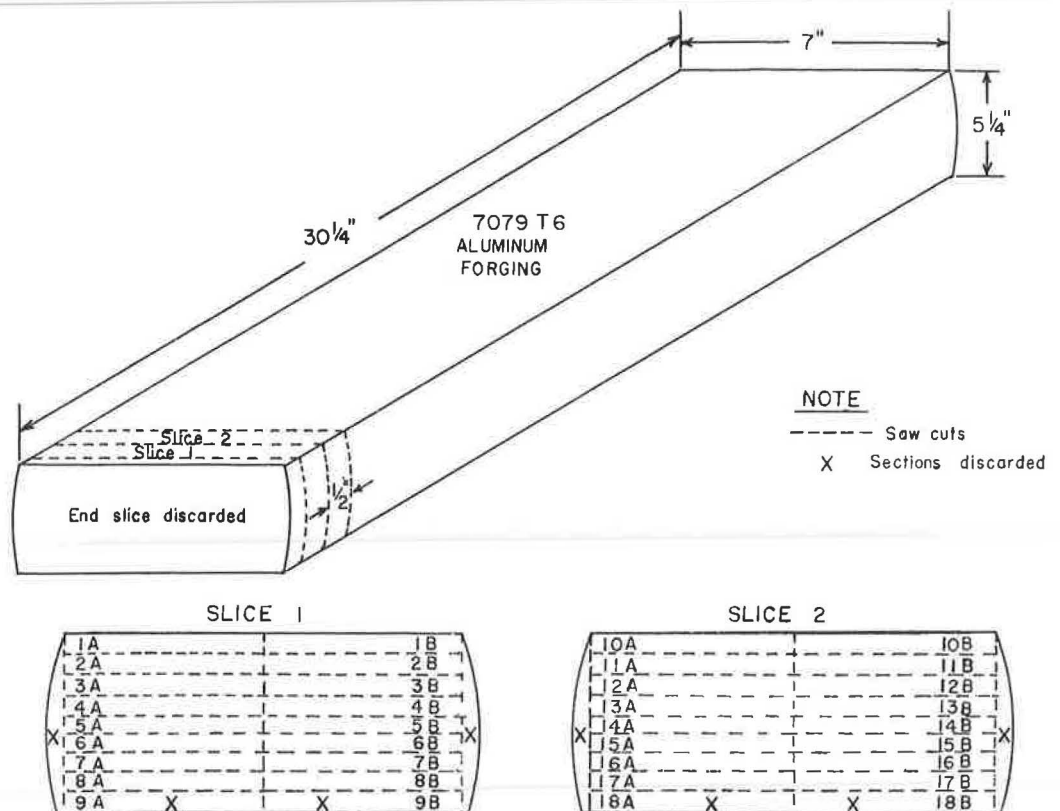
Figure 5. Location of tensile blanks cut in long transverse direction from 7079-T6 aluminum forging.

A second series of tests was conducted using specimens cut from the long transverse direction (Fig. 5) of a forged billet of 7079 aluminum in the T-6 condition (i.e., solution heat-treated and artificially aged). As in the initial test series, the aluminum test specimens were preloaded to 80 percent of their yield strength and exposed at room temperature under alternate immersion in solutions (saturated at 32 F) of NaCl, CaCl_2 , urea and an amide mixture. The tests were conducted on a 24-hr day, 5-day week basis.

Tensile specimen blanks were cut from the long transverse direction of this forging, as shown in Figure 5. A $\frac{3}{4}$ -in. slice was cut from the end of the forging and discarded. Because specimens cut from end slices often exhibit erratic effects due to unusual end grains produced during forging, the next two $\frac{1}{2}$ -in. slices were sawed into specimen blanks located as shown. Blanks 9 and 18 proved undersized and were discarded. All remaining specimen blanks were then machined to ASTM Standard (E8-57T) small-size specimen dimensions. The gage length sections of each specimen were carefully polished with No. 600 metallographic paper.

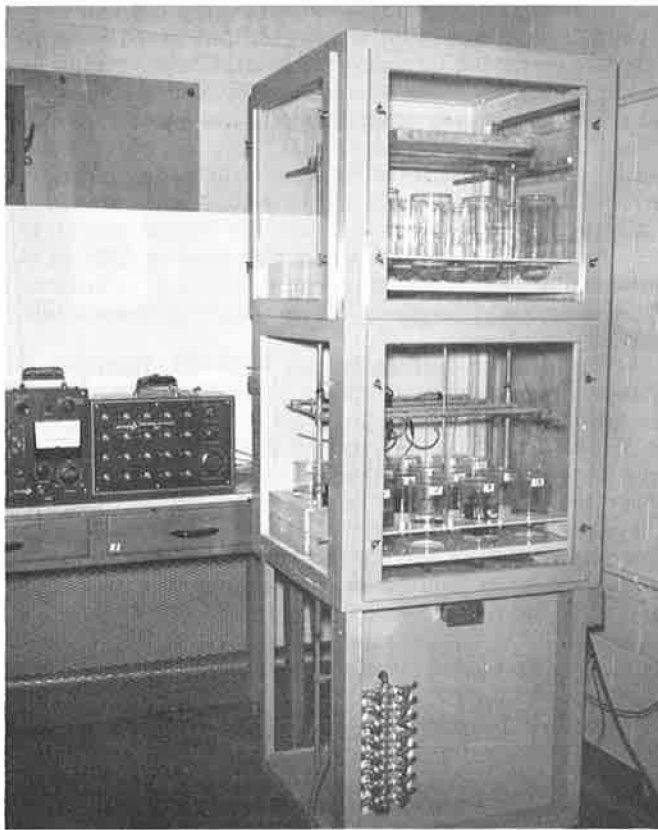
Figure 6. Apparatus for alternate immersion of specimen in ice melting solutions and suspending in air.

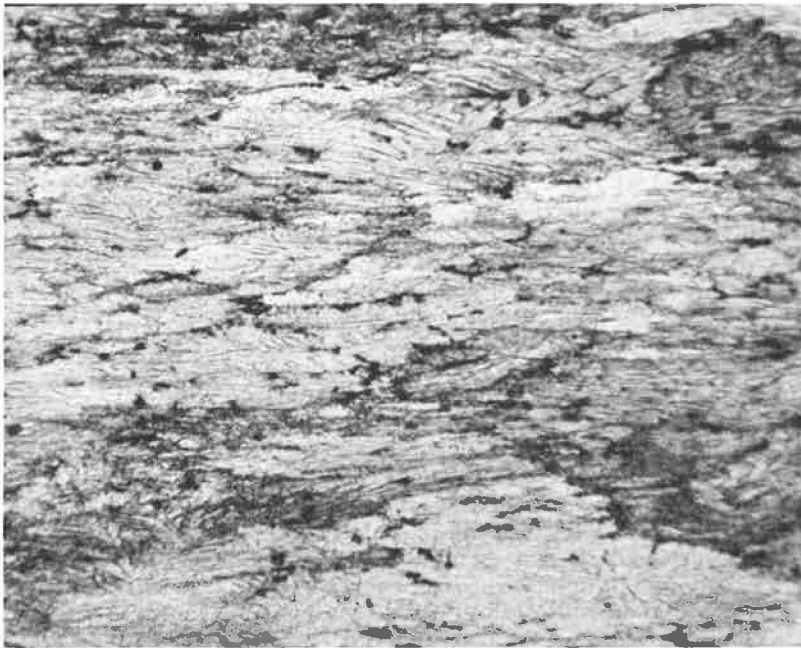
Figure 7. Photomicrograph of typical structure (parallel to long axis) of forged 7079-T6 billet (60X)—Keller's etch.

Figures 7 and 8 are photomicrographs (60X) representative of the 7079-T6 forging from which all specimens were cut. Figure 7 shows a view of the gross grain structure of the billet parallel to the long axis of forging. The grains, while not well defined, appear to be generally greater than 0.075 in. long. Even at this low magnification their length is greater than the field shown. Such grain size is considered typical for the alloy in a T-6 condition. Figure 8, taken perpendicular to the long axis of the 7079 forging, shows the distribution and size of the grains in Figure 7 from an end

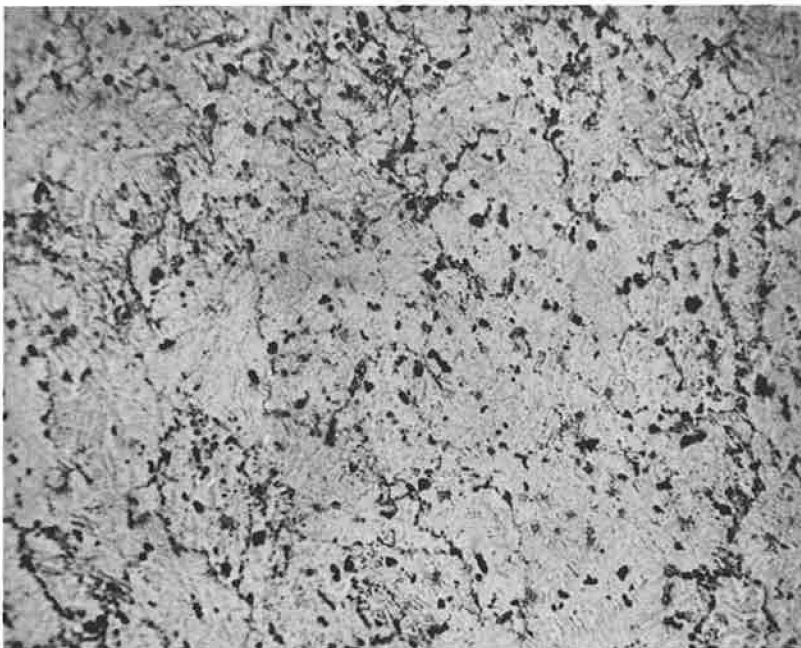
Figure 8. Photomicrograph of typical structure (perpendicular to long axis) of forged 7079-T6 billet (60X)—Keller's etch.

on view. More importantly, it shows the distribution, size and number of intermetallic constituents and inclusions found in the test specimens.

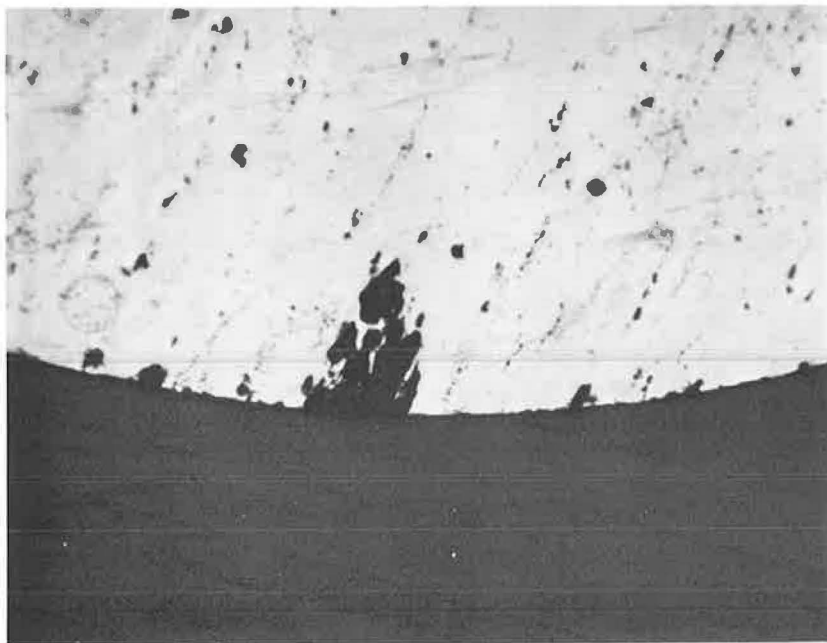
Figure 9. Photomicrograph of unetched cross-section of specimen 5B after cyclic exposure under stress to CaCl₂ solution for 318 hr (60X).

Figure 9 is a photomicrograph of specimen 5B which failed after 318-hr exposure to the test solution. The large pit shown here is 0.014 in. deep by 0.008 in. wide and is located about $\frac{1}{4}$ in. from the fracture zone. There appear to be numerous such pits scattered over the test gage length. Several smaller pits may be seen in the surface of the specimen in both directions from the large pit.

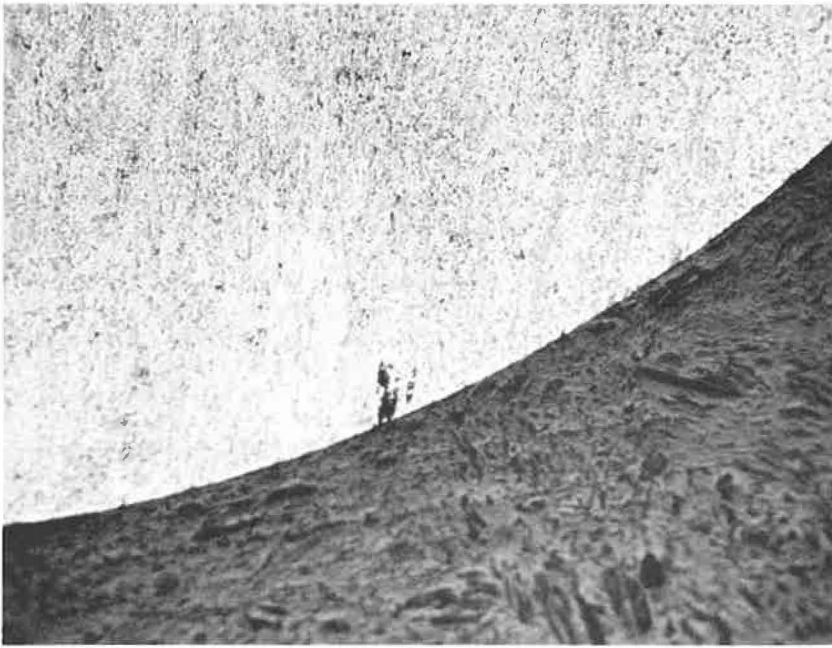
Figure 10. Photomicrograph of cross-section of specimen 13A after cyclic exposure under stress to NaCl solution for 238 hr (60X)—HF etch.

Figure 10 is a photomicrograph at 60X of specimen 13A, which failed after cyclic exposure of 238 hr in NaCl solution. This specimen appears different from that of Figure 9, as it was etched with Keller's solution. The pit shown is about 0.005 in. deep by 0.002 in. wide and was the only one found on the particular cross-section. In general, substantially fewer pits were found in the general area of the pit shown. In this series, surface pitting was less frequent and extensive on specimens exposed to NaCl solutions than ones exposed to CaCl₂ solutions.

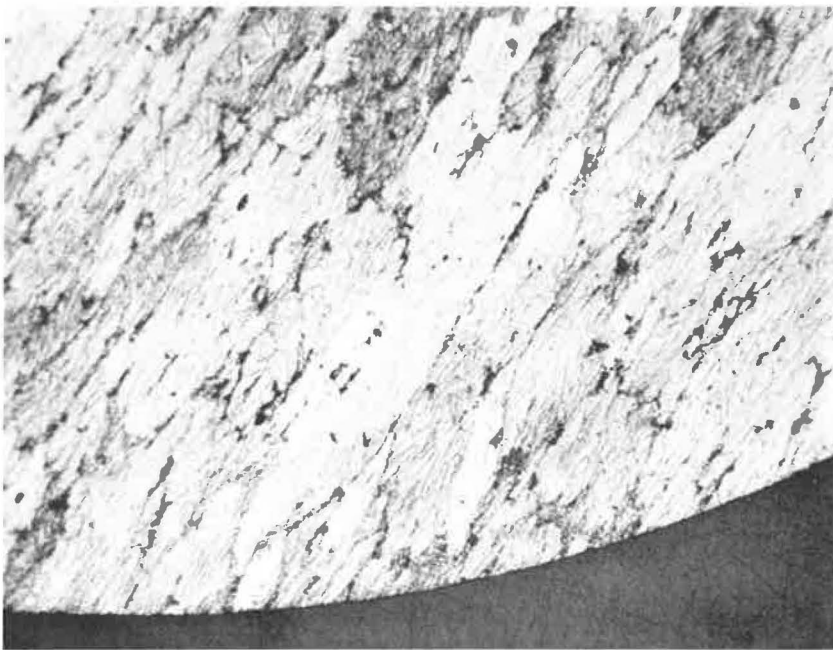
Figure 11. Photomicrograph of specimen exposed for 536-hr cyclic tests in solution of sample D ice melting product (60X)—Keller's etch.

Figure 11, a photomicrograph of specimen 17B which failed only after 536 hr of testing, shows a complete absence of any surface pitting in the area illustrated. A complete examination of several cross-sections of this and other specimens did not reveal a single area of attack by pitting. However, the specimen did fail in a brittle manner, typical of all specimens tested in this program. The method of attack or mode of failure is not understood as of this date.

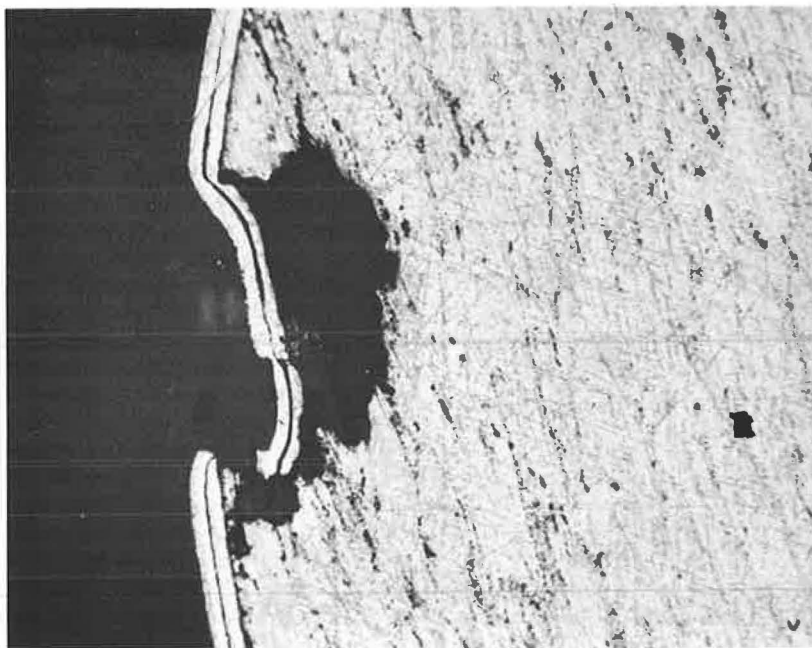
Figure 12. Photomicrograph of specimen exposed for 938+ hr cyclic tests in solution of urea ice melting compound (60X)—Keller's etch.

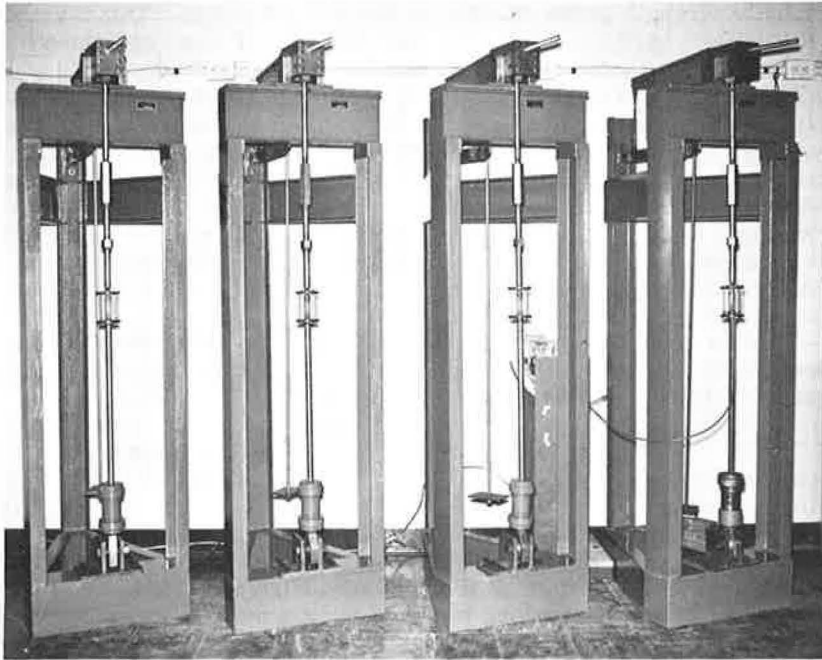
Figure 13. Stress corrosion stands for testing steel specimens.

Apparatus.—Special stands (Fig. 13) were fabricated to provide the loadings to stress specimens to the required level. Small glass containers with rubber ends contained the salt solutions around the specimen. These containers were fed from a reservoir system which alternately raised and lowered the solution according to a predetermined cycle. This cycle, repeated until the specimen failed, consisted of exposing the specimen to the salt solution for 10 min, draining the solution from around the specimen and allowing it to air-dry for 20 min. Each test specimen was under constant load for the duration of the test.

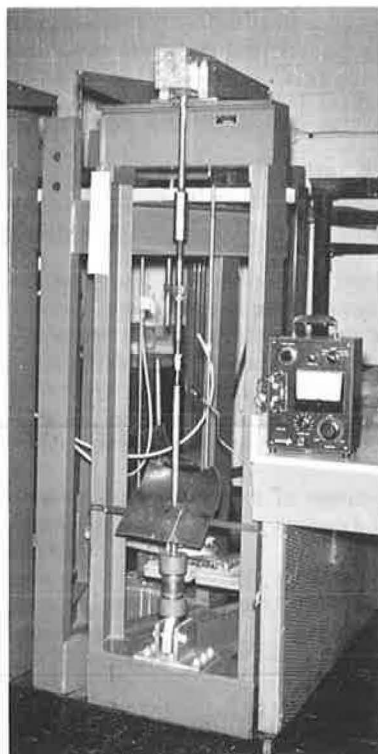
Figure 15. Strain gage load cell.

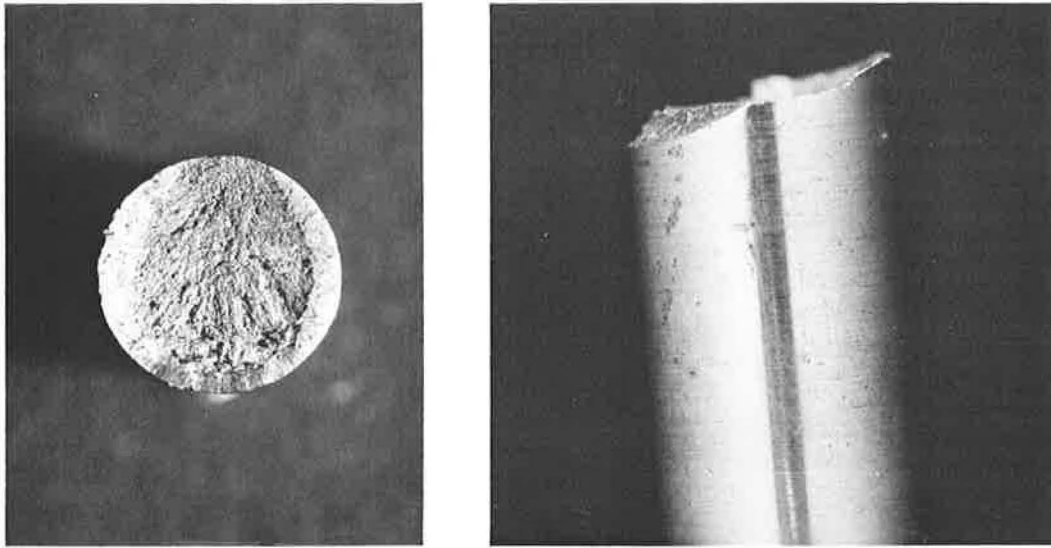
Figure 16. End-on and lateral view of fractured test bars subjected to stress in CaCl_2 solution, for less than 5 hr.

On the basis of visual examinations of the failed specimens, some ductility was exhibited, evidenced by "shear lips" at the fractured surfaces (Figs. 16, 17, 18).

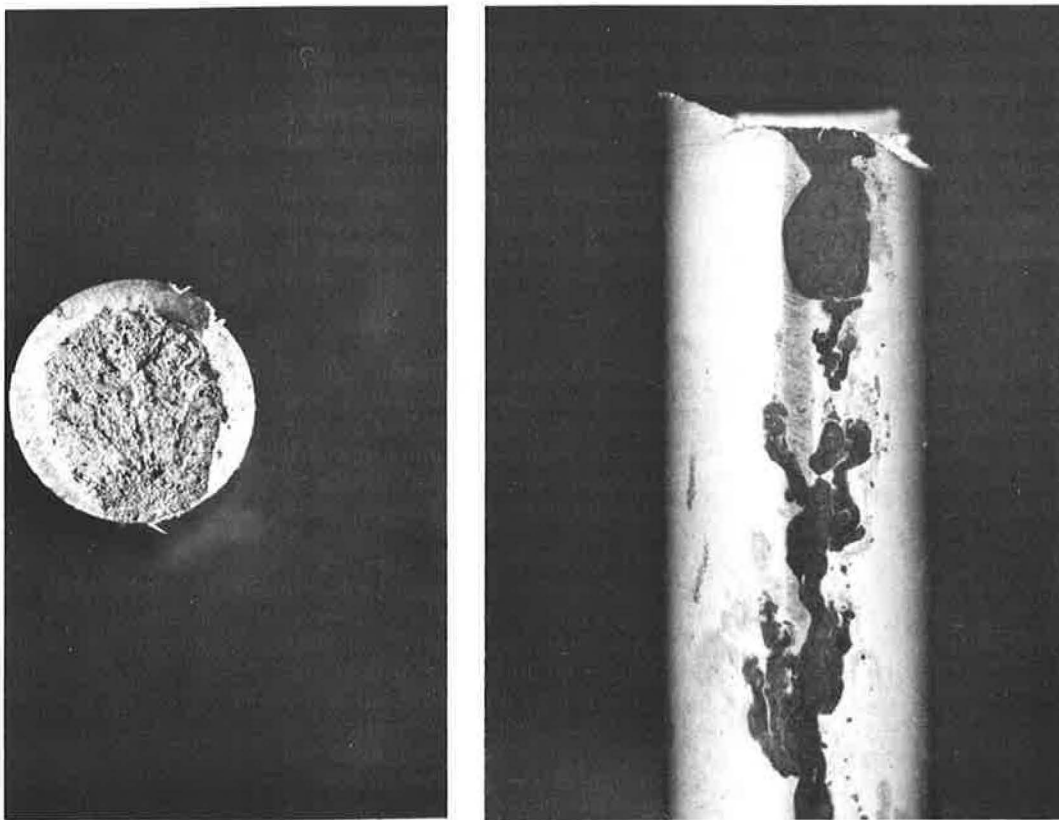
Figure 17. End-on and lateral view of fractured test bars subjected to stress in solution of Dayton tap water, exposed for over 100 hr.

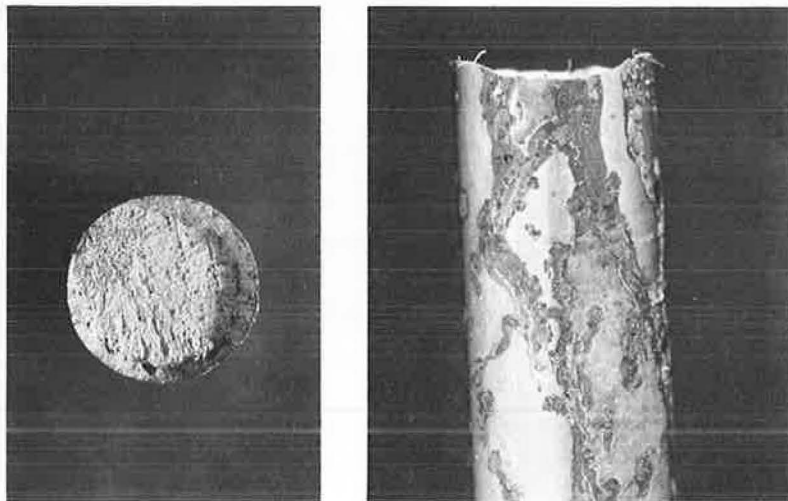
Figure 18. End-on and lateral view of fractured test bars subjected to stress in solution of urea, exposed for over 250 hr.
