Rehabilitation of Deteriorated Bridge Slabs

ALDEN L. WEST

Engineer, Structural Maintenance, The Port of New York Authority

A review is presented of the methods utilized by the Central Maintenance Engineering Division of The Port of New York Authority to rehabilitate concrete bridge decks, improve riding surfaces and provide maximum protection against effects of deicing chemicals and the elements.

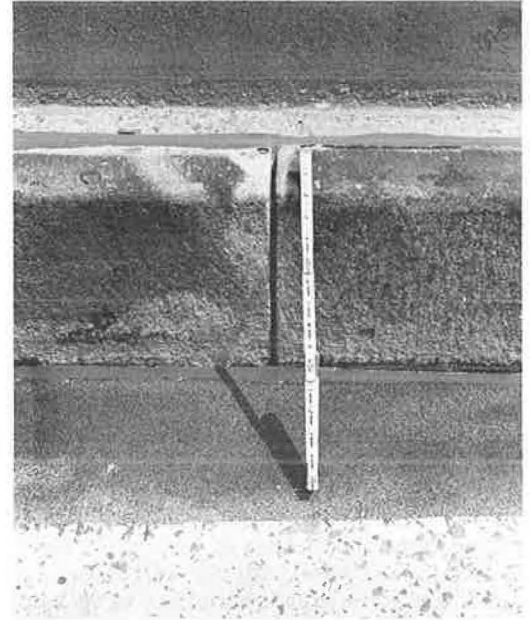
Figure 2. Goethals Bridge, newly poured polysulfide joint at curb and deck junction, polysulfide joint back of curb and cleaned vertical joint adjacent to epoxy-coal tar patch.

Polysulfide joint sealer was installed in a joint formed by saw cutting along the junction of the curb and existing concrete deck. All transverse joints were routed, cleaned and repoured with a joint filler of polysulfide or rubber asphalt. Curb joints were cleaned out by specially adapted grinding equipment and repoured with polysulfide joint filler (Fig. 2). The concrete deck was cleaned by sandblasting before application of a grit tar waterproofing system. A $\frac{3}{4}$ -in. wearing surface of stone-filled silica sand asphalt was placed over a tack coat of asphalt cement. Rubber-tired paving equipment was required in addition to steel-wheel and pneumatic-tired rollers. All transverse joints poured with polysulfide were reflected through the new pavement by saw cutting a $\frac{3}{4}$ -in. wide joint in the new pavement and were then poured flush with a rubber asphalt joint filler. This was done to control reflection cracking.

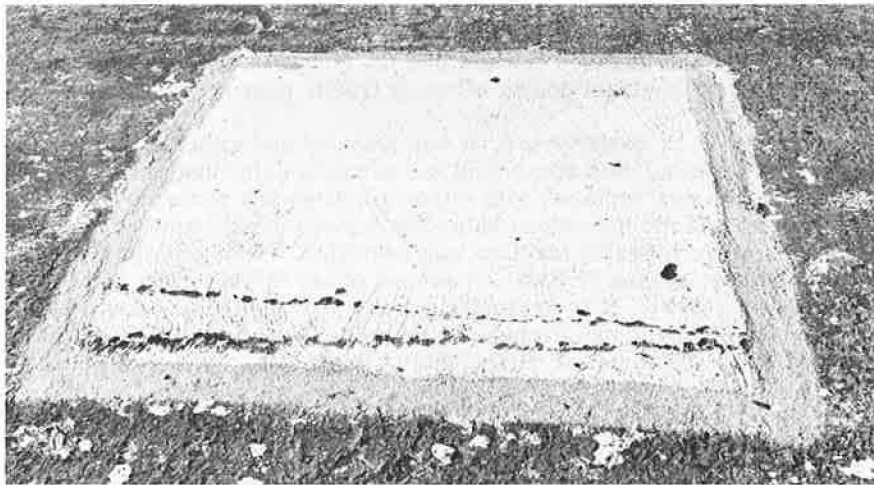
Figure 4. Bayonne Bridge, concrete patch with perimeter seal of sanded polysulfide adhesive.
