Fatigue Strength of $\frac{3}{4}$ -Inch Stud Shear Connectors

A. A. TOPRAC, Professor, Department of Civil Engineering,
University of Texas

Results of fatigue tests performed on seven steel-concrete composite beams are presented. The shear between the steel 24 WF 68 beams and the 6-in. thick slab is developed by means of $\frac{3}{4}$ -in. diameter headed steel studs. The beams were all identical except for the number of studs. The beams were 36.0 ft long and were divided into two groups: (a) four commercially good and acceptable specimens, and (b) three inferior specimens not acceptable to the Texas Highway Department.

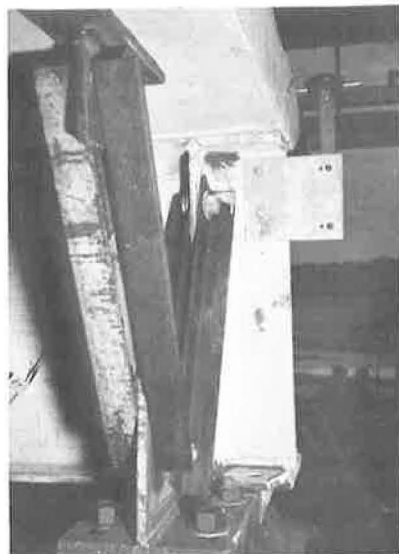
Figure 4. End braces and end slip measuring device.

The slip of the concrete relative to the steel beam was measured at each end of the beam using dial indicators. The dial indicators were rigidly attached to the steel beam and held in the same position throughout the test. To avoid damage to the gage, the point was restrained from touching the concrete during dynamic tests. Figure 4 shows the apparatus used to measure end slip.

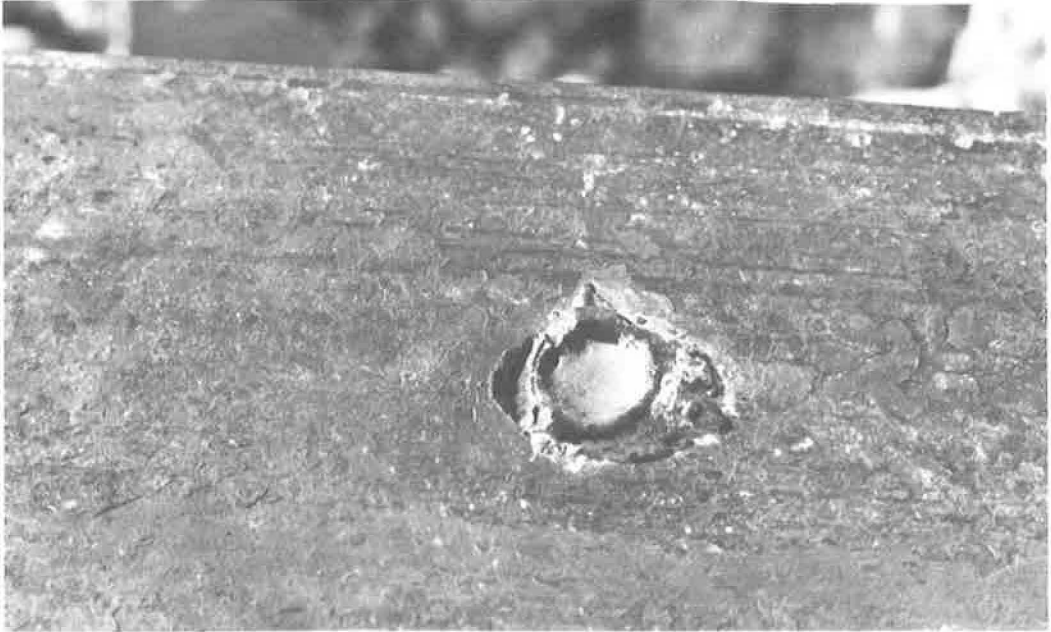
Figure 13. Stud failure in specimen 2-C.

Concrete was also removed from specimen C. Visual inspection of the stud fracture seemed to indicate defective welds. One of these failures is shown in Figure 13.
