Fatigue Strength of 1/2-Inch Diameter Stud Shear Connectors

D. C. KING, R. G. SLUTTER, and G. C. DRISCOLL, Jr.

Lehigh University, Department of Civil Engineering, Fritz Engineering Laboratory, Bethlehem, Pa.

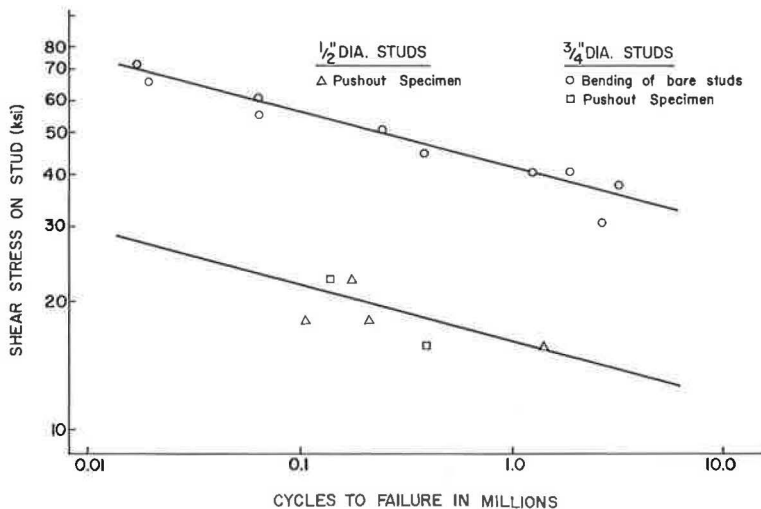
Figure 1. S-N curves for previous tests of stud shear connectors.

of A_s , and I_{tr} is the moment of inertia of the transformed composite section. These data have not been plotted on Figure 1 since no failures were obtained. A comparison of the data from the beams with data from the pushout test specimens reveals that the beam test points would plot near the lower curve of Figure 1.

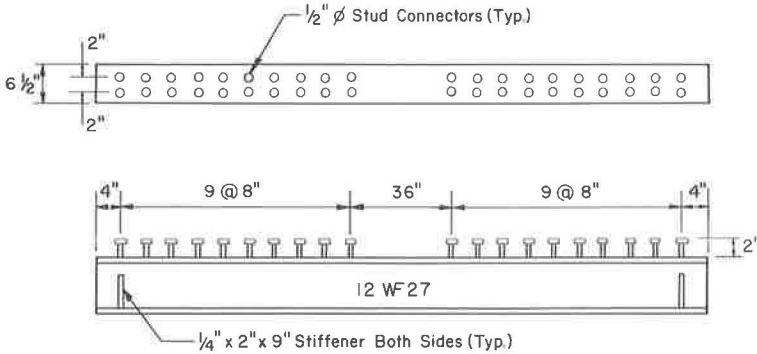
Figure 7. Stud shear connector arrangement for BF-1 through BF-8.

The shear connectors were $\frac{1}{2}$ -in. diameter headed studs which varied in length after welding from 2 in. to $2\frac{3}{8}$ in. The studs were welded by a stud-welding process at a local fabrication shop. The welding was typical of general shop welding in quality. Connectors were arranged in pairs on the eight test beams. Details of the specimens are shown in Figure 6. The concrete slab reinforcement consisted of No. 4 bars at 9 in. center-to-center in both the longitudinal and transverse directions. The transverse slab reinforcement was supported $1\frac{1}{2}$ in. from the bottom of the slab, and the longitudinal reinforcement was supported by the transverse steel. The arrangement of the 40 shear connectors, identical in all eight test members, is shown in Figure 7. Section properties and design strengths of the composite beams are given in Figure 8.

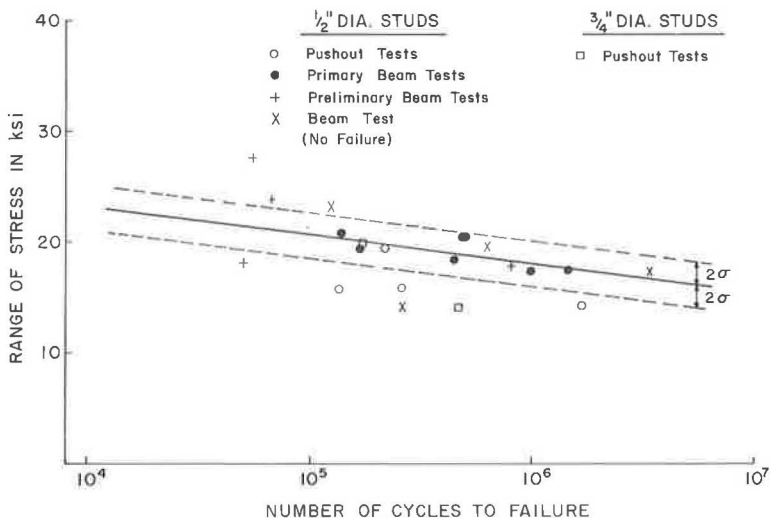
Figure 12. S-N curve for primary beam tests.

The resulting curve is plotted in Figure 12 with the range of stress as ordinate and the number of cycles to failure as abscissa. Data points from all beam and pushout tests are shown. The failure criterion for determining the value of N differs for each group of tests. That for pushout specimens was complete failure of connectors on one or both flanges. The failure criterion for the preliminary beam tests and primary beam tests is described in the following sections. A statistical analysis of the seven data points from the primary beam tests resulted in an unbiased standard deviation of $\sigma = 1.027$ ksi. The 95 percent confidence limits of the data are shown in Figure 12.

As each member was cycled between the minimum and maximum loads given in Table 4, the first obvious indication of failure was an audible banging of the slab on the steel section. For the preliminary beam tests, this determined the number of cycles to failure recorded in Table 4. This is also the failure criterion used in plotting the preliminary beam test data points in Figure 12.

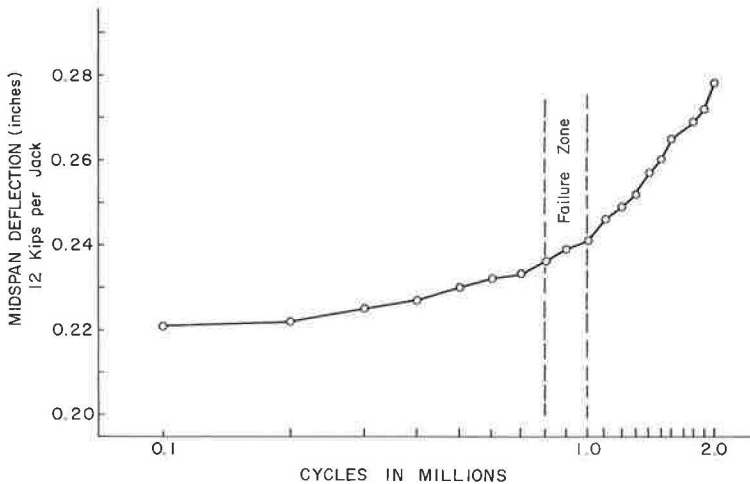
Figure 14. Midspan deflection vs cycles for BF-D.

The static deflection at a load of 12 kips per jack obtained in each static test is plotted in Figure 14 vs the number of cycles of loading plotted on a log scale. There is no distinct change in the slope of this curve in the vicinity of 820,000 cycles. It would not have been possible to determine when failure occurred from this curve alone.

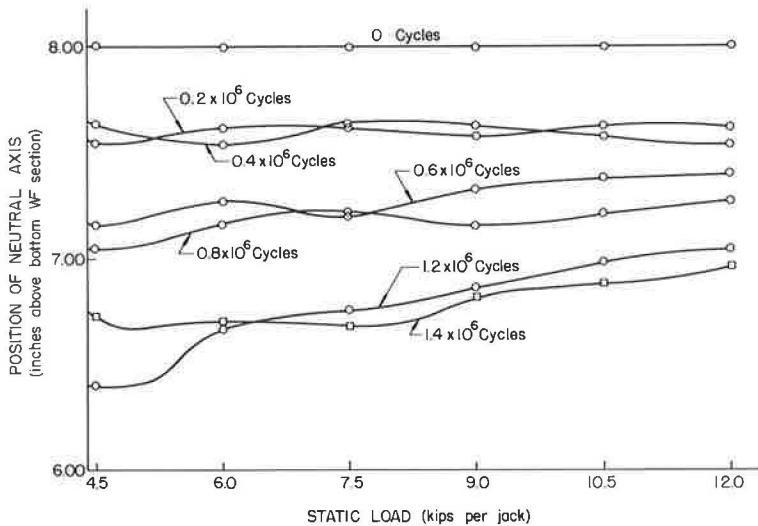
Figure 15. Movement of neutral axis under static load as fatigue failure progresses for BF-D.

A plot of the position of the neutral axis vs applied load at various numbers of cycles for specimen BF-D is given in Figure 15. These curves indicate a loss of interaction throughout the test, but a gradual shift of the neutral axis. Even when a curve was plotted for each static test, the point of failure of connectors could not be determined with any degree of certainty. There was a large shift in the neutral axis between zero cycles and the next static test because of failure of bond, and this was typical for all specimens.

The deflection of members at maximum cycling load increased from the first cycle to the completion of the test in the primary beam tests in about the same manner as that shown for specimen BF-D in Figure 15. In the early stages of loading, the increase in deflection would seem to be due to bond failure and polishing of the slip plane due to movement of the slab with respect to the steel beam on each cycle. A second stage of deflection increase might be due to inelastic deformation of concrete around connectors. Finally, the increase in deflection becomes due to failure of connectors. It is not possible to separate these stages on a curve such as Figure 15.

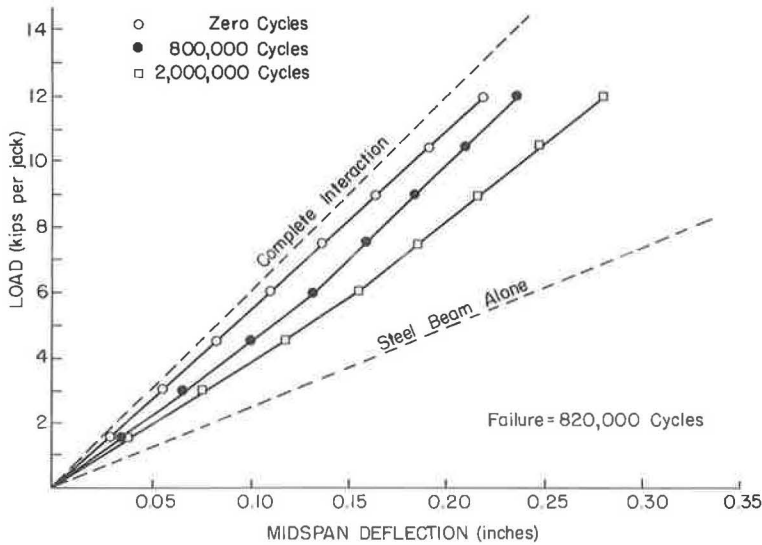
Figure 16. Load vs deflection curves for BF-D.

The load vs deflection curves of specimen BF-D at the start of the test, at 800,000 cycles, and at the end of the test are shown in Figure 16 along with the theoretical curves for a composite beam with complete interaction and the steel beam alone. The departure of the initial curve from the theoretical curve for complete interaction is due to the fact that these members were designed with a weak shear connection to insure that failure would take place in the shear connection rather than in the bottom flange of the steel beam. The number of shear connectors was about 57.5 percent of that required to develop the static ultimate strength of the member. The plotting of load vs deflection curves at intervals of 100,000 cycles was not useful in pinpointing the initial failure of connectors because of the gradual loss of interaction throughout the test.

After two million cycles of loading the test was stopped. As can be seen in Figure 16 the final load vs deflection curve for specimen BF-D is situated about midway between the two theoretical limits of complete interaction and bare steel beam. The concrete slab was removed and it was discovered that six of the eight shear connectors per shear span were fractured at one end and seven were fractured at the opposite end of the member. Some of these were actually broken when the slab was removed, but only about 10 percent of the cross-sectional area of these studs remained uncracked after fatigue loading. It is interesting to note that the fracture of about 80 percent of the total shear connector cross-sectional area in the shear spans resulted in approximately an 18 percent increase in deflection as compared with the original curve, whereas complete loss of interaction would result in an increase of 105 percent in deflection.

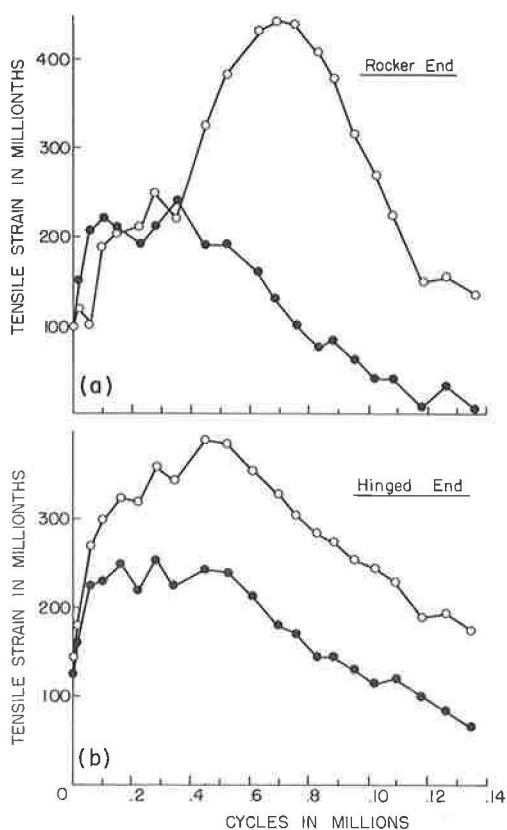
Figure 17. Strain readings of distortion gages at maximum load vs cycles for end pairs of connectors of BF-7.

During a test, readings on these strain gages were taken at each load increment of a static test. As the test proceeded, the strain readings at the maximum static load was plotted as ordinate and the number of cycles of loading was plotted as abscissa. This was done for several connectors at each end of the member. Typical curves obtained from these readings are shown in Figure 17. Curves of strain at the maximum applied static load of 13 kips per jack vs number of cycles for the pair of connectors on each end of BF-7 are shown.

The curves for the end connectors were chosen for the purpose of illustration because the strain in the top flange being measured is due almost solely to the flange dis-

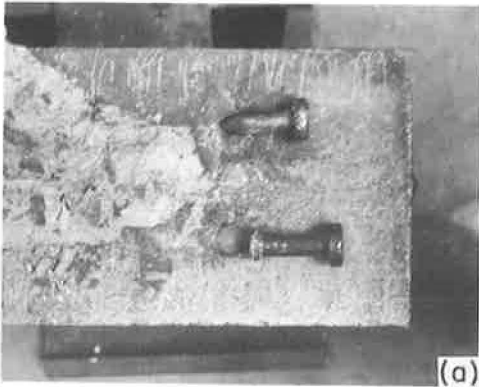
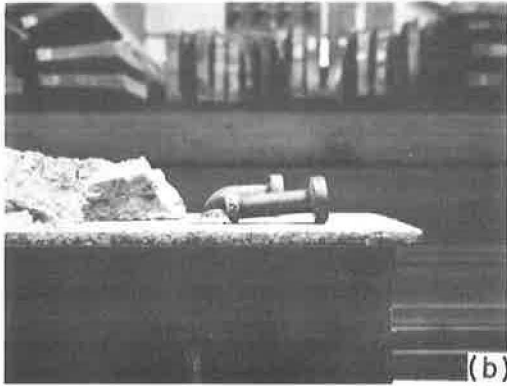
Figure 18. Stud fatigue failure adjacent to uncracked connector.

One occurrence particularly proved the validity of the distortion readings. The strain readings under the end studs of specimen BF-3 indicated that one connector had completely failed and the other stud of the pair was still 100 percent effective. The concrete was broken away to check this result because it did not seem possible. However, inspection verified the findings from the distortion strain readings as shown in Figure 18. One stud was completely fractured and the other stud could be completely bent over with a hammer without cracking the stud. This example, along with the other inspections of beams after testing, caused complete confidence in the use of the distortion gages for the prediction of shear connector failures.

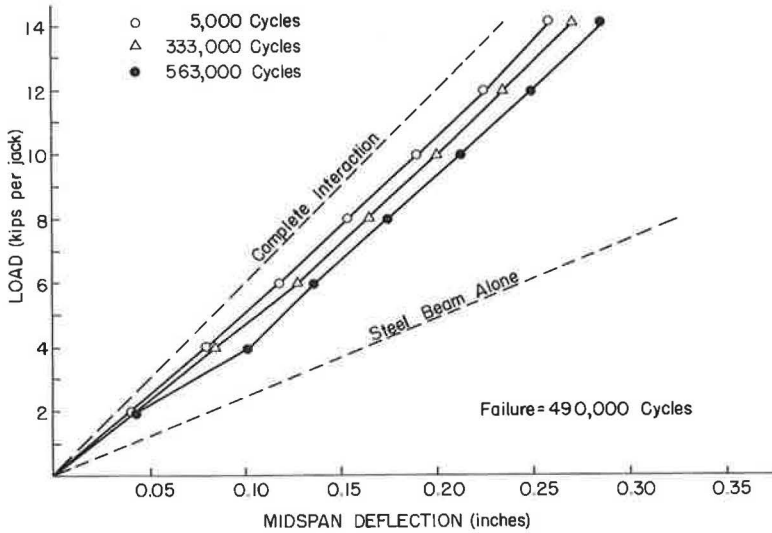
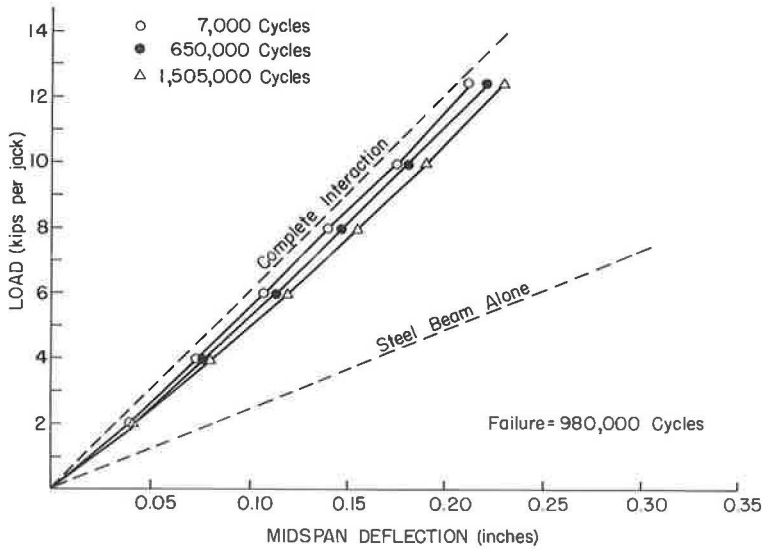
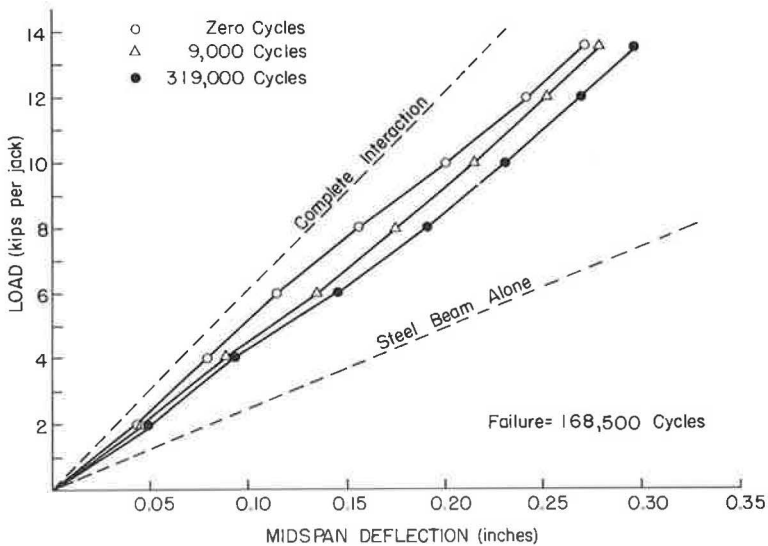
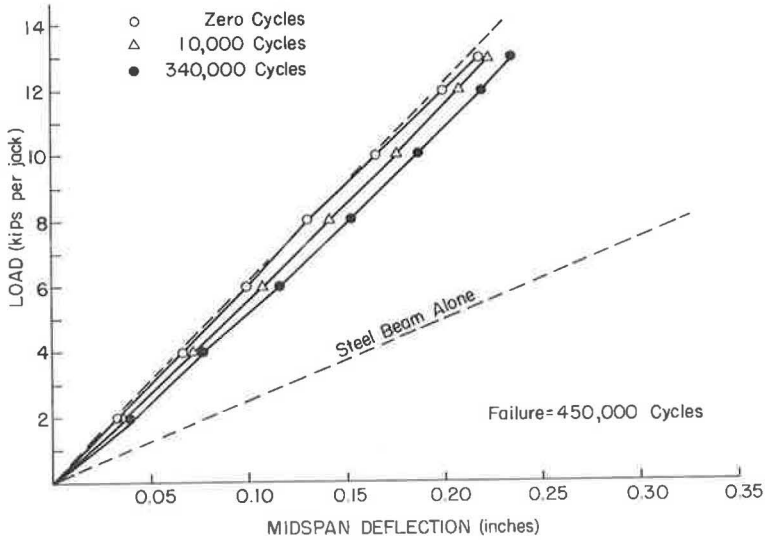
Figure 21. Load vs deflection curves for BF-1.

Figure 22. Load vs deflection curves for BF-2.

Figure 23. Load vs deflection curves for BF-3.

Figure 24. Load vs deflection curves for BF-4.

Figure 25. Load vs deflection curves for BF-5.

Figure 26. Load vs deflection curves for BF-6.

taken at various numbers of cycles of loading. On each figure two dotted lines are shown for the limits of composite action. The upper dotted line represents complete interaction and the lower dotted line represents the steel beam alone. Deflection due to shear has been taken into account in establishing the upper dotted line. The criterion for establishing the number of cycles to failure shown is discussed in the following section of the report. The curves shown in Figures 21 through 28 represent only a portion of the load vs deflection data taken during the tests.

Comparison of the eight sets of curves in Figures 21 through 28 shows some correlation between deflection data and fatigue failure. The change in deflection curves between the zero cycle curve and a curve before failure is less for members in which connector failure takes place after a larger number of cycles. In Figure 24, for in-

Figure 27. Load vs deflection curves for BF-7.

Figure 28. Load vs deflection curves for BF-8.

A comparison of the load-deflection curves from static tests of the primary beam specimens is of interest. In Figures 21 through 28 are shown load vs deflection curves

stance, there was hardly a measurable change in the various load-deflection curves from start to finish of the test, and in this member none of the connectors failed.

The amount which the initial curve departs from the theoretical curve for complete interaction was different for various members. In the case of the two members with the best fatigue endurance, the initial and theoretical load-deflection curves nearly coincide. A study of these curves reveals that the increase in deflection which takes place after failure of connectors is not significant. In several members, the deflection increase with cycles of loading is about the same before failure as it is after failure.

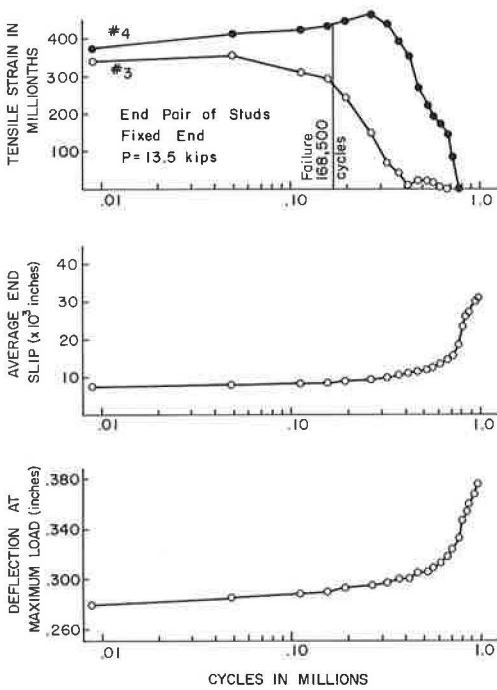
The data obtained from slip readings seem to have a significance equal to that of the load-deflection data. The relationship of connector failure, slip, and deflection is shown for beam BF-6 in Figure 29. Significant changes in the slope of the slip and

Figure 29. Slip, deflection, and distortion gage readings for BF-6.
