HIGHWAY RESEARCH RECORD

Number 103

Bridges and Structures 8 Reports

27 Bridge Design

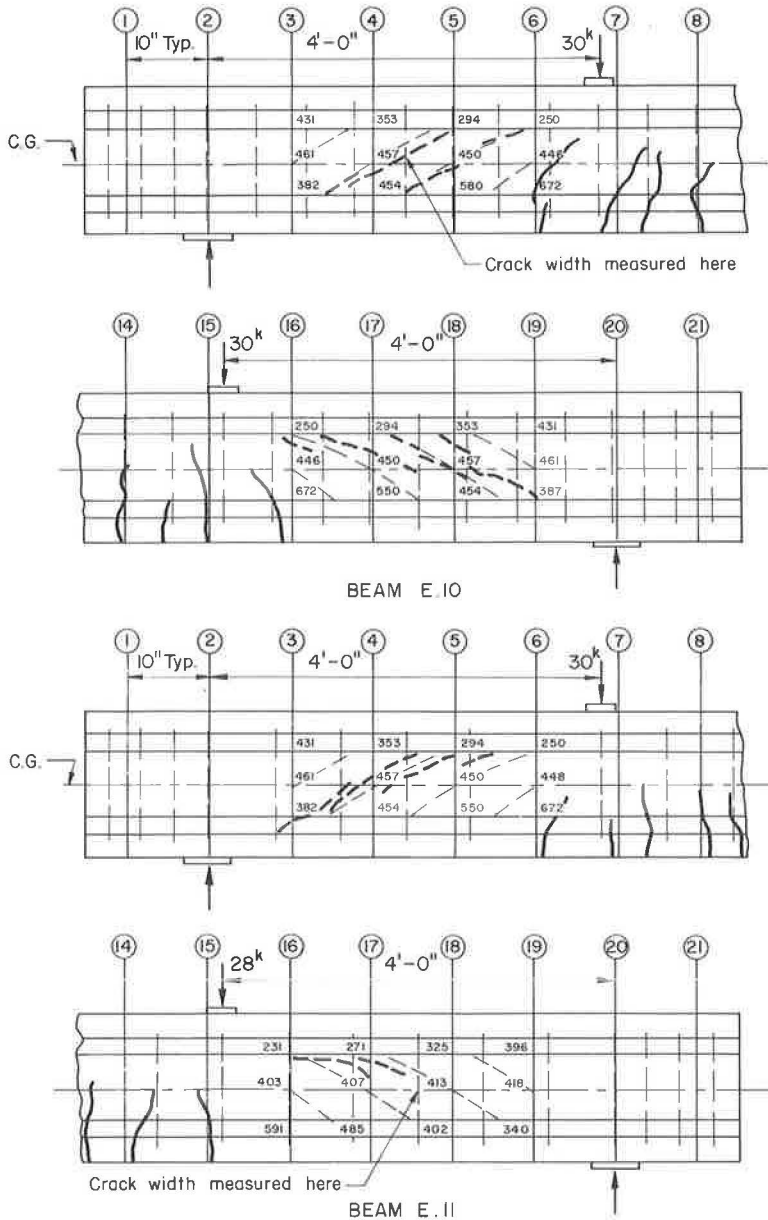
Figure 5. State of stress at diagonal tension cracking.

the diagonal tension cracks at the locations shown in Figure 5 was also measured.

After diagonal cracking in E.10, transverse crack width was measured at the location shown in Figure 5. At V equal to 30 kips, the crack width was 0.006 in. Increasing V to 32 kips opened the crack to 0.008 in. The width of the crack after the beam was unloaded was 0.002 in. Subsequent variation in the width of the crack at the minimum and maximum shear in the repeated load cycle with N is shown in Figure 8. In the static tests at any N , there was no observable opening of the crack up to a shear of 10 kips. From 10 kips to the maximum shear, the increase in crack width was approximately proportional to the increase in shear above 10 kips.

The location shown in Figure 5 was selected to measure the transverse crack width after the crack had extended completely across the web at a shear of 30 kips. The width at V equal to 30 kips was 0.010 in. , and the crack opened an additional 0.001 in.

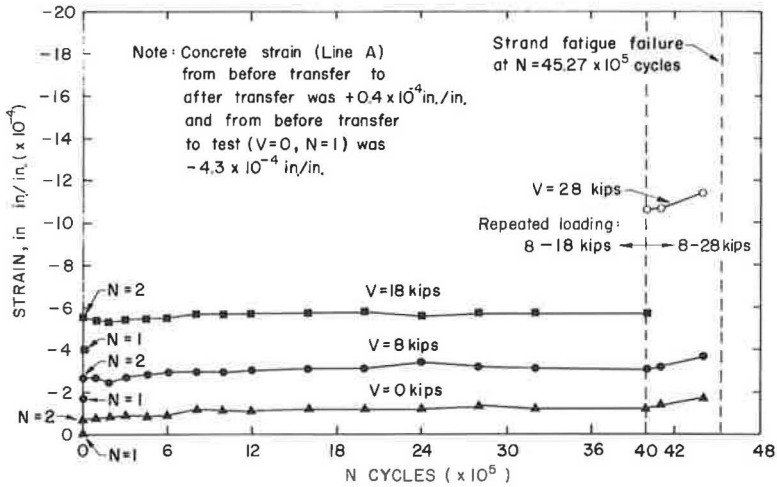
Figure 9. Variation in concrete strain of top fibers during test of E.10.

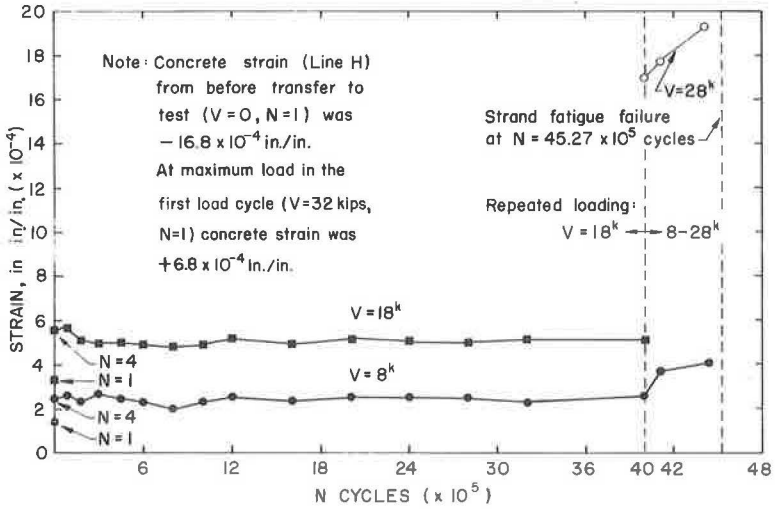
Figure 11. Variation in concrete strain at level of lower strand during test of E.10.

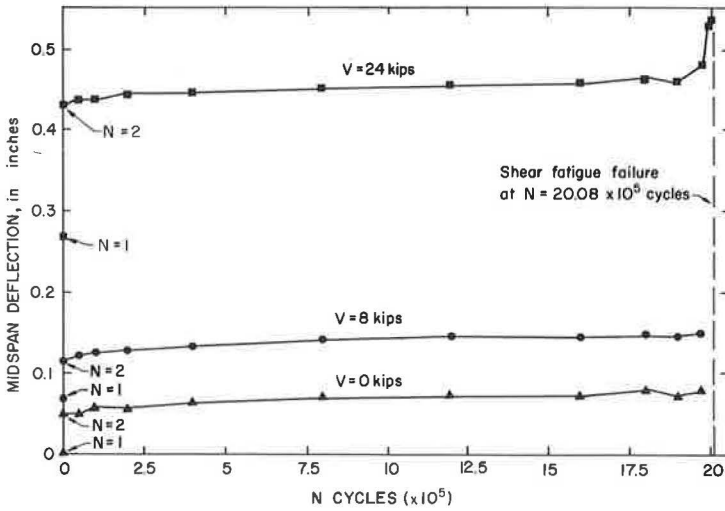
Figure 14. Deflection-N curves for E.11.

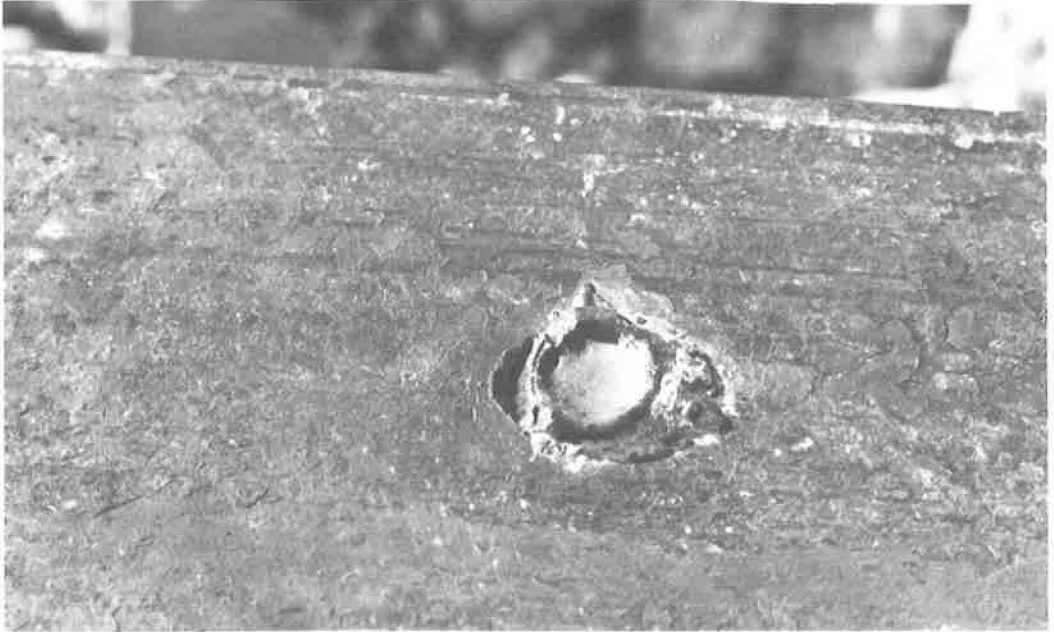
Figure 13. Stud failure in specimen 2-C.

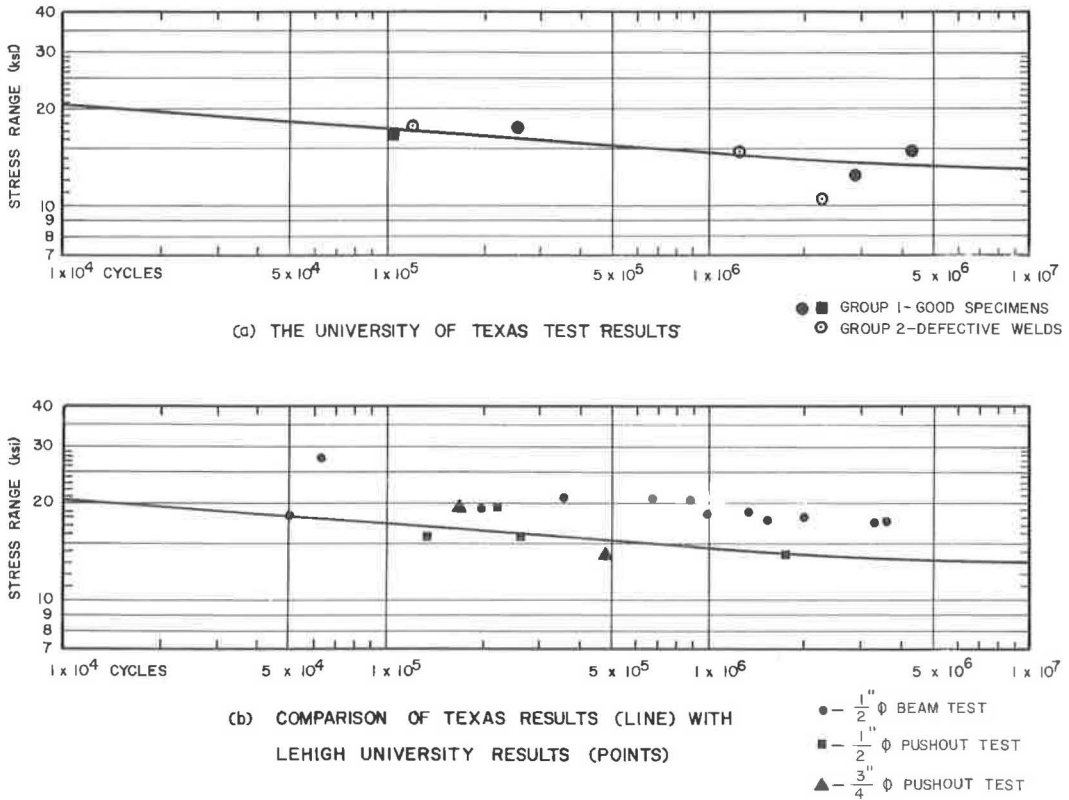
Figure 29. S-N curve for $\frac{3}{4}$ -in. stud connectors.
