# **Expansion and Contraction of Asphalt Concrete Mixes**

#### ERNEST ZUBE and JAMES CECHETINI

Respectively, Assistant Materials and Research Engineer and Materials and Research Engineering Associate, California Division of Highways

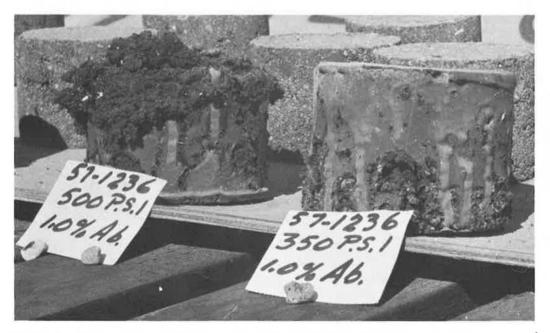
Figure 1. Epoxy-coated specimens, made from absorptive aggregates, exposed on roof 6 mo: left, specimen compacted at 500 psi; right, specimen compacted at 350 psi.

<u>Group 1</u>.—During a periodic inspection of the briquettes on the roof shortly after exposure, the specimens made from highly absorptive aggregates and compacted at 500 psi showed signs of expanding. Hairline cracking and stretch marks were visible in the epoxy coating. About 3 mo from the time the specimens were placed on the roof, the first signs of cracking appeared in the epoxy coating. The other briquettes, nonabsorptive and uncoated, showed no signs of stress under the same environment. This also includes the highly absorptive specimens compacted at 350 psi. However, at the end of 6 mo, signs of distress were visible in the coating of the absorptive specimens compacted at 350 psi (Fig. 1). We believe the highly absorptive specimens compacted at 500 psi ruptured their epoxy coating before identical AC samples compacted at 350 psi primarily because of insufficient void space. The additional void space of

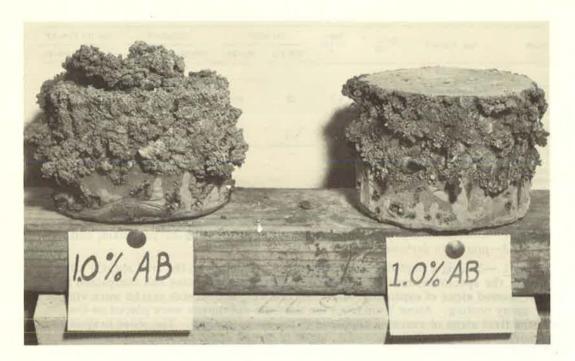
Figure 2. Same specimens as in Figure 1 after 1 yr.

At the end of 1 yr, the highly absorptive specimens compacted at 350 and 500 psi had completely ruptured their epoxy coating (Fig. 2), but the nonabsorptive encapsulated specimens remained in excellent condition (Fig. 3).

In answer to the first question, we might state that there probably were microscopic holes in the epoxy coating and asphalt binder through which moisture could pass. The absorption of moisture by the aggregates caused a sufficient increase in volume to crack the epoxy coating. This destructive cycle of moisture absorption and expansion continued until the AC briquettes were completely ruptured (Fig. 2).

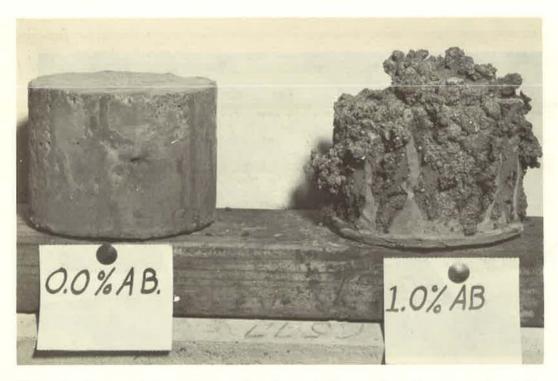
Figure 3. Epoxy-coated specimens after 1 yr: left, nonabsorptive aggregate; right, absorptive aggregate.

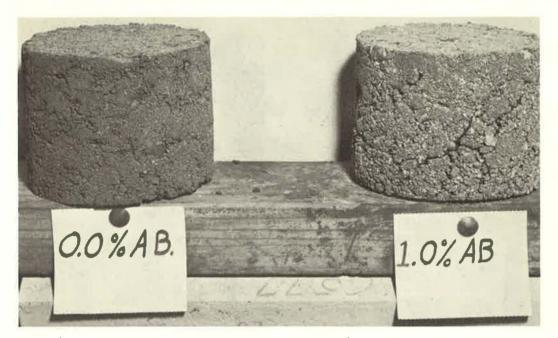
Figure 4. Nonencapsulated specimens exposed on roof 6 mo: left, nonabsorptive aggregate; right, absorptive aggregate.

The nonencapsulated specimens showed the same trend. The absorptive briquettes had cracks over the entire surface, whereas the nonabsorptive briquettes had no indication of cracking. Figure 4 shows their appearance after 6 mo. After 6 yr, the diameter of the absorptive (1.0 percent) specimen increased from 4.0 in. to an average of 4.25 in. The height increased from 3.0 to 3.15 in. This is an increase of 18.8 percent in volume. No expansion in volume occurred in the nonabsorptive briquette (Fig. 5).

The absorptive briquettes which were not encapsulated (Fig. 4) had noticeable cracks over their entire surface. Their movements were not confined, allowing expansion and contraction to occur without complete rupture, which was not the case with the encapsulated briquettes.

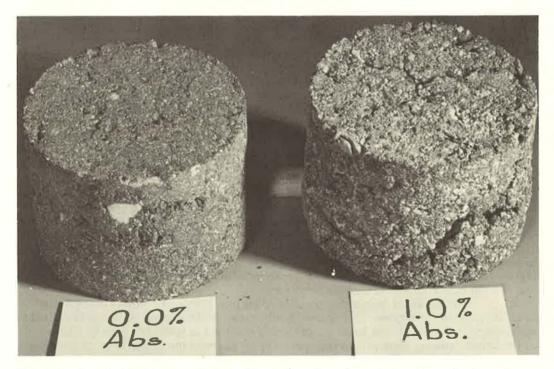
Figure 5. Same briquettes as shown in Figure 4; after 6 yr, briquette made from absorptive aggregates (1.0 percent) increased in volume 18.8 percent; no increase in volume was seen in briquette fabricated from nonabsorptive (0.0 percent) aggregate.

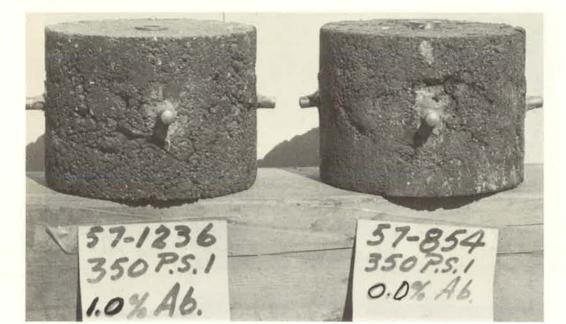
Figure 6. Stainless steel pins cemented to sides of specimen to measure volume changes.

After noticing this volume change in the absorptive AC specimen, we made our first attempt to measure the expansion. Stainless steel reference pins,  $\frac{1}{2}$  in. long, were cemented with epoxy resin to the vertical sides of the test specimens made from absorptive and nonabsorptive mixes (Fig. 6). The specimens were then placed on the roof and expansion measurements were made. However, after about 1 wk, the weight of the pins and the ambient temperature caused the mix aroung the pins to soften and disintegrate. As is mentioned later, this problem was overcome by measuring the volume change of a slab and test beam specimen.

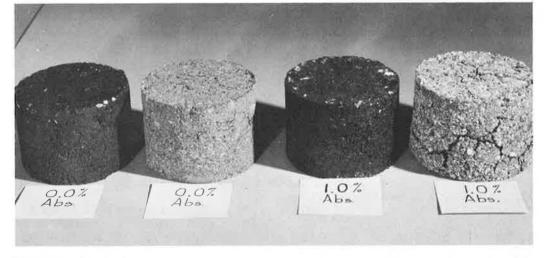
Figure 7. Absorptive and nonabsorptive AC briquettes; dark-colored specimens stored in cabinet for 6 yr, and light-colored specimens exposed on roof for 6 yr.

<u>Group 3</u>.—Both absorptive and nonabsorptive briquettes stored in a cabinet free from sunlight and moisture remained in excellent condition. Figure 7 shows the appearance of these specimens after 6 yr. For comparison, identical specimens stored on the roof for 6 yr are shown in Figure 5.

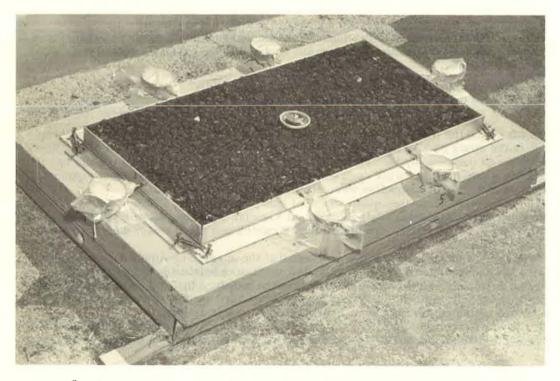
Figure 8. Slab specimen 1 ft by 2 ft by 3 in.; note springs holding aluminum sides surrounding surface course.

After the test slab was compacted in a heavy wooden split frame, the top portion of the frame was removed and replaced with aluminum sides which permitted free expansion and contraction. The unrestrained movement was recorded by six dial indicators reading to the nearest 0.001 in. and located around the surface course (Fig. 8).

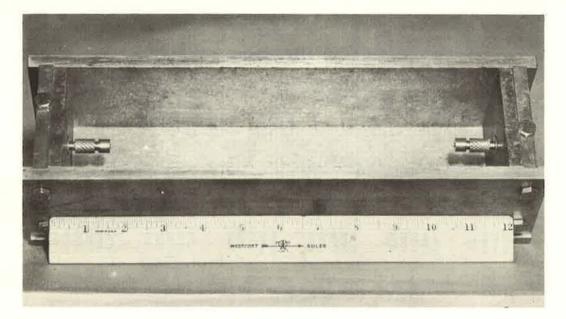
Figure 11. Steel mold, 3 by 3 by 11.25 in., for fabricating bars; note steel pins in end of plates for measuring AC bars.

To reduce the expense of constructing large test samples, a new method was adopted. Asphalt mixes were compacted into 3- by 3- by 11.25-in. steel molds (Fig. 11). Briefly, the method consists of heating the AC mixture to 230 F, rodding it into two layers in the preheated mold, and compacting it with the kneading compactor. On cooling, the mold is stripped and the steel pins at the end of the specimen are fastened into place with epoxy. The bar is cured in a 100 F oven for 3 days and then subjected to the weathering cycles, one cycle consisting of 7 days in a moist room and 7 days in a 100 F oven. Daily measurements of the specimen are made and any cracks or unusual behavior recorded. The specimen is subjected to a total of 3 to 6 weathering cycles. Detailed procedure is given in the Appendix.

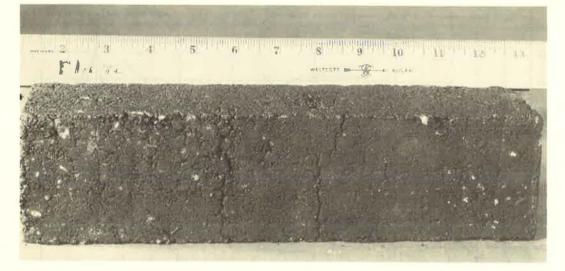
Figure 13. Test bar 62-1908; transverse cracks appeared after first cycle.

Transverse cracks were visible on sample 62-1908 at the end of first cycle (Fig. 13). Rapid expansion (0.045 in.) at the beginning of the drying cycle suggests that this specimen is susceptible to moisture in the vapor state. This sample also exhibited several transverse cracks at the end of the third cycle.

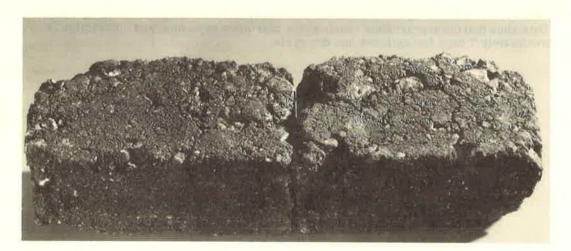
Figure 14. Test bar 62-1863, completely block-cracked at end of third cycle;  $\frac{1}{2}$  in. section sawed from center of test bar for microviscosity test.

Figure 14 is a close-up of test bar 62-1863. Transverse cracks appeared first on the surface of the specimen, then progressed downward. At the end of the third cycle, the bar was completely block cracked.

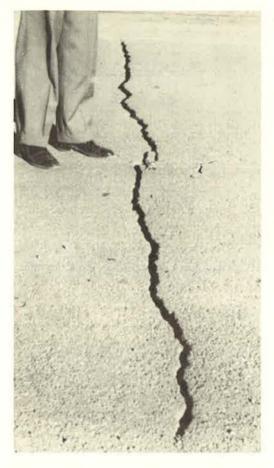
Figure 15. Transverse cracks ranging from  $\frac{3}{4}$  to  $\frac{1}{2}$  in. in width.

In 1962 we were asked to investigate an AC pavement failure in one of our districts. This failure (Fig. 15) consists of transverse cracks from  $\frac{3}{4}$  to  $\frac{1}{2}$  in. wide in the surfacing at irregular intervals ranging from 10 to 20 ft apart throughout the entire

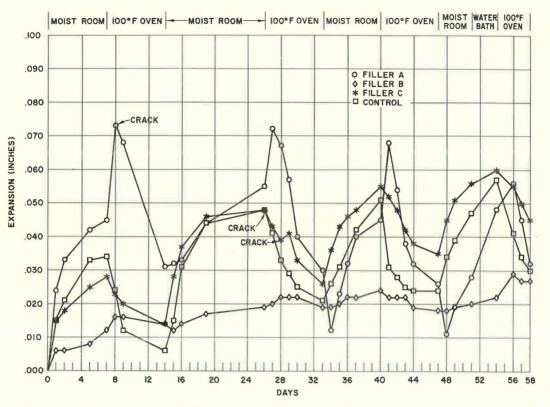
Figure 18. Effect of various fillers.

As shown in Figure 18, Filler A expanded excessively during the first hours of the dry cycle. This phenomenon did not occur in the AC control bar or the other AC bars with different fillers added. From results obtained, we assumed that Filler A was the contributing factor which caused this high expansion during the dry cycle. Transverse cracks appeared during the dry period of the first cycle. After cracking, the amount of expansion decreased. This usually occurs when the cracks have progressed through the test bar.

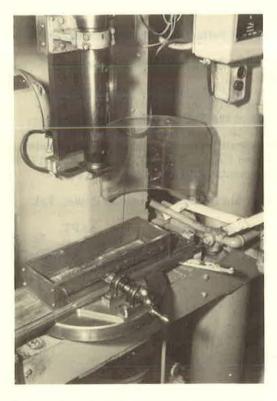
Figure 21. Mold and carriage which holds steel mold during compaction.

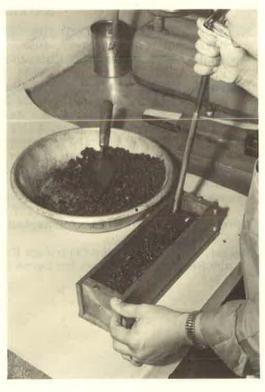
Figure 22. AC mix being rodded with 3/8 in. bullet-nosed rod.

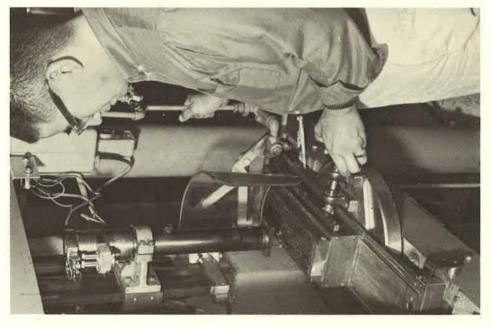
Figure 23. AC mix ready to be compacted with 2- by 3-in. rectangular compacting foot (2 by 3 in.).

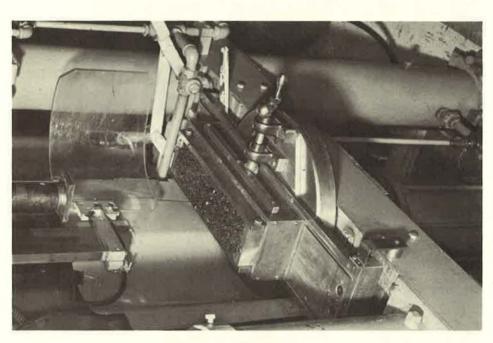
Figure 24. AC bar being fabricated; crank is turned  $\frac{1}{n}$  rev after each stroke of compactor foot.

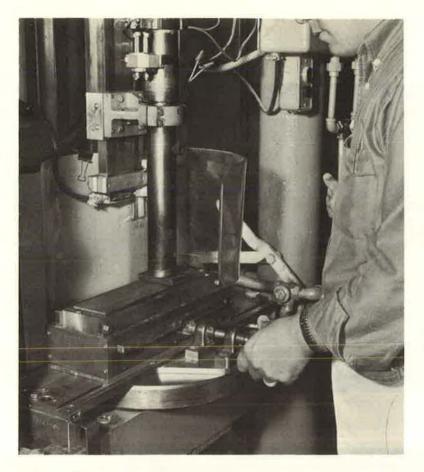
Figure 25. AC bar receiving leveling-off load.

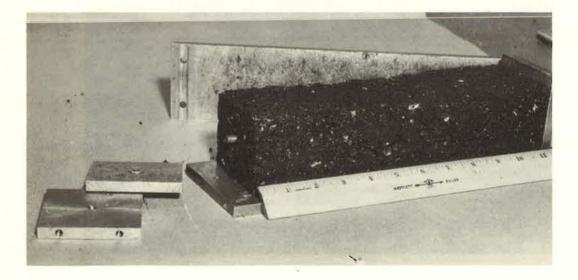
Figure 26. Metal mold being stripped from AC bar, showing steel pins used for measurement.

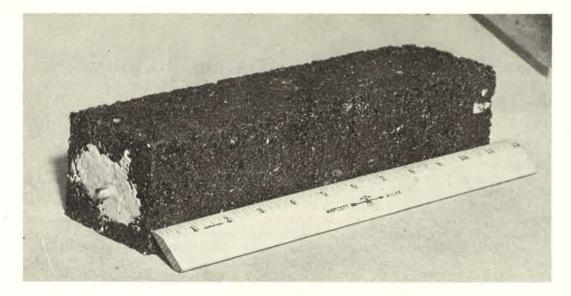
Figure 27. Finished AC bar showing steel pins secured into bar with epoxy.
