Fatigue Tests of Plates and Beams With Stud Shear Connectors

J. E. STALLMEYER and W. H. MUNSE, Professors of Civil Engineering, University of Illinois, and K. A. SELBY, University of Toronto

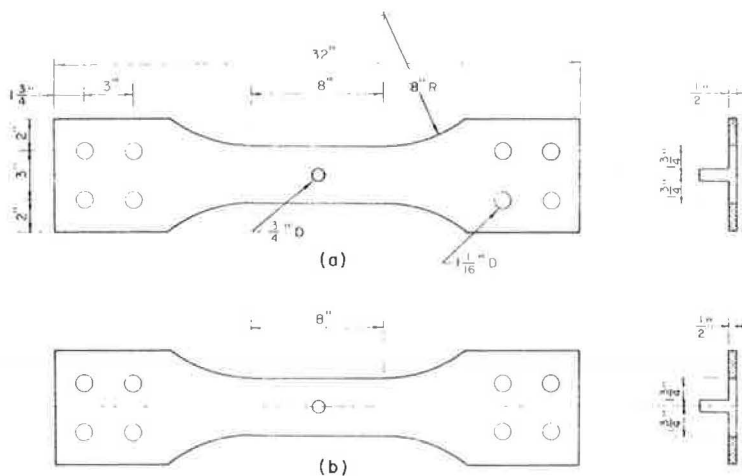
Figure 1. Dimensions of small plate specimens: (a) GIA specimens, and (b) GIB specimens.

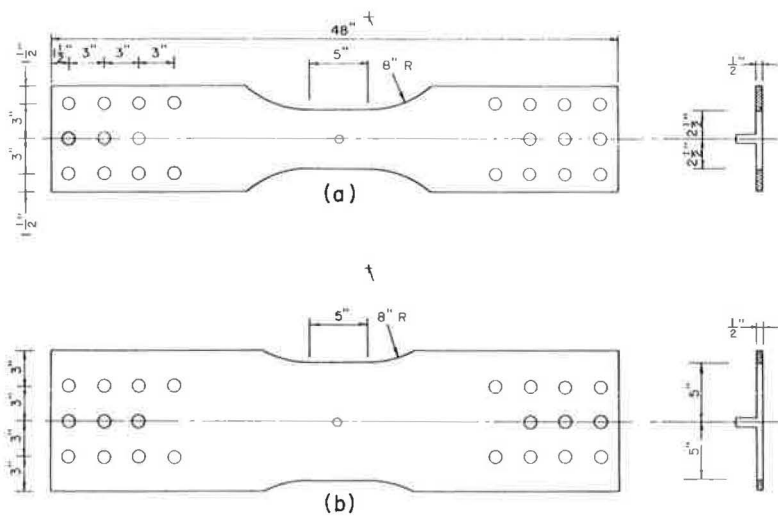
Figure 2. Dimensions of large plate specimens with a single stud: (a) GIC specimens, and (b) specimens GID1 through GID3.

GIC Series.—The only significant difference between the five GIC specimens and those of the GIB series was the width of the cross-section. In this series of tests the width was increased to 5 in. Both series were fabricated from A441 steel and contained a single stud attached at the center of the flat-plate specimen.

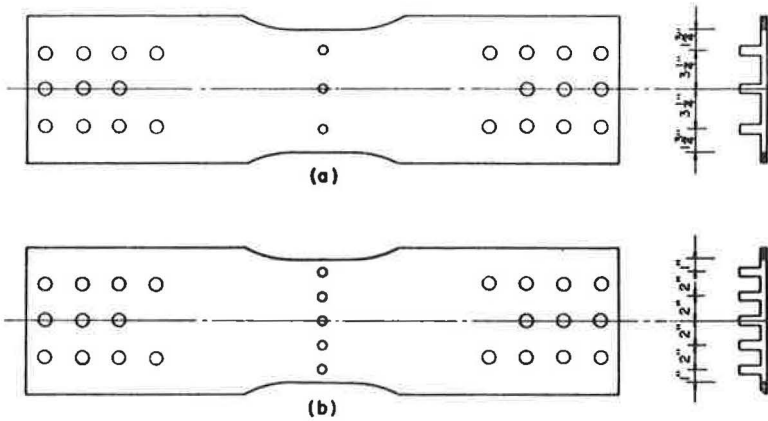
Figure 3. Dimensions of large plate specimens with multiple studs: (a) specimens GID⁴ through GID⁶, and (b) specimens GID³ through GID¹⁰.

GID Series.—To study the effect of multiple studs, ten flat-plate specimens were machined to a 10 in. width across the test section. These specimens were then provided with either one, three, or five studs attached in a single line transverse to the

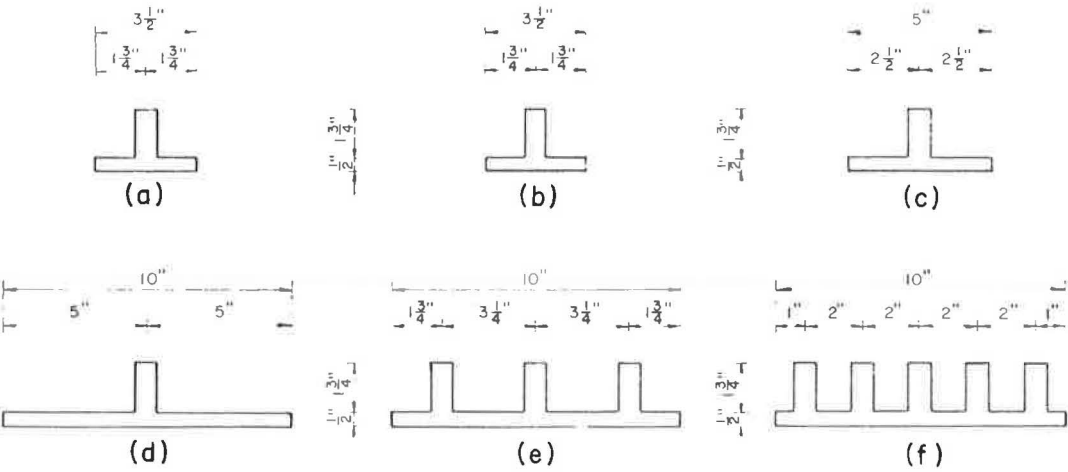
Figure 4. Cross-sections of flat-plate specimens through line of studs: (a) GIA, (b) GIB, (c) GIC, (d) GID1 through GID3, (e) GID4 through GID6, and (f) GID7 through GID10.

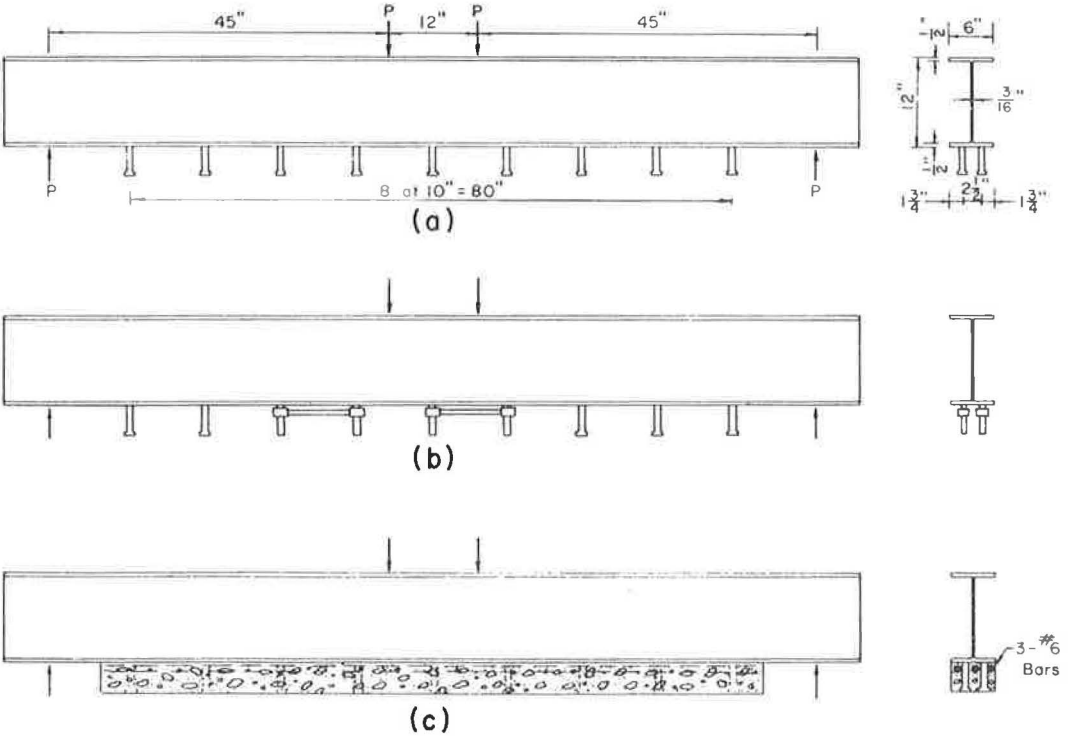
Figure 5. Details of beam specimens: (a) GIE1 through GIE3, (b) GIE4 through GIE6, and (c) GIE7 through GIE10.

Specimens GIE1 through GIE3 were tested as simple flexural members with no external loads applied to the stud shear connectors. Specimens GIE4 through GIE6 were altered in such a manner as to remove the heads from the eight centrally located studs. Specially prepared and calibrated connectors were placed over four pairs of studs as shown in Figure 5b. These connectors were made so that they could be pretensioned to produce any desired shear force in the studs. The force in the connector was measured by strain gages attached to the connector and calibrated in a static testing machine. Additional strain gages were attached to specimens GIE4 and GIE5 to determine the strain distribution across two different cross-sections. The output from

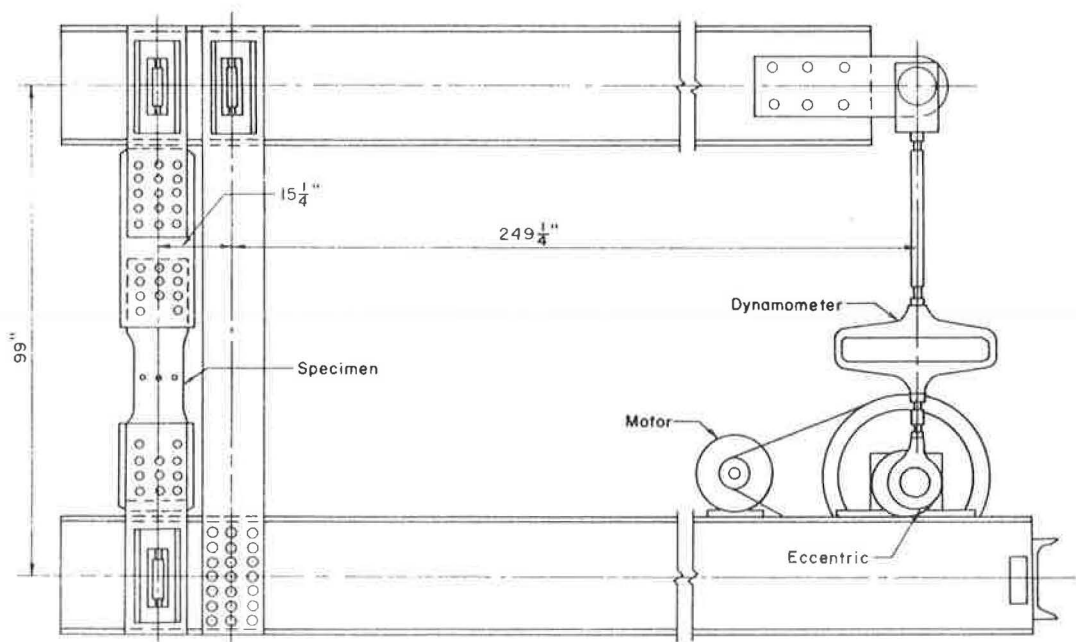
Figure 6. Illinois' fatigue testing machine for axial loading.

A microswitch near the specimen end of the machine is adjusted so that excessive deflection of the specimen trips the switch and stops the machine. During the progress of the fatigue fracture the load is adjusted so that the specimen is subjected to a relatively constant load. Failure is defined as having occurred when the specimen could no longer withstand the prescribed load without yielding.

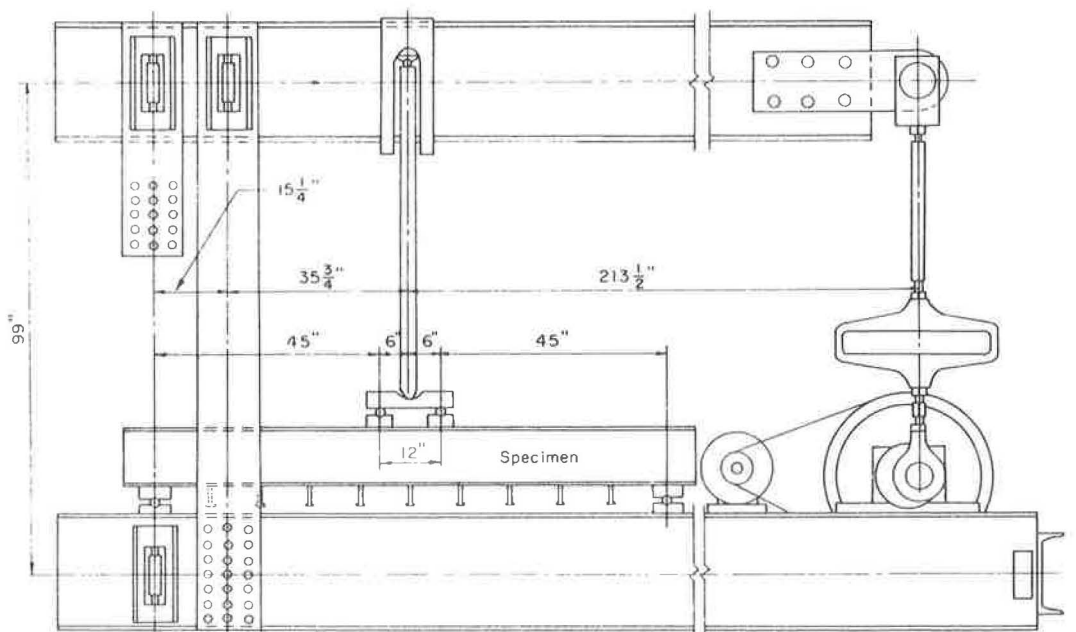
Figure 7. Illinois' fatigue testing machine modified for flexural loading.

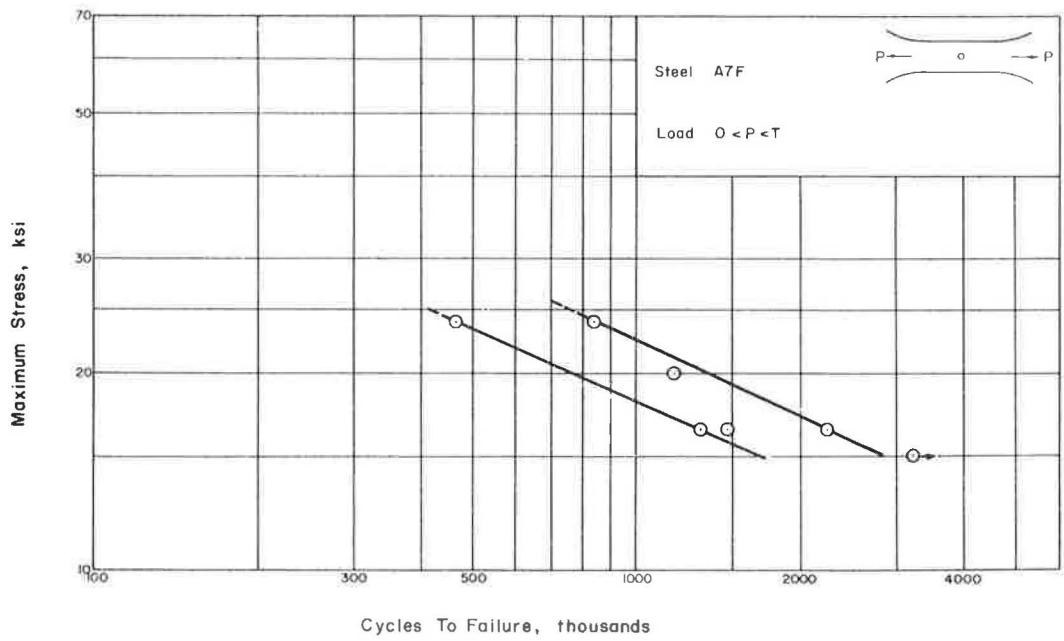
Figure 8. Fatigue results for GIA specimens, zero-to-tension stress cycle.

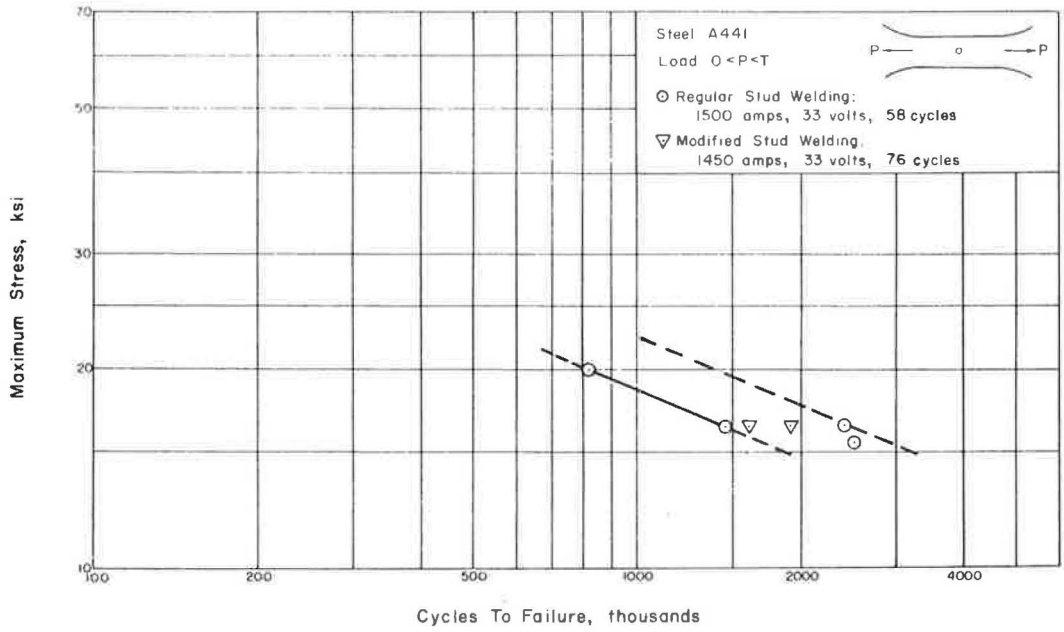
Figure 9. Fatigue results for GIB specimens, zero-to-tension stress cycle.

Two of these specimens, GIB16 and GIB17, were subjected to a zero-to-tension stress cycle in the as-produced condition. The results of these tests are presented in Figure 9 and no significant difference in fatigue life was obtained. One specimen, GIB18, was subjected to a one-half tension-to-tension stress cycle in the as-welded condition and a study of the results given in Table 5 indicates that

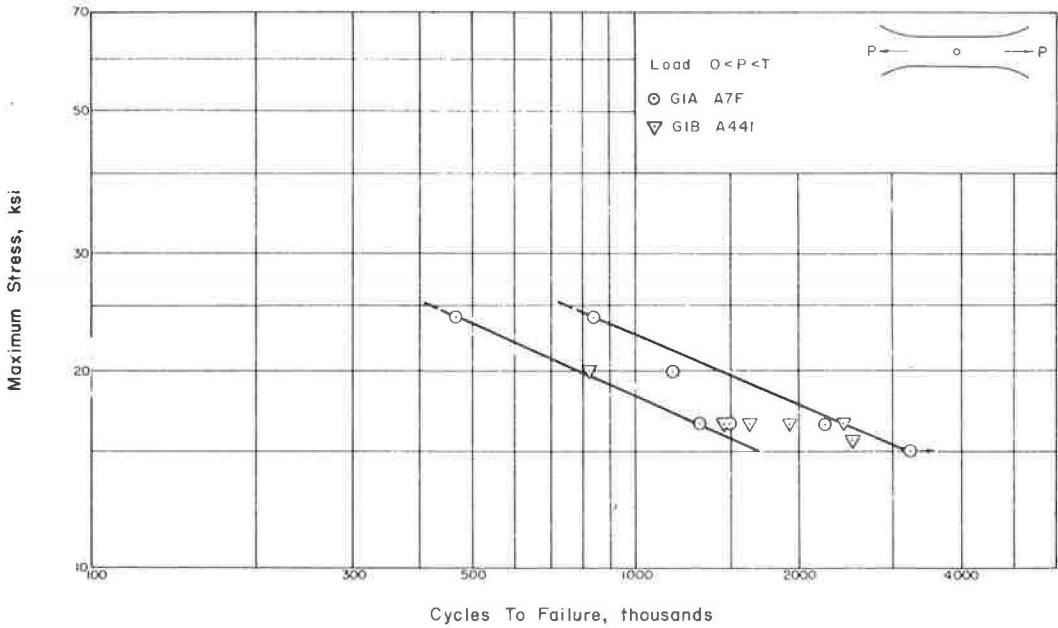
Figure 10. Effect of type of steel on fatigue life, zero-to-tension stress cycle.

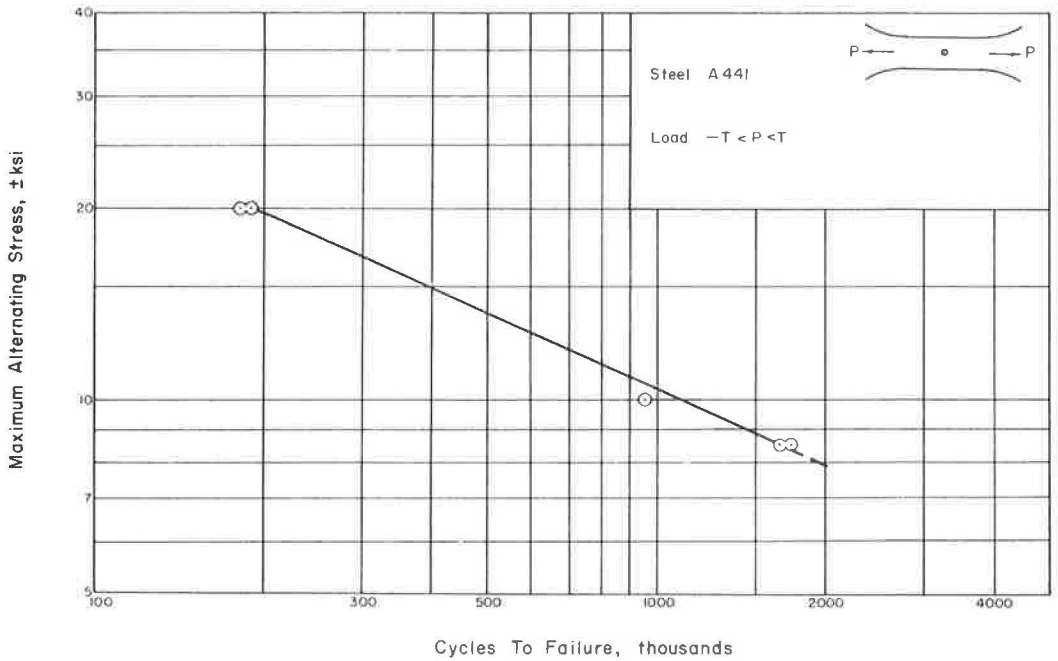
Figure 11. Fatigue results for G1B specimens, complete reversal stress cycle.

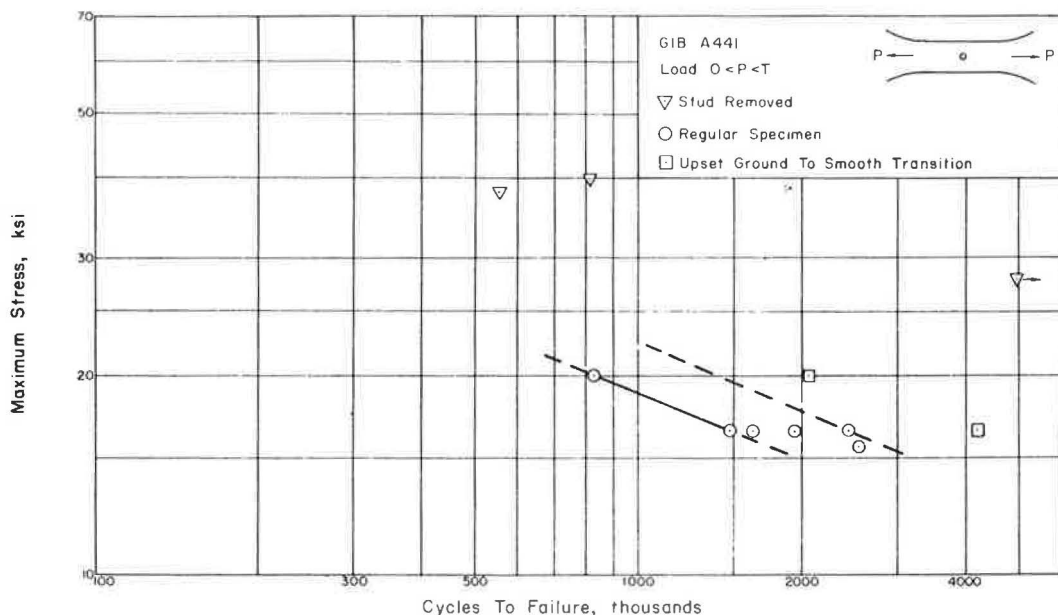
Figure 12. Geometrical effect on fatigue results, zero-to-tension stress cycle.

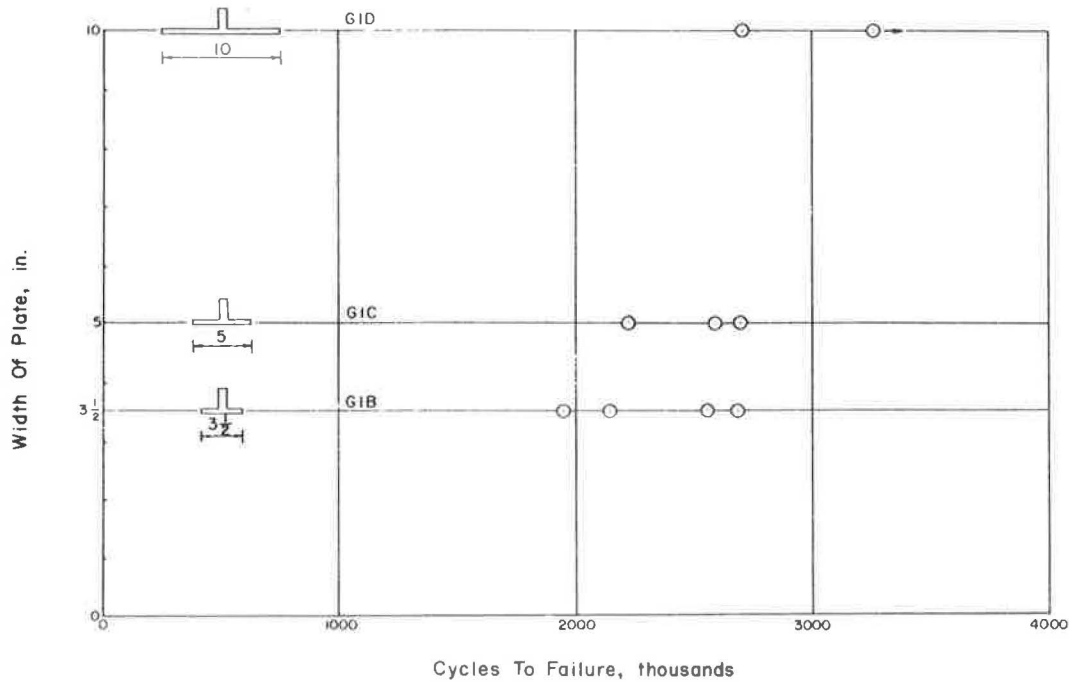
Figure 13. Width of plate vs fatigue life, stress cycle +14.0 to +28.0 ksi.

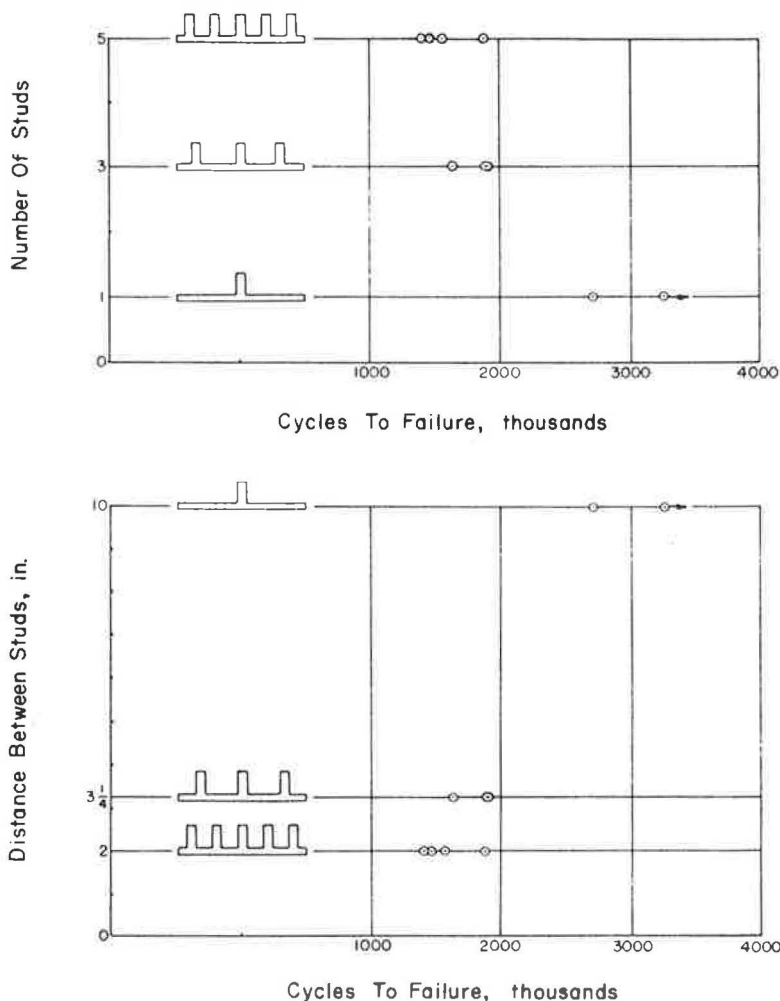
Figure 14. Stud spacing vs fatigue life, stress cycle $+14.0$ to $+28.0$ ksi.

An examination of the test results indicate that neither of these factors is very dominant. As seen in Figure 14, the single-studded specimens are slightly more resistant to fatigue failure. However, a study of the results presented in Figure 13 reveal that the results for a single stud attached to a $3\frac{1}{2}$ -in. wide plate, corresponding to a stud spacing of $3\frac{1}{2}$ in., and the results for the single stud attached to a 5-in. wide plate, corresponding to a stud spacing of 5 in., give results in line with those presented in Figure 14. Although there is a slight decrease in fatigue life as the number of studs in any one line is increased, this difference is not significant when converted to stress levels which would produce failure at the same number of cycles.

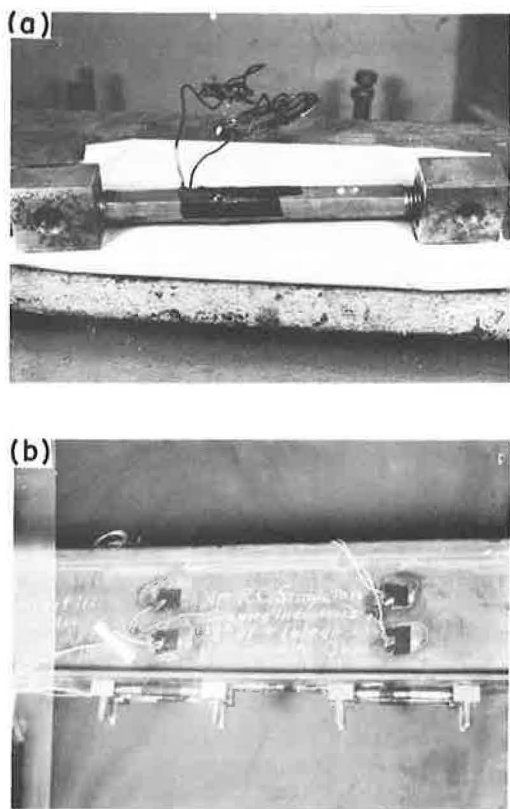
Figure 15. Mechanical stud flexors: (a) flexor, and (b) beam with stud flexors in position.

At the beginning of the fatigue test, the load in the flexor was adjusted so that at a maximum flexural load the shear stress in the studs to which the flexor was attached had a nominal value of 15,000 psi. All beams were tested on a stress cycle which varied from one-half tension-to-tension. The load in the flexor, however, remained nearly constant at the magnitude applied at the beginning of the test. The load in the flexor could be monitored during the individual test cycles and also at various stages during the progress of the test. Such monitoring indicated that at no time during the course of a test on any specimen did the load in the flexor drop below a value of 80 percent of the maximum value set. In only a few cases did the load on the flexor drop to this value. In the other cases, the load in the flexor did not drop below a value of 85 percent of the maximum value. This fact is particularly significant because the stress levels reported in Table 9 are computed on the basis of the section properties of the base beam at the location of the failure. No account has been taken of the effect of the stud flexor on the distribution of stress through the depth of the beam. The local effect of the load transmitted through the stud has also been neglected in the stresses reported.

All failures in this series of beam specimens occurred on the side of the stud away from the flexor used to apply load to the stud. Two failures occurred at the centerline of the beam where the moment and corresponding flexural stress have the maximum value. The other failure occurred at a stud at a distance of 10 in. from the centerline of the beam. At this point, the moment and flexural stress have a value equal to 91 percent of the maximum value at midspan. Since these values are based on nominal stress calculations and neglect the local effect of

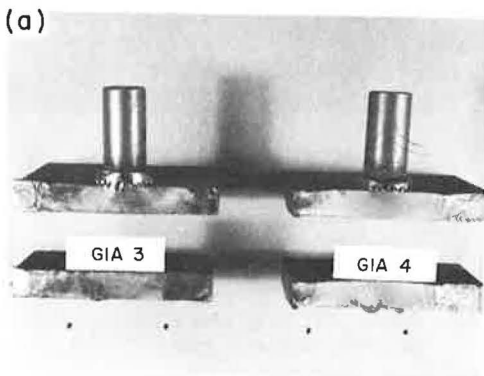
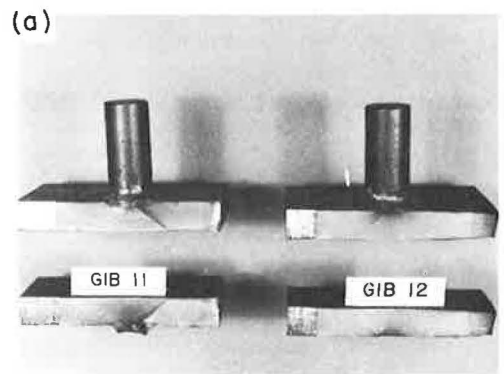
Figure 16. Typical fracture surfaces of single-stud specimens: (a) A7F steel, and (b) A441 steel.

Typical fracture surfaces for the various specimens tested are shown in Figures 16 through 19. The general features of the fractures shown in Figure 16 are very similar and indicate the general nature of all fracture surfaces encountered in the test

Particular note should be taken of Figure 16b which shows the fracture surface for GIB1. In this specimen the fracture actually initiated under the upset. As the crack propagated, it cut across the upset as well as the parent plate, so that when final fracture occurred a portion of the upset was torn from around the stud. This type of failure was encountered in a few of the cases in this study and was primarily affected by the extent to which the upset was bonded to the parent plate. When the upset was not completely bonded, the critical location was actually under the upset and the fracture propagated from this point.

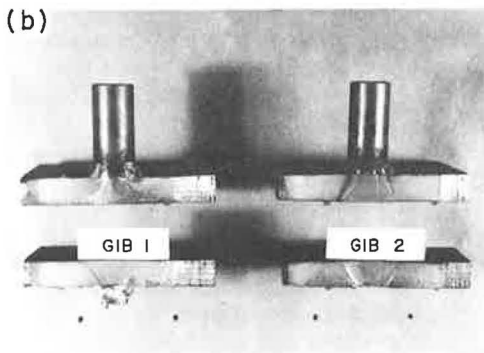
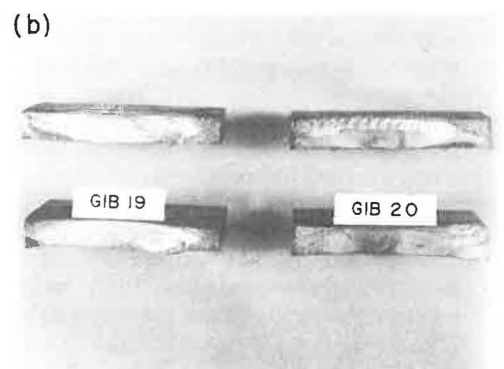
Figure 17. Fracture surfaces of specimens with altered geometry: (a) ground upset, and (b) stud completely removed.

Figure 17 shows the fracture surfaces which resulted when the geometry of the upset was altered. The top portion of this figure shows the result when the upset was ground to a smooth transition between the parent plate and the stud. Failure surfaces in this case are very similar to those previously presented except that the region of slow propagation is somewhat larger than when the upset is subjected to no treatment. Figure 17b shows the fracture surfaces which resulted in the two cases where the stud was completely removed. Here again the fracture surface is not greatly different from that previously reported, except that the region of slow propagation is somewhat larger. The failures initiated at locations corresponding to where the edge of the stud would have been, had it not been removed. This would indicate that the metallurgical structure in this area is weaker as a result of the changes occurring during the welding

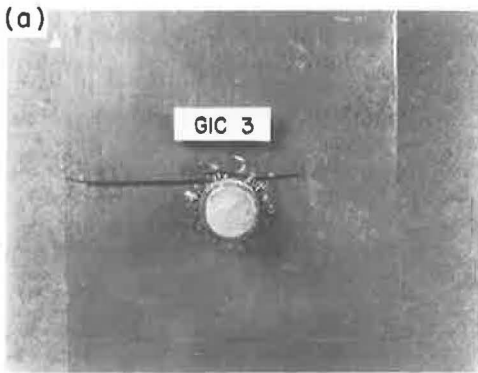
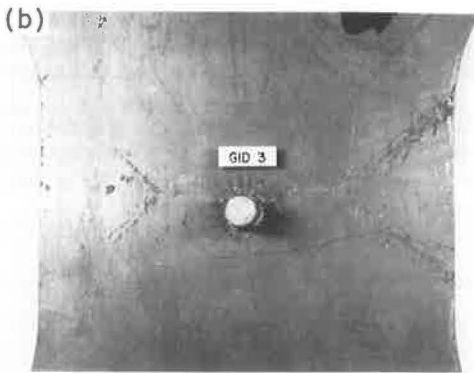
Figure 18. Fractures of single-stud wide-plate specimens: (a) 5 in. wide, and (b) 10 in. wide.

Figure 18 shows the fracture locations for the cases where a single stud was attached to a wider plate. The fracture surfaces in these cases were similar to those previously presented. A very interesting feature of the multiple stud specimens is shown in Figure 19, where typical failures of wide plates with multiple studs are presented. Close examination of the photograph of specimen GID6 reveals several independent cracks which have initiated in a manner identical to that obtained for the plate specimens with a single stud. The photograph of specimen GID8 shows how these cracks which initiate and propagate independently join up to form a continuous crack which eventually causes final fracture.

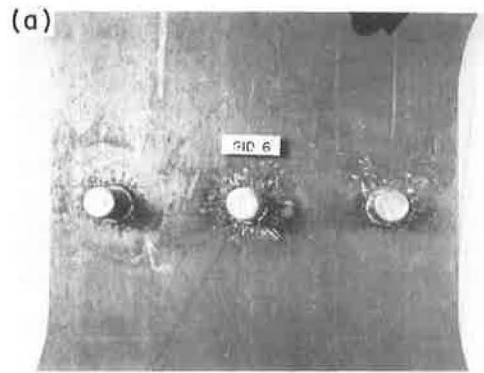
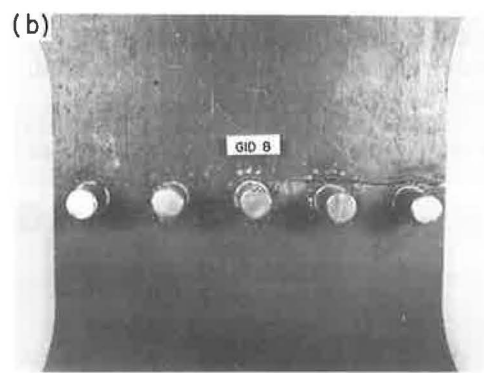
Figure 19. Fractures of multiple-stud wide-plate specimens: (a) three studs, and (b) five studs.

Although it is not readily apparent in the photographs of the specimens with multiple studs, close examination of the specimens revealed that a large number of independent cracks had actually initiated. In the case of the specimens with three studs, at least three independent cracks were initiated. In the case of the specimens with five studs, the number of independent cracks varied from six to eight, indicating that in all cases at least some cracks were initiated on both sides of the studs. This observation is of particular importance since it indicates that the fatigue resistance of such installations is not a case of the weakest link but rather that the fatigue resistance of all of the studs is virtually the same and that fracture initiates at all studs at very nearly the same number of cycles. Some further indication of this fact is contained in the following section.

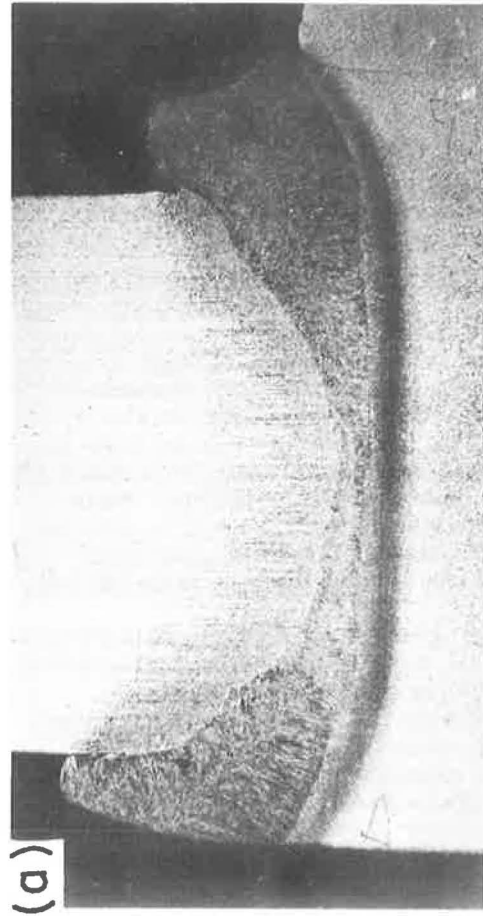
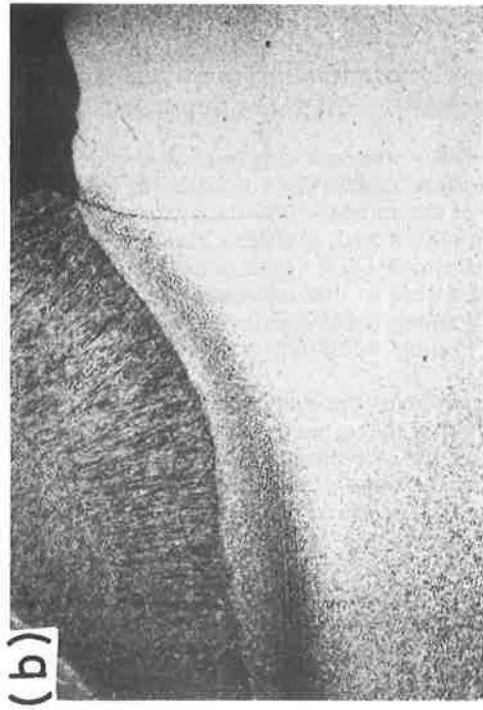
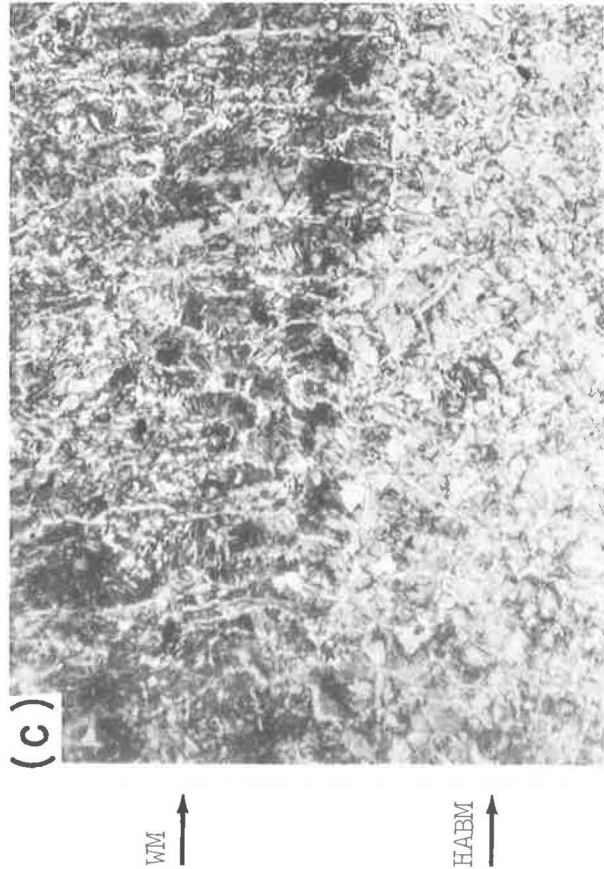
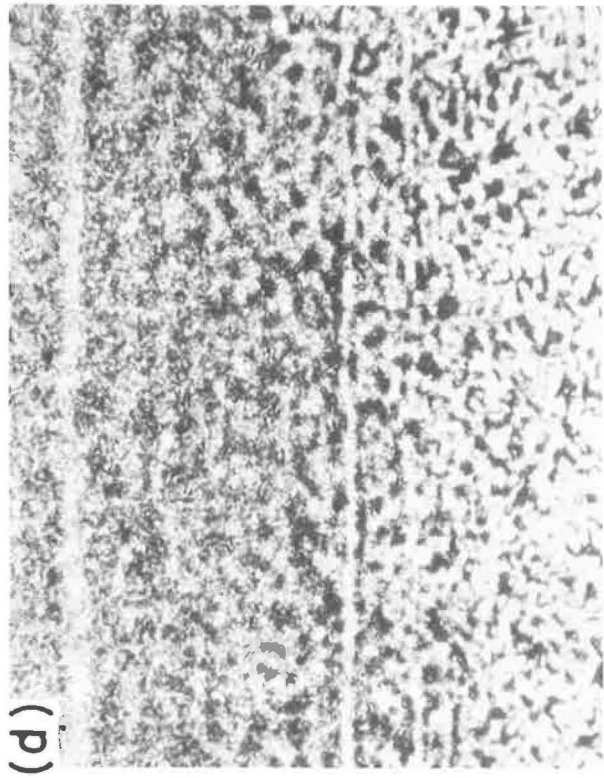
FIGURE 20. Specimen GIA2: (a) macrograph 3X; (b) macrograph 6X; (c) and (d) micrographs 72X.

Typical failure of all specimens is evidenced in GIA2. Both of the macrographs in Figure 20 shows a fatigue crack on the right-hand edge of the stud which initiated at the fusion line and traversed the heat-affected zone. This is not the crack which resulted in final failure of the specimen but is rather 180° away from the source of ultimate failure. Propagation of the crack is transgranular as seen in GIA2.

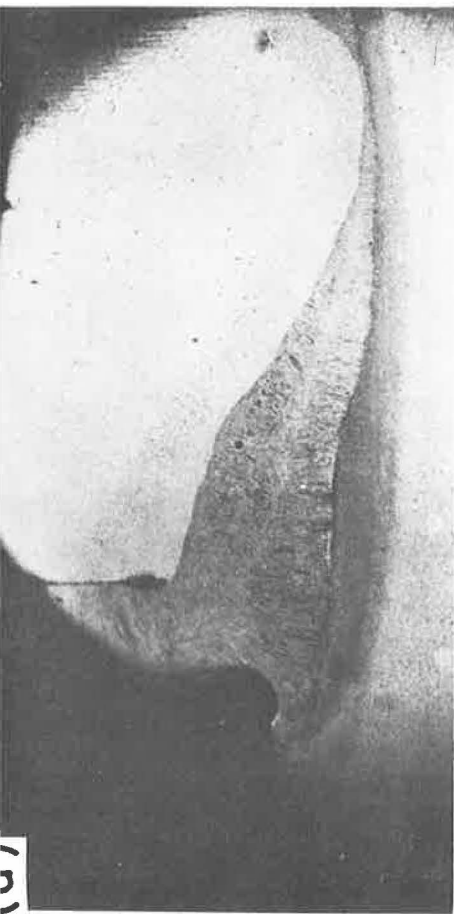
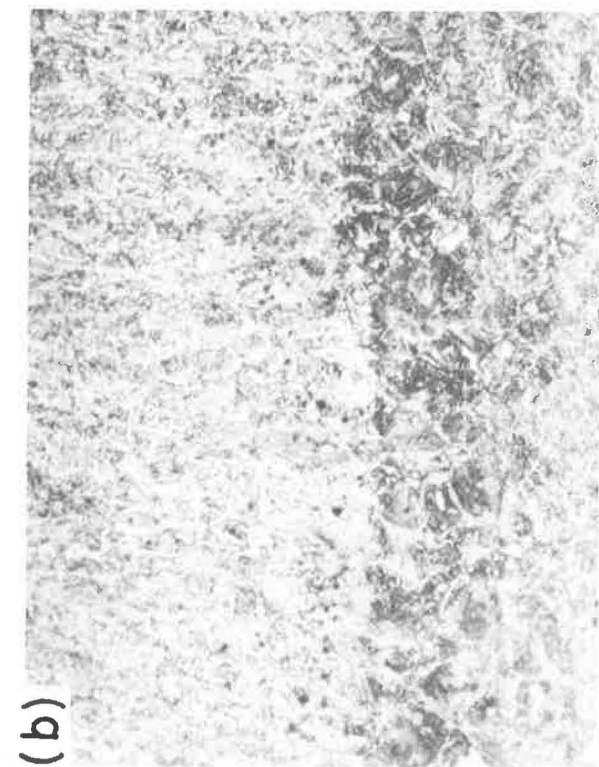
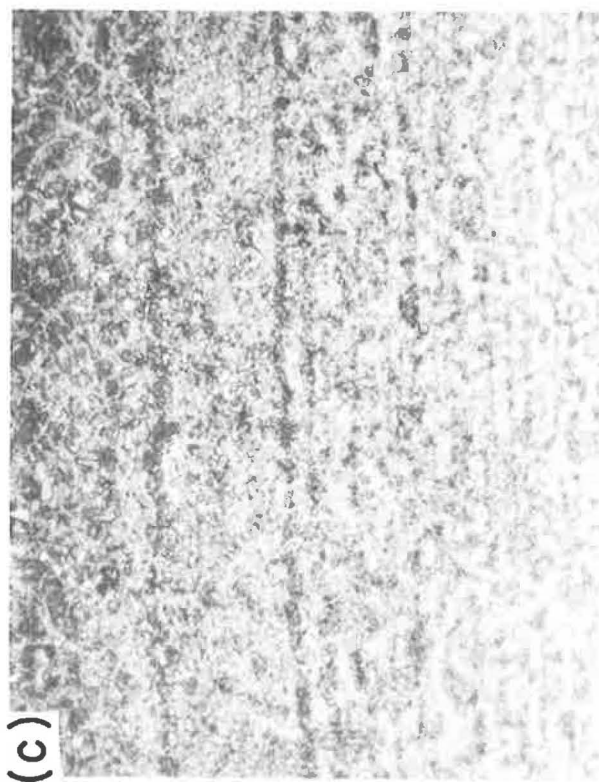
Figure 21. Specimen GIB1: (a) macrograph 5X; (b) and (c) micrographs 72X.

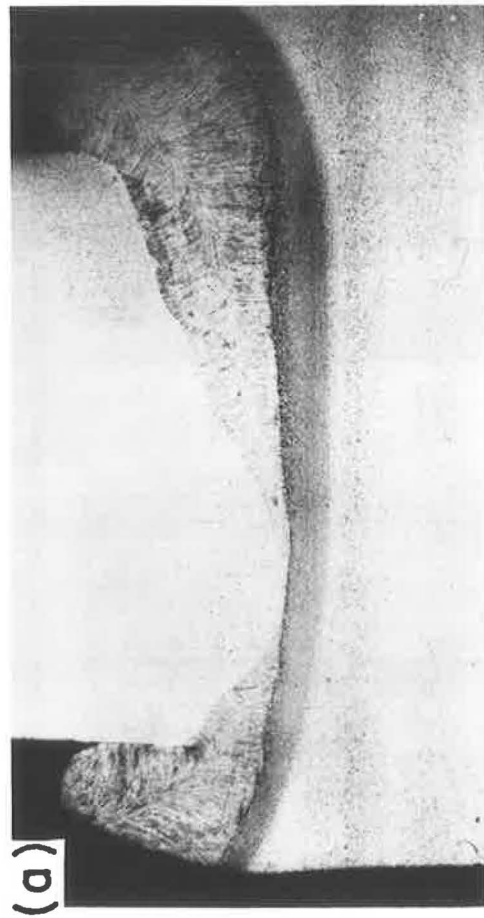
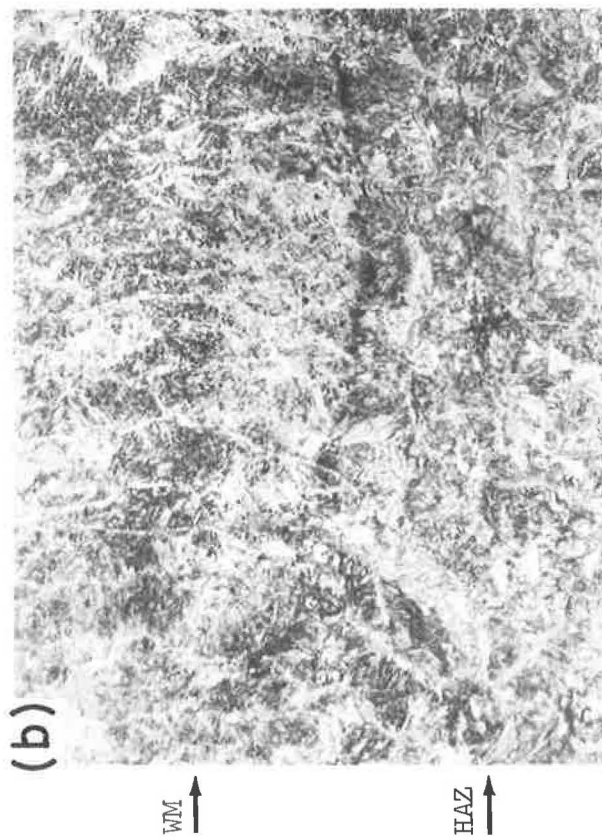
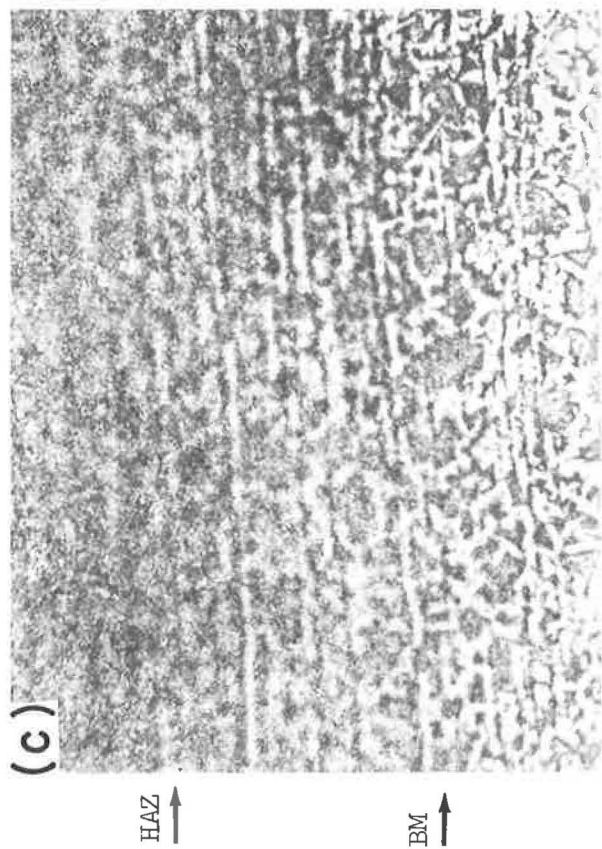
Figure 22. Specimen GIB16: (a) macrograph 3X; (b) and (c) micrographs 75X.

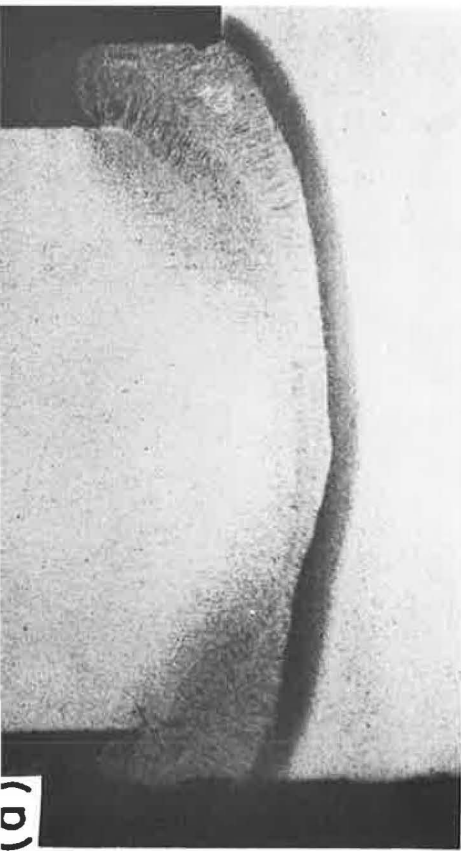
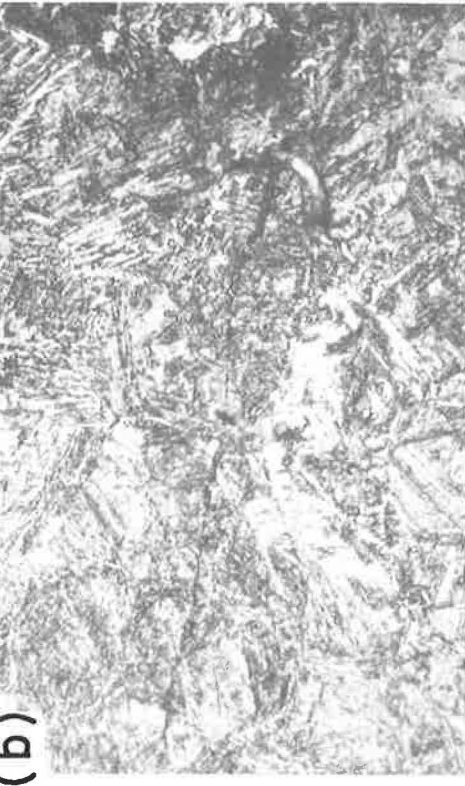
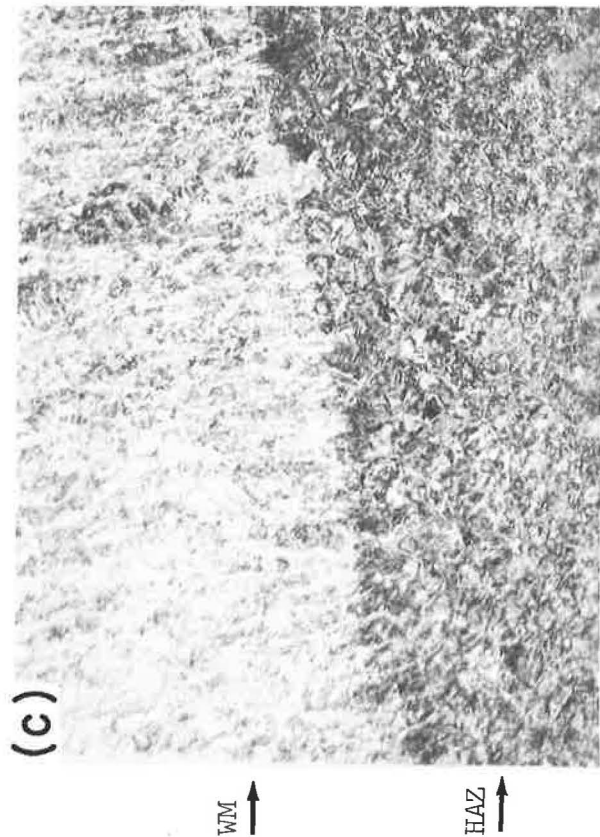
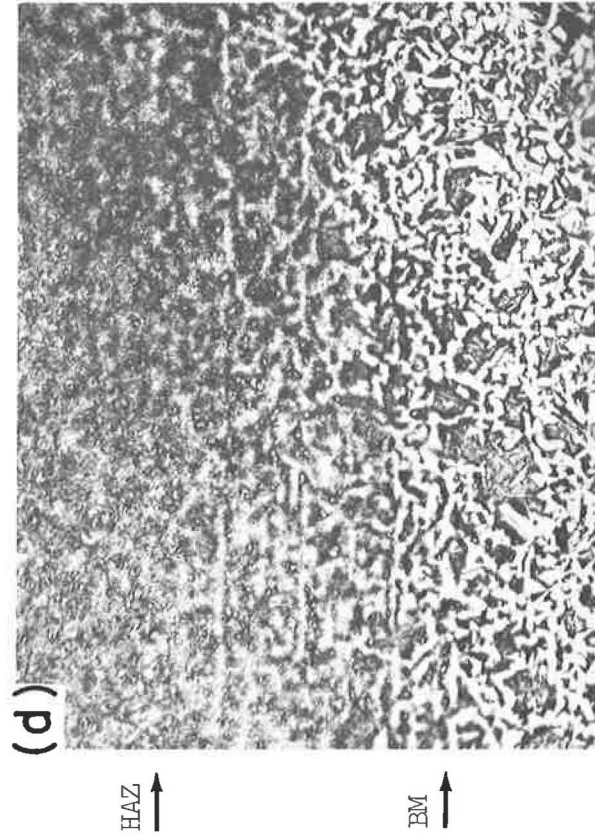
Figure 23. Specimen G102: (a) macrograph 3X; (b) micrograph 500X, showing crack in HAZ; (c) and (d) micrographs 75X.

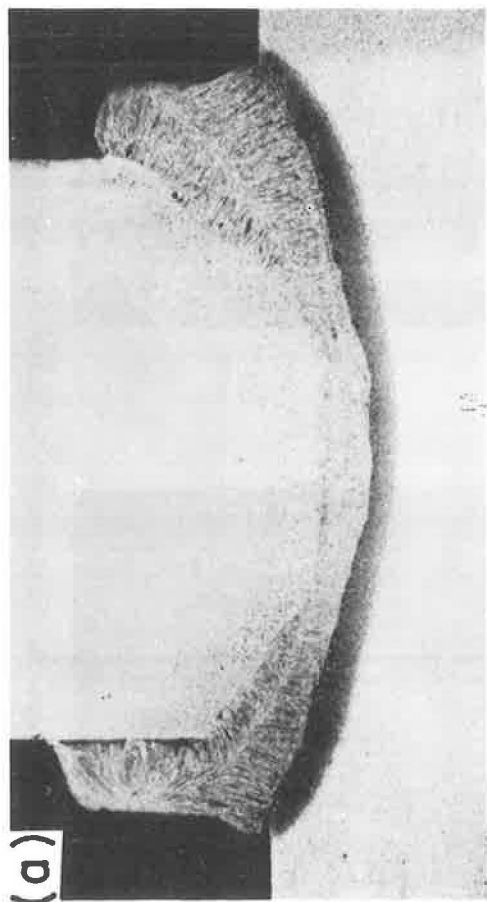
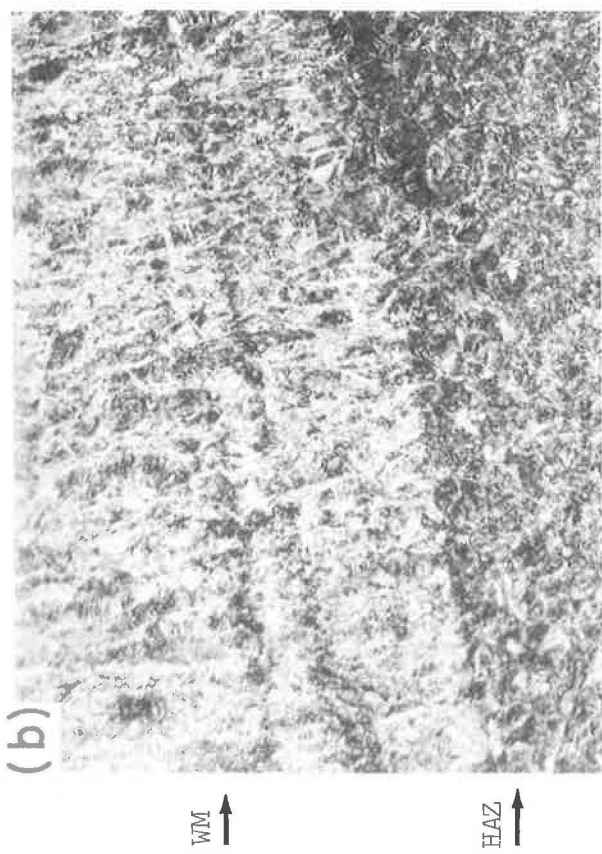
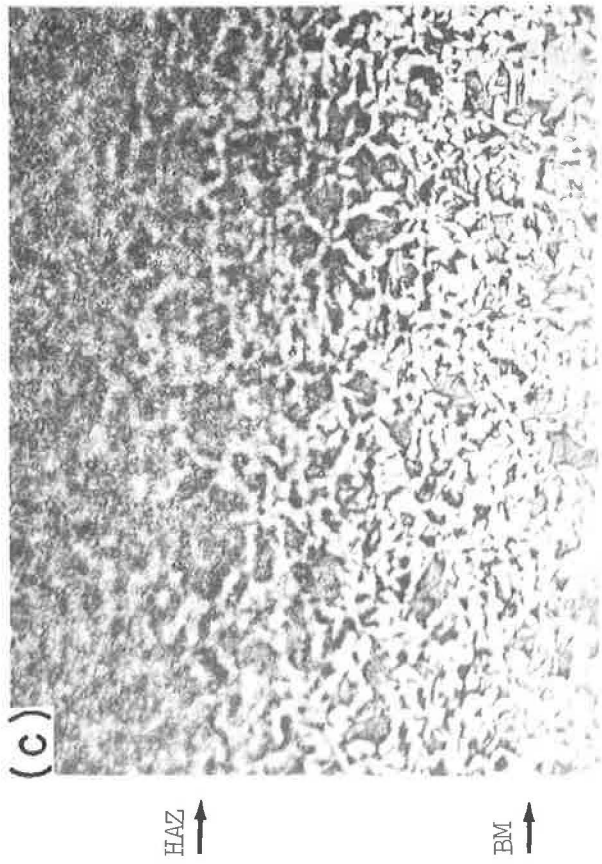
Figure 24. Specimen G105: (a) macrograph 5X; and (b) and (c) micrographs 75X.

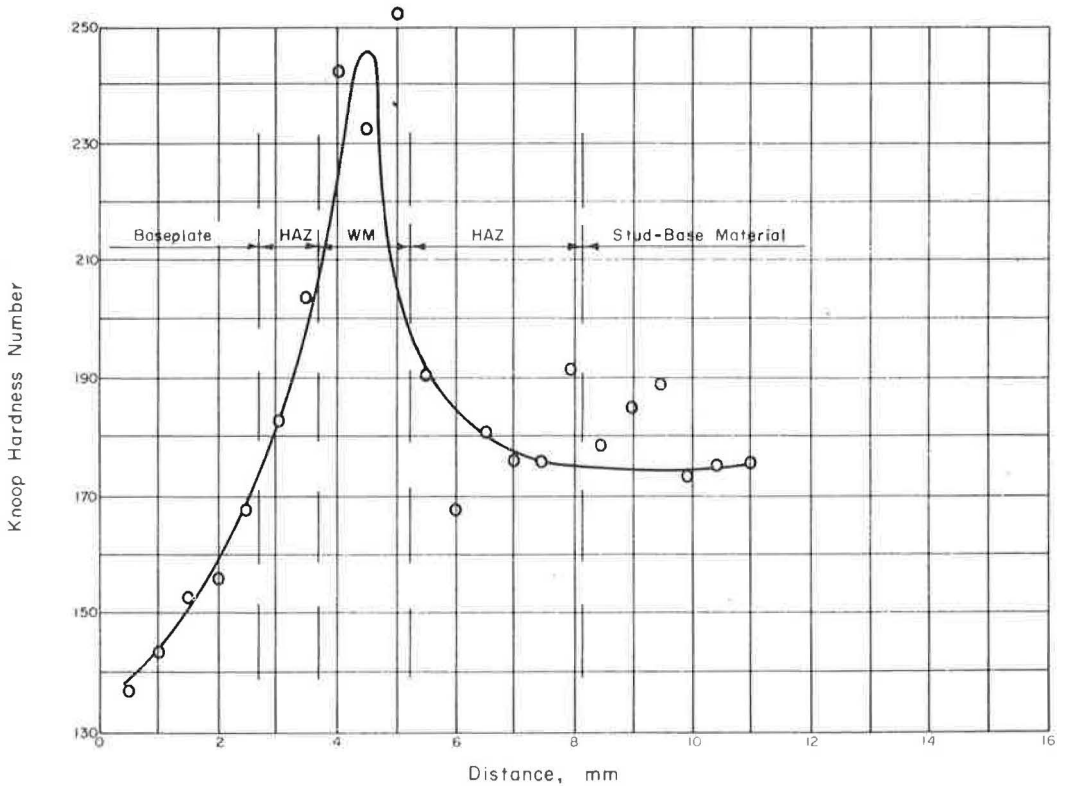
Figure 25. Hardness survey, specimen GIA2.

As would be expected on the basis of metallographic observation, the hardness of the material increases as the percent of martensite increases. As a result, the hardness of the heat-affected zone of the plate GIB16 is considerably higher than that of GIB1, and the same is true of the weld-metal zones. It is also true that the hardness of the heat-affected zone of the plate and the weld-metal zone of GIB1 is considerably higher than the corresponding hardness in these regions of GIA2, due to the increased alloy content of A441 steel as compared to A7F. Table 10 contains a summary, from four different specimens, of the size and average hardness of the various zones which result from the welding operation.
