Fatigue Tests of Plates and Beams With Stud Shear Connectors

J. E. STALLMEYER and W. H. MUNSE, Professors of Civil Engineering, University of Illinois, and K. A. SELBY, University of Toronto

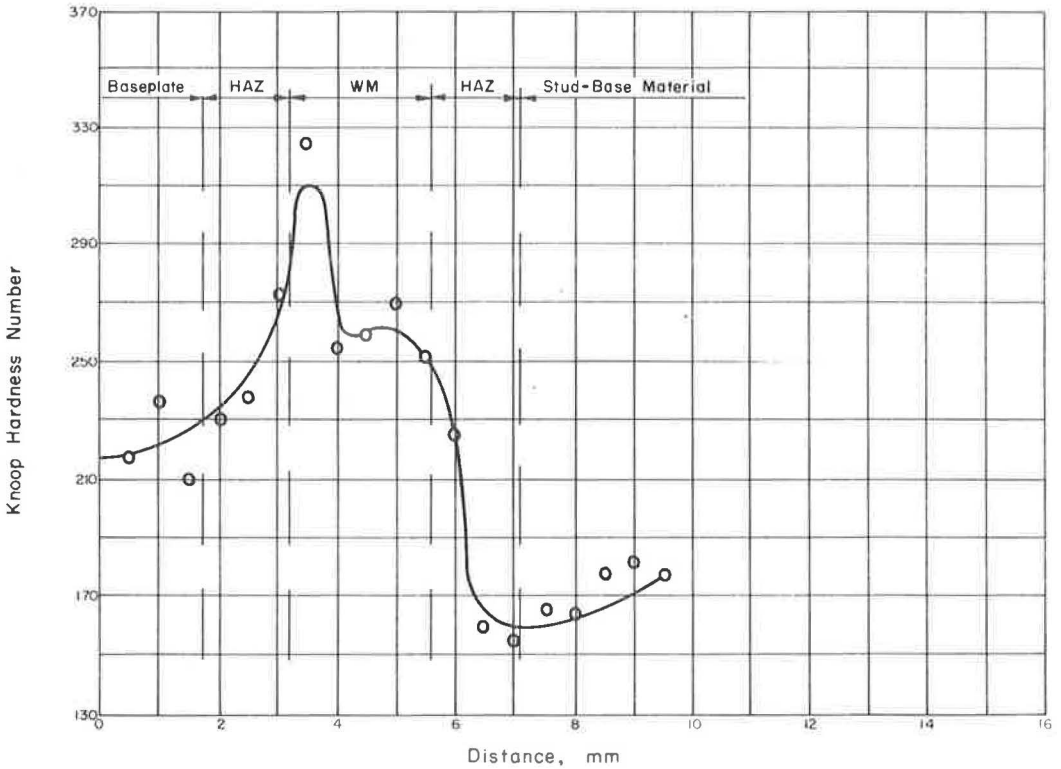
Figure 26. Hardness survey, specimen G1B1.

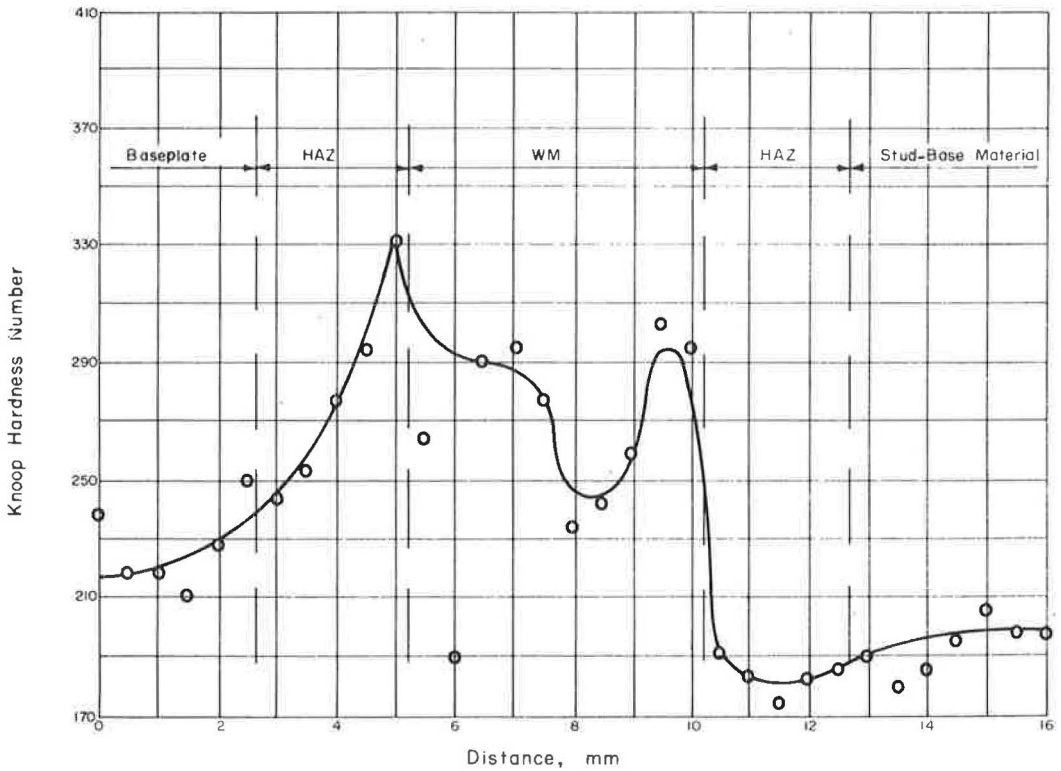
Figure 27. Hardness survey, specimen GIB16.

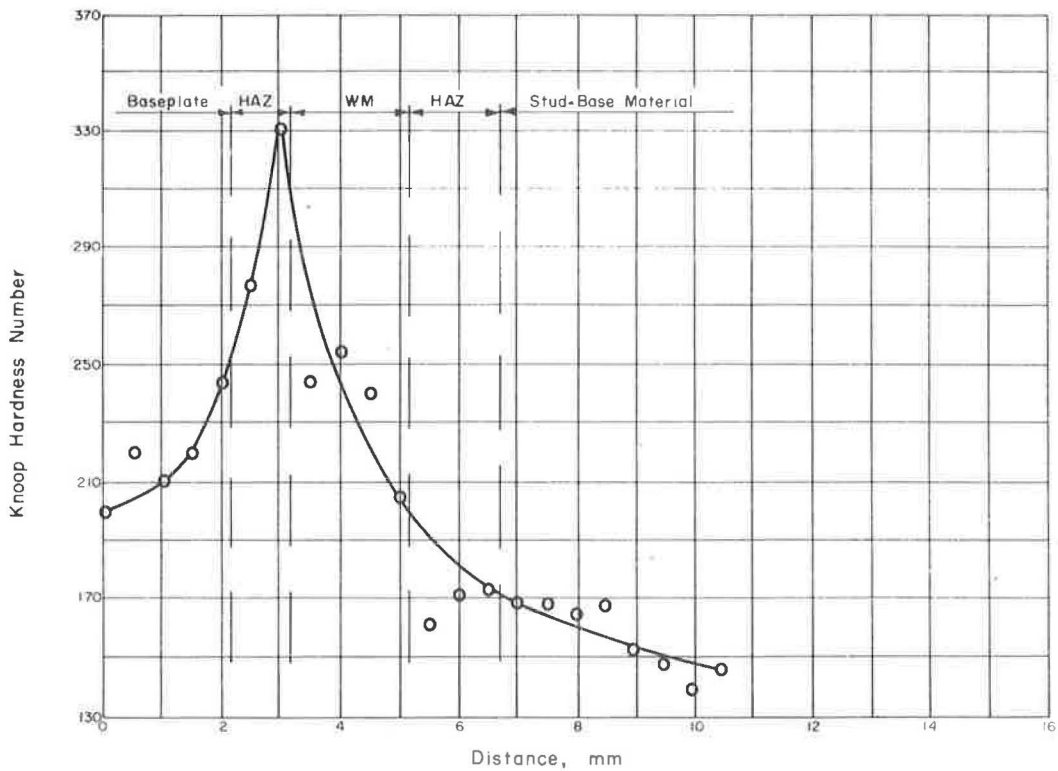
Figure 28. Hardness survey, specimen GIC5.

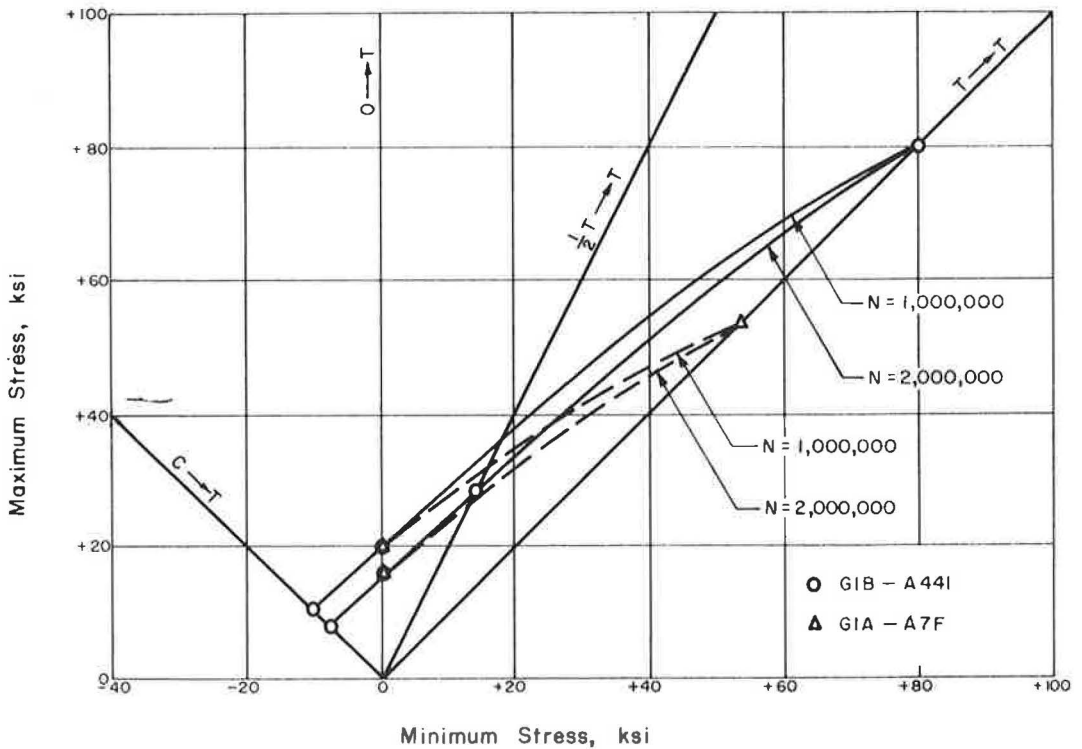
Figure 29. Modified Goodman diagram for GIA and GIB specimens.

With this as a basis, the modified Goodman diagram presented in Figure 29 should serve for the development of suitable provisions for fatigue in the case of designs which utilize stud shear connectors for composite action in negative moment regions. This diagram yields a stress range of 16,000 psi for complete reversal, 16,000 psi for zero-to-tension, and 14,000 psi for half tension-to-tension for failure in 2,000,000 cycles. A somewhat smaller range would be required for stress cycles above this level. Applying a factor of safety of approximately 1.6 on these stresses results in permissible stress cycles of approximately 10,000 psi.
