# Effect of Guardrail in a Narrow Median Upon Pennsylvania Drivers

WILLIAM LOUIS SACKS

Research and Studies Section, Bureau of Traffic, Pennsylvania Department of Highways

A study has been performed to identify and evaluate changes in traffic behavior resulting from the erection of a barrier on a 4-ft median of a divided highway.

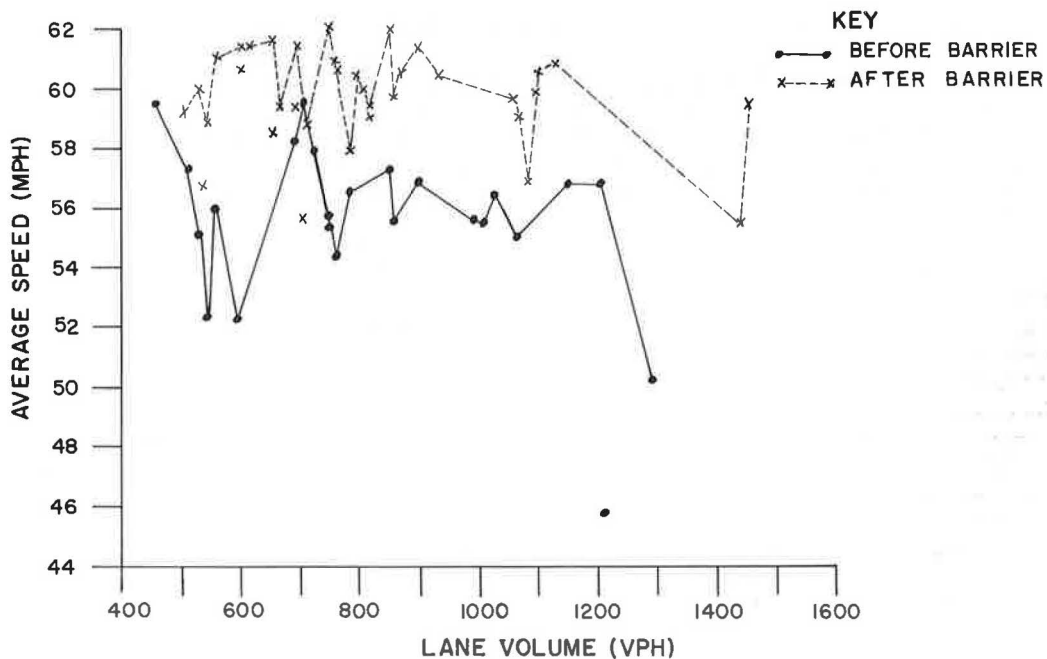
Figure 7. Average speeds and expanded 6-min volumes; maximum speeds at each observed volume, median lane, Location 2.

Figures 7 and 8 show the maximum speeds attained at observed volume levels for the median lanes of Locations 2 and 4, respectively. It was in these lanes that maximum clearance reductions occurred between adjacent vehicles. The graphs indicate that, in general, equal or greater speeds occurred at each volume level after the median barrier was constructed. Therefore, it can be concluded that the median barrier did not, in terms of volume and speed, lower the level of service.

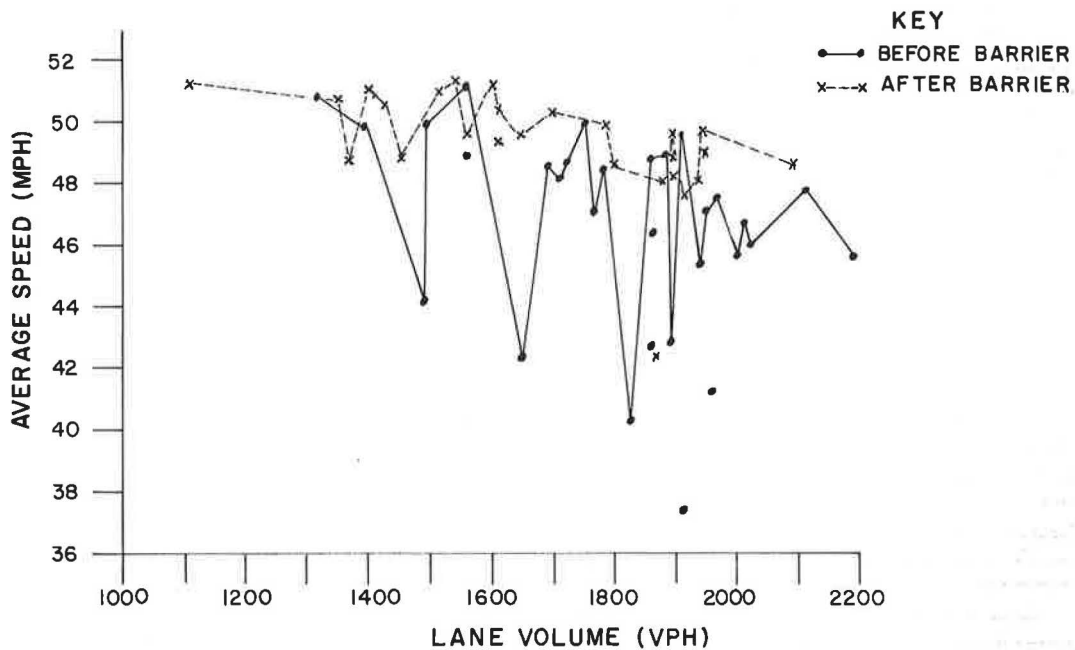
Figure 8. Average speeds and expanded 6-min volumes; maximum speeds at each observed volume, median lane, Location 4.

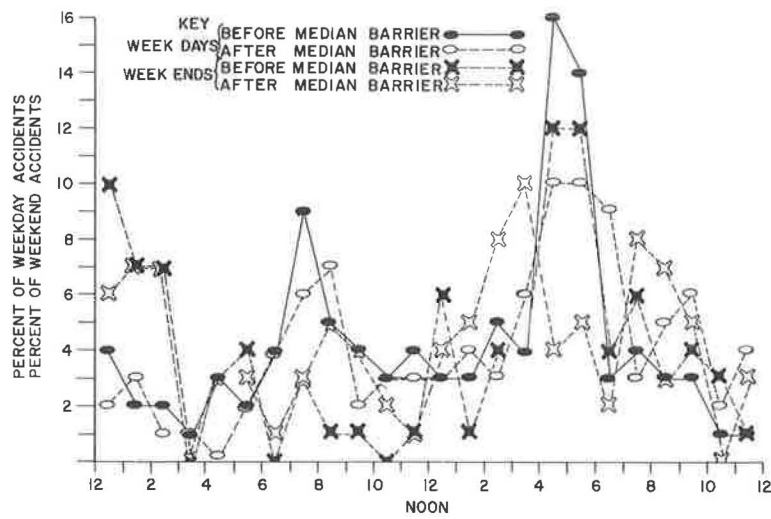
Figure 12. Distribution of hourly accident occurrence, Contract II.

Time distributions of accident occurrence by month, day and hour (the latter separately for weekdays and weekends) have been prepared (Figs. 10, 11, and 12). The time distributions, while not subjected to rigorous analysis, do not appear to show any significant differences between the "before" and "after" periods. Thus it seems that the increase in traffic accidents experienced after median barrier construction is proportionately distributed throughout the hourly, daily and monthly time periods.
