Crown on Soil-Aggregate Roads

J. W. SPENCER

Highway Research and Extension Engineer, Department of Agricultural Engineering,
Cornell University

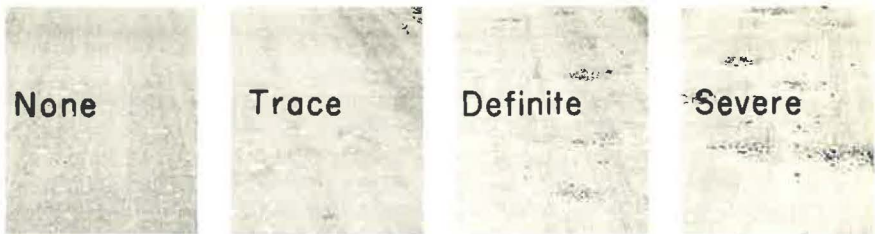
Figure 2. Visual definition of pothole severity.

Pothole severity at the location of the measurements (on only that side of the road where slope measurements were then being taken) was observed and classified as none, trace, definite or severe. Visual definition of these degrees of potholing is provided in Figure 2.

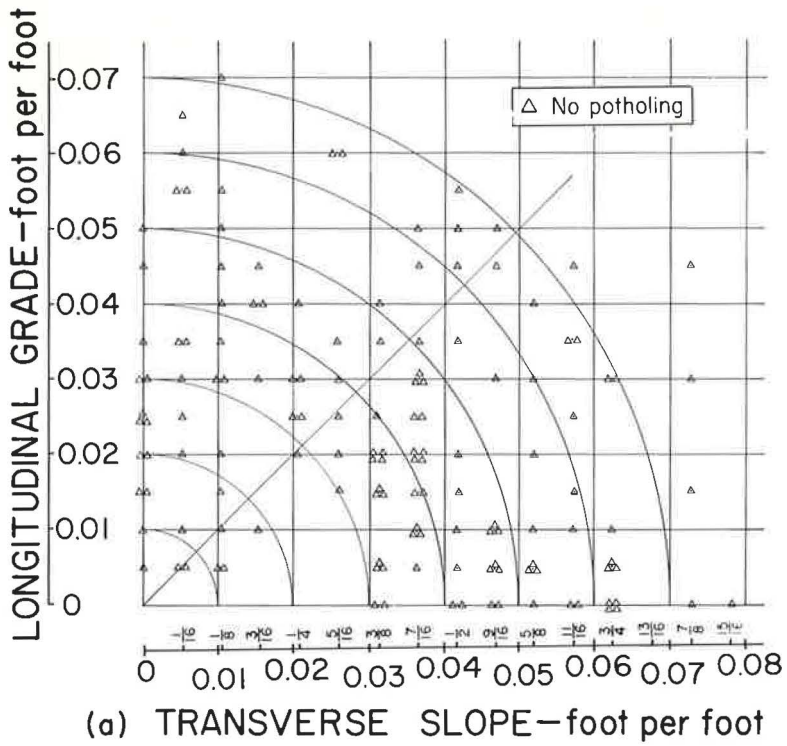
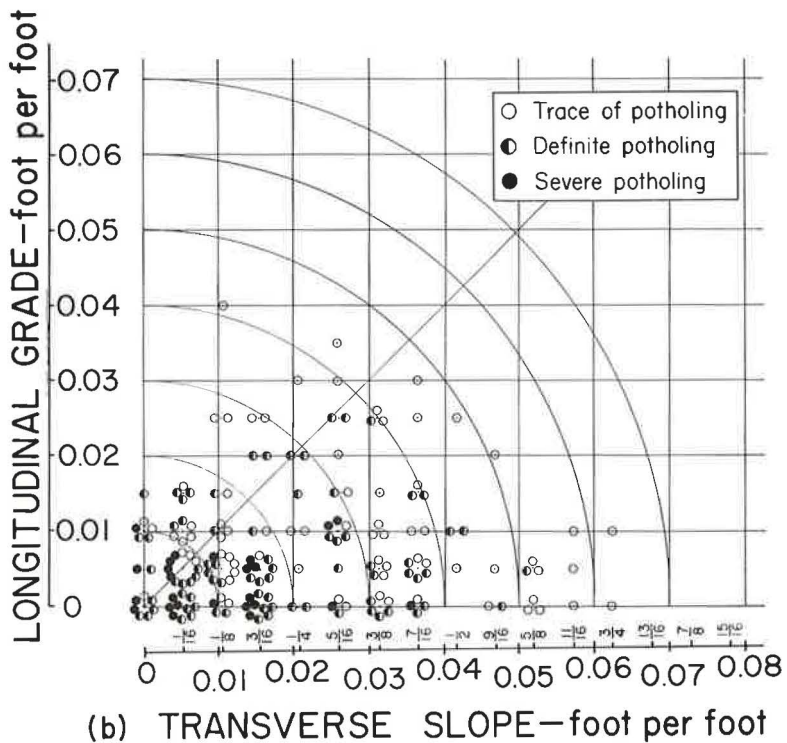
Results of this portion of the study are shown in Figure 3. To minimize clutter, Figure 3a defines only those situations where no potholing was observed. Figure 3b defines situations where potholing was observed and, by symbol, whether the potholing at that location was classified as trace, definite or severe. On both plots, each symbol represents one location of measurements and observation, with longitudinal grade plotted on the vertical axis and transverse slope on the horizontal axis. Where there were two or more observations at a particular combination of transverse slope and longitudinal grade, slope and grade are indicated by a point near the center of the symbol cluster. Maximum resultant slope, defined in Figure 4, at any of the points plotted in Figure 3 is indicated by its radial distance from the origin of coordinates.

Figure 3. Relationship of potholing severity to transverse slope and longitudinal grade:
 (a) no potholing, and (b) potholing.

longitudinal grade only and the frequency and severity of potholing. Although longitudinal grade is usually fixed by considerations other than potholing, its relation to potholing tendencies is at least of academic interest. Figure 3 indicates that, in this study, only traces of potholing were observed, irrespective of crown, where longitudinal grade exceeded $2\frac{1}{2}$ percent. In contrast, there were more than traces of potholes where grades were flat or slight and crown slope exceeded $2\frac{1}{2}$ percent. Figure 3 also indicates that there was lesser severity of potholing (for the several ranges in maximum resultant slope) where longitudinal grade exceeded transverse slope than where a predominant slope was in the transverse direction.

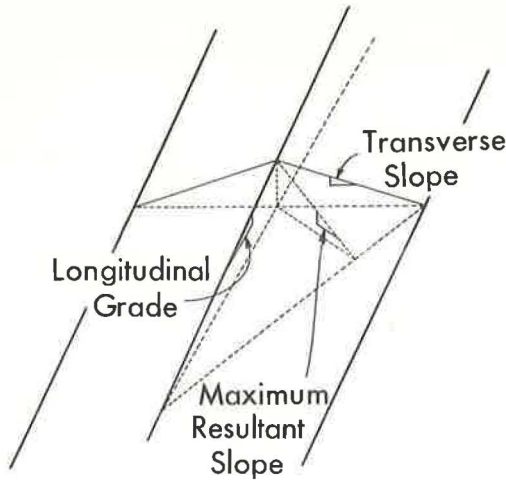
Figure 4. Definition of maximum resultant slope.

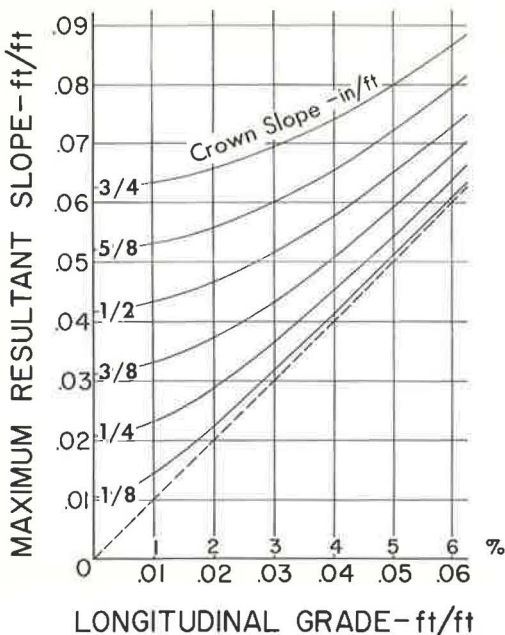
Figure 8. Maximum resultant slope for variations in longitudinal grade and crown slope.

Figures 6 and 8 may be useful as guides for design. Assuming that about 9 to 1 odds against definite or severe potholing are acceptable, a minimum tolerable maximum resultant slope in the range of 0.04 to 0.05 ft/ft might be $\frac{1}{2}$ in./ft (Fig. 6). Where longitudinal grade is absolutely flat, a minimum crown slope of $\frac{1}{2}$ in./ft would, of course, be indicated. Where there is some longitudinal gradient, Figure 8 indicates the extent to which crown might be lessened and still maintain the desired resultant slope. For example, if longitudinal grade is about 2 percent, minimum crown slope could probably be between $\frac{3}{8}$ and $\frac{1}{2}$ in./ft, and if the grade is about 4 percent, the slope could be as low as $\frac{1}{8}$ in./ft. Although zero crown is shown as a dotted line in Figure 8, some

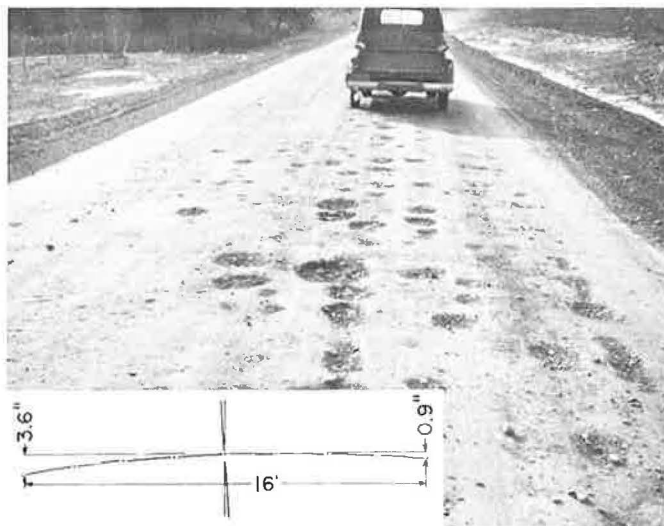
Soil-aggregate roads on sidehill locations are more likely to be potholed on the uphill than downhill side of the road. Such situations usually reflect, as in Figure 9, a lesser crown slope on the uphill side. It was hypothesized that crown slope should tend to be flatter on the uphill side of the road because of a downhill tilt of the crown caused by a misjudgment of vertical (or horizontal) datum in sidehill terrain by a grader man shaping a road by eye.

Figure 9. Potholing on uphill side of soil-aggregate road.

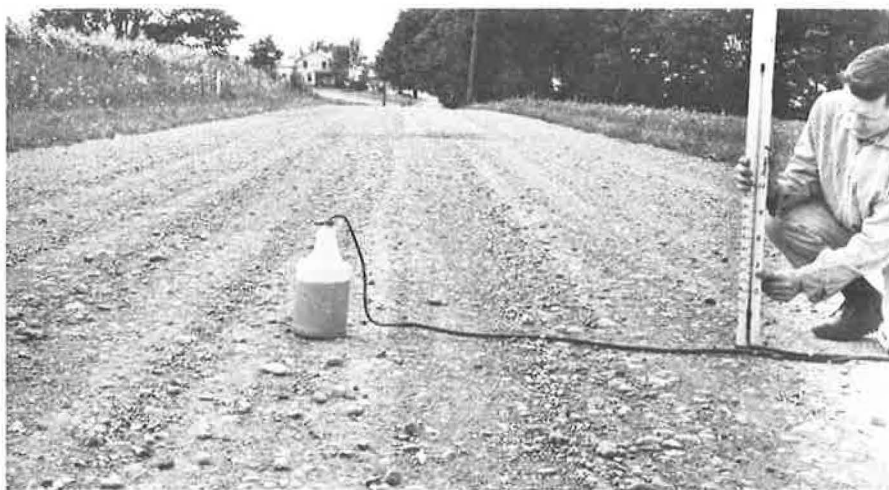
Measurement of Crown.—Crown measurements were made with the liquid-level device shown in Figure 10. With the gallon jug placed approximately (by eye) at the center

Figure 10. Measurement and recording of crown.

line of the road, readings of the drop in elevation were taken at intervals of 2 ft to the left and right of the center line. The readings were plotted on a record card, shown in Figure 10.

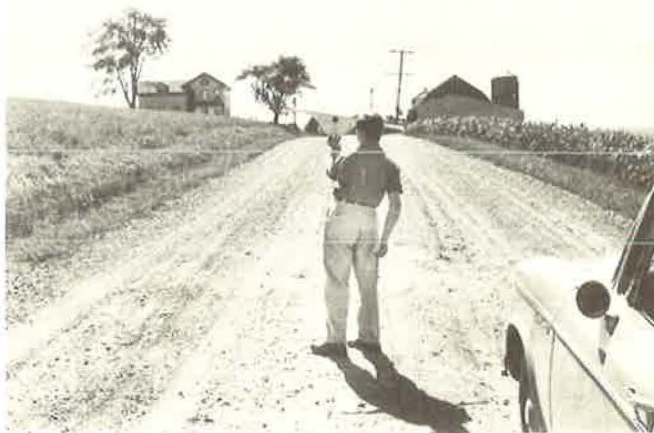
Figure 12. Measuring transverse terrain slope.

Measurement of Transverse Terrain Slope.—Average terrain slope was determined with a protractor as shown in Figure 12. The observer stationed himself so as to be able to align the flat edge of the protractor with average slope of terrain at the location

where crown measurements had been made; slope was recorded to the nearest $\frac{1}{2}$ percent. Although for simplicity, this terrain slope was measured at the location of crown measurement, it is recognized that a grader operator's concept of vertical (or horizontal) was influenced by topography as he approached and even looked some distance beyond the points where measurements were made in this study.

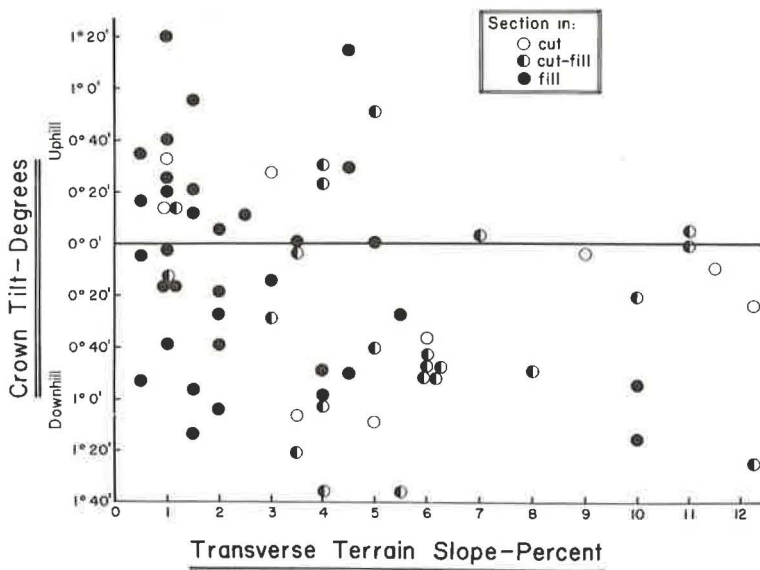
Figure 13. Crown tilt vs transverse terrain slope.

Crown tilt in relation to transverse terrain slope at the 66 points included in this study is summarized in Figure 13. Points on the chart are coded to indicate whether the road cross-section at that point was in cut (8 points), on fill (35 points), or on cut-fill (23 points).

Considering all 66 points together (ignoring whether sections were in cut, fill or cut-fill), it is noted in Figure 13 that for transverse terrain slopes of 2 percent or less, there was equal frequency of uphill and downhill tilt (13:13). For transverse slopes of $2\frac{1}{2}$ through $5\frac{1}{2}$ percent, there were 14 downhill tilts in contrast to 7 uphill tilts and 2 sections without perceptible tilt. For transverse terrain slopes of 6 percent and over, there was considerably higher frequency of tilt in the downhill direction; in these situations, 15 cross-sections were tilted downhill in contrast to only 2 uphill. Although frequency of downhill tilt appears generally to be related to transverse terrain slope, the amount of tilt does not.

There are too few points in Figure 13 to make any conclusive statements concerning relative tendency to tilt road crown downhill on cut, fill, and cut-fill cross-sections. It is noted, however, that average tilt for the cut-fill cross-sections was $0^{\circ} 30'$ for the fill sections and $0^{\circ} 9'$ for the cut sections; average tilt in each case was in the downhill direction. Mention of average tilt should be qualified by average transverse terrain slope for each type of cross-section; these were 5.8, 2.7 and 5.9 percent for the cut-fill, fill and cut cross-sections, respectively.
