HIGHWAY RESEARCH RECORD

Number 95

Field and Laboratory Testing of Aluminum 2 Reports

A Preliminary Study of Aluminum as a Culvert Material

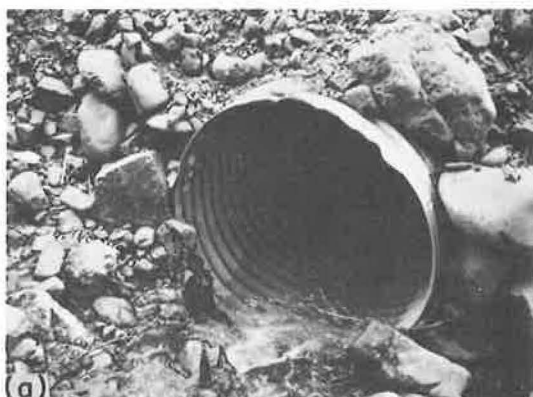
Figure 1. Field test site, I-Hum-35-C, mile 1.19: (a) inlet of test pipe—aluminum section; (b) samples removed from invert after 2-yr exposure.

Figure 2. Field test site—aluminum, I-Hum-35-C, mile 1.19: (a) sample from invert of aluminum culvert; (b) typical loss of cladding at abrasion surface—2 yr; (c) cladding intact—2 yr.

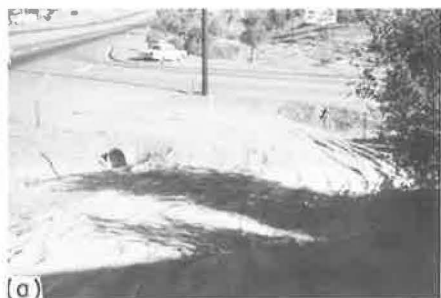
Figure 4. II-Sha-3-B, right of Sta. 265±: (a) field test site; (b) typical invert samples removed after approximately 1.5 yr of test.

In our report, Figures 4, 6, and 13 show the complete loss of sections of the aluminum culvert invert. At the present time, the aluminum culvert shown in Figure 4, II-Sha-3-B, has complete losses of metal in the bottom of the pipe which range up to 1 ft in length. The waters which flow through these three culverts are natural waters. They do not emanate from a mine or a commercial source. These particular test culverts were placed in the same drainage channels in which metal culverts were previously used when corrosion testing was not practiced in the normal course of highway construction.

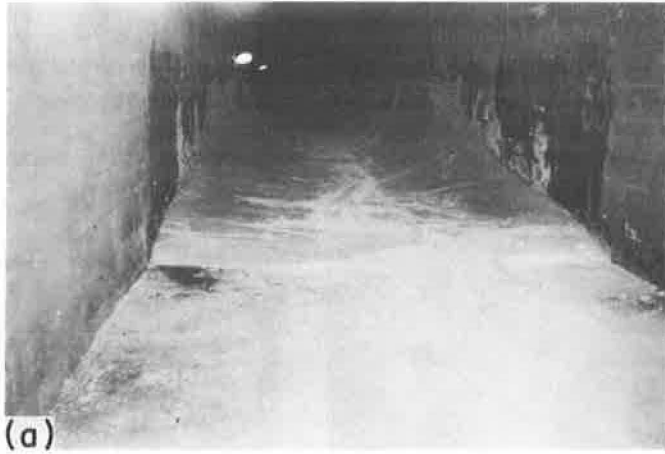
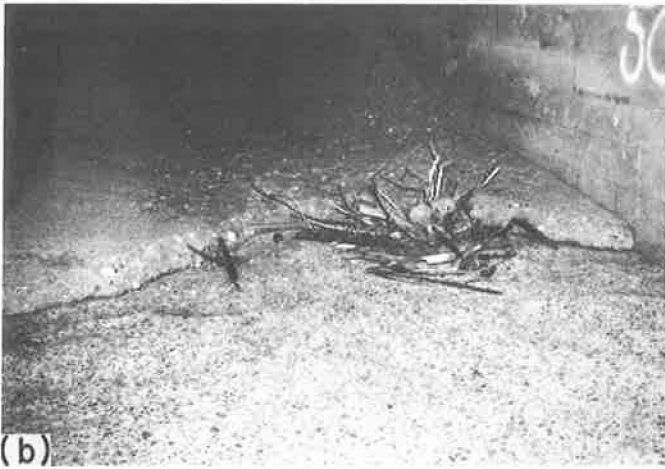
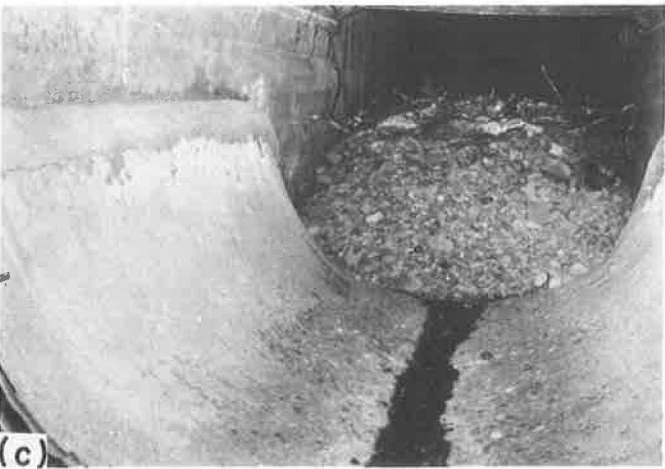
Figure 8. Abrasion test site, IV-SC1-5-C, Sta. 250+25, Bridge No. 37-165: (a) "as built" concrete test section at inlet section of test culvert; (b) appearance of concrete test section after 1.4 yr of service showing severe abrasion; (c) view showing loss of approximately $\frac{1}{2}$ in. of concrete in the concrete test section at the outlet (note deposit of culvert).

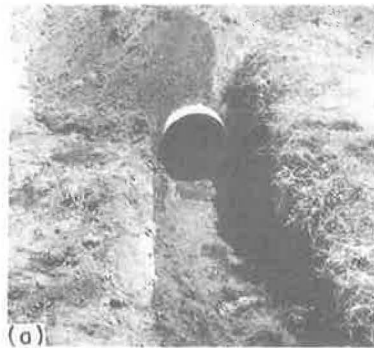
Figure 14. Field test site, X-SJ-53-C, right of Sta. 6±: (a) field test site: (b) backfill side: (c) inside (invert). Appearance of cleaned galvanized steel samples after 2.4 yr of test.

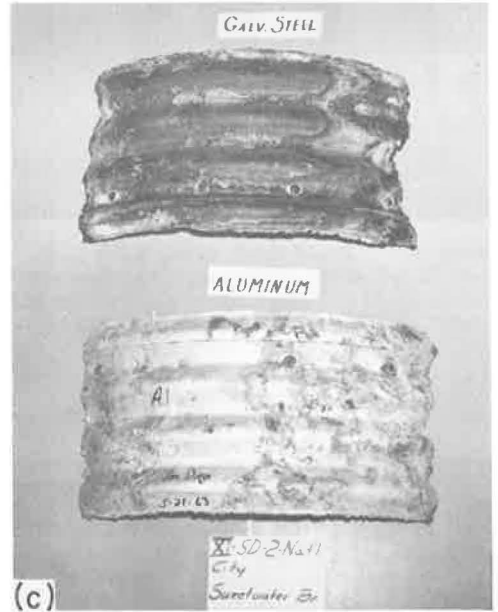
Figure 18. Field test site, XI-SD-2-Nat.Cty at Sweetwater Creek: (a) field test site at high tide; (b) sample removed from culvert inverts after approximately 1.6 yr of test; (c) backfill side of same culvert samples.

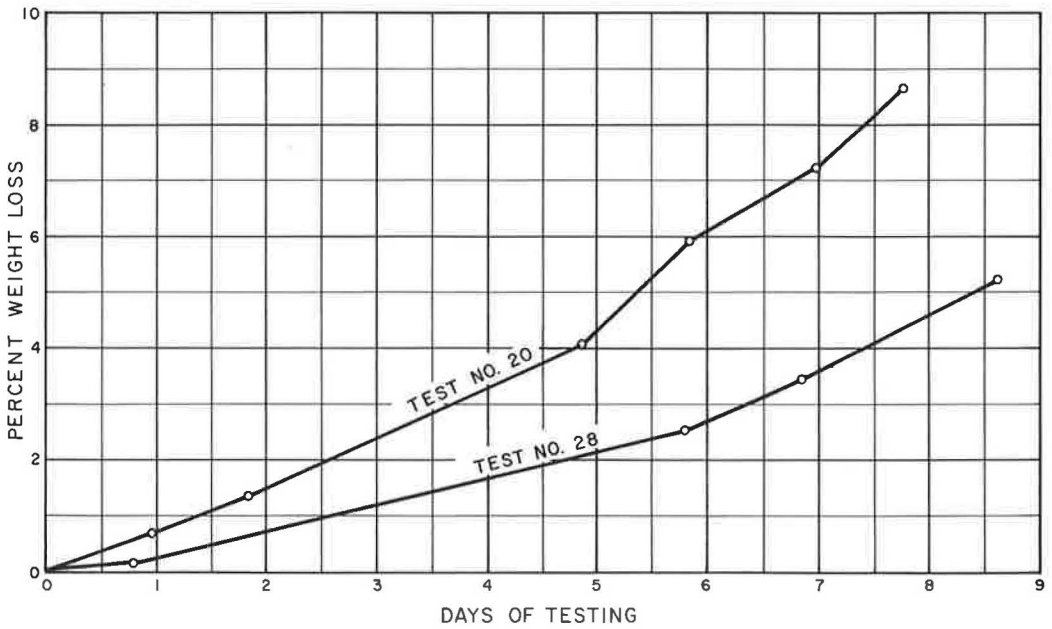
Figure 27. Laboratory corrosion-abrasion test, reproducibility of plain steel.

Figures 27 and 28 are shown to depict the accuracy in reproducing a single type of test. From these data, it is obvious that the individual test results probably have a test accuracy of ± 20 percent.

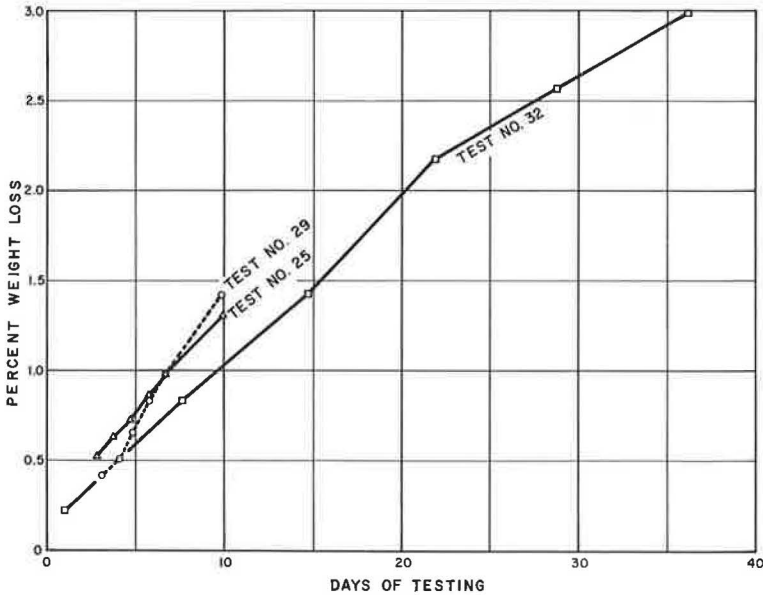
Figure 28. Laboratory corrosion-abrasion test, reproducibility of aluminum.

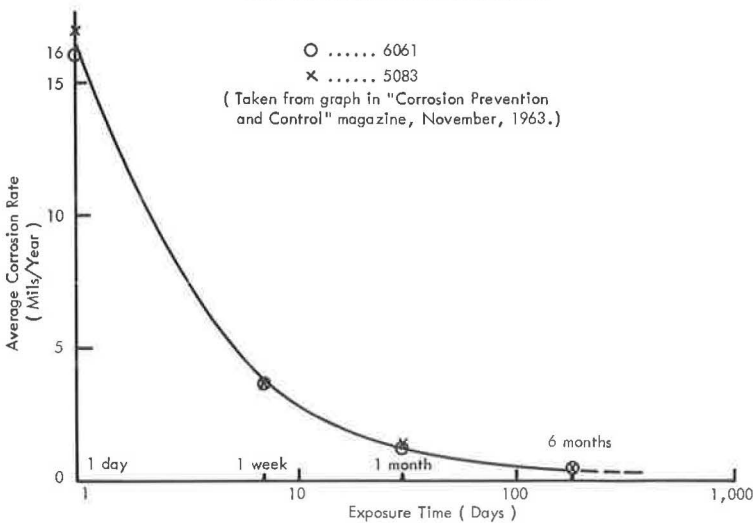
Figure 41. Rapid decrease in corrosion rate with increasing exposure, of aluminum alloys 6061 and 5083 to 10 percent (by wt) and to saturated sodium carbonate solutions at room temperature.

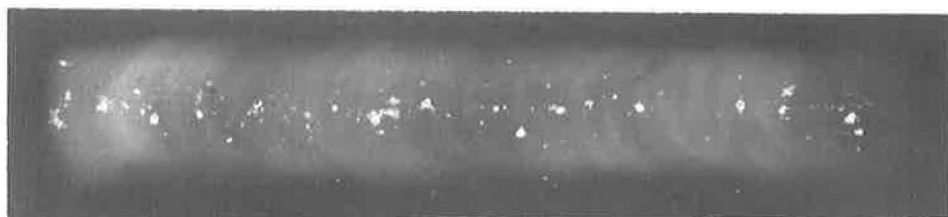
S278456 - TIG WELD WITH TUNGSTEN INCLUSIONS

Figure 2 illustrates radiographs of welds containing tungsten inclusions, oxide inclusions and craters. Light patches associated with the high density tungsten inclusions stand out very sharply. The oxide inclusions require closer scrutiny and appear as small spots of porosity near the right-hand end of the weld bead. The craters appear as rounded zones with relatively dark centers.

Figure 2. Radiographs of welds in $\frac{1}{2}$ -in. 2219-T87 plate.

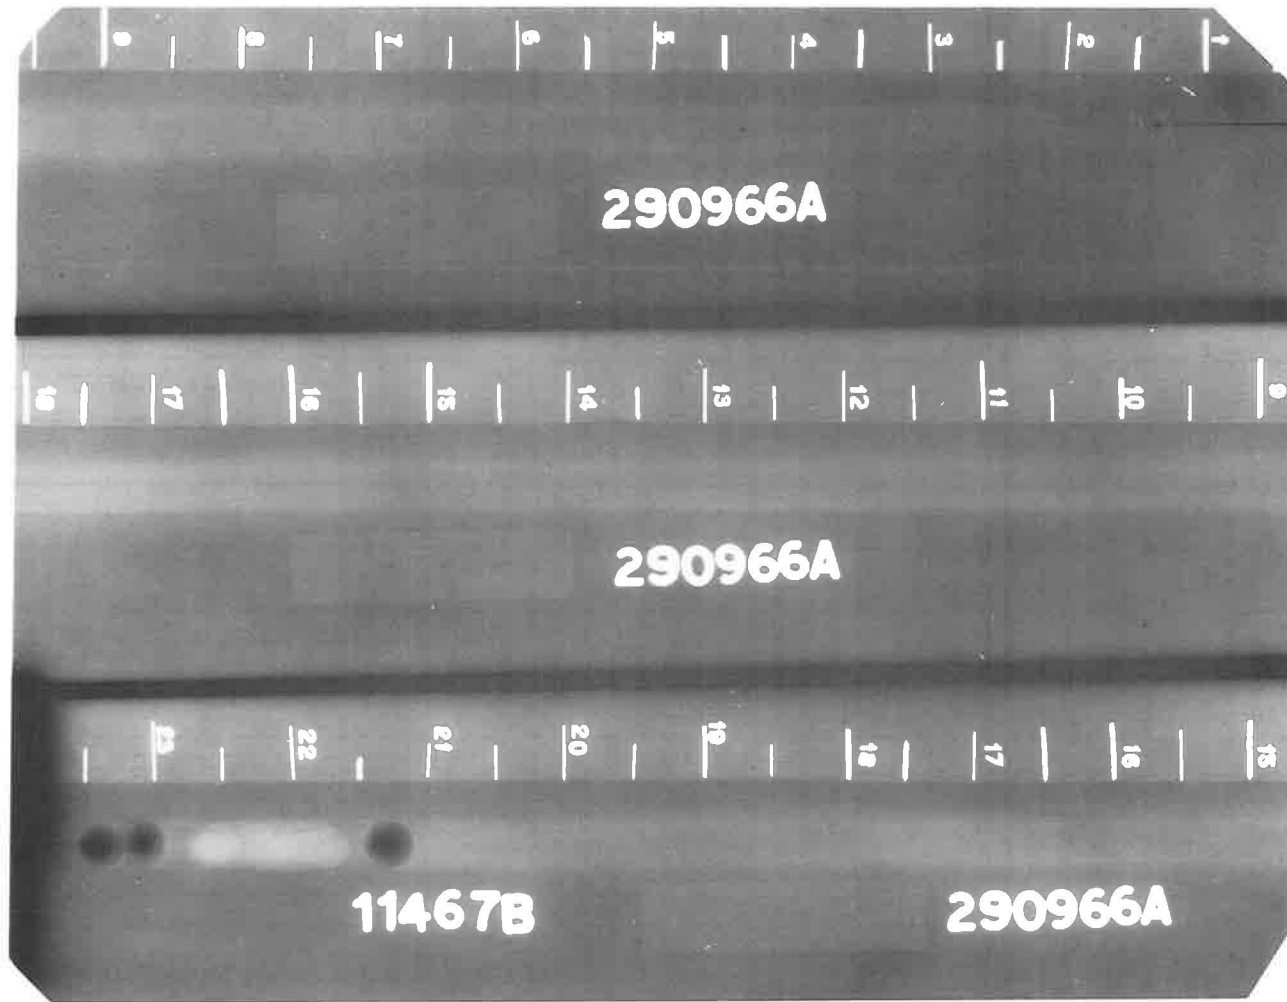
Figure 7. Radiograph of weld in panel S290966 after scarfing (about two-thirds original size). Weld starts about $1\frac{1}{4}$ in. from "reference" end of plate (upper right); incomplete penetration is evident for a distance of about three-fourths in. at beginning of weld; circular indentations (dark spots) may be associated with weld setup or attachment of equipment.

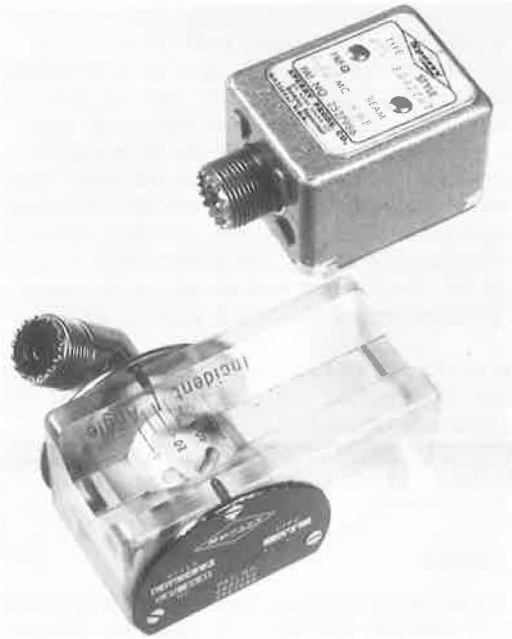
Figure 9. Angle-beam search units used for ultrasonic weld inspection; unit in upper right is contact unit transmitting a shear wave into aluminum at a refracted angle of 48° , other unit is a liquid filled, variable angle unit.

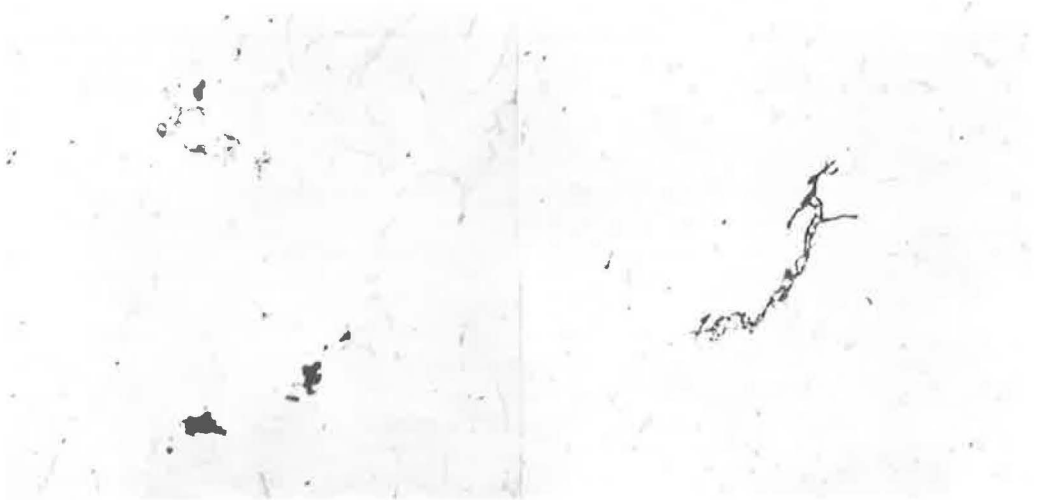
Figure 28. Micrographs showing oxide inclusions in MIG weld in $\frac{1}{2}$ -in. 2219-T87 plate (S-278598, mag. 500X, etch Keller's).

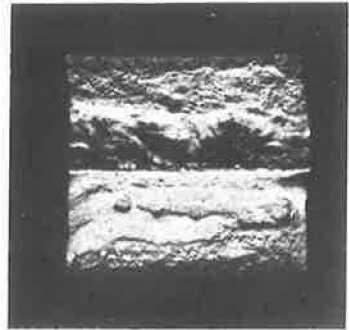
S278511
LACK OF ROOT FUSION
