Effectiveness of Median Barriers

ROGER T. JOHNSON, Traffic Department, California Division of Highways

More than 200 mi of median barrier have been installed on the highest volume freeways in California since 1959. The two types of median barrier are cable chain link barrier and double blocked-out median barrier. They were installed to prevent cross-median head-on accidents. This study was initiated to determine the effect of the installation on all types of accidents. The construction and maintenance costs of the two barriers were also studied.

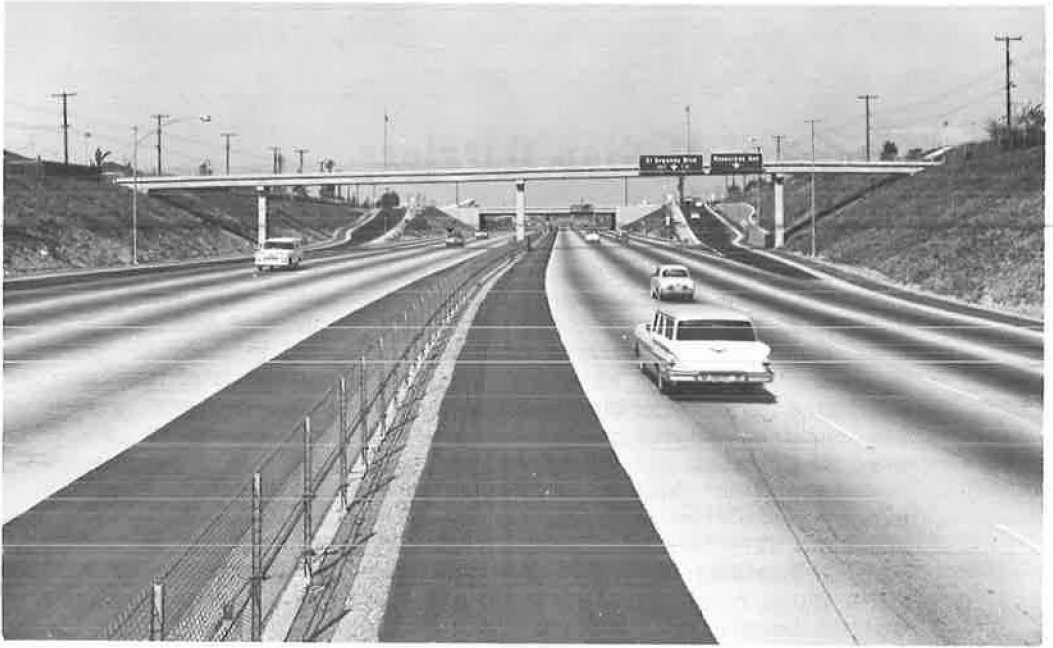
Figure 1. Cable chain link median barrier.

•THIS IS a report on the effectiveness of median barriers on California freeways. An interim report on this study was published in December 1962. A before-and-after study was made of 26.6 mi of cable chain link barrier (Fig. 1) and 27.6 mi of double blocked-out metal beam barrier (Fig. 2). The various sections of each type of barrier have at least 1 yr each of before-and-after experience. The construction period was omitted from the study.

The cable barrier is normally installed in medians with a width of 16 ft or more, and the beam barrier is normally installed in medians having a width of less than 16 ft. This is because the cable barrier will normally deflect up to approximately 8 ft when struck and also because 8 ft is the minimum clearance practical for parking a vehicle to repair damaged areas.

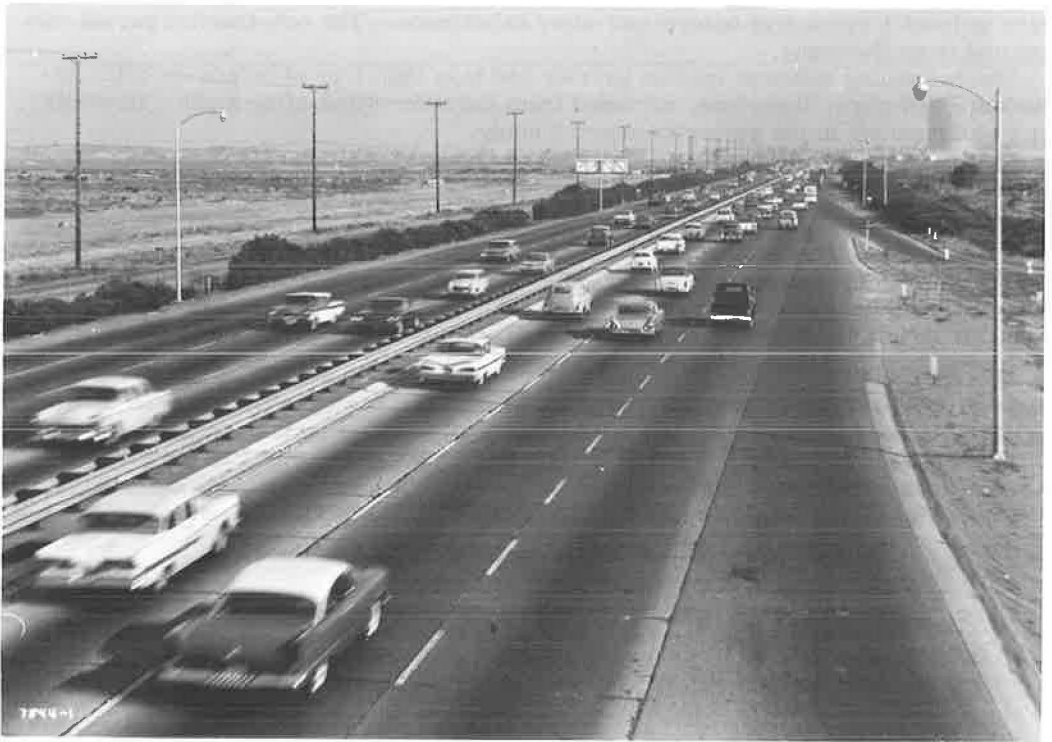
Figure 2. Double blocked-out metal beam barrier.

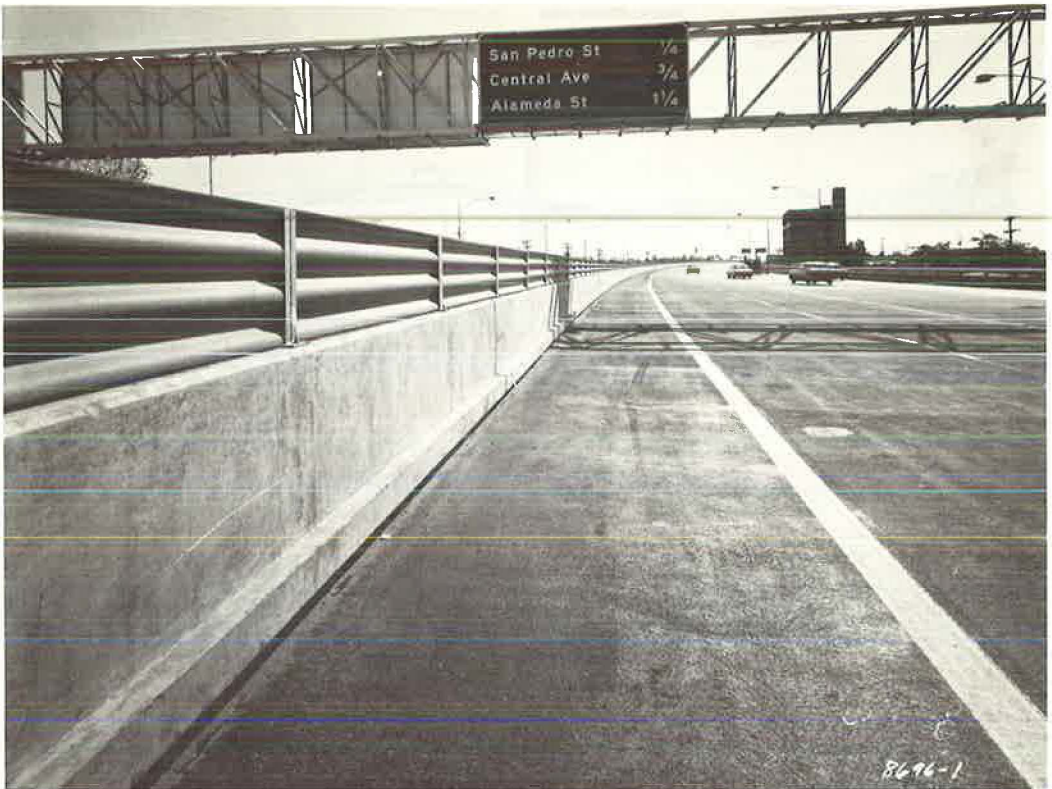
Figure 8. Concrete median barrier with headlight glare screen.

The Santa Monica Freeway is an 8-lane elevated viaduct between the Harbor Freeway and the Santa Ana Freeway. It has 10 ft shoulders on the right of traffic and 8 ft on the left. The median width is 16 ft. The median is narrow because of the high cost of construction. A concrete median barrier was installed which would not deflect and involve cars in the opposing lanes (Fig. 8). The average daily traffic during the study period was 45,000, giving a total of 48.39 MVM. The accident record for this 2.48-mi section with barrier is as follows:

The accident experience with this type of barrier is limited. The freeway has a low accident rate and the rate of accidents involving the median is low. Drivers may tend to avoid the median because of the concrete median barrier. If they are avoiding the median, they do not seem to be causing a lot of accidents on the traveled way.
