HIGHWAY RESEARCH RECORD

Number 105

Traffic Control: Devices and Delineation 7 Reports

Presented at the
44th ANNUAL MEETING
January 11-15, 1965

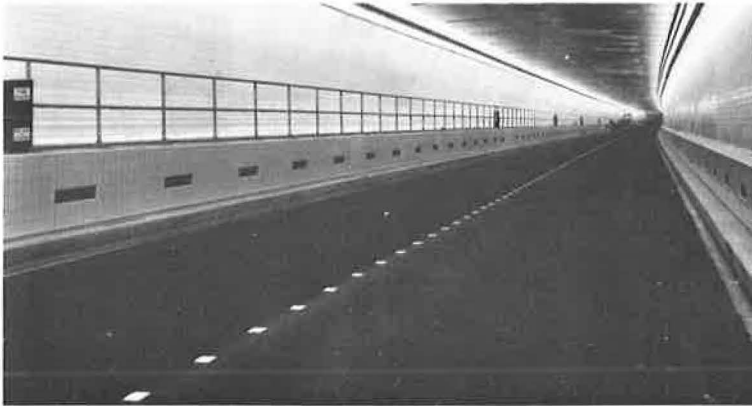
Figure 6. Two-way wedges, white non-beaded, on the roadway of the Webster Street Tube.

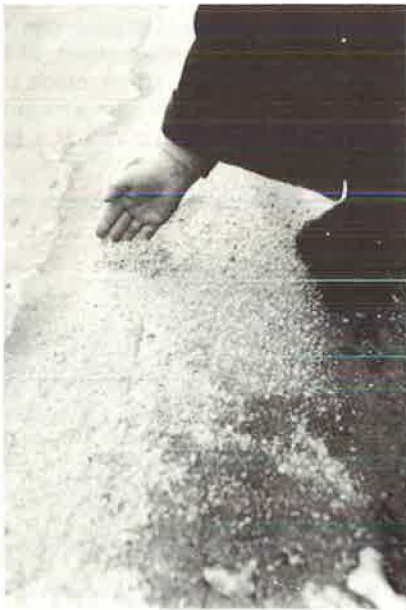
Figure 6. Windrow of de-icer salt piled up by passing vehicles on Edens Expressway.

Below a depth of about 2 ft, the salt content of the median soil becomes tolerable, so there is still a possibility of some form of tree and shrub culture, even if not in the usual sense. The development of salt-resistant plant species or special methods of planting to prevent dissolved salt from seeping down along the trunk and roots of the plant may be possible. However, this approach may be considerably more expensive than the use of some of the more recently developed plastic trees and shrubs, disliked by a large portion of the driving public.

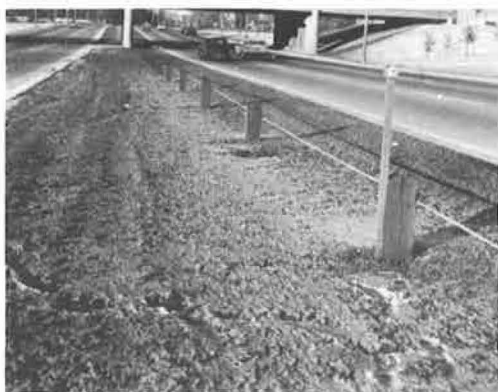
Figure 7. Reflective delineators on Edens Expressway.

Assuming that the greatest benefit from delineation is obtained at night (9), reflective delineators may be a partially acceptable alternate. In trial installations

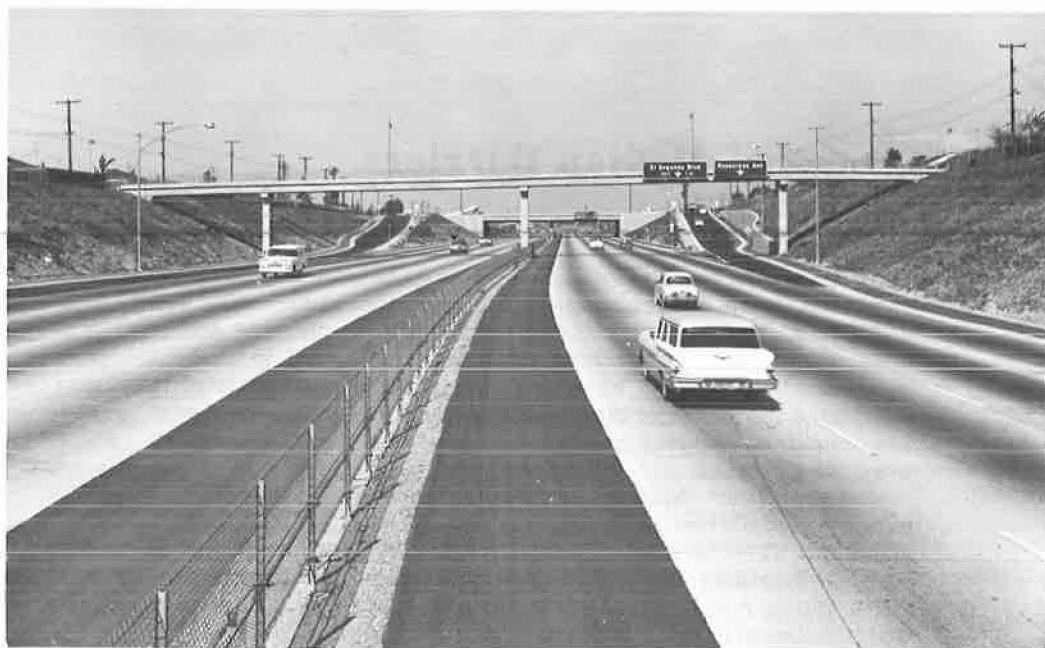
Figure 1. Cable chain link median barrier.

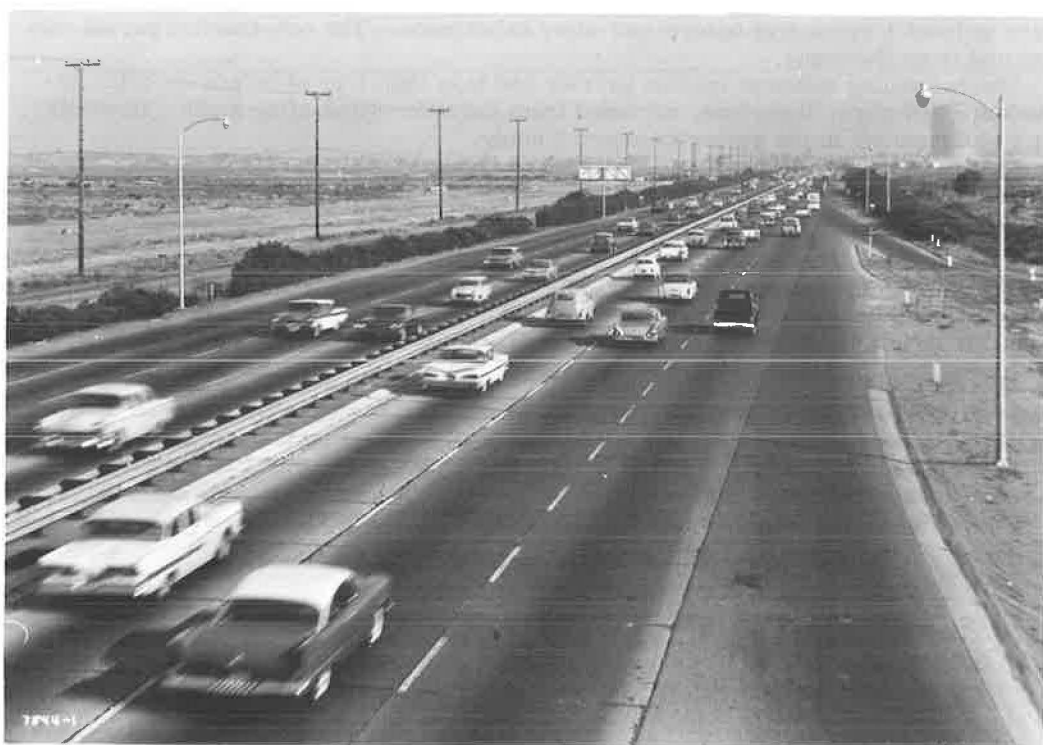
Figure 2. Double blocked-out metal beam barrier.
