# A Low-Cost Maintenance-Free Structural Steel for Highway Applications

S. K. COBURN

Applied Research Laboratory, United States Steel Corporation, Monroeville, Pennsylvania

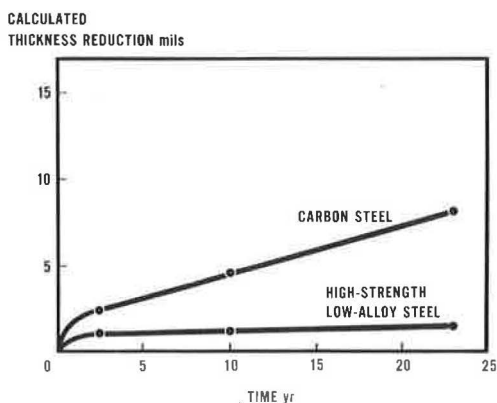
Figure 3. Comparative corrosion of steels in semirural atmosphere.

Time-corrosion curves describing the performance in an industrial atmosphere of the high-strength low-alloy steel in comparison with a copper-bearing steel and a carbon steel are shown in Figure 2. For these curves, the calculated reduction in thickness in mils of test specimens is plotted against the time of exposure in years. It is evident that the high-strength low-alloy steel is far more resistant to corrosion in an industrial atmosphere than are either the copper-bearing steel or the carbon steel. The narrowness of the bands shows that the thickness of the respective test specimens did not influence the corrosion rates and indicates that corrosion is a surface phenomenon. Similar results illustrating the superiority of the high-strength low-alloy steel over carbon steel in a semi-rural atmosphere are shown in Figure 3.

Figures 2 and 3 also show that approximately 80 percent of the corrosion occurring on the high-strength low-alloy steel in both the industrial and the semi-rural atmospheres occurs within the first 2 to 3 yr of exposure. This amounts to a reduction of about 1.5 mils in metal thickness. The corrosion that occurs in the next 20 yr reduces the thickness by only about another 0.5 mil. Thus, it is clear that the structural integrity of the high-strength low-alloy steel is not endangered by corrosion when it is properly used in the boldly exposed condition.

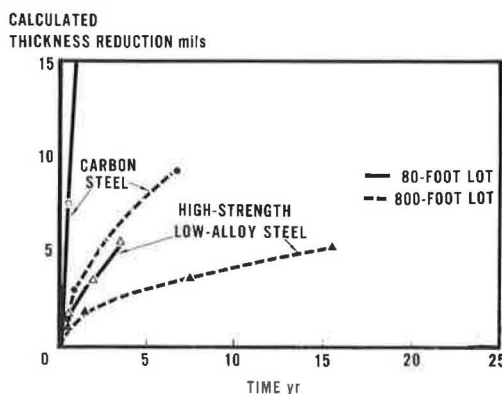
Figure 4. Comparative corrosion of steels in marine atmosphere, Kure Beach, N.C.

Figure 4 illustrates the comparative corrosion losses for specimens of carbon steel and the high-strength low-alloy steel at 80 and 800 ft from the Atlantic Ocean at Kure Beach, N. C. Although the performance of the high-strength low-alloy steel at the 80-ft lot is superior to that of carbon steel, the corrosion rate is so high that its use in the unpainted condition would be inadvisable in severely corrosive marine atmospheres. Specimens located 800 ft from the ocean corrode at a considerably lower rate, and the superior performance of the high-strength low-alloy steel over carbon steel is again evident. Applications close to seawater may warrant consideration of galvanizing or painting the high-strength low-alloy steel.

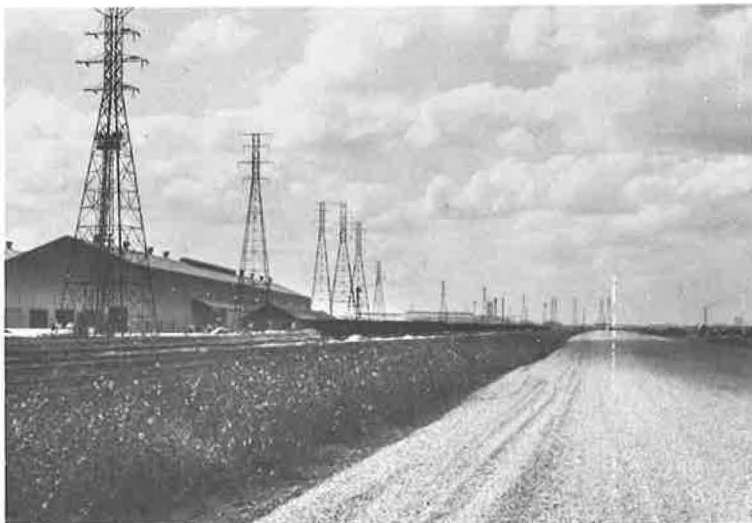
Figure 8. High-strength low-alloy steel 69-kv transmission towers, Gary Steel Works.

Figure 8 shows a few of the seventeen 69-kilovolt (kv) double-circuit transmission towers located on the south shore of Lake Michigan within the Gary Sheet and Tin Works of the U. S. Steel Corp. The towers were erected early in 1960. Atmospheric conditions at this location—frequent lake breezes and mist, sunshine, rain, and proximity to an industrial plant—are optimum for the rapid formation of the protective oxide

film on the unpainted steel. Recent examinations of these towers have shown that the rust film is tightly adherent to the base metal and has assumed a dark brown color.

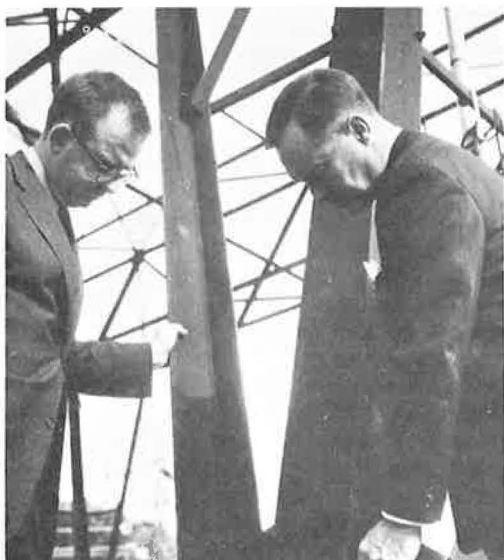
Figure 9. Appearance of high-strength low-alloy steel in Project EHV after 2 yr near Pittsfield, Mass.

Transmission tower No. 18 in General Electric Company's Project EHV (11) was erected of high-strength low-alloy steel in a semi-rural area near Pittsfield, Mass., in 1960. Figure 9 shows the surface after 2 yr of exposure. The texture of the rust is still slightly granular but is generally tightly adherent to the base metal. The structure has assumed a deep brown color.

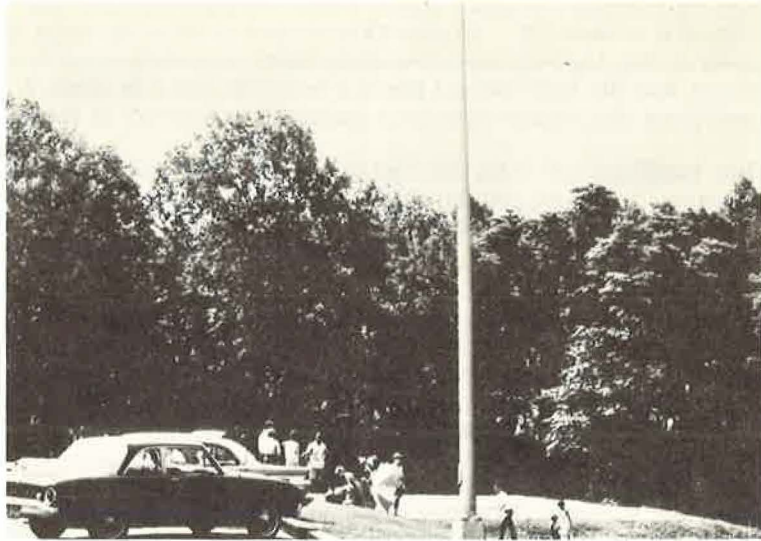
Figure 17. High-strength low-alloy steel light standard in background.

A high-strength low-alloy steel light standard was installed in Monroeville, Pa., some 15 mi east of Pittsburgh. The oxide film in this semi-industrial location is developing at a satisfactory rate. One of the most impressive observations is that the light standard remains quite unobtrusive when compared with an adjacent light standard constructed of conventional materials. Figure 17 is a view of the two light standards taken during a picnic period. The high-strength low-alloy steel standard blends into the forested background, and the conventional light standard presents a contrasting

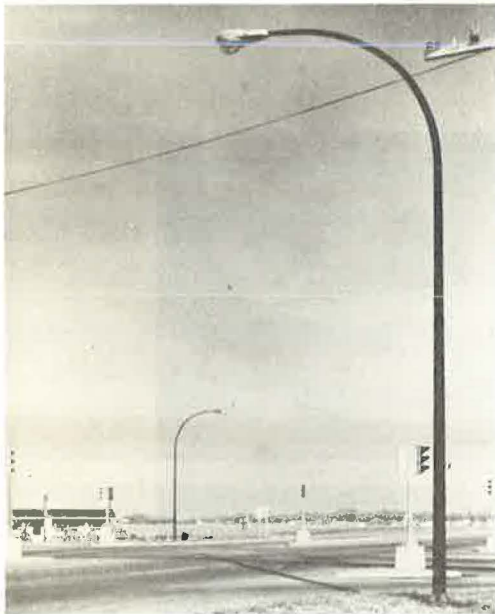
Figure 18. High-strength low-alloy steel light standards in midwestern city.

appearance. Figure 18 is a view of a high-strength low-alloy steel light standard in a midwestern state, one of a group of 20 such test units that have been in service in this vicinity for about 2 yr.

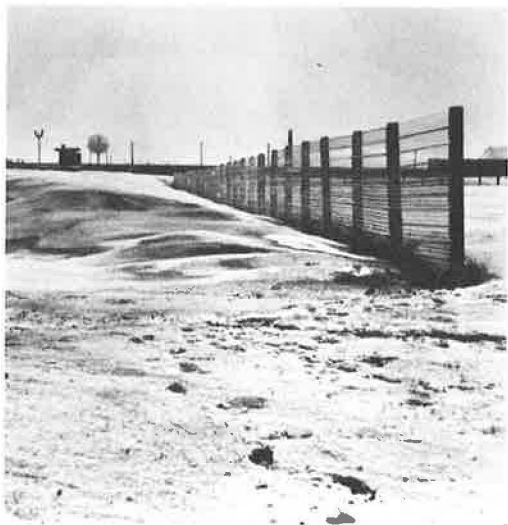
Figure 19. View of new snow fence design.

steel might be considered. The Roadway and Ballast Committee of the American Railway Engineering Association (18), in a report on methods of protecting roadways and track against drifting snow and sand, has evaluated the performance of perforated corrugated steel panels. This type of fence has been installed by several railroads, and comments on initial cost of materials and erection are favorable. The cost of installation and removal is comparable to those incurred with wood lath. The fence may be installed in the same manner as temporary lath fence and removed during the off-season. Because of the corrugations and perforations, stacking is simple, and the slots can be chained together to prevent pilfering. Presently, these fence panels are supplied painted and galvanized. However, they could be fabricated from high-strength low-alloy steel, in which case painting and touchup maintenance costs as well as galvanizing costs can be eliminated. Figure 19 illustrates the fence in service.
