HIGHWAY RESEARCH RECORD

Number 110

Bridge Materials, Construction, Inspection and Cathodic Protection 6 Reports

A LOW-COST MAINTENANCE-FREE STRUCTURAL STEEL FOR HIGHWAY APPLICATIONS	
S. K. Coburn	1
THE LIZOTTE BRIDGE: A Review and Discussion of "The Case for Galvanized Bridges" by J. R. Hall, <i>Abridgment</i>	
Roger Main	19
SOIL RESISTIVITY AS RELATED TO UNDERGROUND CORROSION AND CATHODIC PROTECTION	
W. J. Schwerdtfeger. . . <i>Abridgment</i>	20
STUDY OF INSPECTION METHODS AND QUALITY CONTROL FOR WELDED HIGHWAY STRUCTURES	
W. W. Sanders, Jr., and W. ^{Hamm} H. Munse	22
FABRICATION OF ORTHOTROPIC DECK SECTIONS FOR PORT MANN BRIDGE	
R. ^{alph} G. Smylie.	36
SURVEY OF STEEL-FORMED BRIDGE DECKS IN ILLINOIS	
Irwin A. Benjamin and Martin P. Walsh, Jr. . <i>Abridgment</i> . .	43

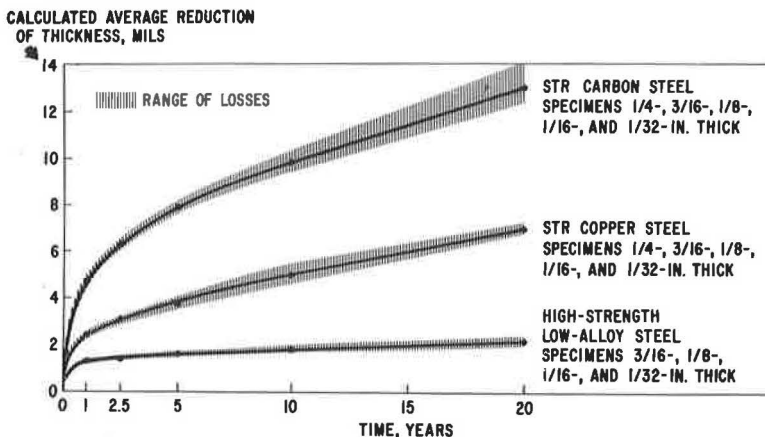
Figure 2. Comparative corrosion of steels (1-ft square specimens) in industrial atmosphere, Kearny, N.J.

Time-corrosion curves describing the performance in an industrial atmosphere of the high-strength low-alloy steel in comparison with a copper-bearing steel and a carbon steel are shown in Figure 2. For these curves, the calculated reduction in thickness in mils of test specimens is plotted against the time of exposure in years. It is evident that the high-strength low-alloy steel is far more resistant to corrosion in an industrial atmosphere than are either the copper-bearing steel or the carbon steel. The narrowness of the bands shows that the thickness of the respective test specimens did not influence the corrosion rates and indicates that corrosion is a surface phenomenon. Similar results illustrating the superiority of the high-strength low-alloy steel over carbon steel in a semi-rural atmosphere are shown in Figure 3.

Figures 2 and 3 also show that approximately 80 percent of the corrosion occurring on the high-strength low-alloy steel in both the industrial and the semi-rural atmospheres occurs within the first 2 to 3 yr of exposure. This amounts to a reduction of about 1.5 mils in metal thickness. The corrosion that occurs in the next 20 yr reduces the thickness by only about another 0.5 mil. Thus, it is clear that the structural integrity of the high-strength low-alloy steel is not endangered by corrosion when it is properly used in the boldly exposed condition.

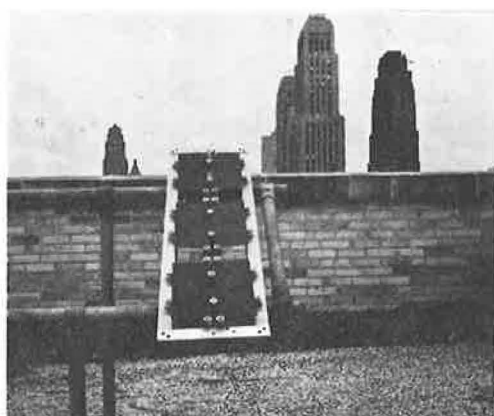
Figure 6. Carbon steel and high-strength low-alloy steel specimens on roof, Chicago, Ill.

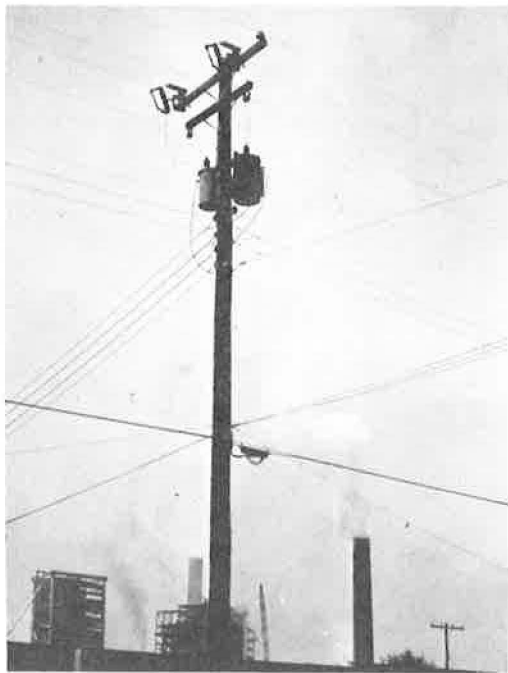
Figure 12. Effluent from smoke stack deposits on transformer tank of high-strength low-alloy steel and painted carbon steel, Georgetown, S.C.

In Georgetown, S. C., about 10 mi from the ocean and just outside a large paper mill, a 25-kva distribution transformer is incased in an unpainted high-strength low-alloy steel tank and cover. A painted carbon steel unit is mounted next to it. After 3 yr of exposure, a pleasing dark brown rust film has formed on the surface of the high-strength low-alloy steel tank and its cover. It has been the experience of the Georgetown utility company engineers that the painted carbon steel tanks require touch up maintenance at the end of 3 yr of service and complete repainting after 5 yr. When the 3-yr inspection was made in June 1964, large areas of paint were observed flaking from the carbon steel tank cover and base. The high-strength low-alloy tank was in good condition (Fig. 12). It is evident that this essentially rural area in close proximity to the paper mill actually is quite corrosive. These particular atmospheric conditions, however, effectively promote the formation of the dark tightly adherent oxide film.

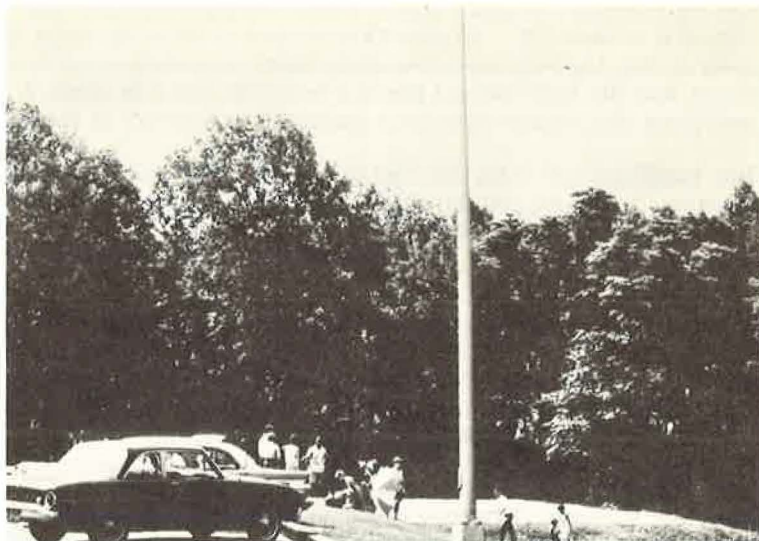
Figure 17. High-strength low-alloy steel light standard in background.

A high-strength low-alloy steel light standard was installed in Monroeville, Pa., some 15 mi east of Pittsburgh. The oxide film in this semi-industrial location is developing at a satisfactory rate. One of the most impressive observations is that the light standard remains quite unobtrusive when compared with an adjacent light standard constructed of conventional materials. Figure 17 is a view of the two light standards taken during a picnic period. The high-strength low-alloy steel standard blends into the forested background, and the conventional light standard presents a contrasting

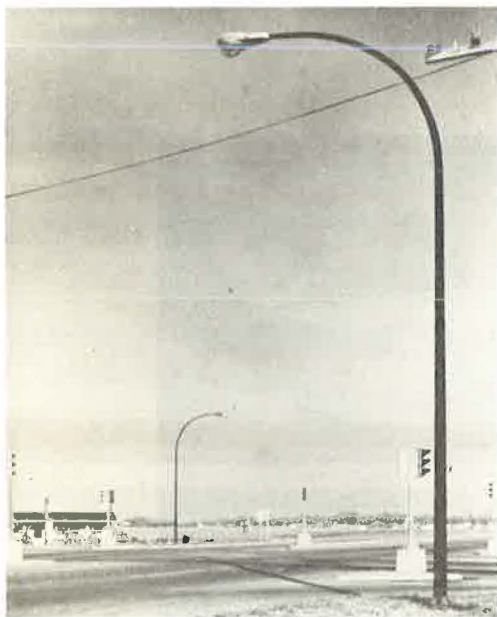
Figure 18. High-strength low-alloy steel light standards in midwestern city.

appearance. Figure 18 is a view of a high-strength low-alloy steel light standard in a midwestern state, one of a group of 20 such test units that have been in service in this vicinity for about 2 yr.

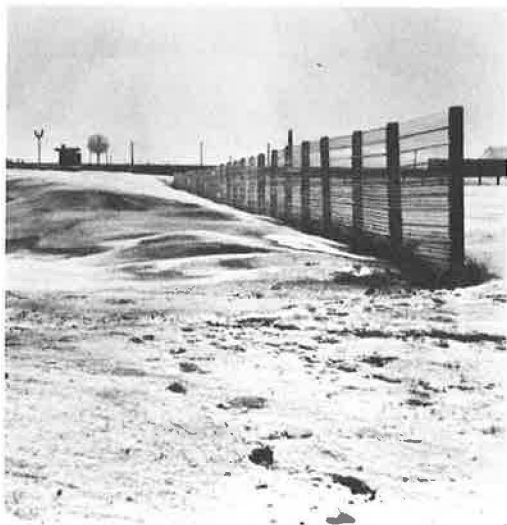
Figure 19. View of new snow fence design.

steel might be considered. The Roadway and Ballast Committee of the American Railway Engineering Association (18), in a report on methods of protecting roadways and track against drifting snow and sand, has evaluated the performance of perforated corrugated steel panels. This type of fence has been installed by several railroads, and comments on initial cost of materials and erection are favorable. The cost of installation and removal is comparable to those incurred with wood lath. The fence may be installed in the same manner as temporary lath fence and removed during the off-season. Because of the corrugations and perforations, stacking is simple, and the slots can be chained together to prevent pilfering. Presently, these fence panels are supplied painted and galvanized. However, they could be fabricated from high-strength low-alloy steel, in which case painting and touchup maintenance costs as well as galvanizing costs can be eliminated. Figure 19 illustrates the fence in service.

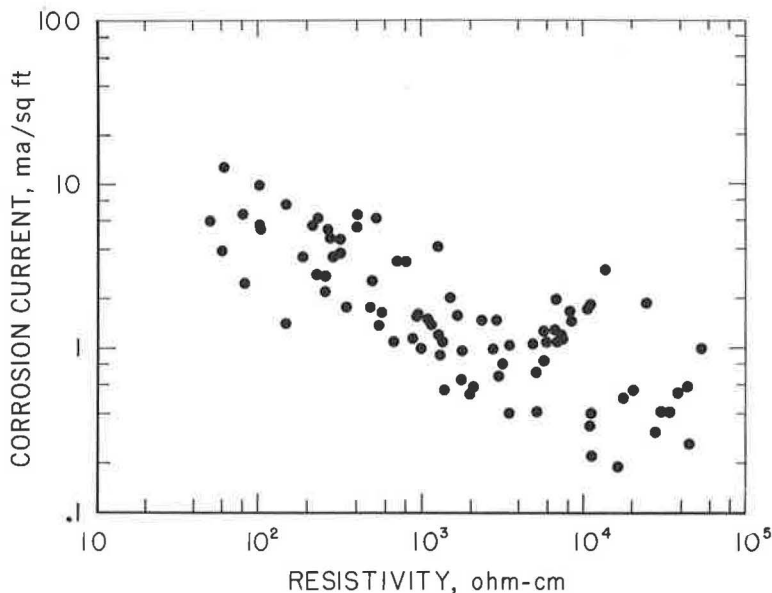
Figure 2. Calculated corrosion current densities based on weight loss rates between 5 and 12, and between 5 and 17 yr of exposure for majority of soils.
