HIGHWAY RESEARCH RECORD

Number 112

Concrete Pavement Design 7 Reports

Presented at the
44th ANNUAL MEETING
January 11-15, 1965

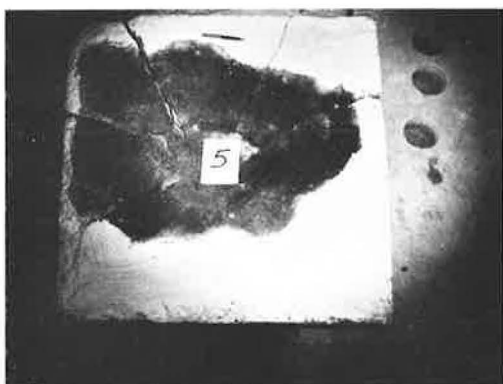
Figure 19. Bottom face of inverted section of pavement after failure under static load.

Test pavements under interior loading failed by punching a cone from the pavement. After the pavements had failed, a section approximately 2½ ft sq was sawed from the pavement and removed, thus exposing the punched-out cone. The removed sections and the cones are shown in Figures 19 and 20. The crack patterns on the bottom surface of the cones are particularly significant.

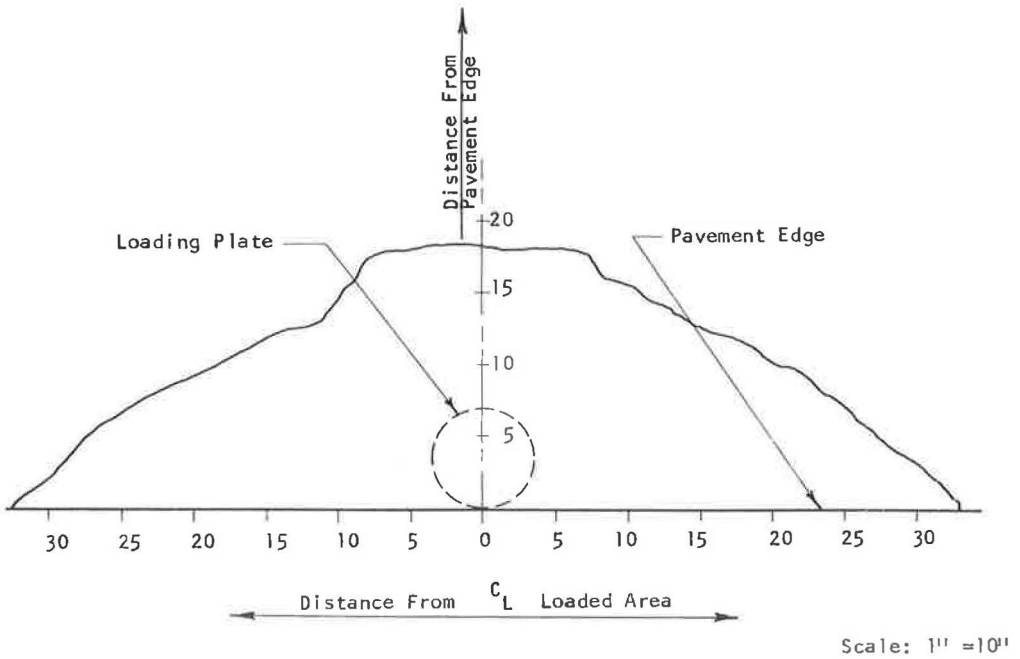
Figure 22. Load No. 6: crack pattern on surface of pavement at end of static load test.

Pavements tested under edge loads failed by developing semicircular cracks at an interior point (Figs. 21 and 22). The initial crack always appeared first along a radial line perpendicular to the pavement edge. The crack farthest from the pavement edge in Figure 21 appeared first, with the crack nearer the edge developing as additional loads were applied.

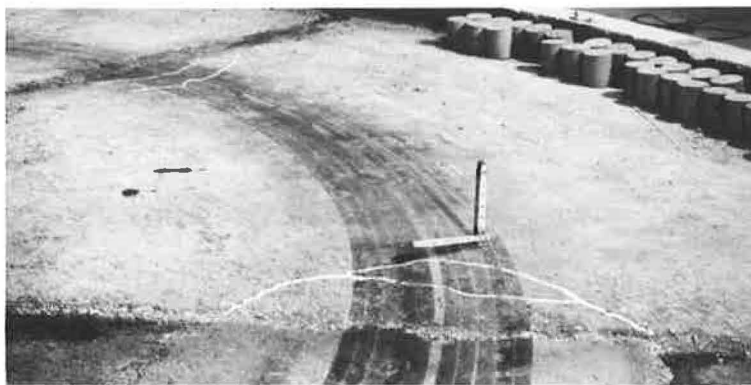
Figure 28. Crack patterns observed on test pavement 2 of test set IV after 175 load applications with white paint applied to outline location of cracks.

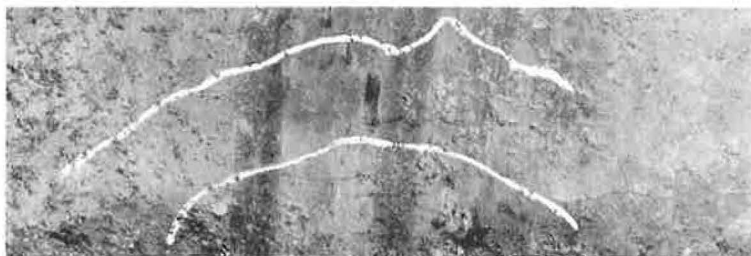
Figure 29. Crack patterns observed on test pavement 6 after 175 load applications, with white paint applied to outline location of cracks.

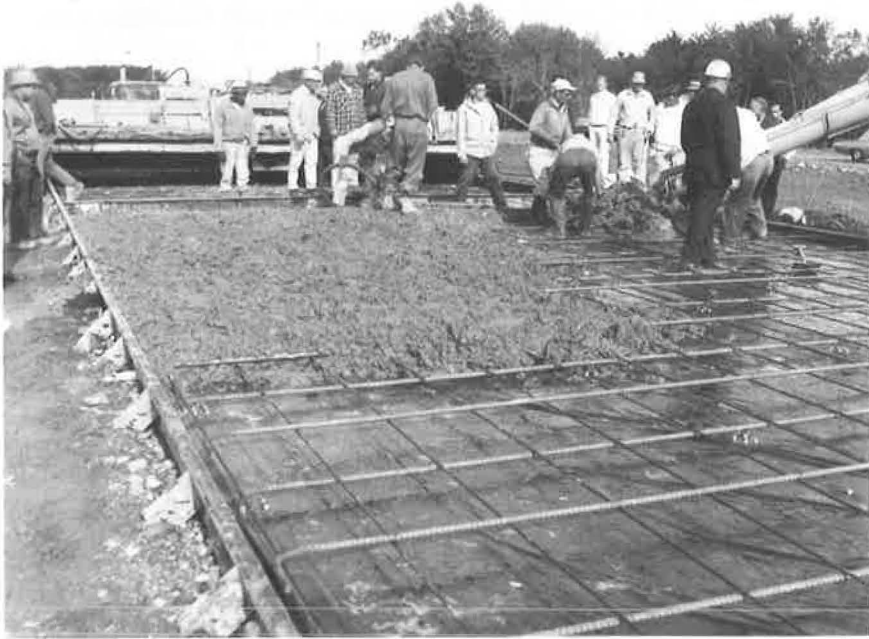
Figure 12. Placement of first load of concrete, showing inadequate slump.

Although the concrete was very wet during placement, it became stiff within 10 min after placing, as evidenced by the large roll of stiff mortar carried by the transverse screed. It was decided that no concrete would be accepted at the paving site which had been in transit more than 15 min, and only two trucks were to be dispatched from the

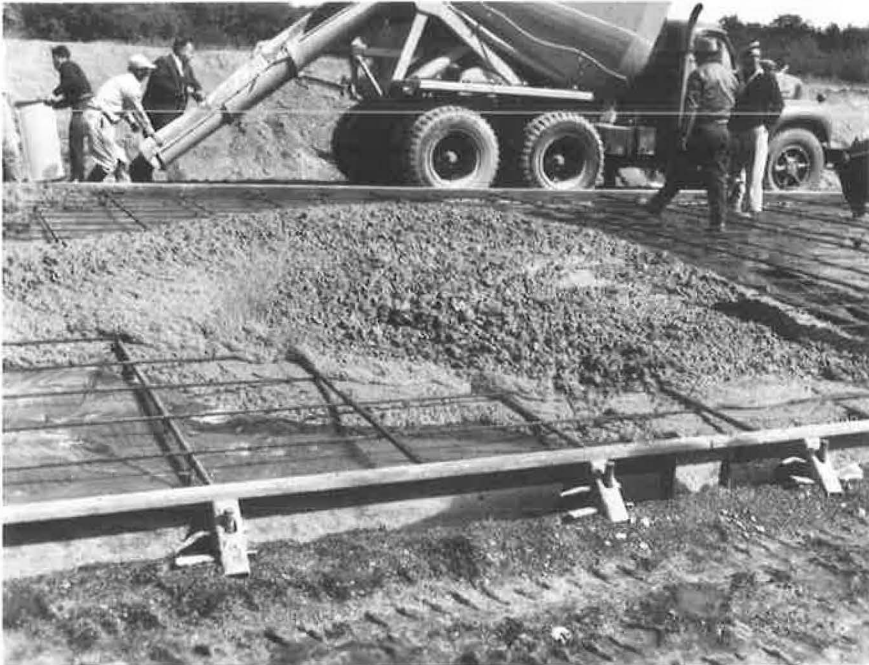
Figure 13. Placement of high-slump concrete, showing considerable segregation.

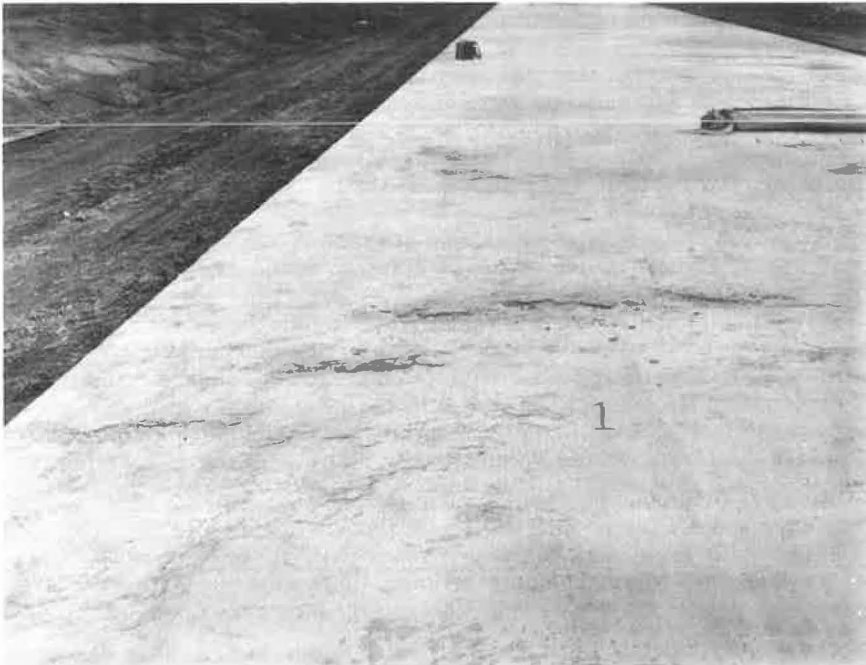
Figure 15. Surface cracks in slab I, day after completion.

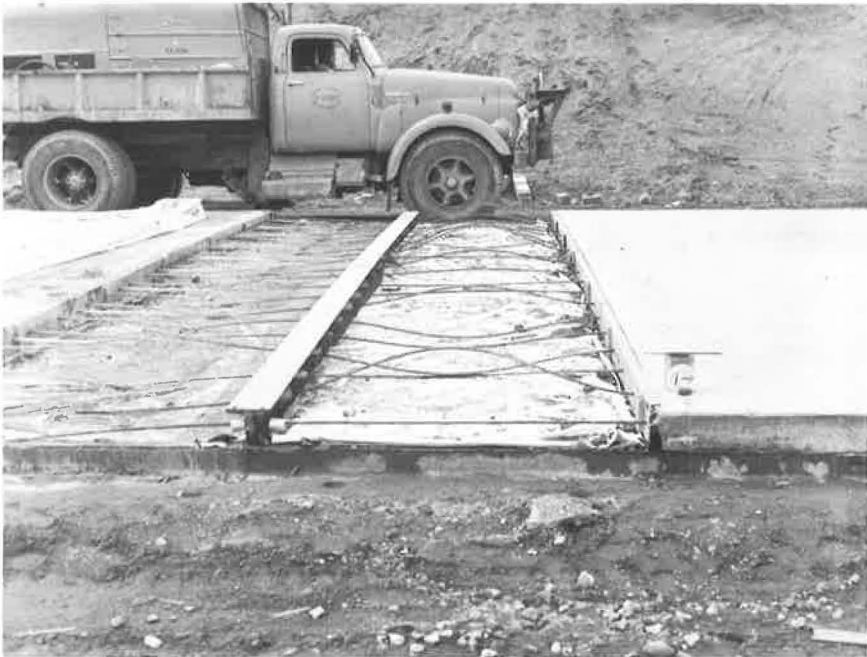
Figure 28. Slack cables protruding from ends of slabs.

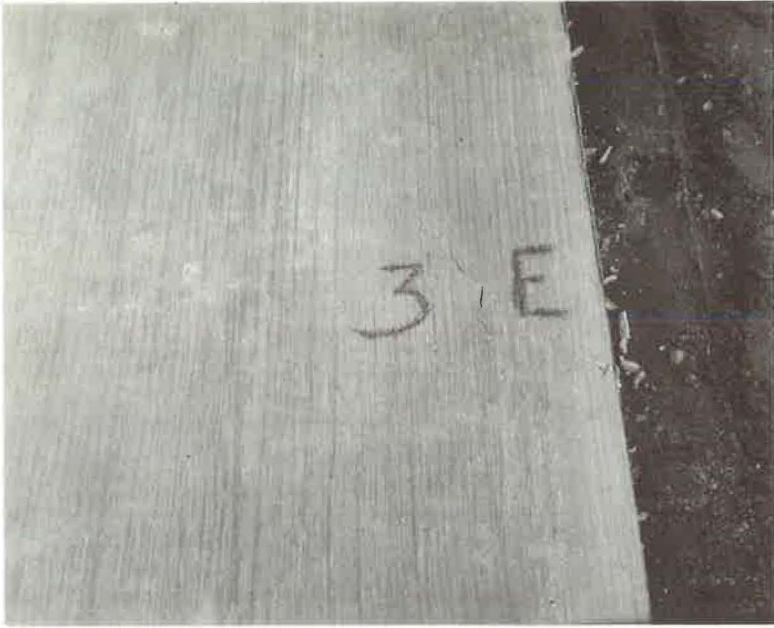
Figure 29. Longitudinal surface cracks occurring at edges of slabs.

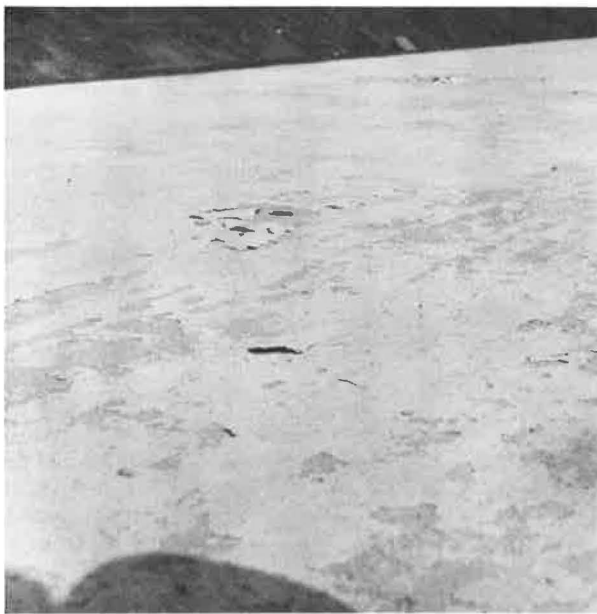
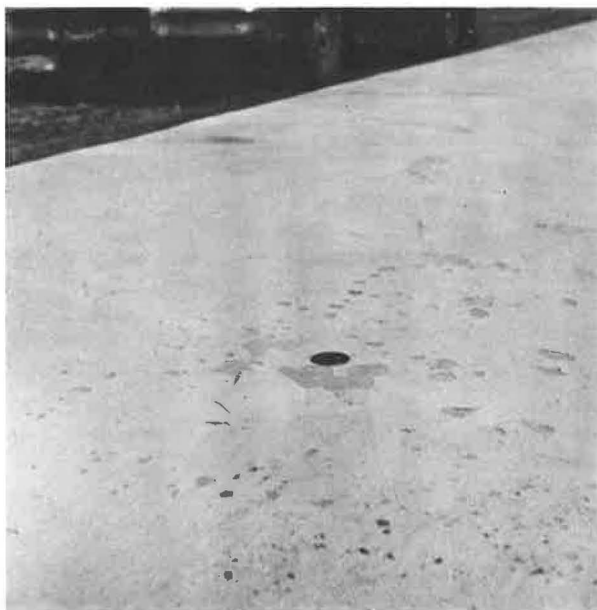
Figure 30. Blisters formed on exposed surface of experimental slab from dried exudation product.

A thin layer of a white deposit was observed on all exposed surfaces of the experimental slabs the day following placement of the concrete. This laitance, or exudation product, could be mistaken for white pigmented membrane-forming curing compound. Under the fog cure, the layer could be easily flaked off by hand; after drying it hardened to a chalk-like consistency and separated locally in the form of blisters as shown in Figure 30. Under traffic, the membrane-like coating was crushed into dust and worn away.

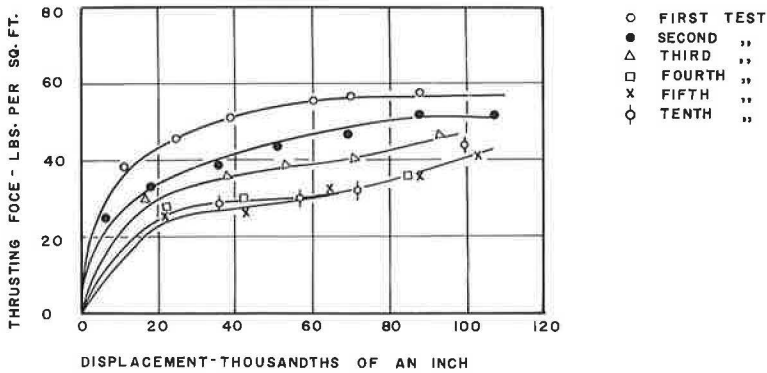
Figure 5. Force-displacement curves for repeated tests on 6-in. slab.
