Three-Year Evaluation of Shell Avenue Test Road

SHELL AVENUE TEST ROAD COMMITTEE,¹ W. A. Garrison, Chairman

The purpose of this report is to present an evaluation of performance over a 3-yr period of an experimental asphalt-concrete overlay pavement constructed on Shell Avenue in Contra Costa County, California. The overlay pavement was constructed on an existing pavement exhibiting fairly large deflections under a 15,000-lb axle load, and subjected to a large proportion of truck traffic in terms of the average daily traffic applied to the highway. Because of the existing conditions, it was planned that the test pavement should provide information on the resistance to deformation (stability) and fatigue resistance of heavy-duty mixes using conventional asphalt concrete and asphalt concrete with asbestos as a special mineral filler.

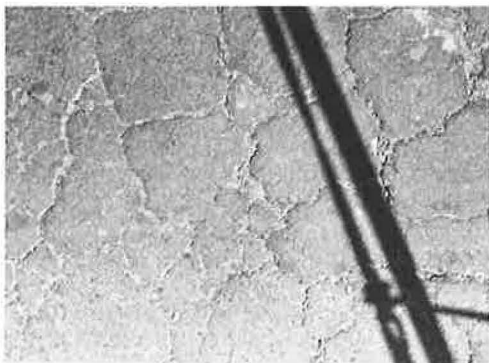
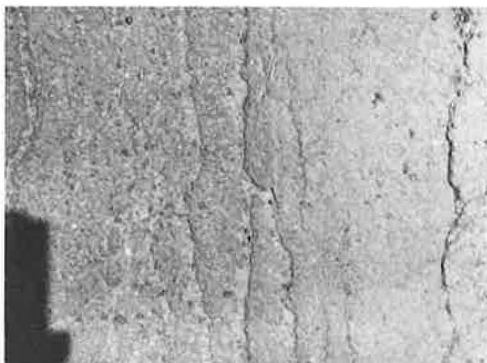
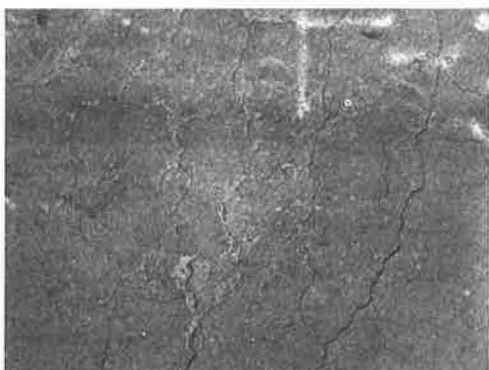
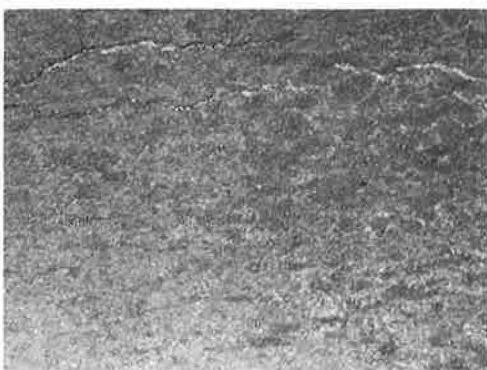
Figure 9. Typical pavement failure.

Figure 10. Typical pavement failure.

Figure 11. Typical pavement failure.

Figure 12. Typical pavement failure.

A condition survey was made of the existing pavement by measuring deflections throughout the length of the project and by conducting a crack survey. Deflections were measured in both the inner and outer wheelpaths of the northbound and southbound lanes using the traveling deflectometer developed by the California Division of Highways. Except for the first approximately 600-ft length of the project (the northern section), the initial deflections were relatively uniform. A representative deflection for a section of this latter (major) portion is shown in Figure 7. For comparison, deflections from the northern 600 ft are shown in Figure 8. Deflections as high as 0.135 in. were obtained in this area. Areas which were patched or considered to be failed as a result of the crack survey are also shown (Figs. 7 and 8). Figures 9 through 12 show typical examples of the failed areas.
