# Moving Load Test on Experimental Prestressed Concrete Highway Slab, Part B—Additional Investigations

JOHN R. SMITH and JAMES L. EVANKO, Civil Engineering Department, University of Pittsburgh

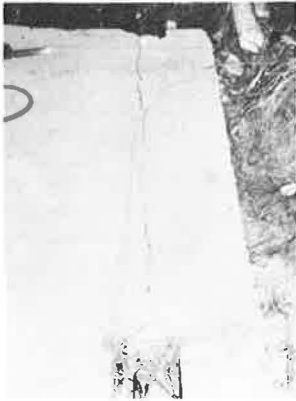
Figure 5. Failure at slot J.

The final step was to reduce gradually the length of bond between the transverse cut and the slots until bond failure occurred. Work was started on the east side first. It was decided to remove 12-in. increments of the concrete until a point was reached where bond failure would be impending and then proceed at a slower pace until bond failure was accomplished. Starting at the transverse cut a 12-in. increment was sawed about 1 in. deep. The electric chipping hammers and a sledge were used to break away the concrete. The resulting forces and shock waves caused longitudinal cracks to develop over two additional tendons (Fig. 5). This caused these tendons to relax. The remaining tendons on the east side were released and strain readings on the unstressed strands were recorded.

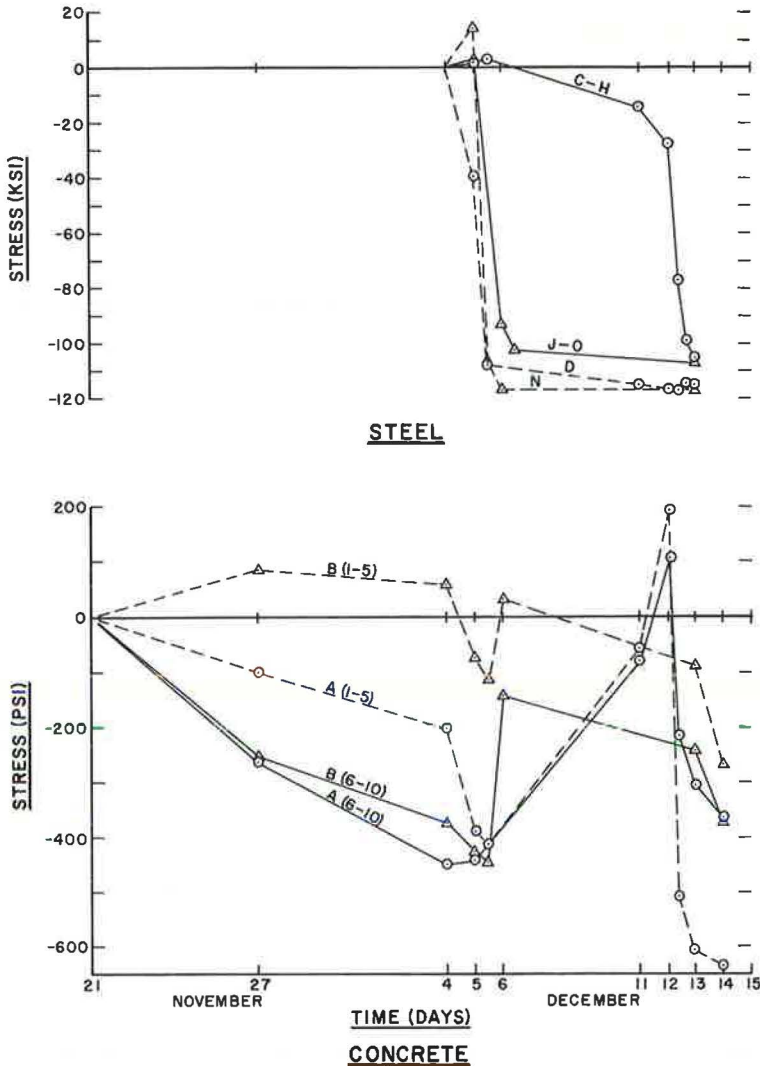
Figure 7. Average change in stress.

Figure 7 shows the average value of the change in stress in the steel and the concrete for each reading. The diagram for the steel stresses shows four separate conditions. C-H and J-O represent the average stress for the grouted tendons to the west and to the east, respectively, of the transverse cut. D and N represent the average stress for the ungrouted tendons west and east of the cut (Fig. 2).

The two curves for each condition agree reasonably well. The final stress for the ungrouted tendon is about 115,700 psi and the average for the grouted tendons is 106,000 psi. One might, at this point, conclude that the loss in prestress would be the difference between the two, since cutting the slots in the pavement would have a negligible effect on the stresses in the ungrouted tendon. However, the stresses reported after the release of the jacks, during the construction of the pavement, indicate a variation in stress from the anchors to the midlength of the slab (1).

The stresses shown in Figure 7 are not as well grouped as were the steel stresses. The solid lines represent the stresses at the end of the slots and the dashed lines represent the stresses midway between the slots. The (A) values are for those gages on the west section and the (B) values represent the gages on the east section. The steep slope of these curves indicate that flexural stresses were affecting

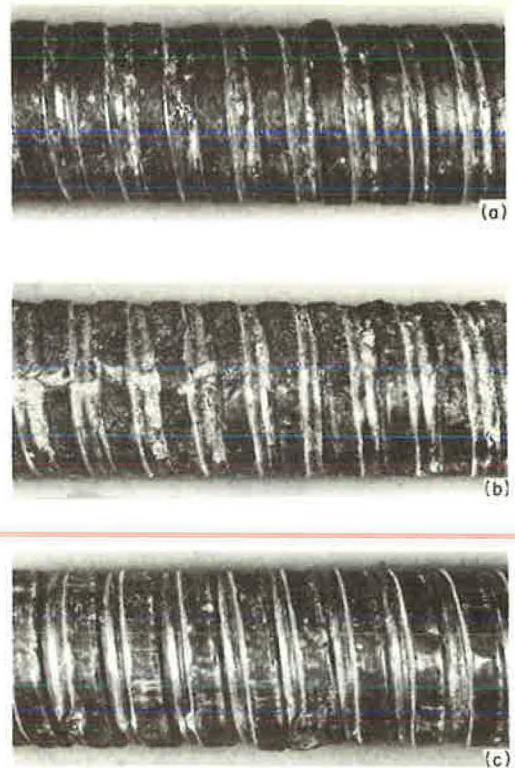
Figure 12 shows the condition of the conduit. Case I, at the top of the figure, has from 25 to 30 percent of its surface covered with a light coating of rust. Case II has been completely penetrated with pin holes in the upper area of the picture while the lower area has very little corrosion. In Case III the conduit is free from rust.

Figure 12. Condition of conduit: (a) Case I, ungrouted tendon; (b) Case II, grouted tendon—initial crack; and (c) Case III, grouted tendon—no crack.

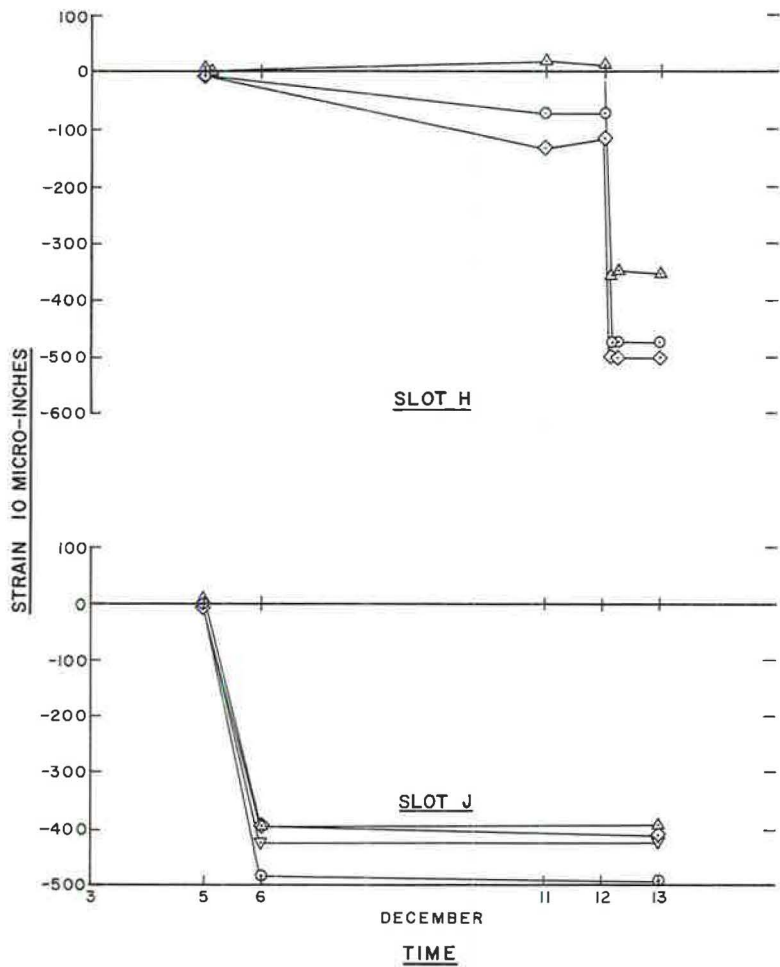
After initial bond failure had been accomplished for the remaining tendons, the strands were freed for total relaxation and the final strain readings were taken. The site was abandoned on December 16, 1964. Graphical representation of the steel and concrete strains is shown in Figures 15 to 20 and Figures 21 to 24, respectively, of the Appendix.
