HIGHWAY RESEARCH RECORD

Number 140

Corrosion and
Protection of
Metals

Five-Year Field Corrosion Study of Steel Pipe To Determine Effects of Backfill Materials

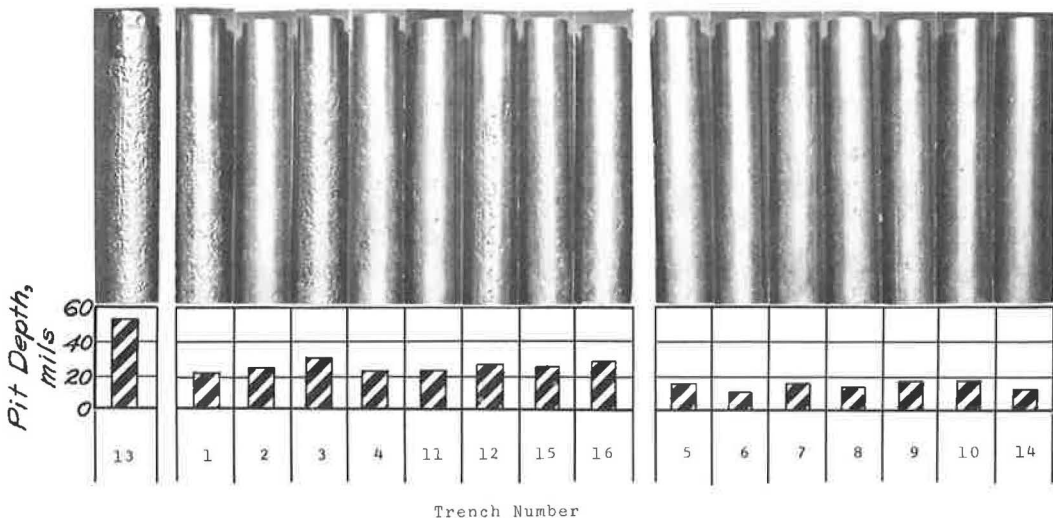
Figure 1 shows the black pipe specimens with a graph of the average depth of the five deepest corrosion pits on each. The areas affected by corrosion varied widely, as did the "fineness" or "coarseness" of the corrosion pattern. No weight loss data are available to determine any correlation with affected areas.

Figure 1. Corrosion of black pipe specimens after 5 years of exposure.

However, depth of pitting is of greater potential importance than weight loss in pipe corrosion, since it may result in perforation and leakage, and, therefore controls pipe life. The cinders are far more corrosive than any of the other backfill materials, with the entire exposed area of the pipe severely pitted. Only the cinders produced greater corrosion than would be expected in any moderately corrosive soil.

For the other backfill materials used, variations between materials, within either of the two groups into which they are divided in Figure 1, are minor and of no significance in view of the variability in such exposure tests. Similarly, the data fail to show any significant effects caused by different sizes of a given material or by variations in percentages of magnetic particles in the slags.

In fact, it seems probable that all backfill materials, except cinders, should be considered as falling in the same range, without significant differences among them. The average depth of pitting for all materials is 22.4 mils, with individual deviations from this value of -51 percent and +132 percent (cinders). Excluding the cinders, the average for the others is 20.4 mils with maximum individual variations of -46 percent and +47 percent. In NBS studies (11), depths of corrosion pitting on pipe specimens sometimes varied more than 50 percent from the average for two such specimens exposed to presumably identical conditions. In view of the extreme variability encountered in other studies of this type, even between duplicate specimens, significance of the groupings used for the results (with one exception) cannot be established. Only the difference between cinders and the other materials seems to be sufficiently large to be considered significant.

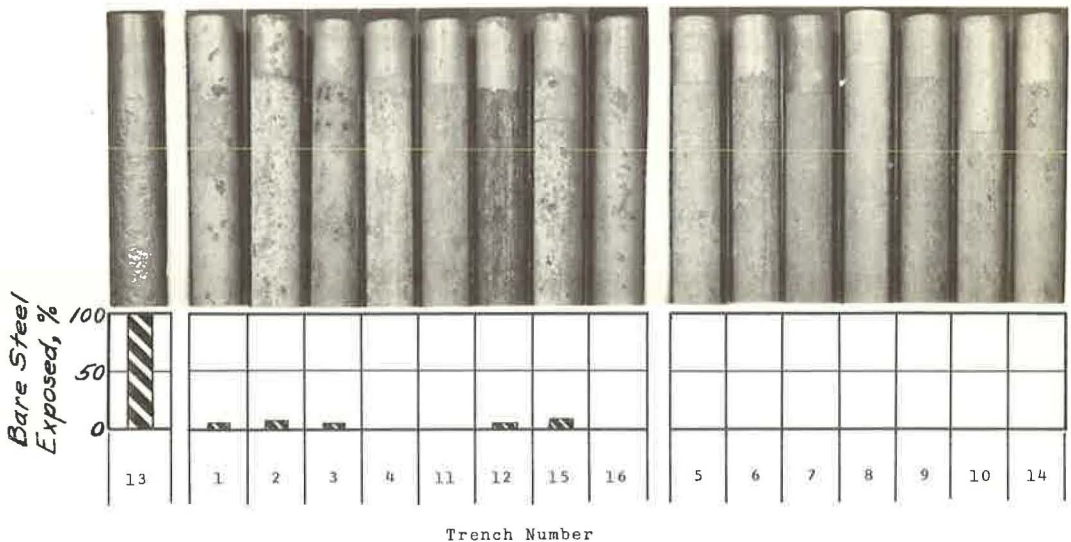
Figure 2 shows the galvanized pipe specimens with a graph indicating the area of bare steel exposed (from which all zinc and zinc-iron alloy had been removed by corrosion). For convenience, results are shown in the same order (by trench numbers) as those previously mentioned. Discoloration of the remaining zinc and zinc-iron alloy coatings on these specimens (especially in the case of the one in native soil—Trench 12) makes photographic presentation of the corrosion effects difficult. However, corrosion pitting and exposure of bare steel were extremely minor or nonexistent on all specimens except that from the coal cinder backfill (Trench 13). In the case of the

Figure 2. Corrosion of galvanized pipe specimens after 5 years of exposure.

cinders, all of the zinc had been removed by corrosion exposing the base steel over the entire pipe, and extensive pitting had begun indicating very corrosive conditions.

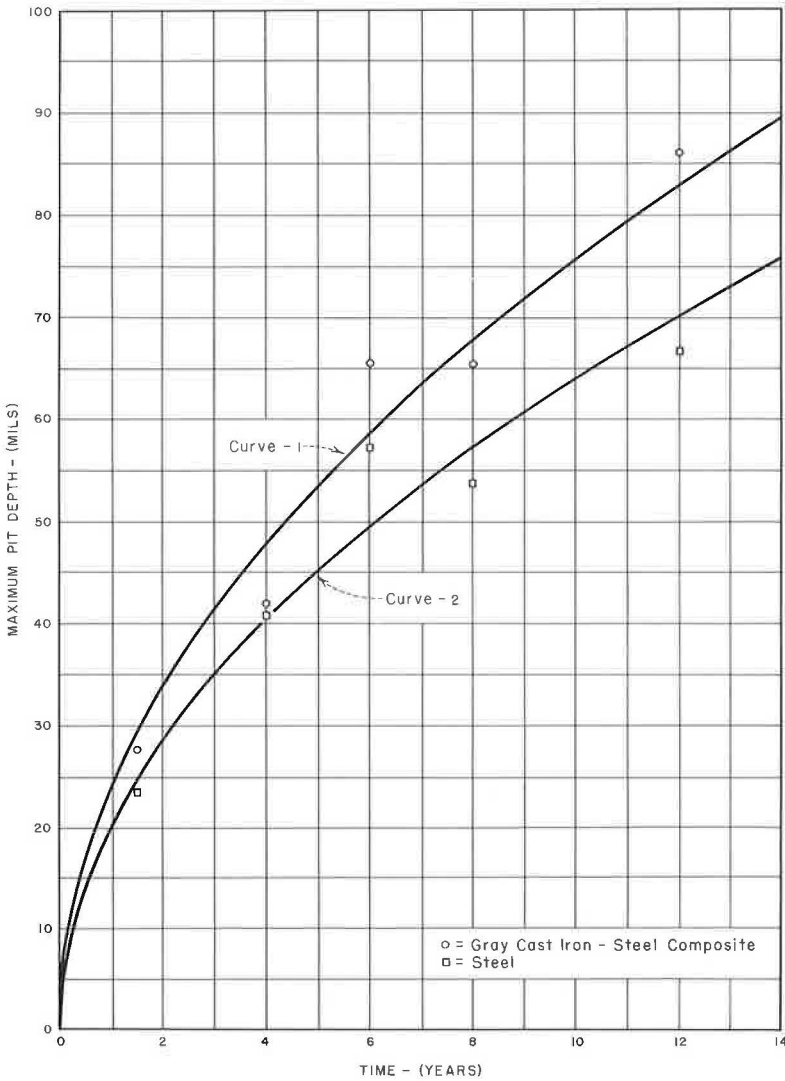
Figure 1. Pit depth-time curves.

be much lower. Some of the data plotted in Figure 1 are a composite for gray cast iron and steel and have been taken from Circular No. 579, Tables 13 and 27. These data are for Material K, open hearth steel, and for Material L, gray cast iron, in Soils 1 to 19 with the exception of Soil 13 where the exposure period was shorter than for the others. In making up the composite, the data for the two metals have been accepted as though they were one and the same metal. This expediency doubles the number of measurements included in a plotted point.

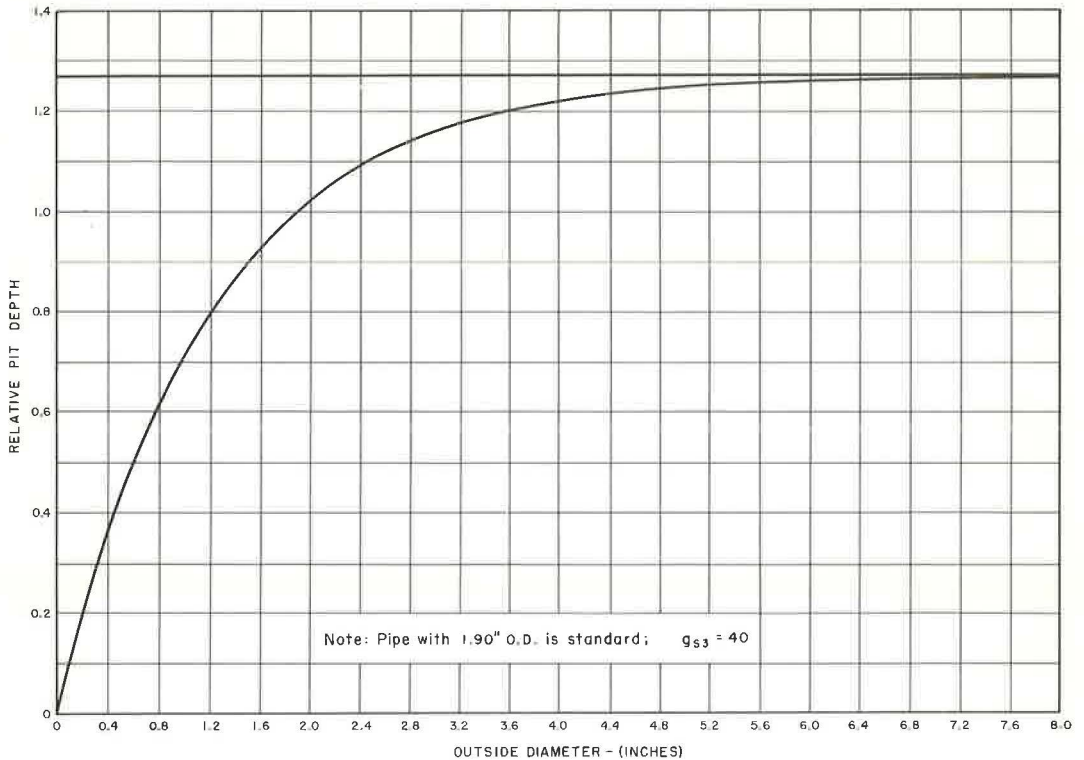
Figure 2. Effect of pipe size on the relative maximum pit depth of Bessemer steel.

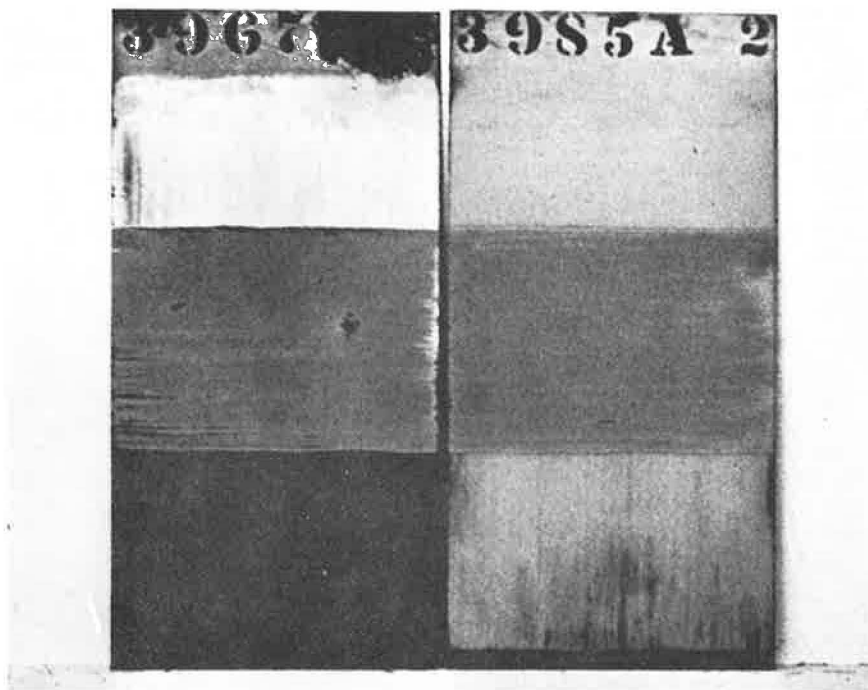
Figure 1. Comparison of red lead (left) and basic lead silico chromate (right) in a long oil alkyd after 110 months exposure at 45° South on Long Island.

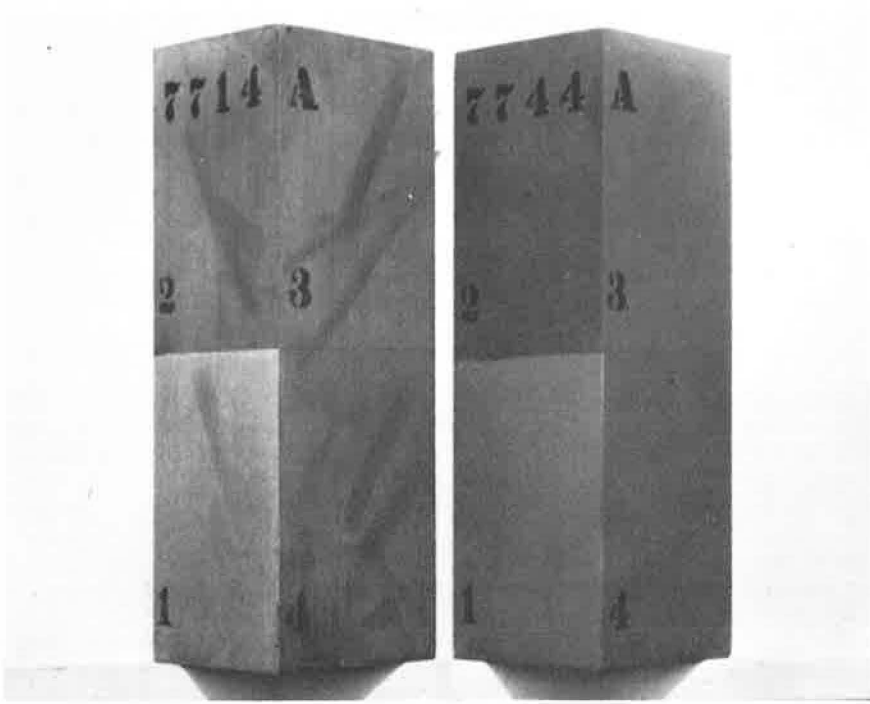
Figure 2. Comparison of control New York State system (left) and experimental basic lead silico chromate system (right) after 19 months exposure at 45° South on Long Island.

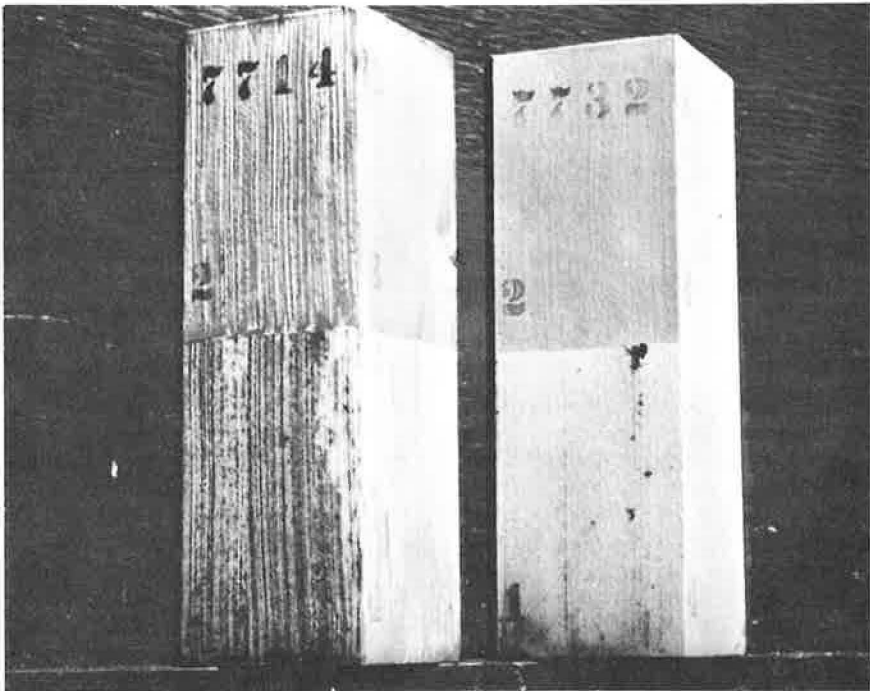
Figure 3. Comparison of control New York State system (left) and experimental basic lead silico chromate system (right) after 66 months exposure at 45° South on Long Island.

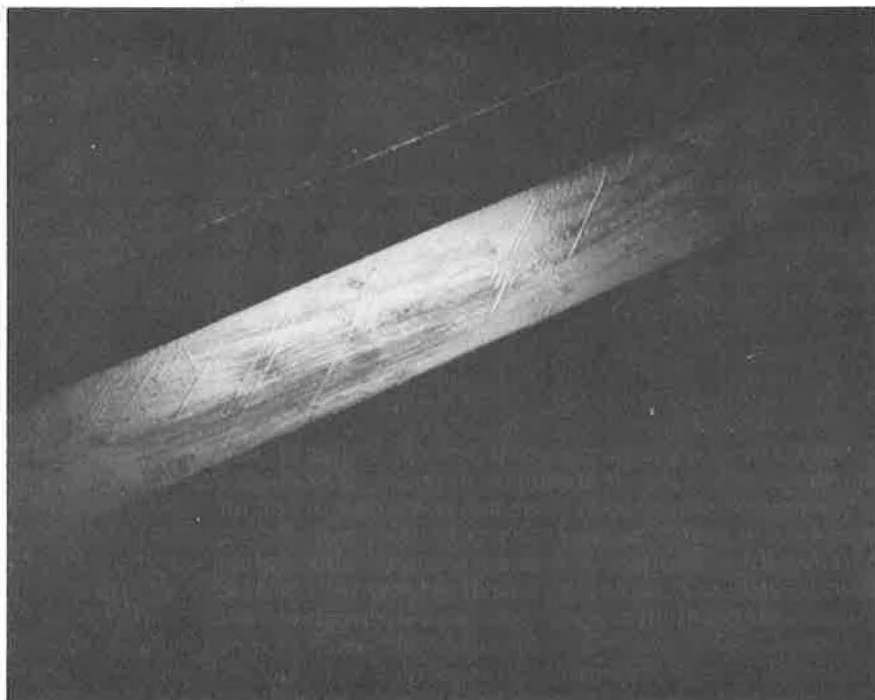
Figure 4. A demonstration of irregular gloss experienced with gray-green finish coat paint.

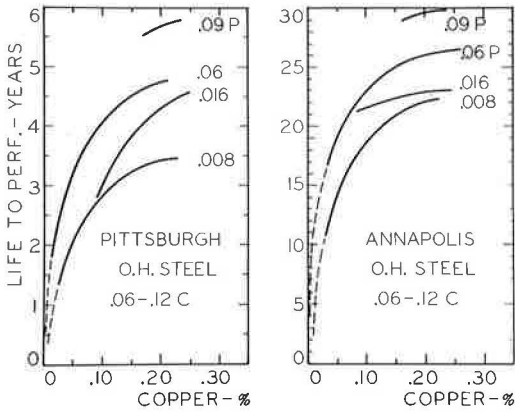
Figure 1. Average life of corrugated black sheets to perforation: 26 x 30 in., 22 gage, 3 to 14 sheets per lot.

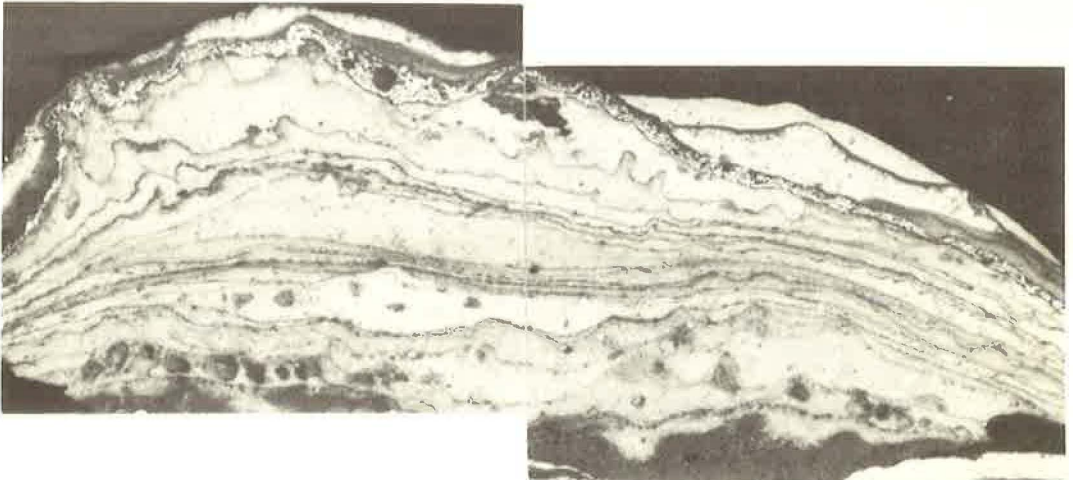
Figure 3. Section of multi-coat paint flake from corroded steel structure.

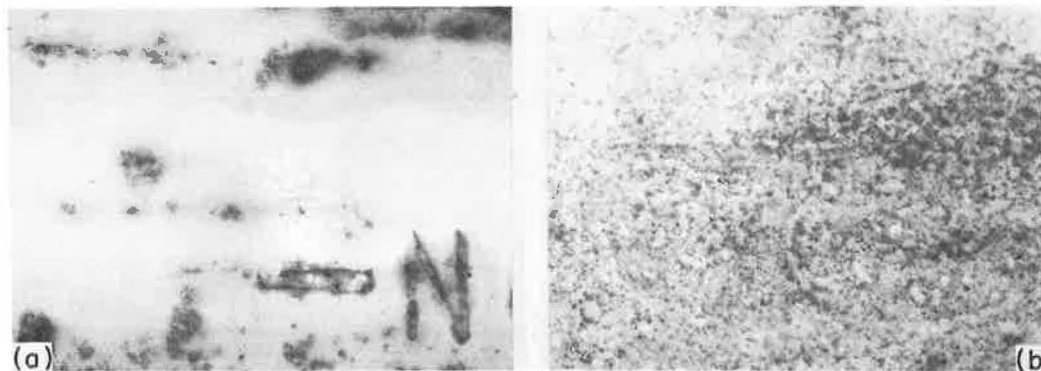
Figure 4 shows the surfaces of two test pieces of structural steel with a prime coat and a top coat totaling only 3 mils dry film thickness, after about 2 years exposure in a

Figure 4. Surface of 3-mil paint system on structural steel after 2 years marine exposure: (a) over intact mill scale; (b) over grit blasted surface.

marine atmosphere. Figure 4a is of a sample with the paint system applied directly over a fairly intact coating of mill scale. The coat is in good shape except for areas where the mill scale layer was broken, giving fine opportunity for local cell action and rusting. Figure 4b is of a specimen grit blasted before painting. Here there is more uniformity of the base, and the moisture and air that permeated the paint film have caused no massive rust, but pinpoints of reaction have formed over the entire surface.

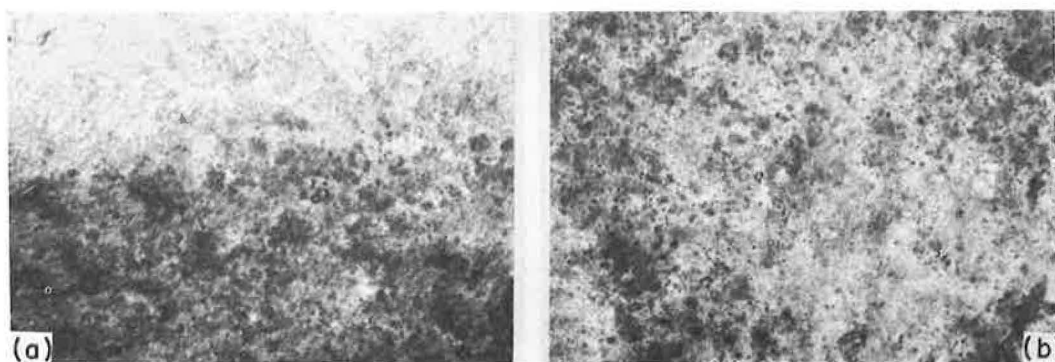
Figure 5. Surface of hot dip aluminum coated low alloy steel panel: (a) pitted and rust stained after 4 years marine exposure; (b) pitted and reported yellow stained after 4 years marine exposure.

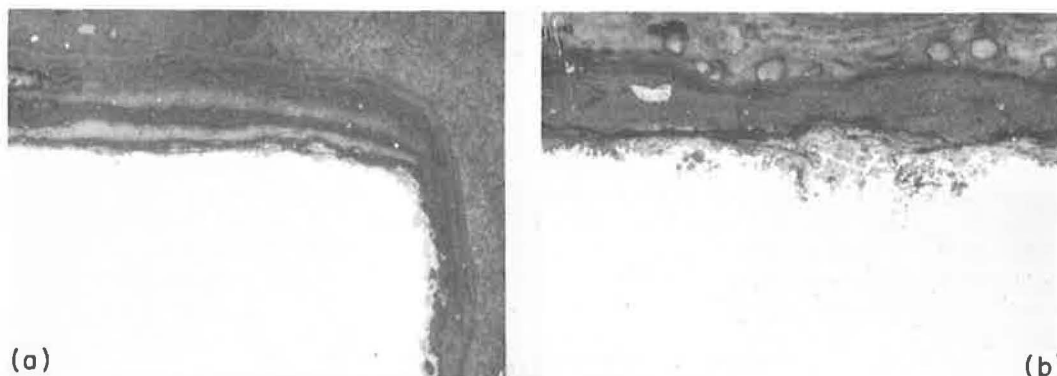
Figure 6. Section of painted cast iron destroyed by atmospheric corrosion, unetched: (a) corrosion (light gray) under multiple paint films, exposed face; (b) corrosion (light gray) under heavy prime coat (dark gray) on mating surface which trapped water.

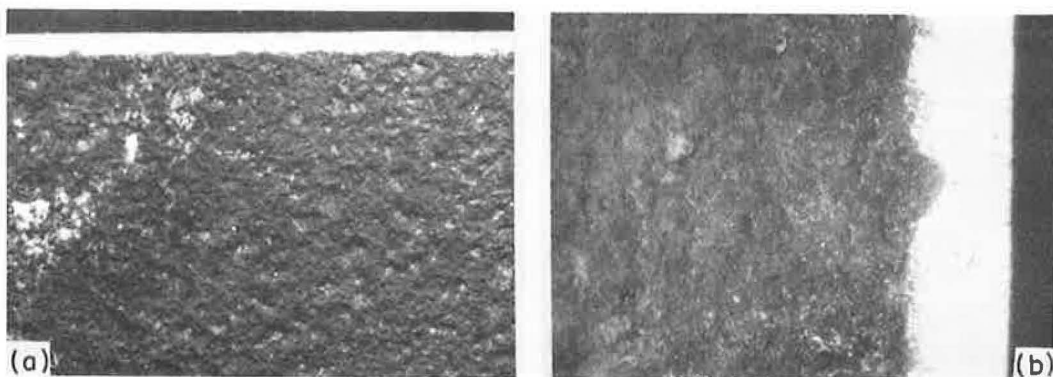
As an example, Figure 7 shows the end of a 2- x 2- x 1/4-in. angle of low alloy steel which had been exposed for some years in an industrial atmosphere without protective

Figure 7. Low alloy steel unprotected 10 years in industrial atmosphere, edge beveled at 30-deg angle [right photo (b) is 5 X left (a)].

coating of any kind, except its own rust film. In Figure 7a, a part of the outer face of one leg is sawed off and then beveled at an angle of 30 deg with the surface. The deep pitting, evident on the surface, is given rough quantitative measure by the trace of the intersection of the bevel plane with the irregular surface.

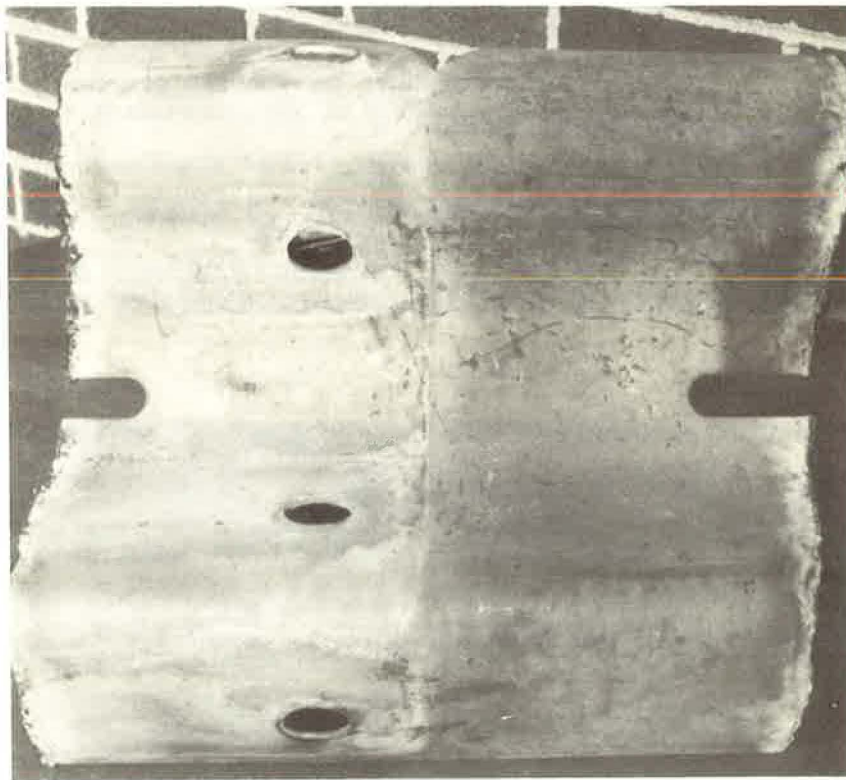
Figure 8. Galvanized guardrail stained by refinery fumes—light gray area covered by lap of adjoining rail; "red brown" stain from precipitated iron from zinc-iron alloy layer of coating ($\frac{1}{8}$ natural size).

Such a condition is seen in the section of galvanized guardrail (Fig. 8) which is stained "dark brown" on the exposed face area, while the part covered by the lap of the adjoining rail is still gray. The micro-section (Fig. 9) of the coating shows that the alloy of zinc and iron, in this case, extends through the entire 7-mil thickness of the galvanized coating. Far from being ready to rust, this structure has twice the specified coating of 2 oz/sq ft of surface (3.4 mil). Yet in this case, authorities elected to paint this surface, stained by close proximity to an oil refinery, because of public reaction to a surface which suggested possible early failure.

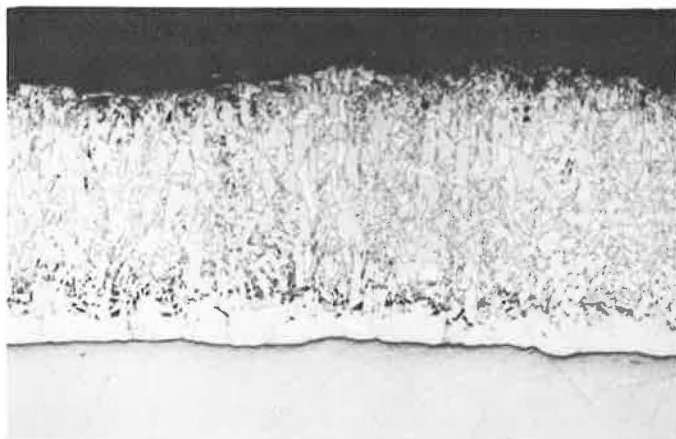
Figure 9. Galvanized guardrail stained by refinery fumes—section of 7-mil coating at covered area, diffuse alloy throughout, nitramyl etch, 200 X.

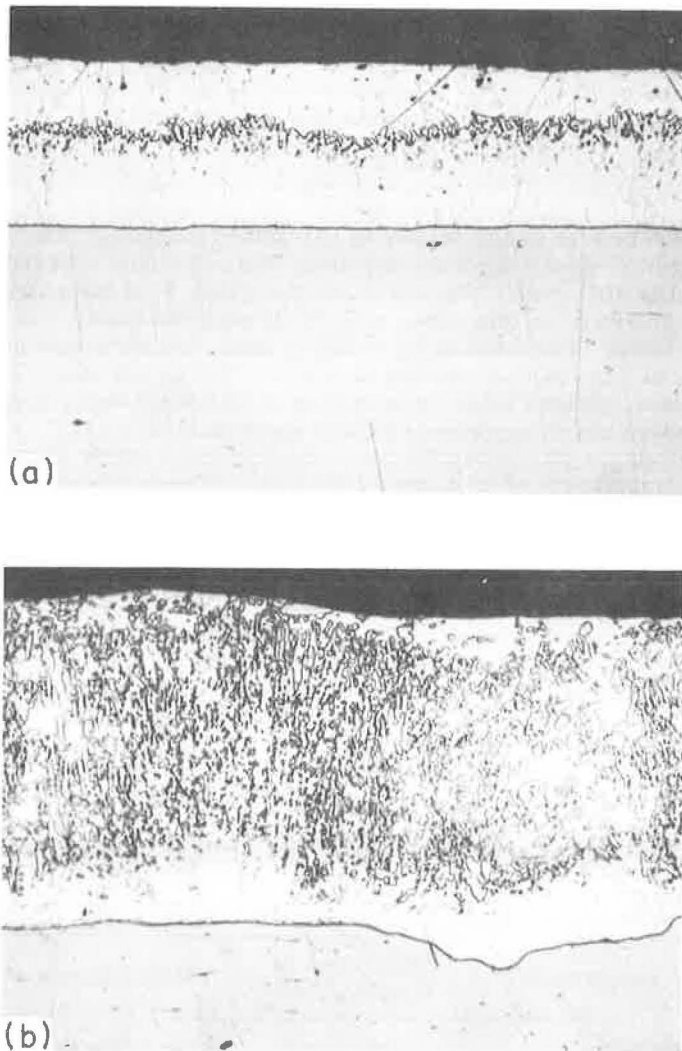
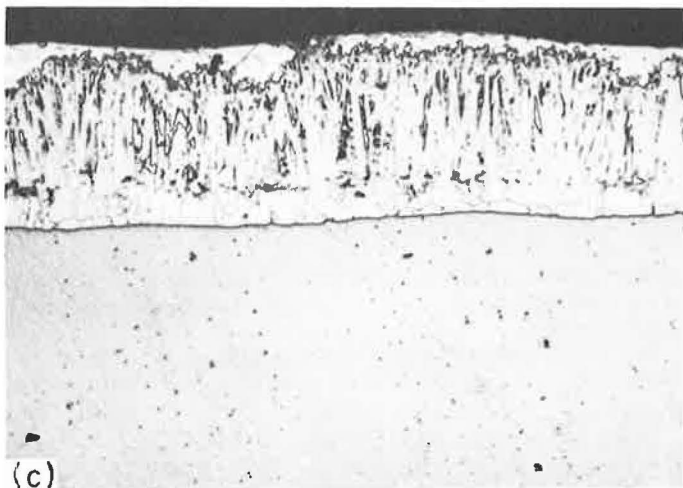
Figure 10. Sections of galvanized coating on 60,000 Y S steel—nitramyl etch, 200 X: (a) smooth, 4.4 mil with 0.02% silicon, dense alloy and zinc; (b) rough, 8.75 mil with 0.05% silicon, diffuse alloy.

Figure 10 (continued). (c) Gray, 5.0 mil with 0.25% silicon, alloy to surface.

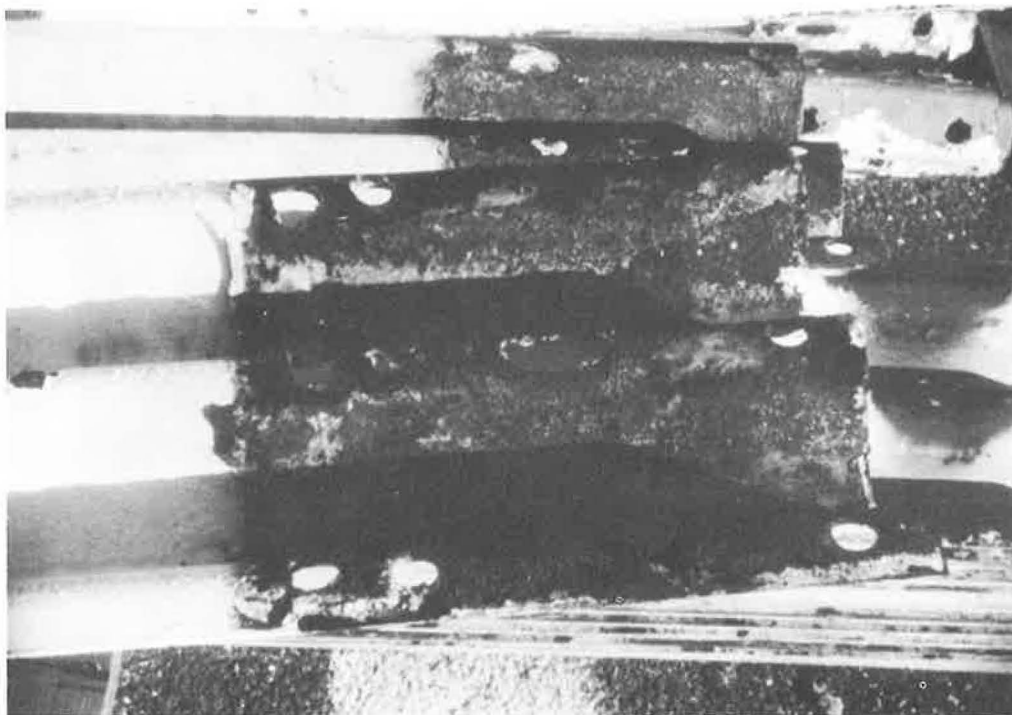
Figure 11. Dismantled, painted (but not galvanized) guardrail, rusted at overlap by entrapped moisture.

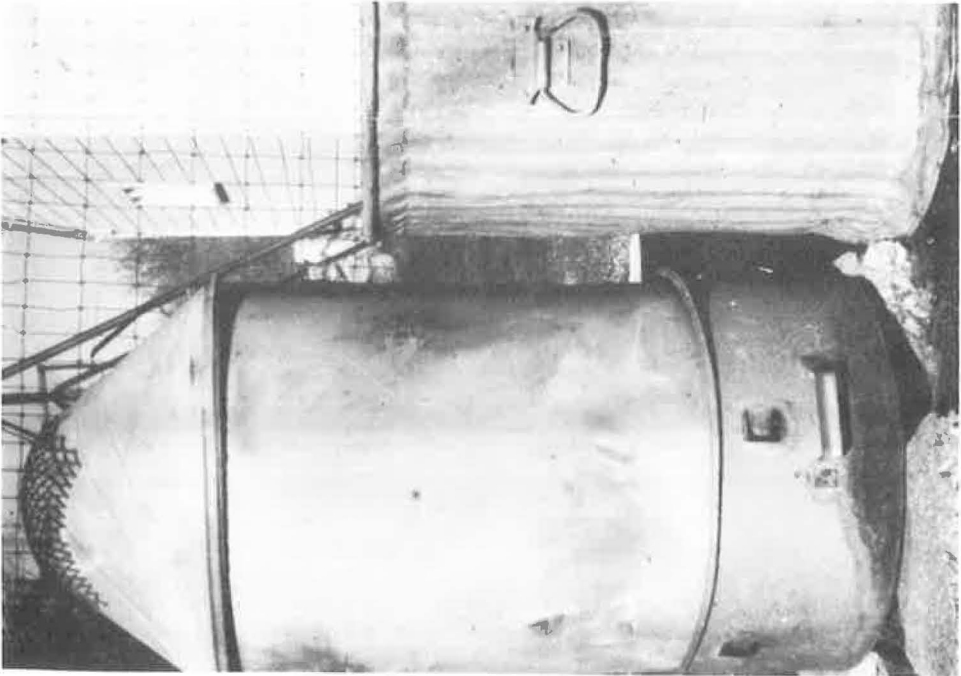
Figure 12. Three-year-old rusted hot dip aluminum-coated burner and 20-year-old hot dip galvanized trash can, unrusted.

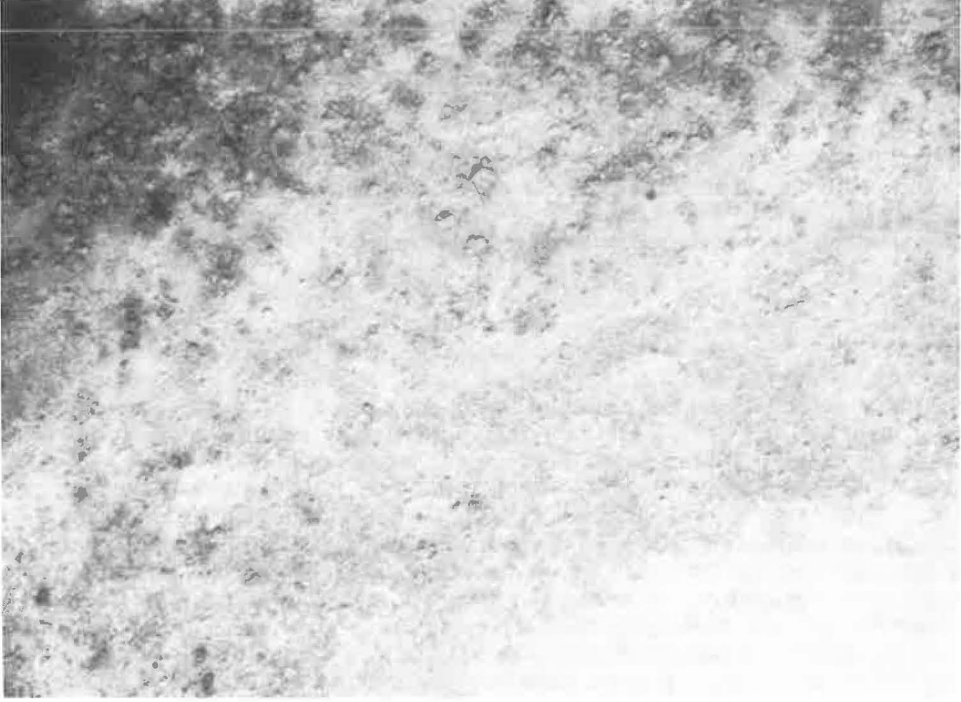
Figure 13. Gray transition zone adjoining rusted area in Figure 12, pits, blisters and rust nodules in aluminum coating (surface 2 X).

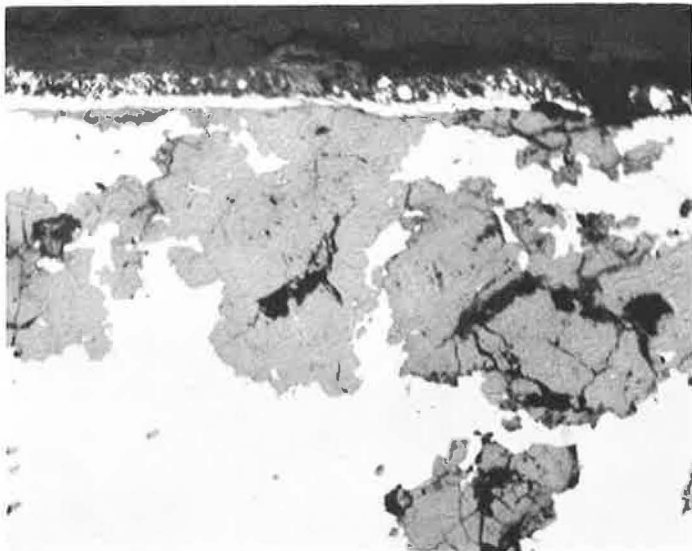
Figure 14. Deep rust penetration at pitted area in aluminum coating of Figures 12 and 13—adherent oxide (gray) and void left by loose oxide (black) above aluminum coating (section 125 X; unetched).

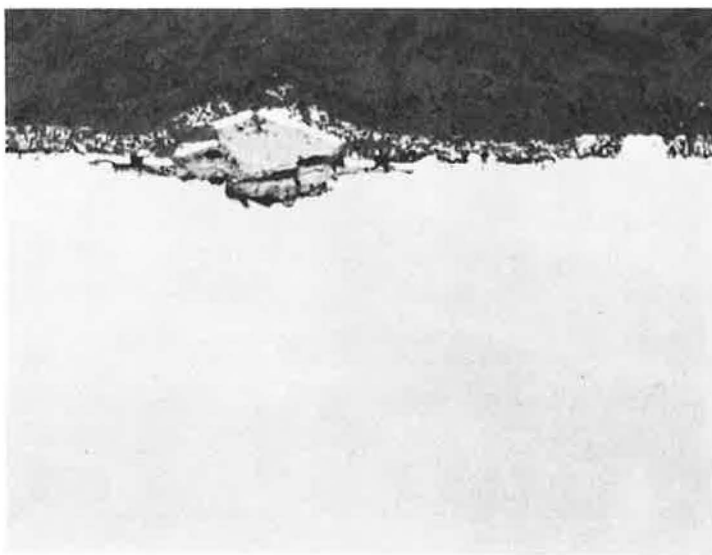
Figure 15. Small blister at gray area in aluminum coating—structureless gray, adherent oxide under textured bakelite mount material and over aluminum coating (section 125 X; unetched).

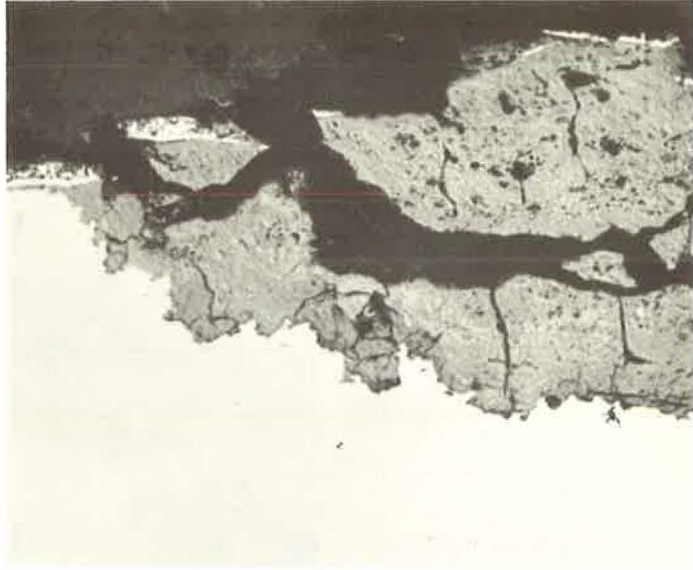
Figure 16. Larger blister at gray area in aluminum coating—fragments of metallic aluminum coating lifted on massive rust from steel base (section 125 X; unetched).

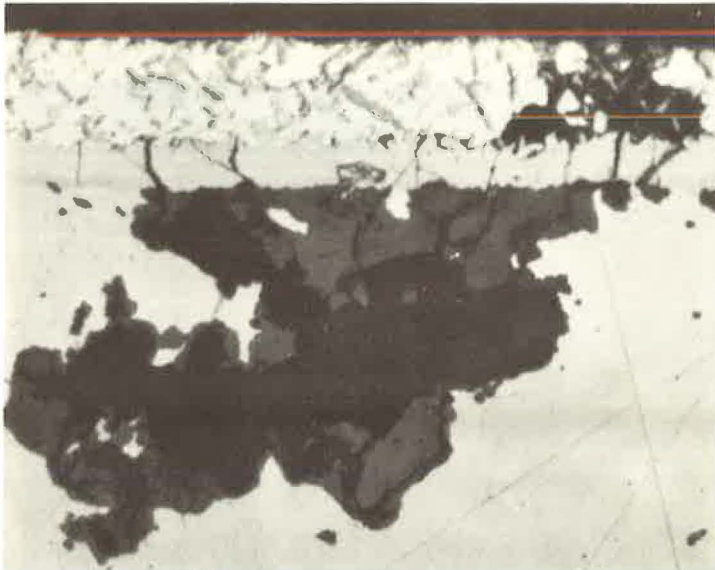
Figure 17. Rusting of base steel under intact aluminum coating at pitted area of Figures 12 and 13—some of the fractures in the aluminum-iron alloy layer of coating have become channels for oxidation process (section 625 X, after 25% reduction in reproduction; unetched after high pressure lapping on paper over plate glass).

These nodes, blisters and pits do not support the statement on page 9 of the Six Year Report, "In the heavily industrial environment (East Chicago) the aluminum coated panels exhibit no evidence of base metal corrosion."

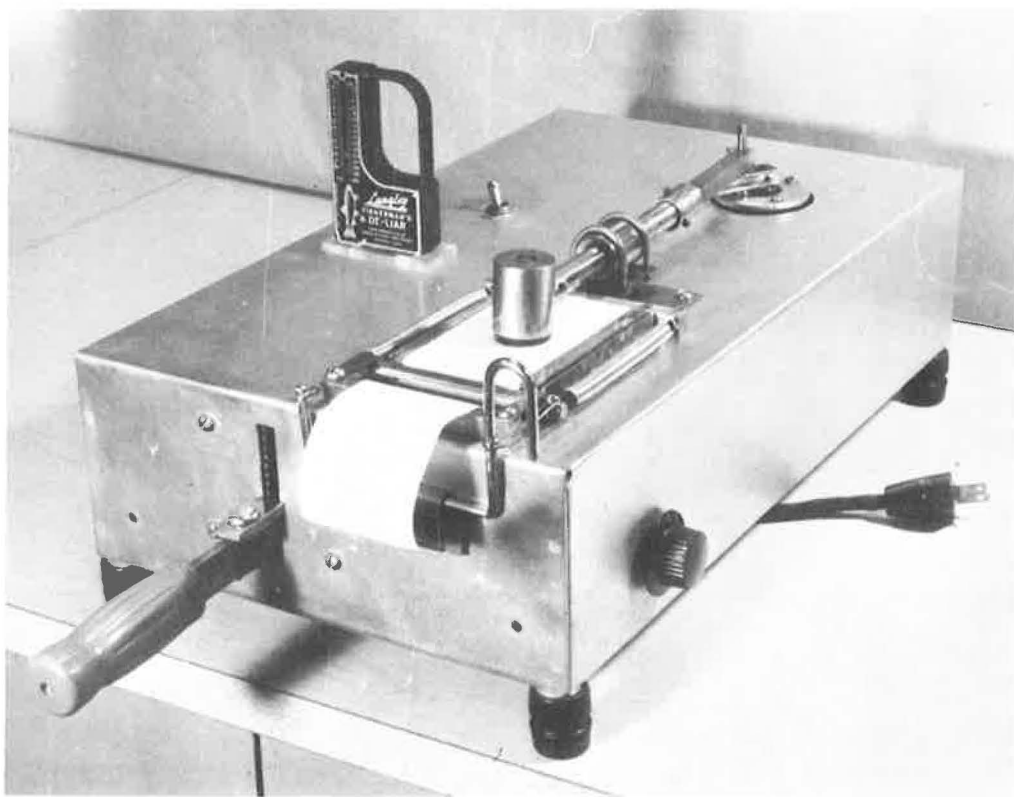
Figure 18. High pressure lap for oxidized micro-sections, or those with wide hardness and electro-potential ranges.
