HIGHWAY RESEARCH RECORD

Number 150

Asphalt Pavements,
Bases and
Surface Treatments

HIGHWAY RESEARCH BOARD

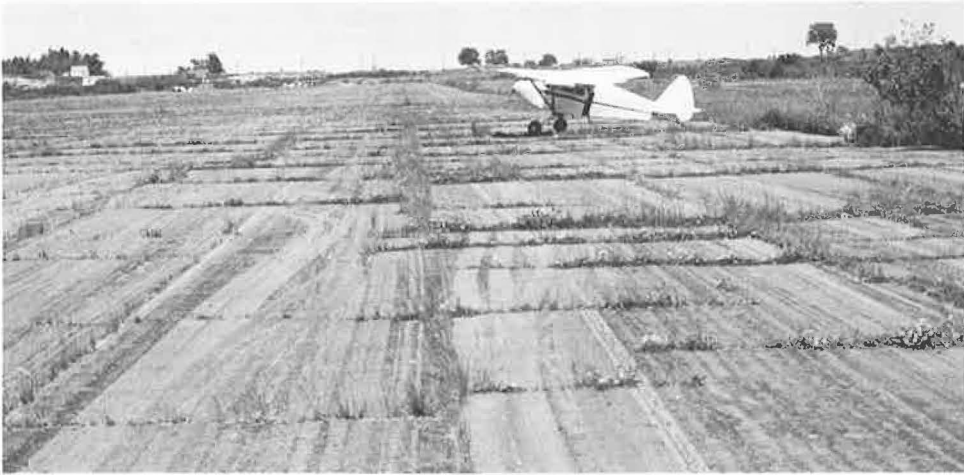
Figure 1. Eastport Airport before bituminous macadam overlay.

In the summer of 1959, a typical 3-in. bituminous macadam overlay course was placed over 1 of the 2 runways at the Eastport Airport, Eastport, Maine. Inspections during the next 4 years revealed no evidence of reflex cracking. During the fifth year one crack occurred, but it had actually healed itself. Obviously the $2\frac{1}{2}$ gal./yd² of flexible asphalt used in this macadam course added greatly to its ability to resist cracking; when cracking did take place, the asphalt was a great asset in rehealing it. The actual material description, amounts and order of application used on the Eastport project, is described in Table 1. Pavement conditions before and after this project are shown in Figures 1 and 2.

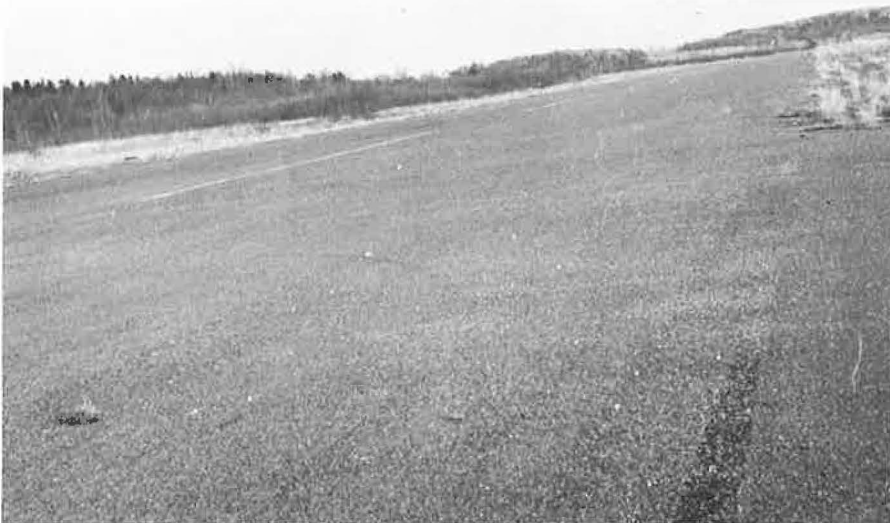
Figure 2. Eastport Airport after a 3-in. bituminous macadam overlay.

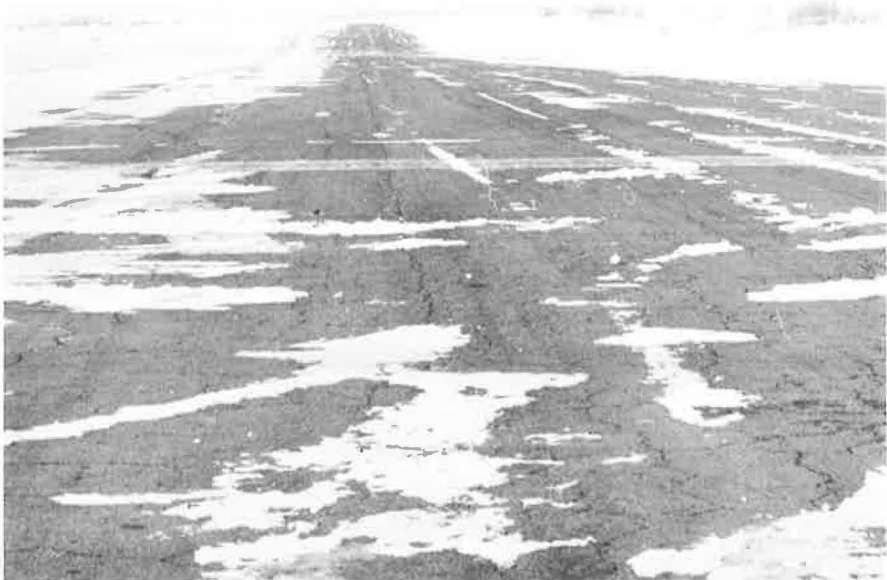
Figure 3. Caribou runway before bituminous macadam overlay.

A 1½-in. macadam overlay pavement was placed on runways at 2 different airports. One was at Caribou, Maine, and the other at Dexter, Maine. Pavement conditions before and after the Caribou project are shown in Figures 3 and 4.

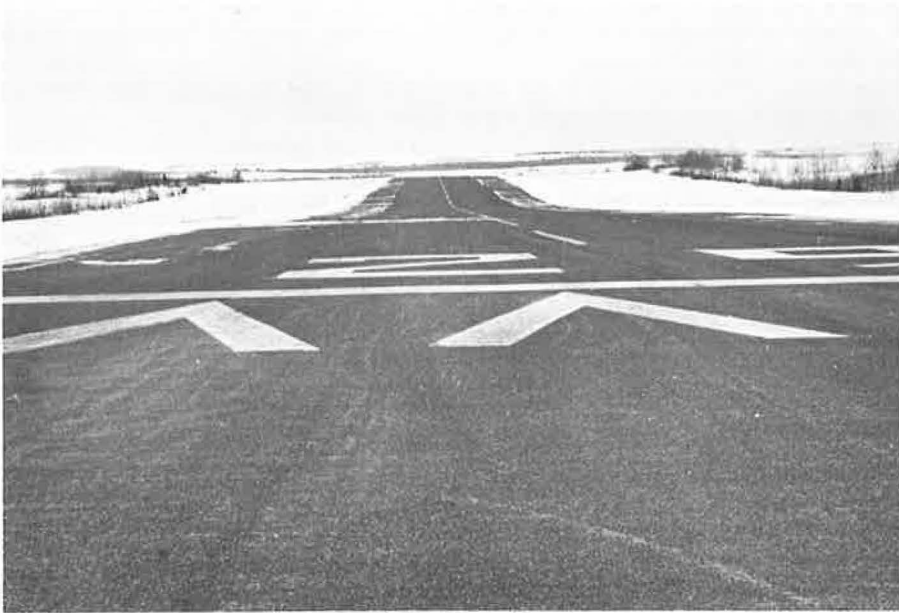
Figure 4. Caribou runway after a 1½-in. macadam overlay.

that they were holding up very well, and most importantly, that reflex cracking was practically nonexistent. Therefore, we now believe that thin overlay bituminous macadam is the most economical and practical approach to the control of pavement reflex cracking that we have tried, observed, or researched to date.

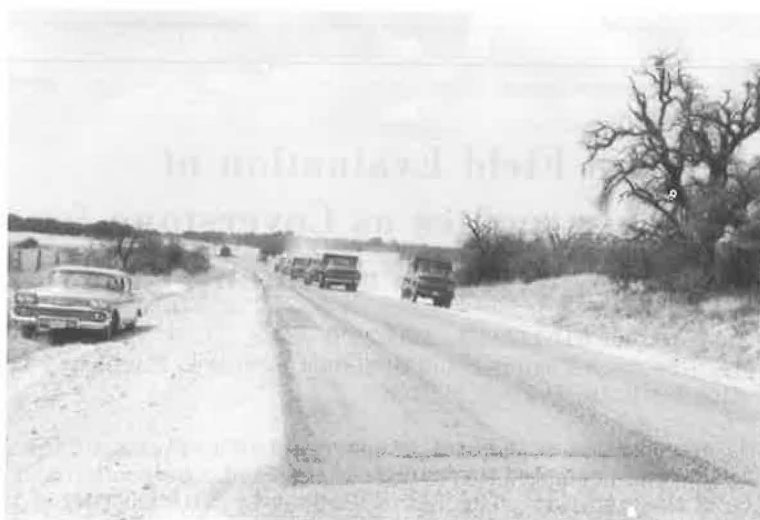
Figure 1. Old surface has variable demand for asphalt from point to point.

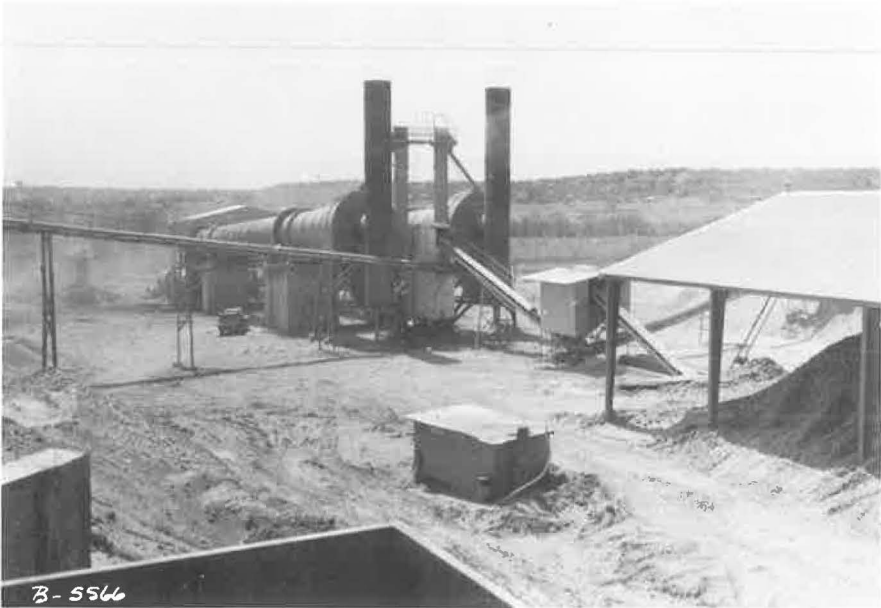
Figure 3. Shale storage and conveyor feed to kilns.

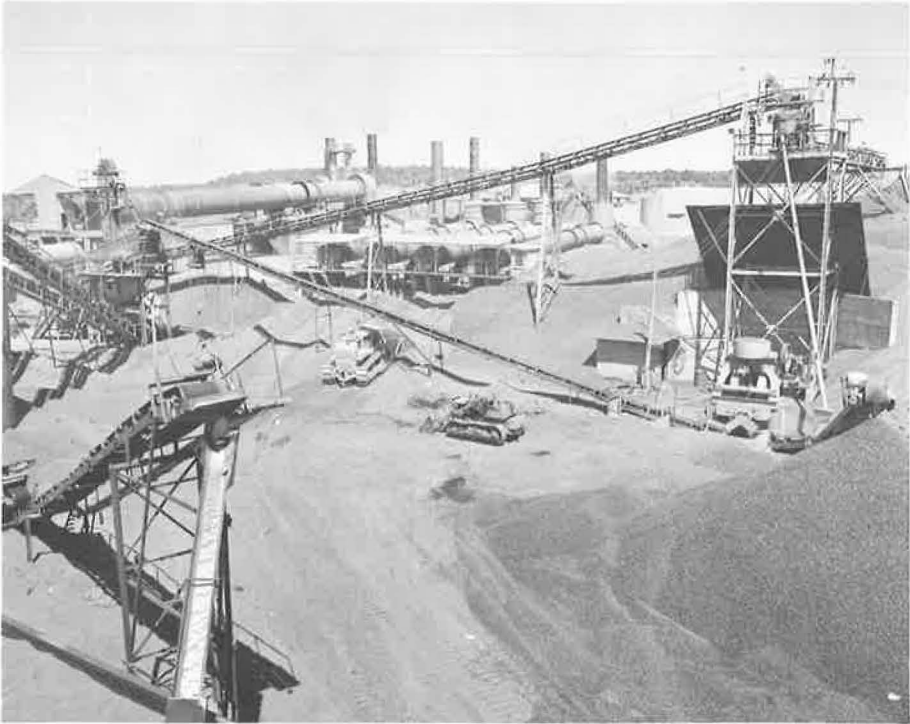
Figure 5. General view of commercial lightweight aggregate plant: crushing and sieving is in right foreground.

The raw shale or clay fines may be formed into pellets and processed in much the same manner as that produced by normal operating procedures. The presized or pelleted material is then burned or calcined for approximately one hour at temperatures in excess of 2000 F in large rotary kilns (Fig. 4). After the clay or shale is heat-processed, it is gravity fed into large rotary coolers and then conveyed to a screening system for removal of certain specified aggregate sizes (Fig. 5). The oversize is sent by conveyors to crushers. The crushed aggregate is then passed through an additional screening system where it is separated into the proper sizes for the market.

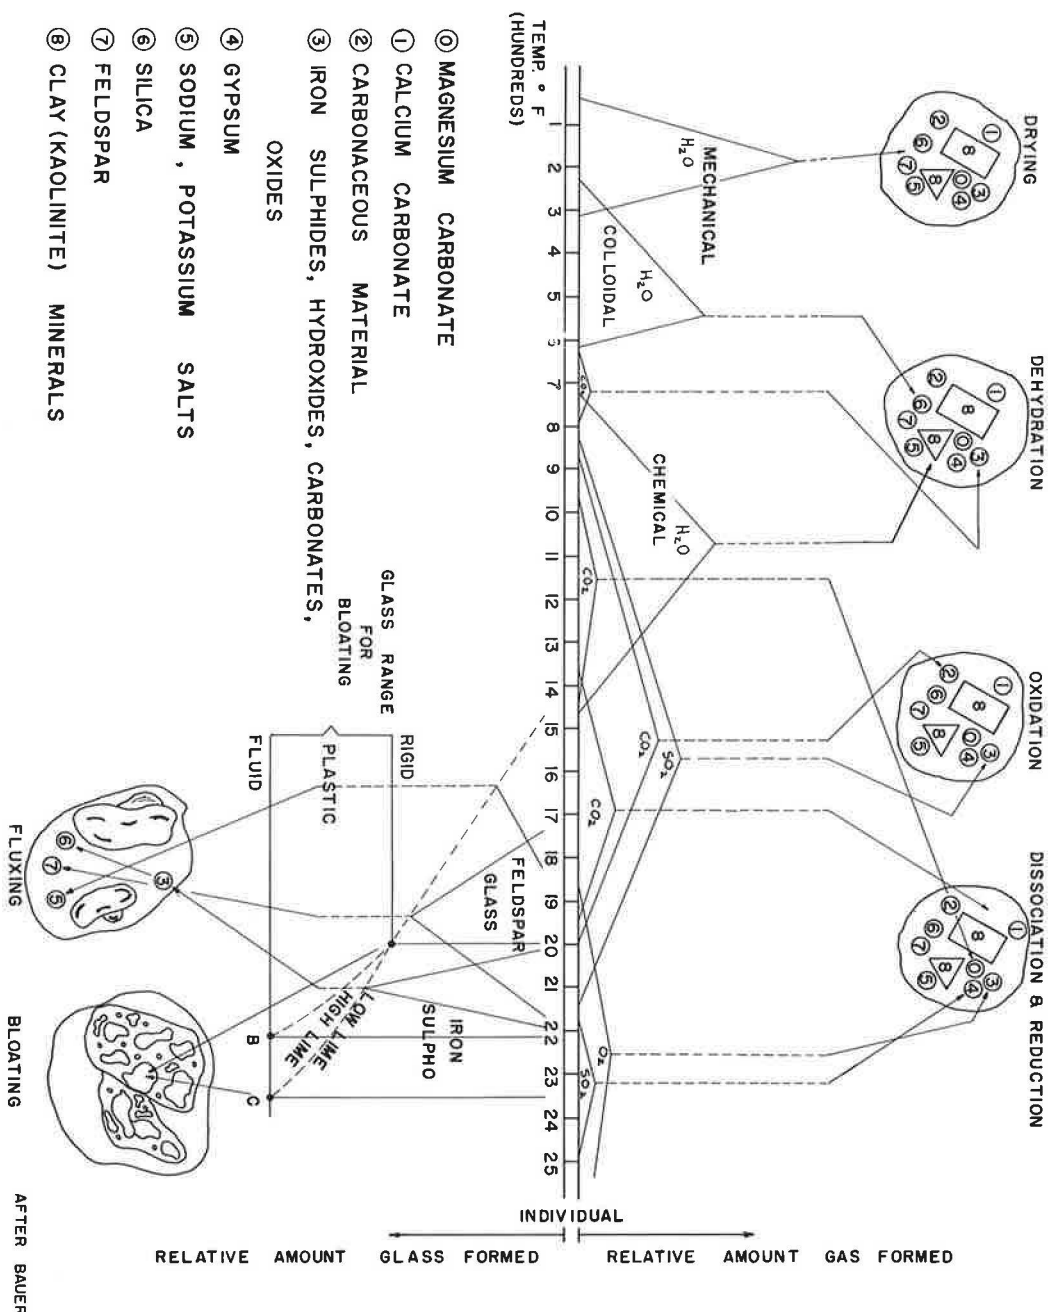
Figure 6. Flow diagram of gas-glass forming vs temperature (6).

Figure 6 shows the principal stages of gas-forming reactions and in turn relates these to the glass-forming reactions along the temperature scale (6). It is evident that most of the reaction periods overlap on the time-temperature scale, and as the chemistry of the clay or shales changes from one deposit to another many and varied shades

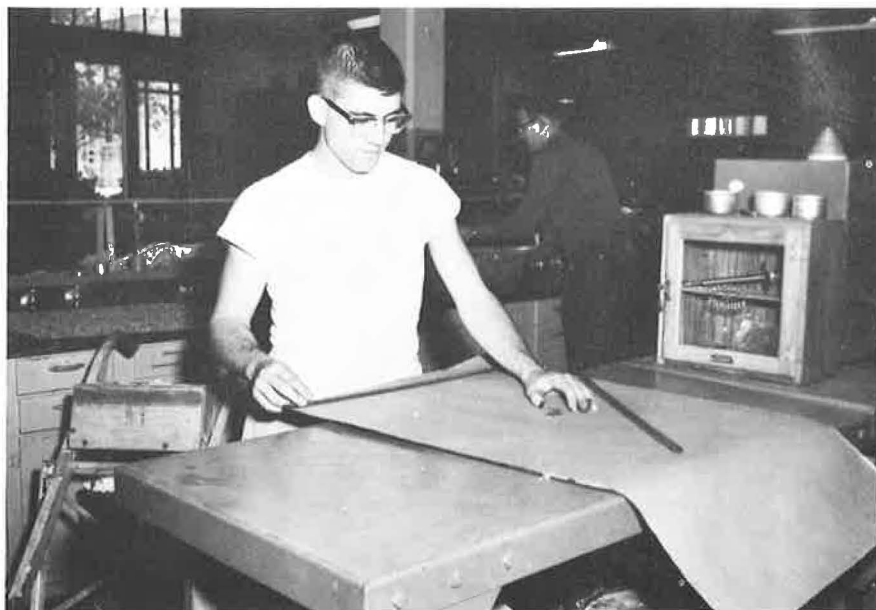
Figure 9. Laboratory surface treatment board being covered with paper.

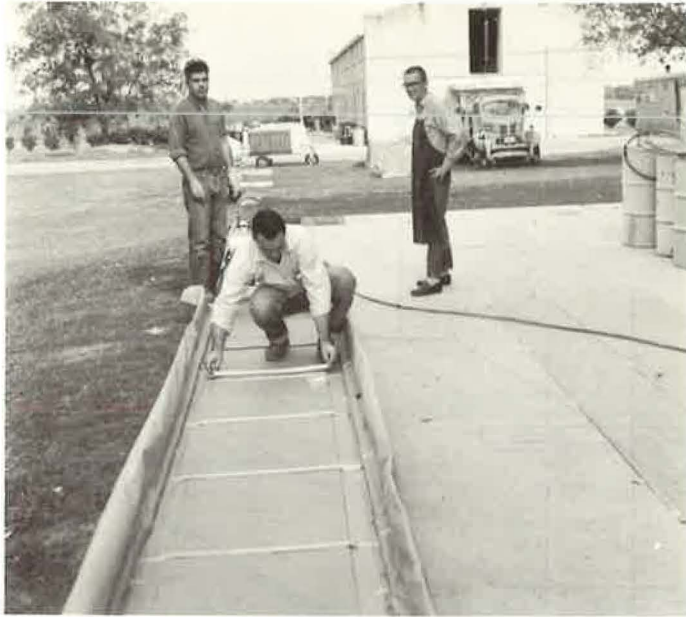
Figure 10. Boards in line for asphalt shot.

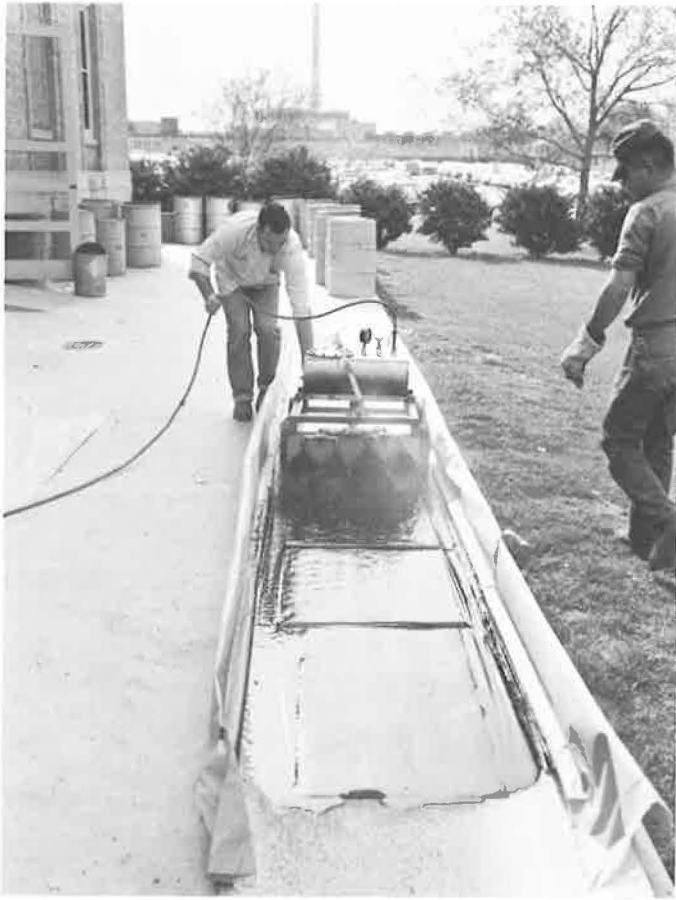
Figure 12. Hot asphalt cement being sprayed from small distributor.

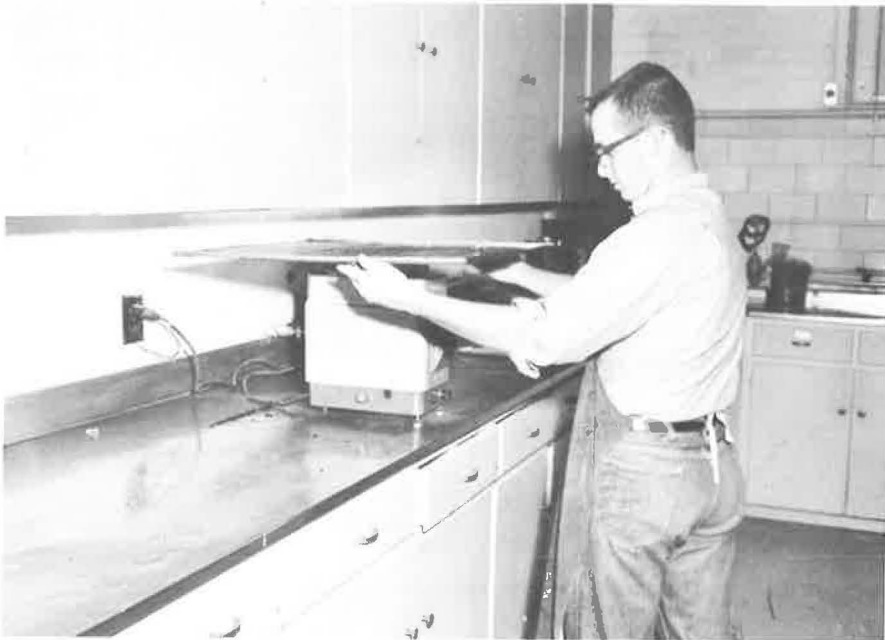
Figure 13. Asphalt coated board being weighed to measure application rate.

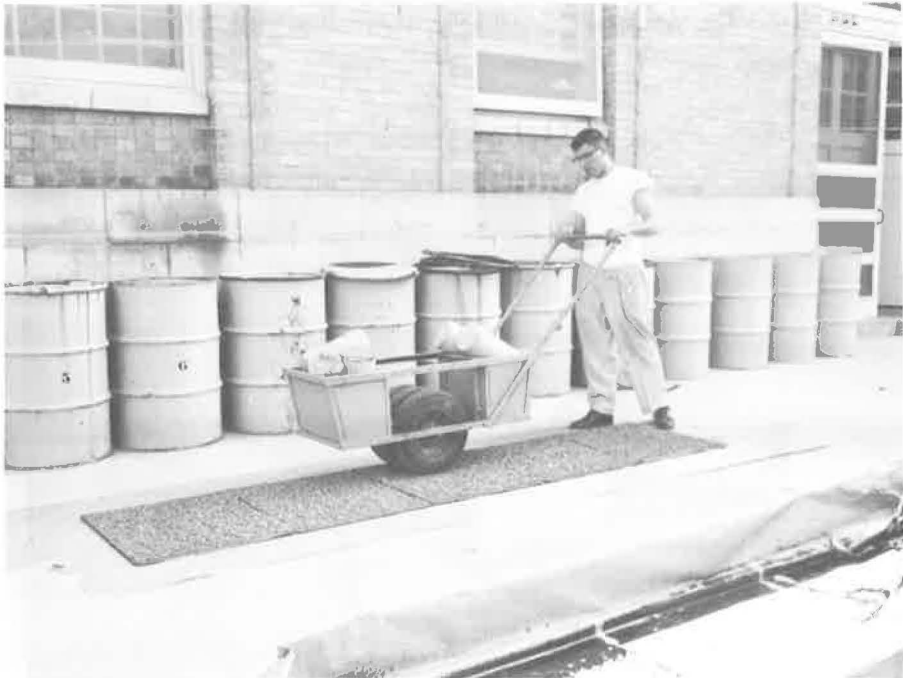
Figure 15. Pneumatic roller used to seat stone on laboratory surface treatments.

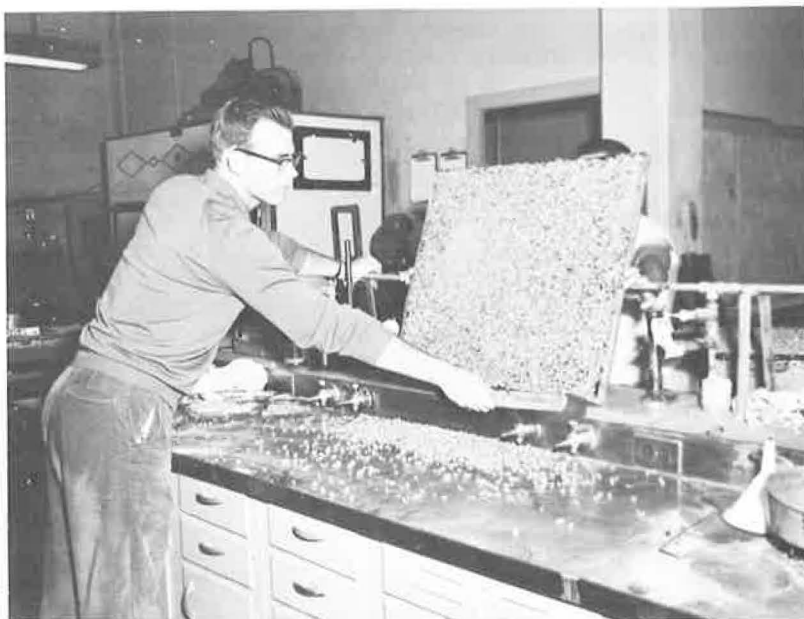
Figure 16. Completed surface is tilted 75 deg and brushed to remove loose stone.

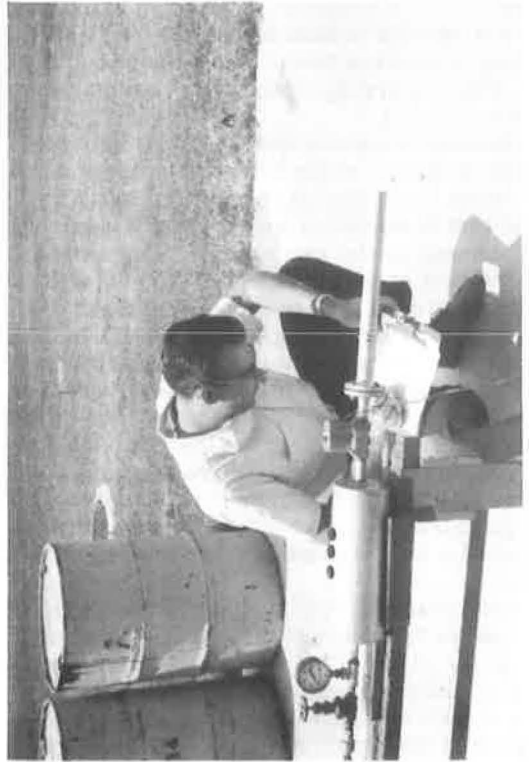
Figure 22. Air-powered gun for shooting stones.

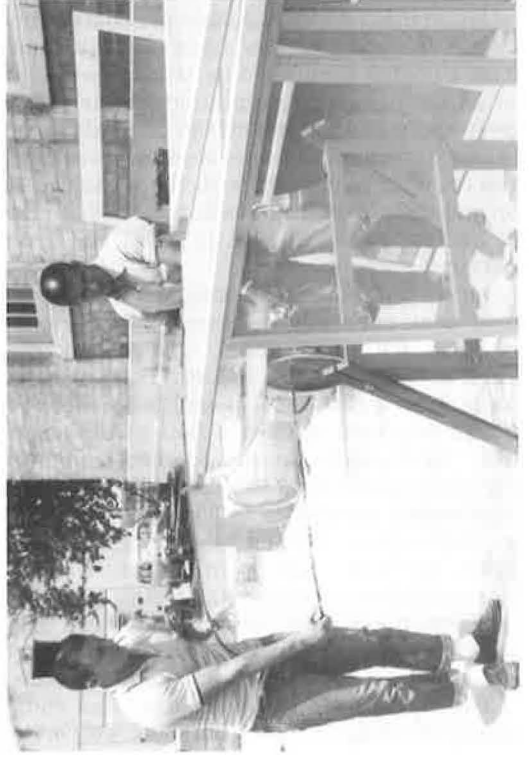
Figure 23. Windshield being placed into position for "flying stone" study.

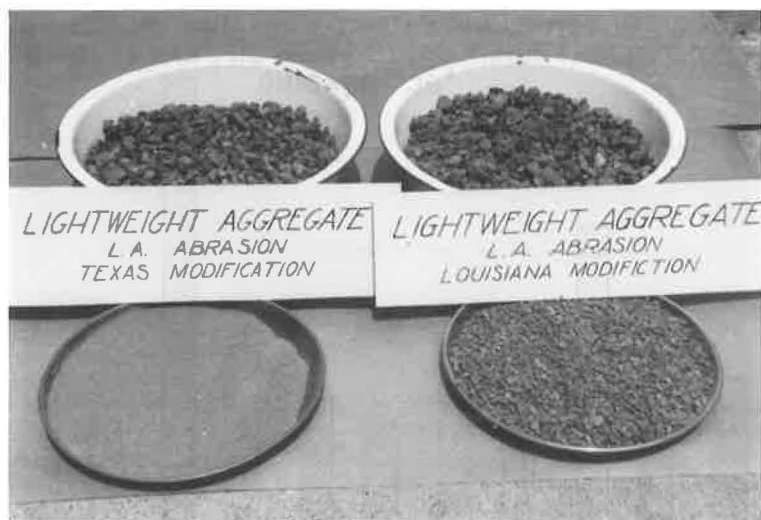
Figure 37. Type F materials after testing by Texas and Louisiana methods for Los Angeles abrasion.

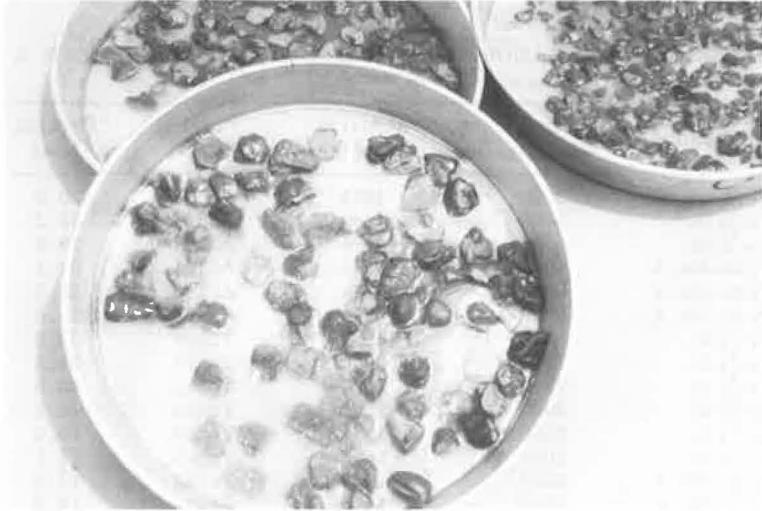
Figure 38. Type F material after freezing in water.

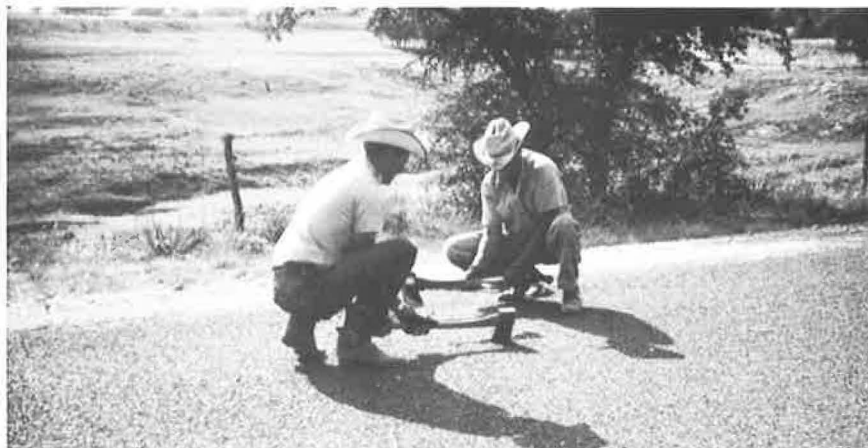
Figure 41. Cutting a field sample with an ax.

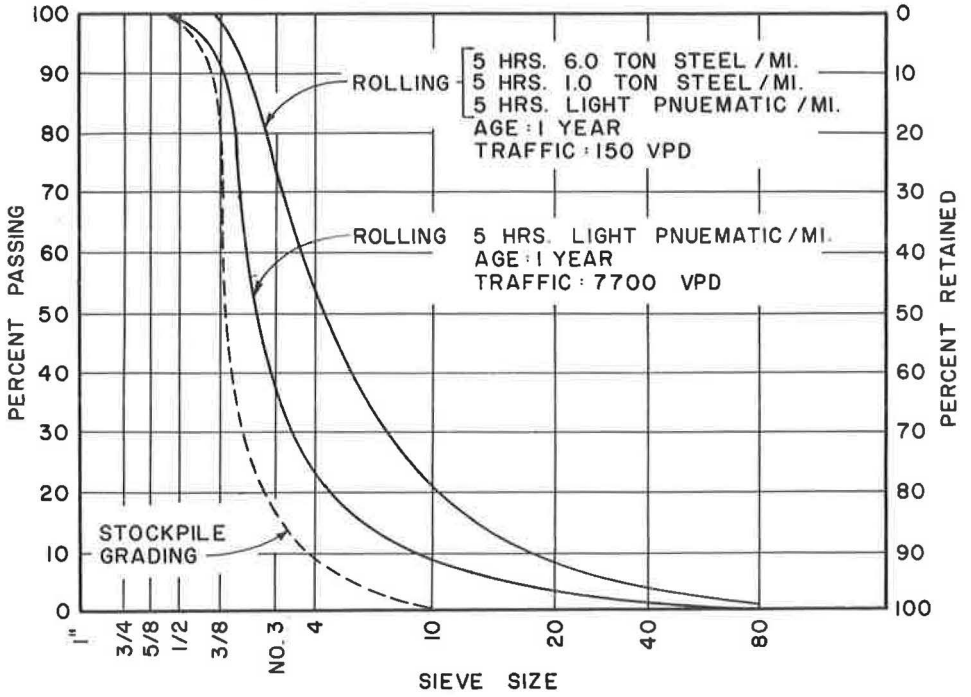
Figure 46. Degradation of type F aggregate due to construction and service.

Figure 46 clearly indicates that the type and amount of construction rolling has a decided effect on the degradation of the coverstone. Admittedly this is no new finding but proper rolling of lightweight (type F) aggregates is quite important, and it is evident from these data that if additional fines were desired, these fines can be produced on the road surface during construction. It should be pointed out that it seems foolish

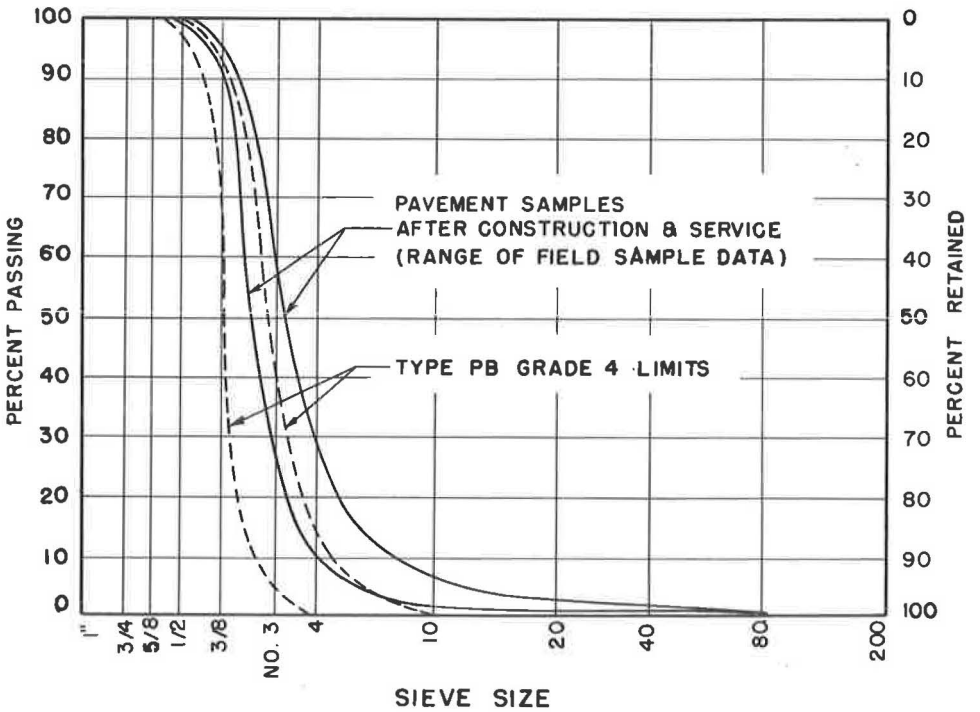
Figure 47. Comparative degradation of precoated limestone due to construction and service.

Comparative data on the construction degradation of precoated limestone are shown in Figure 47. There was some crushing of the cover material during construction, but it is not quite as severe as that for the type F material subjected to similar rolling equipment. None of the precoated material was subjected to the severe steel flat wheel

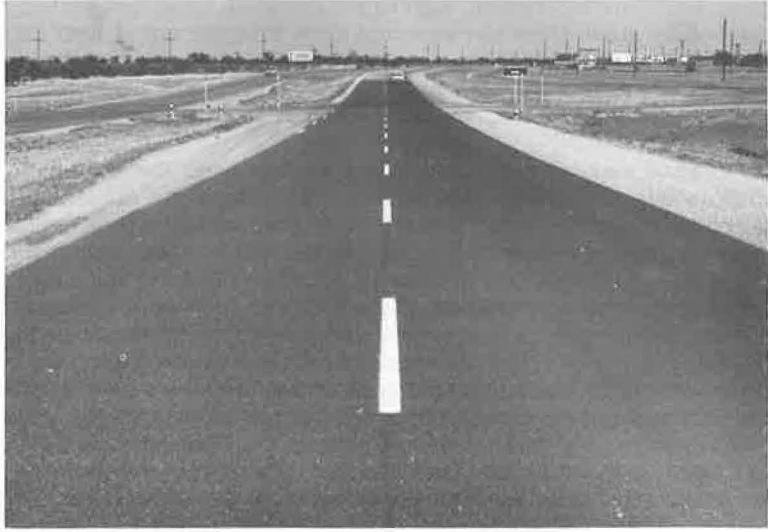
Figure 48. Type F seal two years old with 7700 vpd.

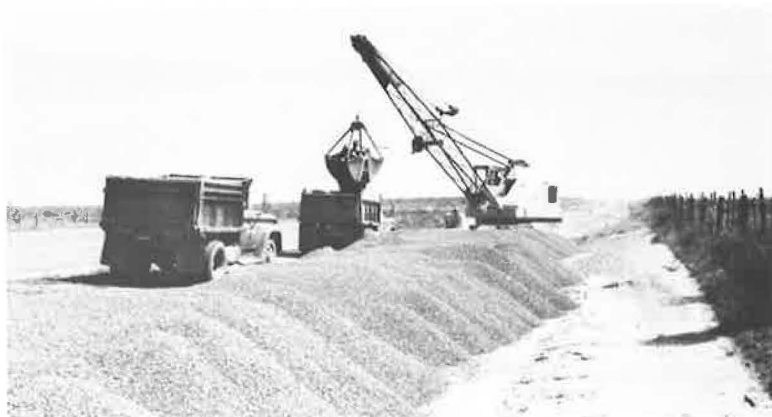
Figure 50. Stockpile and loading operation of type F material.

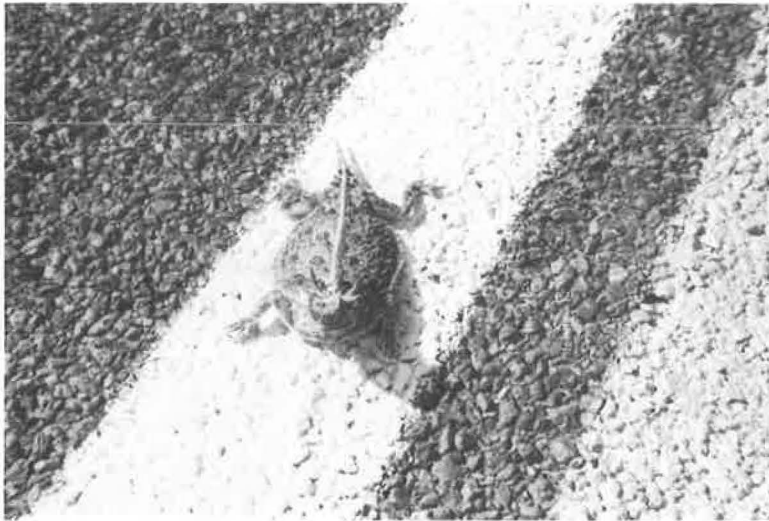
Figure 55. Type F material presents a contrast for center stripe.

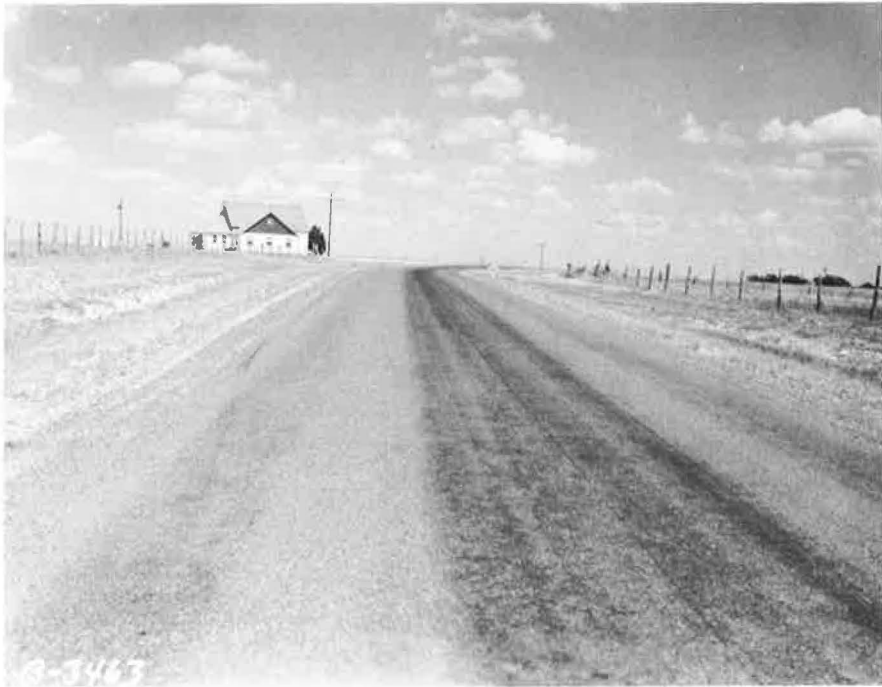
Figure 56. No center stripe concentrates traffic in center third of FM 1192.

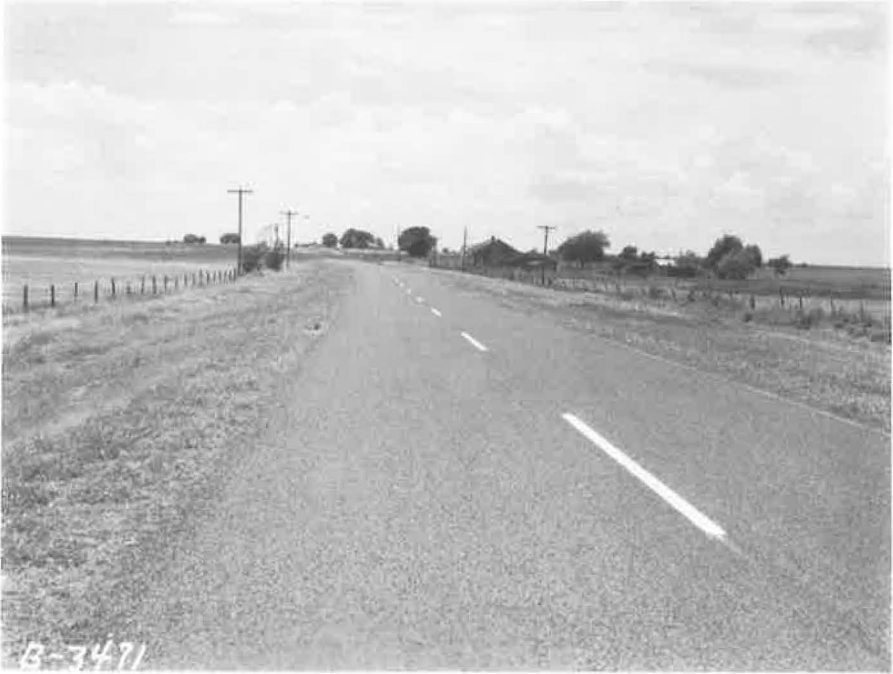
Figure 58. Typical farm-to-market road surfaced with type F material.

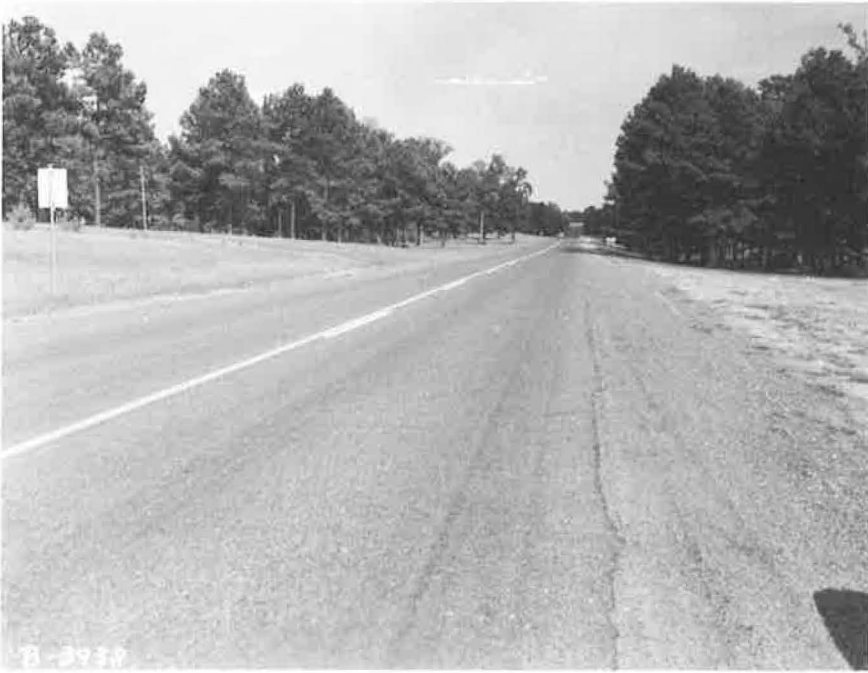
Figure 60. Type F cover aggregate in service three months, 1500 vpd, US 190.

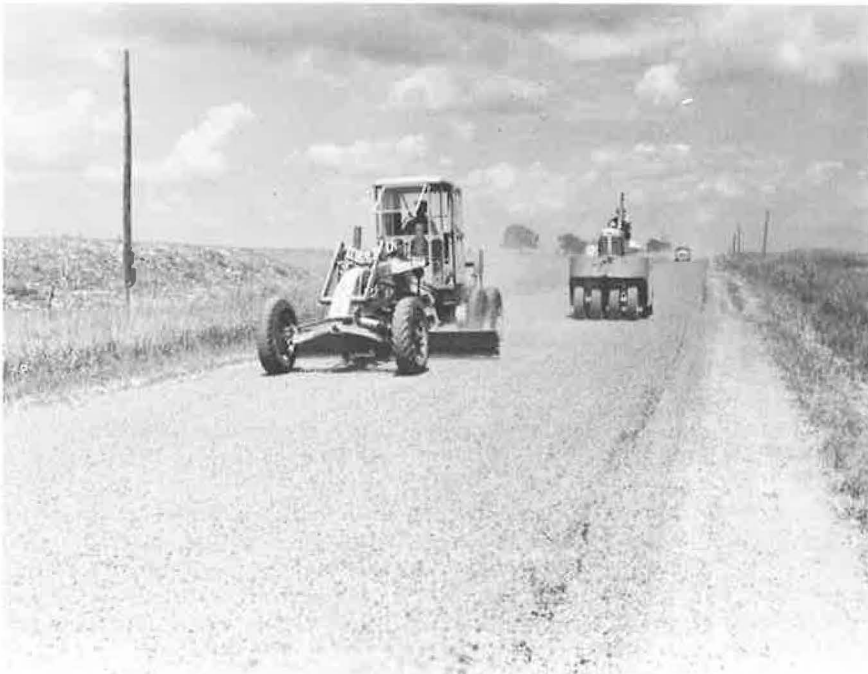
Figure 61. Blade broom successfully used on type F coverstone.

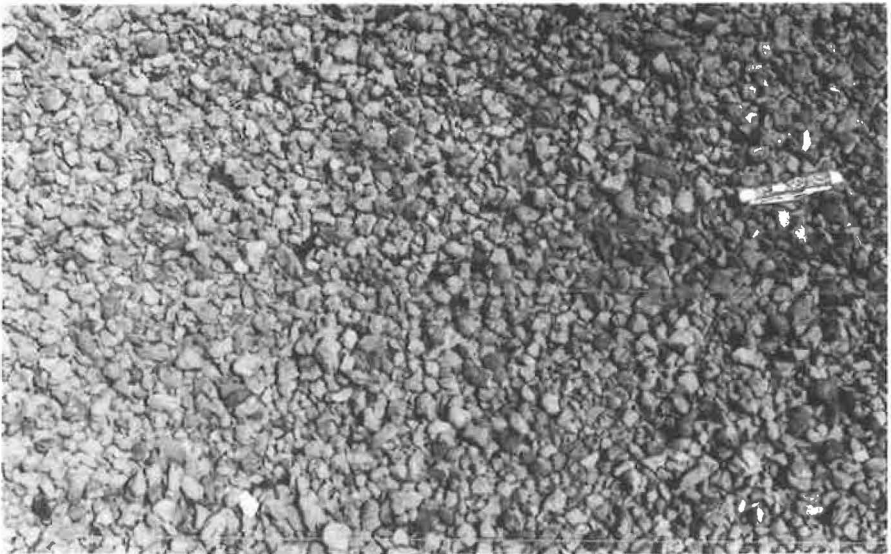
Figure 63. Type F Grade 3 after brooming. Spread rate—130 sq yd/cu yd.
