HIGHWAY RESEARCH RECORD

Number 152

Geometric Design,
Barrier Rails
and
Sign Supports

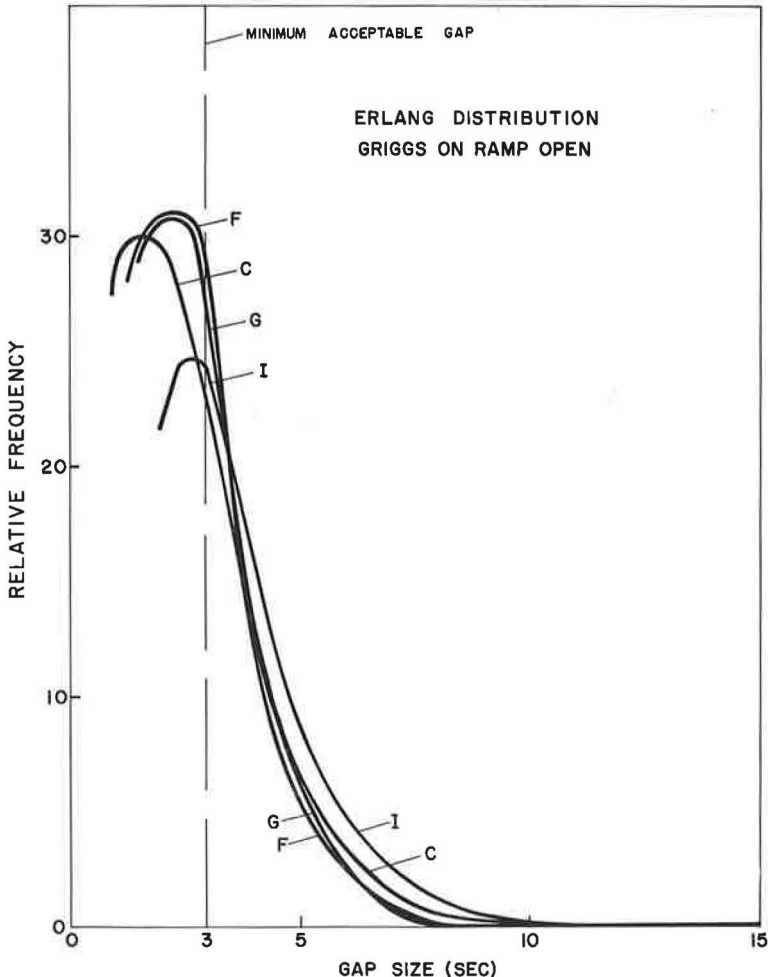
Figure 17. Gap distributions, Brays Bayou, 7:20-7:25 AM, Feb. 18.

The center curve represented the probabilities of the data collected from 7:20 to 7:25 a. m. on February 18 when the Griggs on-ramp was open. The curve shows a very slight increase at Points F and G and a marked increase at Point I. This study would usually have been expected to result in a decrease in the probability of available, acceptable gaps as the distance between the ramps increased. But, while the data were being collected, it was noted that vehicles were leaving lane 1 for the center lane as they approached the Griggs on-ramp because it was located at an up-grade, and at 7:20 a. m. they saw vehicles queued on the on-ramp and the frontage road, waiting to enter the freeway. This curve verified the observation that vehicles were leaving lane 1 in the vicinity of the Griggs on-ramp since it shows an increase in the probability of acceptable gaps. Therefore, the decision was made to study data that were collected when the Griggs on-ramp was closed, to eliminate its effect.

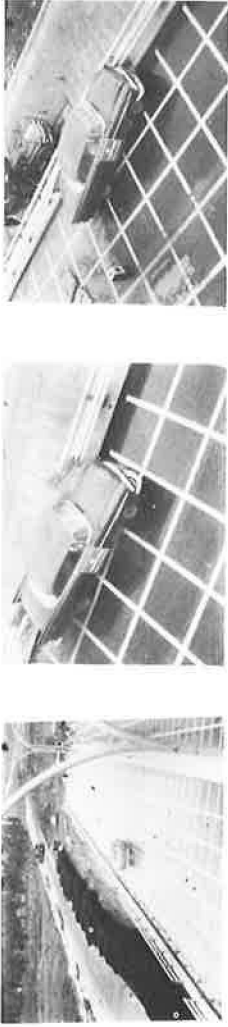
Figure 11. Test No. 4 of steel guide rail at 42 mph (model B).

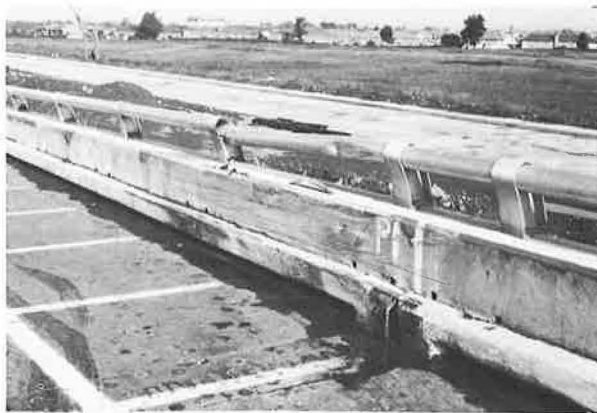
Figure 21. Damages to guide rail model H after the three tests.

Three tests were made on the concrete wall-type guard railing, one at a 17-deg impact angle and 2 at a 21-deg angle. Each impact on this rail produced only a slight rebound. To obtain the 21-deg impact angle, it was necessary to erect a supplementary guiding system, as the test car's centripetal force would have thrown the vehicle out of the ordinary guiding system (Fig. 18). Two tests at the 21-deg impact angle were made because the gas pump of the first car failed about 100 ft from the starting point.

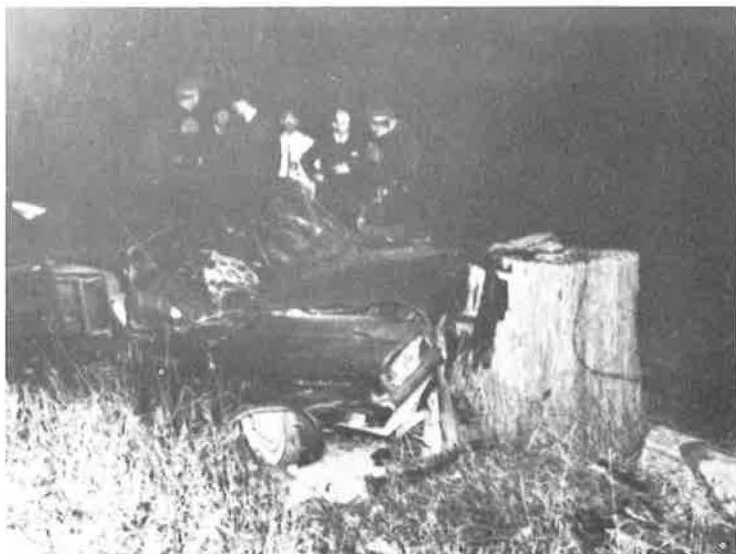
Figure 1. Vehicle went off left side of road and struck tree stump 10 ft from edge of road. Driver killed.

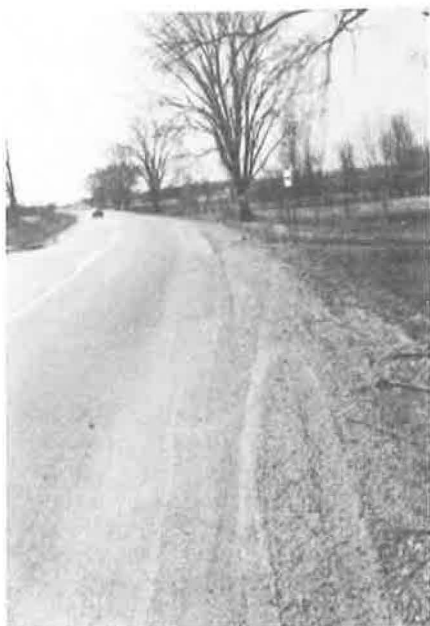
Figure 2. Vehicle left roadway on right side of curve and struck tree (center) 15 ft from edge of road. Driver killed.

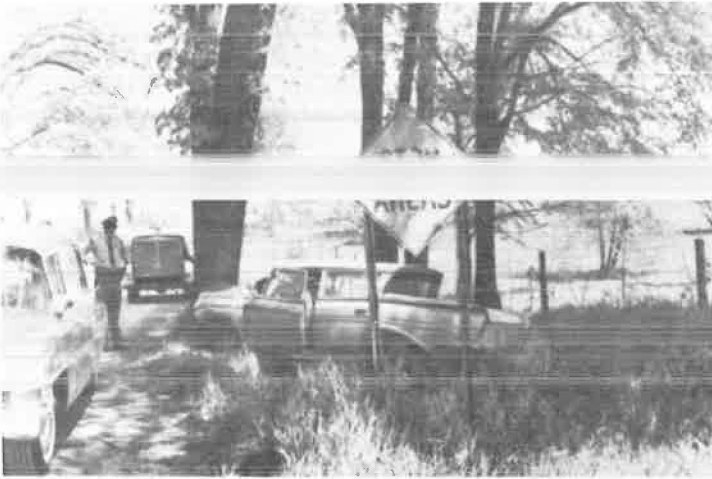
Figure 4. Photograph of car-tree impact.

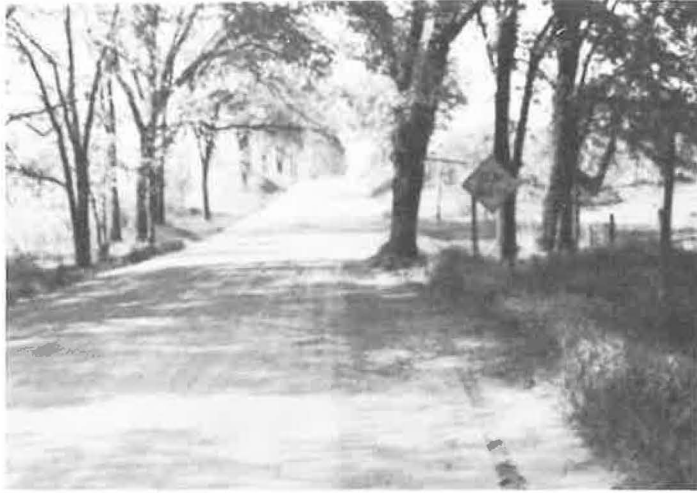
Figure 5. A tree in the road—the scene of accident shown in Figure 4. In Figure 20, this case was plotted at zero feet from road edge.

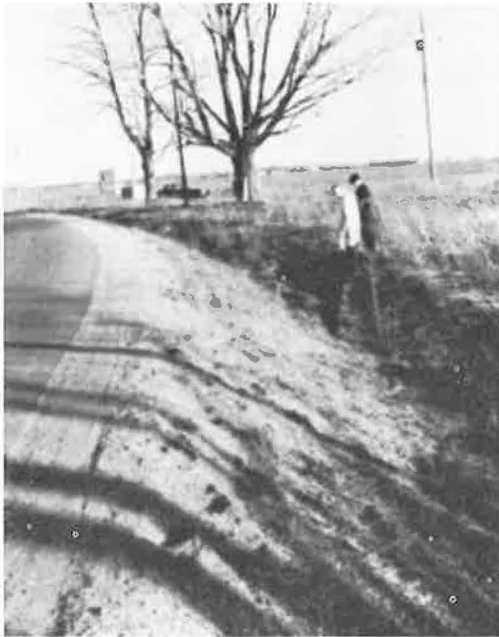
Figure 6. Deep ditch adjacent to road. Vehicle traversed ditch, flew 50 ft and impacted the roof, hood, and trunk against tree located 31 ft from roadside.

Improper ditch design led to at least eight fatal accidents in this study. Figure 6 illustrates a deep ditch adjacent to a curve in the road. The vehicle went off the roadway and traveled in the ditch some 30 ft. It then rocketed out the far side of the ditch and flew 50 ft through the air. The vehicle landed on its front end and, in the upright position, continued for 10 ft striking a tree with the roof, hood, and trunk, killing the driver. Here, two

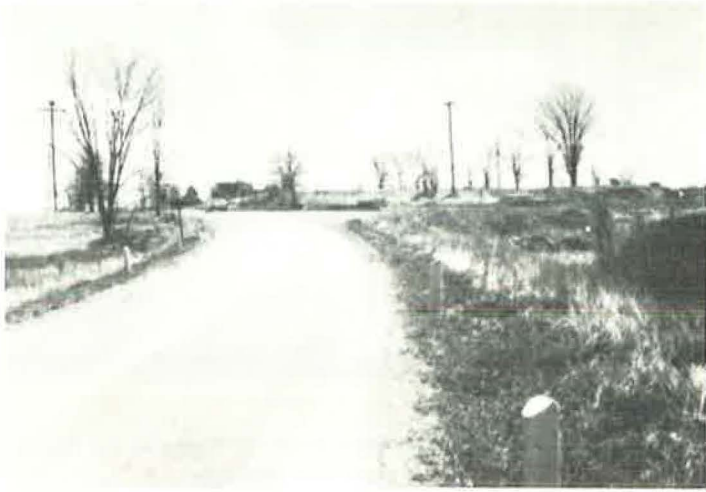
Figure 7. Vehicle "missed the curve" knocking down several guard posts and hit earth embankment in the distance. Proper guardrail design would have prevented a straight-on course to embankment which should have been removed. Impact point location 20 ft from road edge.

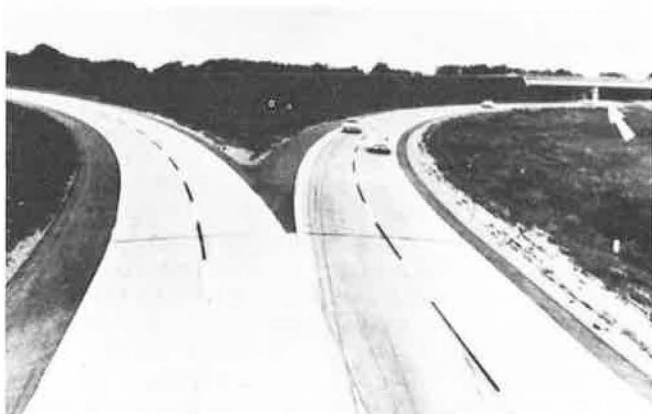
Figure 19. Area where vehicle traveling the wrong way on an expressway struck another car (arrow). Entrance ramp from which the driver turned toward on-coming traffic is on the left.

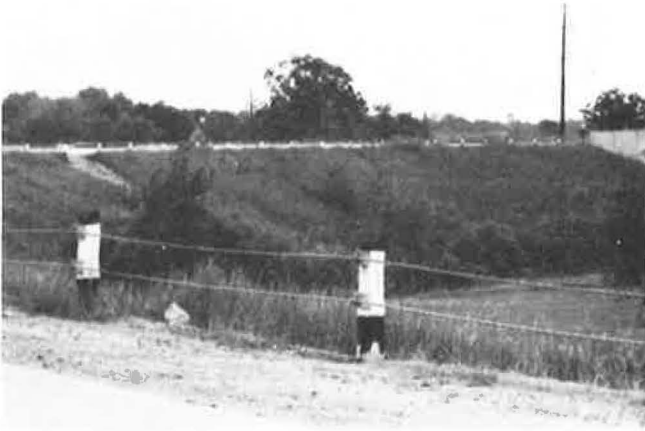
Figure 22. Steep slope and inadequate guardrail adjacent to expressway.

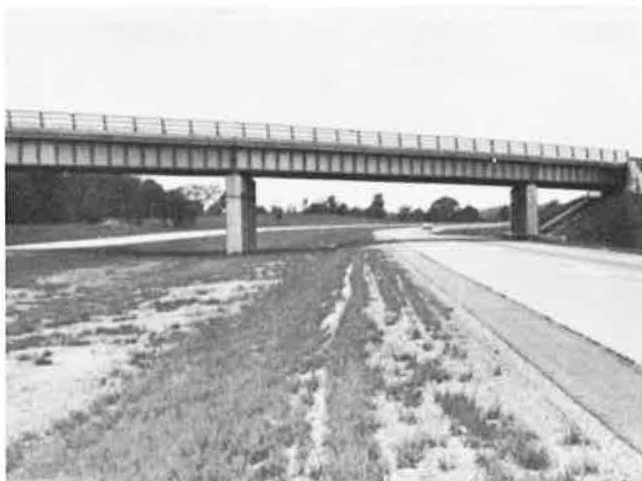
Figure 27. Unprotected bridge abutment—a definite hazard on expressways.

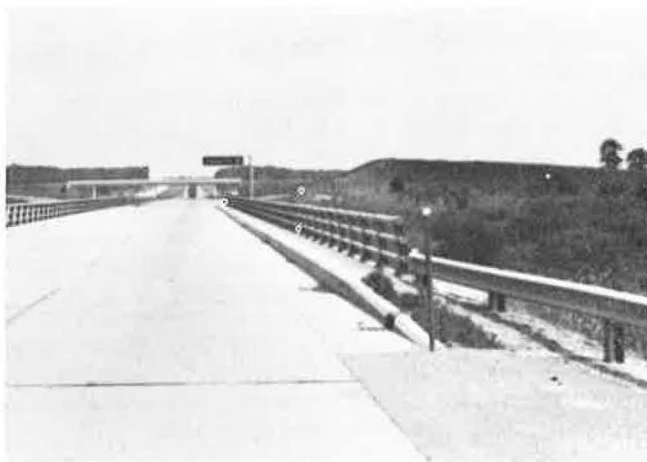
Figure 28. Typical bridge rail design with sidewalk.
