New Highway Barriers:

The Practical Application of Theoretical Design

MALCOLM D. GRAHAM, WILLIAM C. BURNETT, JOHN L. GIBSON, and
ROBERT H. FREER, Respectively, Director, Associate Civil Engineer, Senior
Civil Engineer, and Assistant Civil Engineer, New York State Department of
Public Works, Bureau of Physical Research

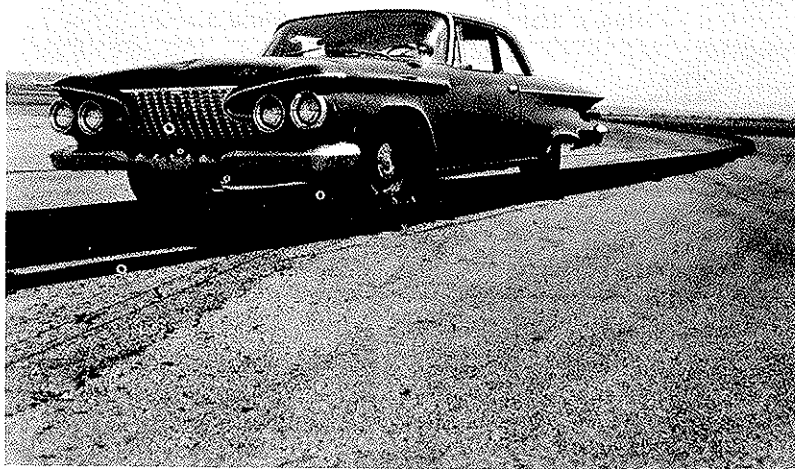
Figure 11. Test car in steel channel track.

Guide Track Control—In both radio-controlled cars and the tethered cars the remote driver tended to oversteer because he had no feel for the car motion. In Tests 20-48 precise control of angle of impact was desired. Therefore, the cars were guided by placing the wheels on one side in a long steel channel (track) nailed to the runway along the predetermined approach to the impact point (Fig. 11). The channel, connected in 40-ft sections, was easily moved for the next test. Signals for ignition cut-off and braking were transmitted through a tether cable by opening a single switch controlled by a man located in good view of the approaching car and the barrier.

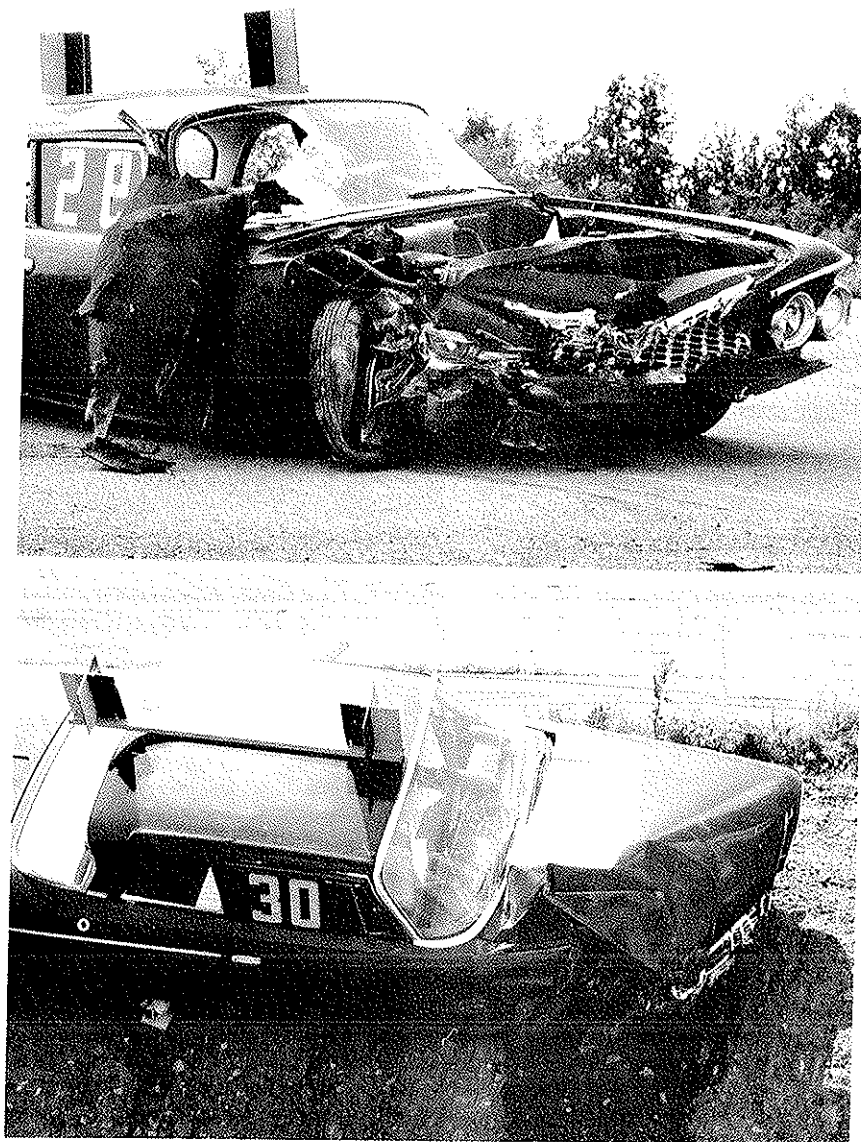
Figure 46. Vehicle damage, rigid bridge rails: top, after Test 29; bottom, after Test 30.

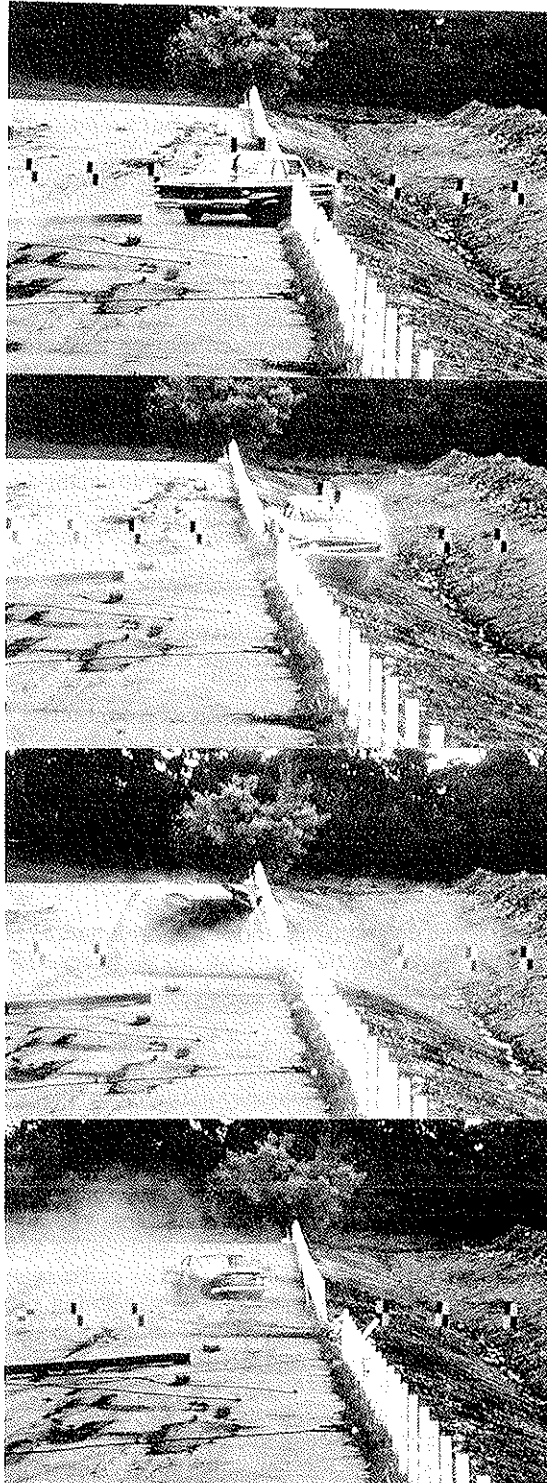
Average Deceleration:
During Highest Period
3.9 g's (0.05 sec.)
During Barrier Contact
2.0 g's (0.940 sec.)

Figure 64. Cable guide rail (Test 20).

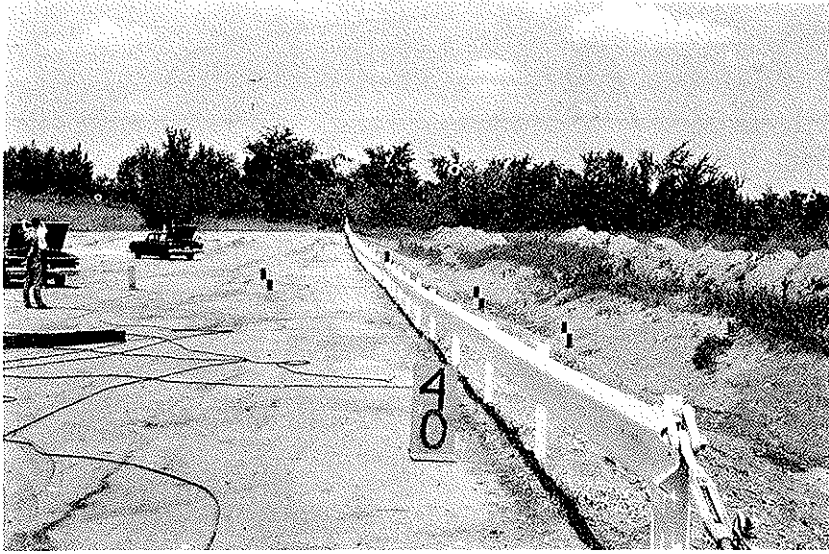
Figure 82. Barrier re-assembled after Test 39.

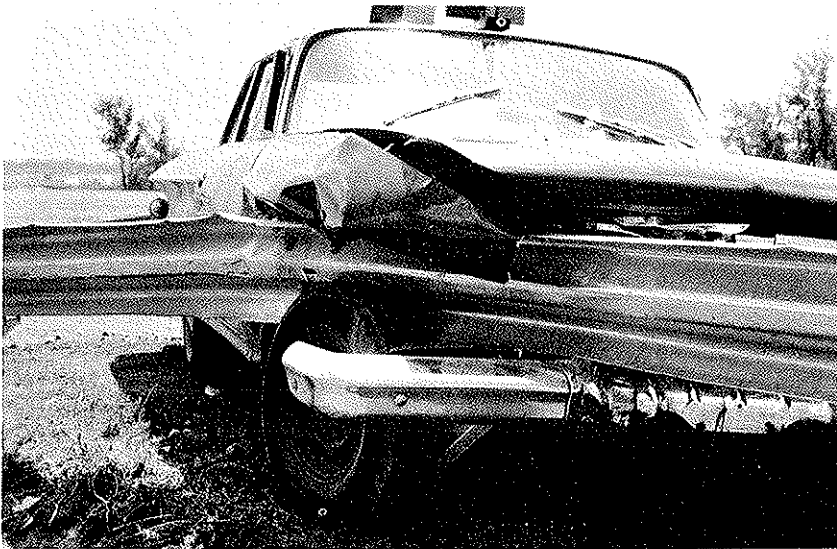
Figure 83. Car snagged on rail in Test 40.

The vehicle trajectories and decelerations for four tests are shown in Figures 77 through 80. In Test 38 (Fig. 77), a faulty end anchor failed and the test is not considered to be significant. There was no significant deceleration in Test 41 (Fig. 80). In Tests 39 and 41 the car was redirected but in Test 40 the car was redirected until the
