# Highway Design and Construction Problems Associated With the Loessial Soils Of West Tennessee

DAVID L. ROYSTER, Tennessee Department of Highways; and  
W. H. ROWAN, Vanderbilt University

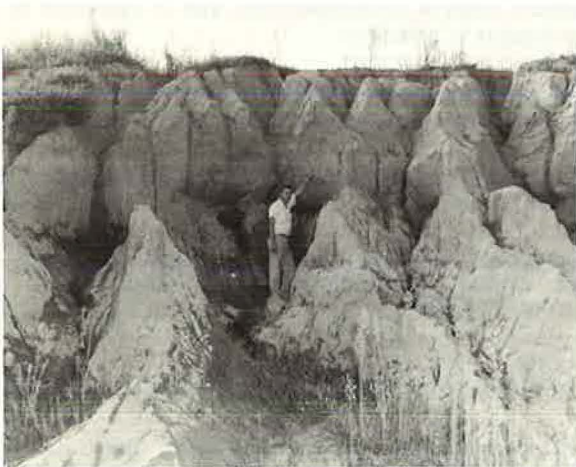
Figure 2. An example of the highly erosive nature of loess. These slopes had originally been constructed on a 2:1 slope ratio and had gone unattended for approximately 18 months.

In the last 2 years, the Tennessee Department of Highways has adopted a backslope design of 3:1 for loessial soils in rural areas. This particular slope was arrived at essentially as a compromise, resulting from a controversy as to whether near-vertical or conventional soil slopes were more desirable. In urban areas, backslopes of 2:1 with sodding are utilized. As in other states where highways are constructed through loess deposits, backslope erosion is a rather significant problem (Fig. 2). It is generally

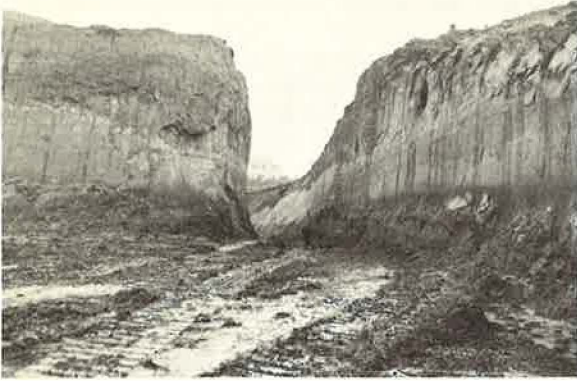
Figure 3. An example of a relatively stable vertical cut in loess. This particular cut is in a gravel pit in Tipton County. It is approximately 25 ft in depth.

believed by some in the department that since loess does possess the rather unusual characteristic of standing on very steep slopes, this inherent characteristic should be taken advantage of in many cases by constructing slopes with near-vertical faces (Figs. 3, 4). This belief is shared only by those persons in the department that are trained or experienced in soil engineering. Design and Construction personnel have maintained that conventional slopes ( $1\frac{1}{2}$ :1 to  $2\frac{1}{2}$ :1) are much more desirable, not only from an aesthetic viewpoint but for maximum stability as well. It is recognized that there is merit in both concepts; therefore, this paper will not attempt to delve into the details involved in either school of thought.

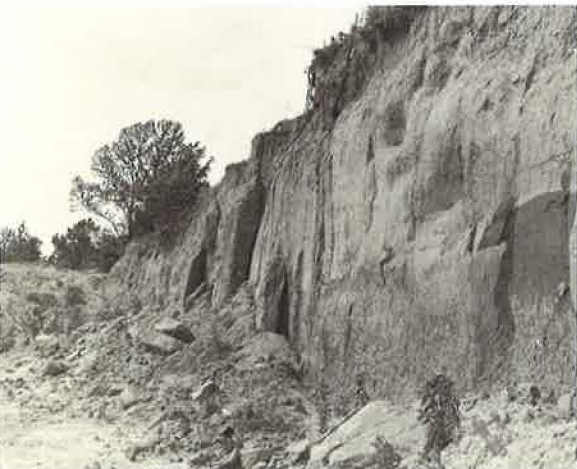
Figure 4. An example of "columnar slabbing" in loess in a gravel pit in Lauderdale County.
