Dynamic Tests of Steel Box Beam and Concrete Median Barriers

ERIC F. NORDLIN and ROBERT N. FIELD, Transportation Agency, Department of Public Works, California Division of Highways

A study to determine the effectiveness of (a) a steel box beam median barrier design developed by the New York Department of Public Works and (b) a concrete median barrier design developed by the New Jersey Highway Department, by means of full-scale dynamic impact tests is reported. Three tests were conducted on the basic New York 6 by 8 by $\frac{1}{4}$ -in. box beam design at speeds of 71, 64, and 49 mph and approach angles of 25, 25, and 7 deg, respectively, with slight modifications to the beam-to-post connections for each test. Three tests were conducted on the 32-in. high New Jersey concrete barrier design at speeds of 38, 65, and 63 mph and approach angles of 7, 7, and 25 deg, respectively.

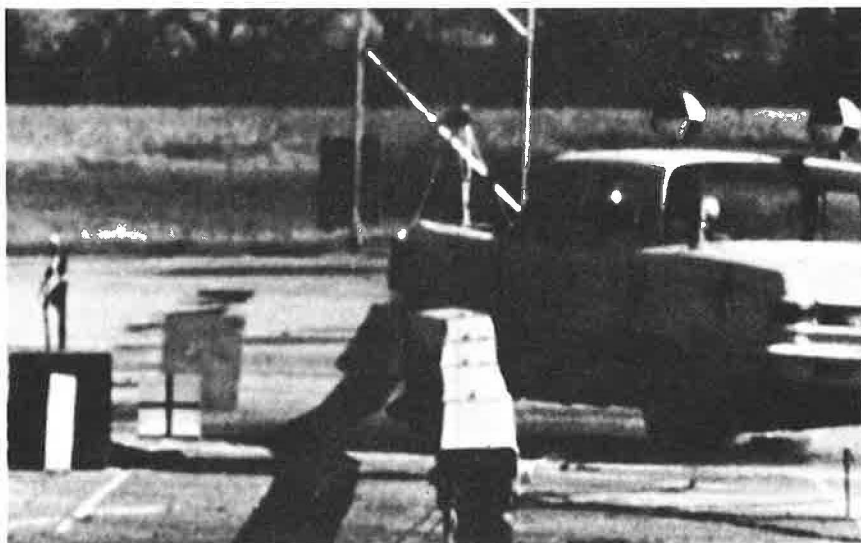
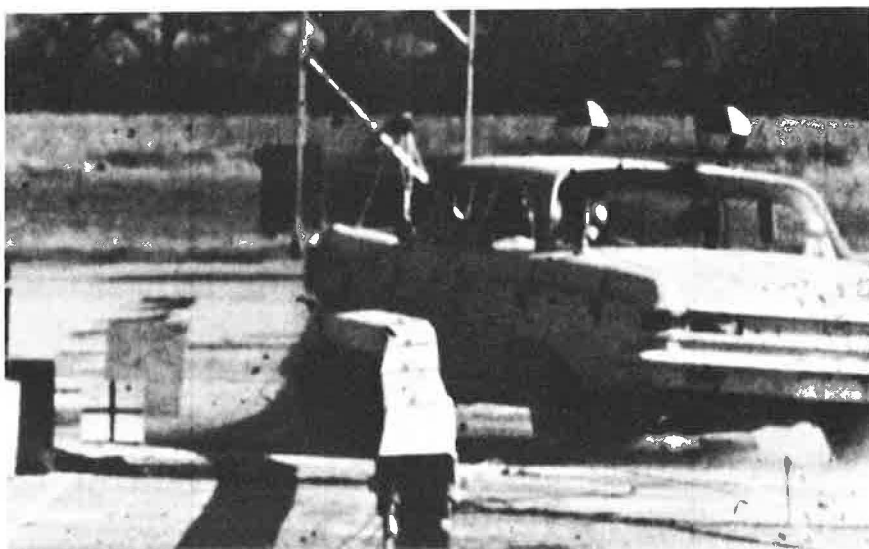
Figure 4. Impact + 0.075 sec.

were damaged during the impact and one post was pulled out of the socket. The paddles on posts that were contacted had damage that indicated they had snagged as they pulled out of the beam slot. The immediate entrapment of the left-front wheel with the first post contacted is shown in Figures 4 and 5.

Figure 5. Impact + 0.100 sec.

Past experience indicates that this wheel/post involvement is typical of most impacts on 27-in. high beam-type barriers that are not blocked-out, or barriers over 27 in. high that are not provided with a rubbing rail mounted below the beam. However, with this strong beam/weak post system, it was felt that the relatively light 315.7 posts did not affect the smooth progression of the vehicle through impact as would an 8 by 8-in. timber post or 6-in. steel H-post. Further review of the data films indicated that the

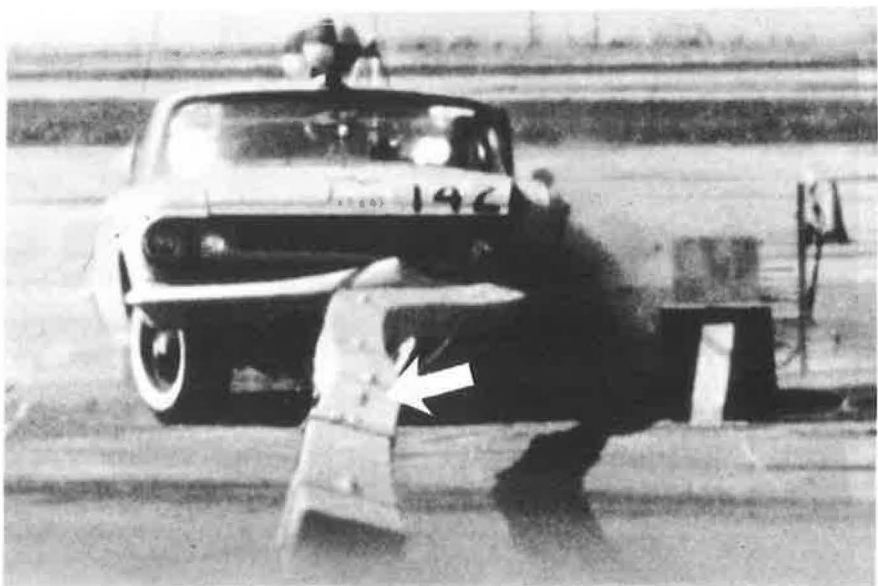
Figure 7. Impact + 0.225 sec.

All of the beam splice bolts (ASTM Designation: A307 steel) sustained some shear deformation and the top and bottom were sheared completely off one bolt. Figure 7 shows the head of the splice bolt and the washer just after shearing. This failure occurred

at the time of maximum dynamic deflection and is a good example of the magnitude of the tensile forces that can be transmitted a considerable distance downstream as well as upstream from impact on any tension barrier system such as the box beam barrier.

This splice bolt failure had no appreciable effect on the overall performance of the barrier as the vehicle had almost been redirected and maximum dynamic deflection had occurred. However, rather than chance a splice bolt failure affecting the results of succeeding tests, the A307 bolts were replaced with high-strength bolts.

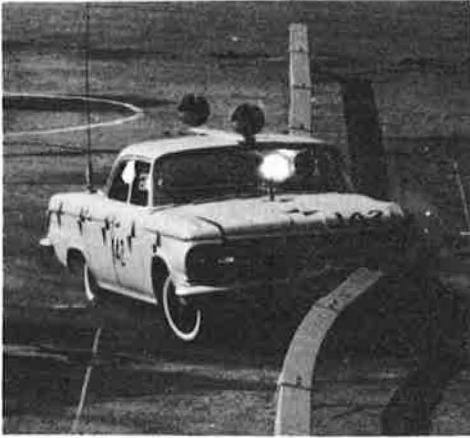
TEST 142. PLATE A.

t + .160 sec.

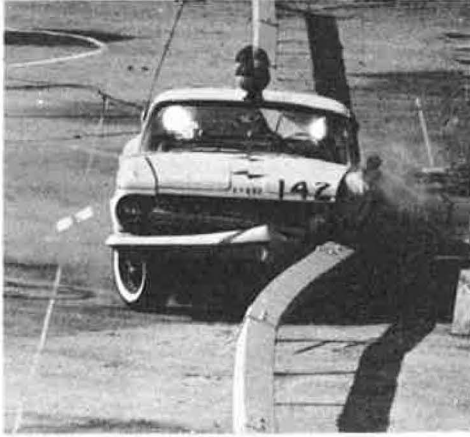
t + .255 sec.

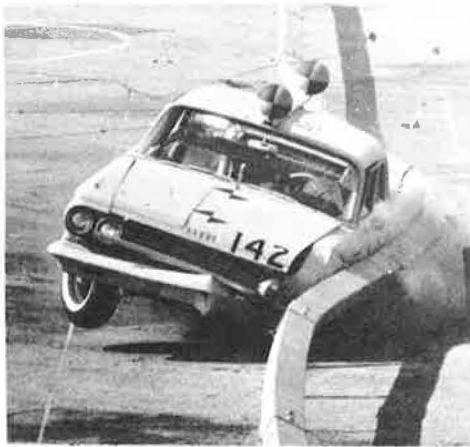
BEAM.....	6" x 8" x 1/4" x 17'-11 1/2" Steel Tube	TEST NO.	142
SPLICE.....	6 5/8" x 8 5/8" x 1/4" x 24" Steel	DATE.....	3-3-66
POST.....	3" ± 5.7 # x 36"	VEHICLE.....	1964 Dodge Sedan
POST SPACING.....	6'-0"	VEHICLE WEIGHT.....	4540#
POST EMBEDMENT.....	16"	(WITH DUMMY & INSTRUMENTATION)	
FOOTING.....	16" dia. x 17" Cl. "A" Conc.	IMPACT SPEED.....	64 mph
LENGTH OF INSTALLATION.....	201'	IMPACT ANGLE.....	25°
BEAM DEFLECTION - MAXIMUM.....	4.05'	EXIT ANGLE.....	6°
BEAM DEFLECTION - PERMANENT.....	2.35'	DUMMY RESTRAINT.....	Lap Belt

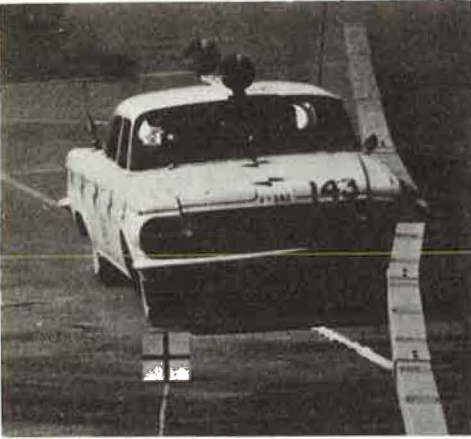
TEST 143. PLATE A.

I + .150 sec.

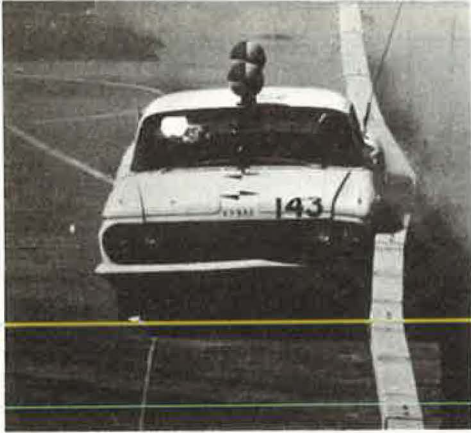
I + 340 sec.

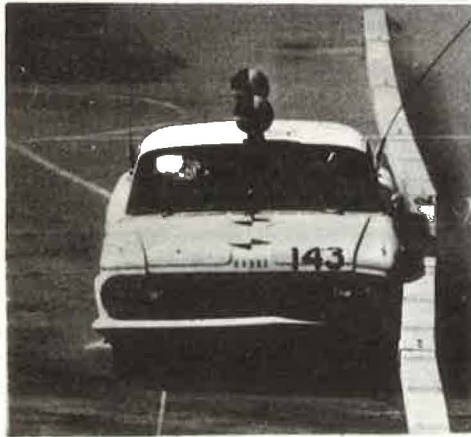
I + .430 sec.

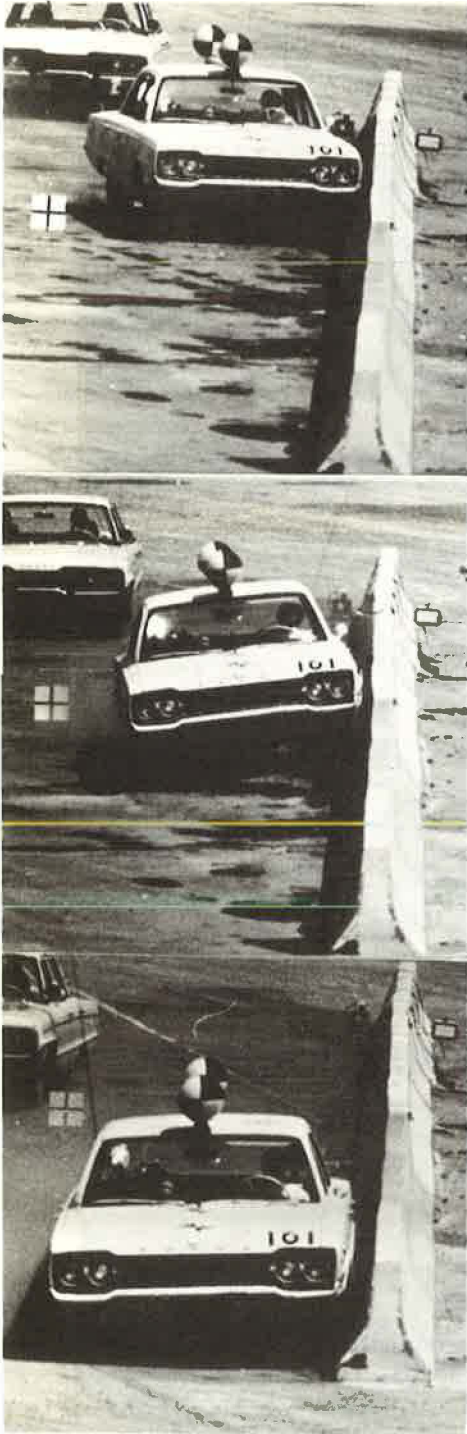
TEST 161-A. PLATE A.

BARRIER.....	Unreinforced Concrete	TEST NO.	161-A
LENGTH OF INSTALLATION.....	150 ft.	DATE	5-4-67
UNIT LENGTH.....	20 ft.	VEHICLE	1965 Dodge sedan
UNIT WEIGHT.....	13,200 #	VEHICLE WEIGHT	4540 #
GROUND CONDITION.....	Dry	(W/DUMMY AND INSTRUMENTATION)	
CONTACT W/BARRIER.....	.95'	IMPACT SPEED.....	38 mph
MAX. VEHICLE CLIMB.....	8"	IMPACT ANGLE.....	7°
MAX. VEHICLE REBOUND.....	0	EXIT ANGLE.....	0°

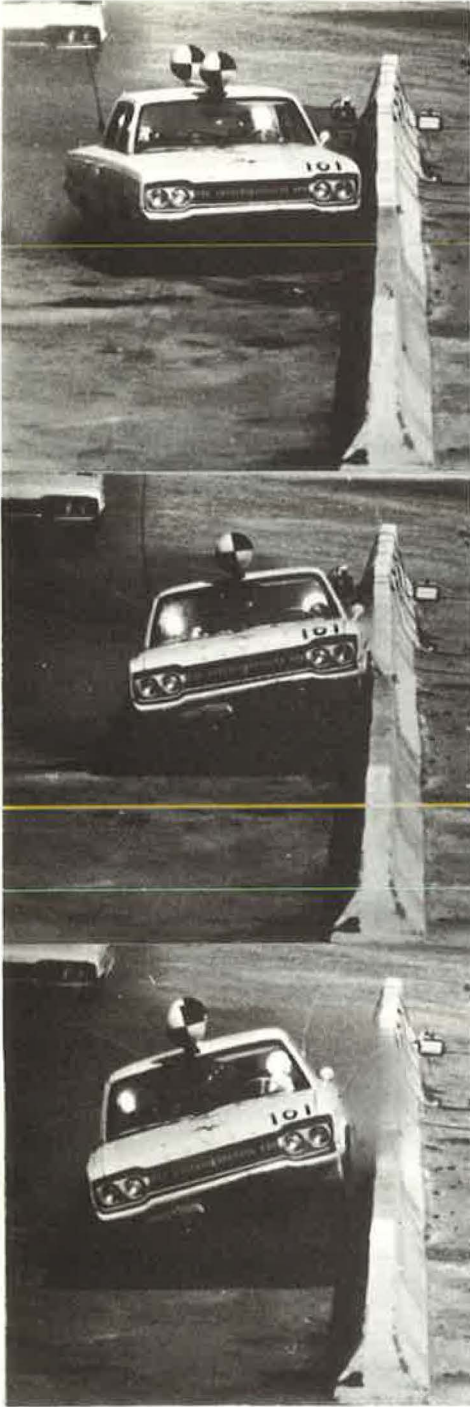
TEST 161-B. PLATE A.

BARRIER	Unreinforced Concrete	TEST NO.	161-B
LENGTH OF INSTALLATION	160 ft.	DATE	5-4-67
UNIT LENGTH	20 ft.	VEHICLE	1965 Dodge sedan
UNIT WEIGHT	13,200 #	VEHICLE WEIGHT	4540 #
GROUND CONDITION	Dry	(W/DUMMY AND INSTRUMENTATION)	
CONTACT W/BARRIER	35'	IMPACT SPEED	65 mph
MAX. VEHICLE CLIMB	.14"	IMPACT ANGLE	.7°
MAX. VEHICLE REBOUND	.14"	EXIT ANGLE	1°

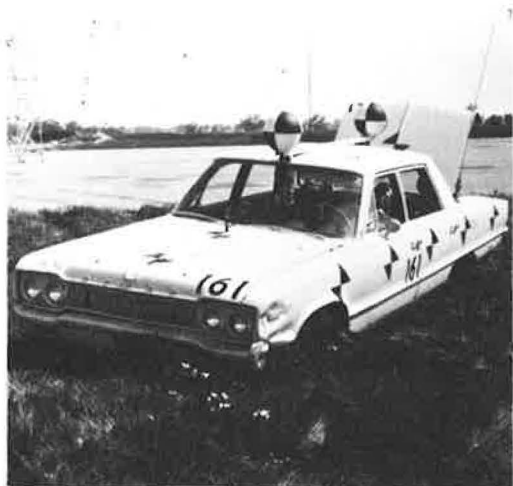
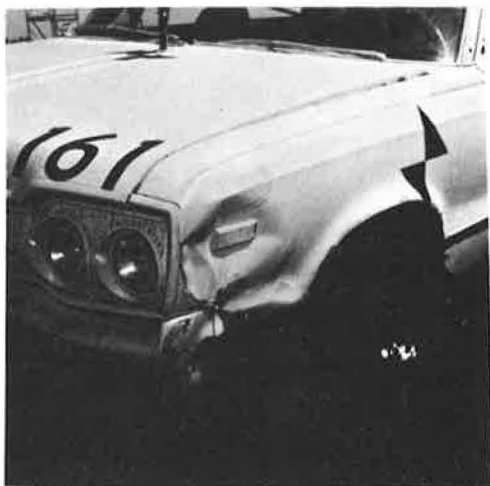
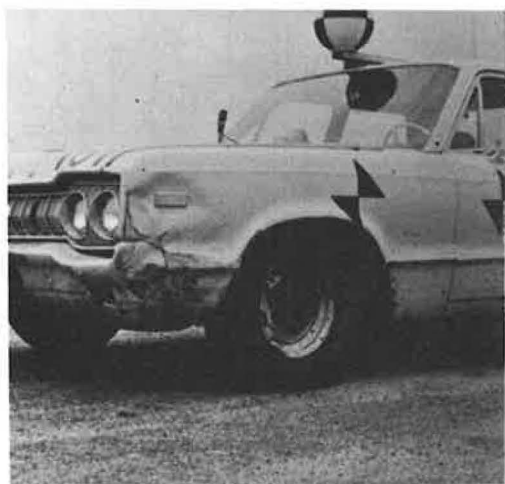
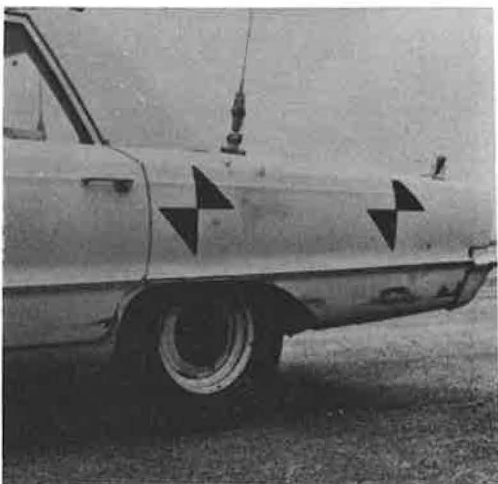
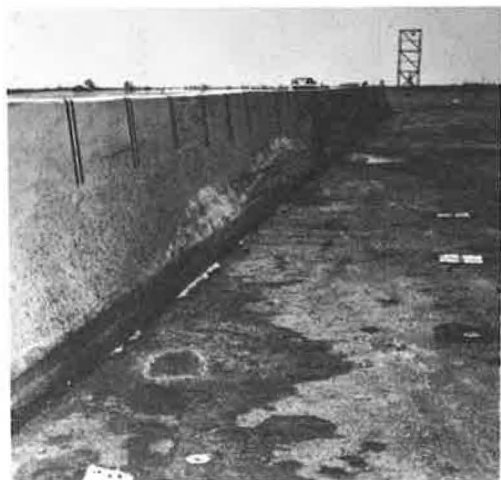
TEST 161-B. PLATE B.

Within 7.5 ft of initial contact, the impacting wheel had climbed 14 in. up the sloping lower face. It remained approximately at this height for an additional 17.5 ft before rebounding away from the barrier. The vehicle did not make contact with the barrier again. However, it was yawing toward the barrier through impact and would have re-established contact had the barrier installation been longer. Application of the brakes caused the vehicle to veer to the right in a sweeping curve away from the barrier.

The vehicle body contacted the upper portion of the parapet at initial impact and for a distance of 12.5 ft. Vehicle damage consisted of minor sheet metal damage to the front fender, a dented bumper, and scratched paint at the left-rear door and quarter panel. The left-front wheel was bent and required replacement. No damage to the steering mechanism or running gear was found, and this vehicle was used with no further repairs for the succeeding test.

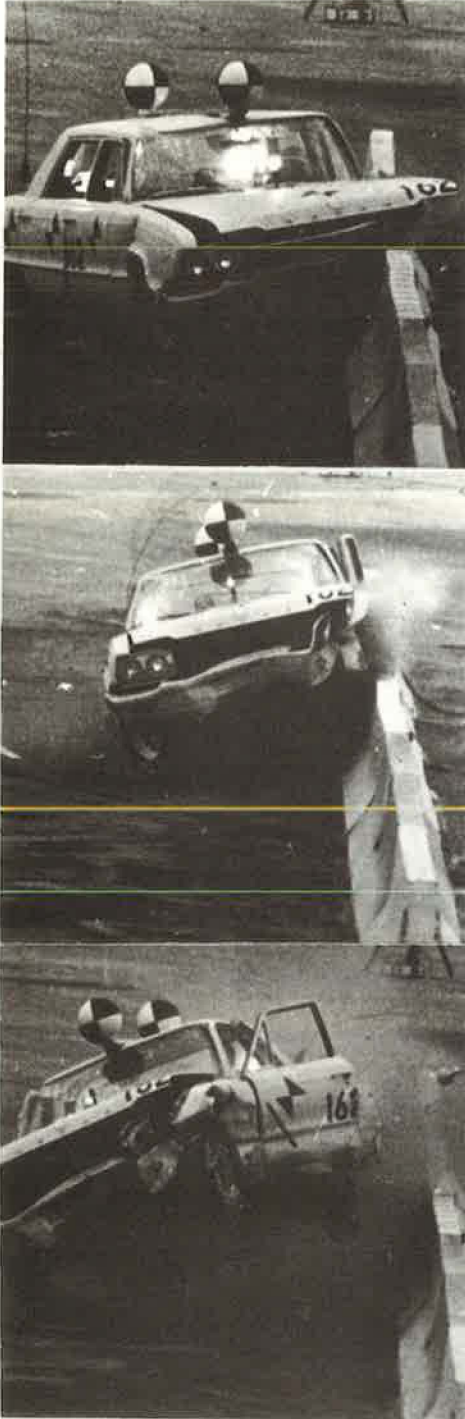
TEST 162. PLATE A.

BARRIER.....	Unreinforced Concrete	TEST NO.	162
LENGTH OF INSTALLATION.....	160 ft.	DATE	5-9-67
UNIT LENGTH.....	20 ft.	VEHICLE.....	1965 Dodge sedan
UNIT WEIGHT.....	13,200 #	VEHICLE WEIGHT.....	4540 #
GROUND CONDITION.....	Dry	(W/DUMMY AND INSTRUMENTATION)	
CONTACT W/BARRIER.....	12.5'	IMPACT SPEED.....	63 mph
MAX. VEHICLE CLIMB.....	.21"	IMPACT ANGLE.....	25°
MAX. VEHICLE REBOUND.....	9.0'	EXIT ANGLE.....	16°

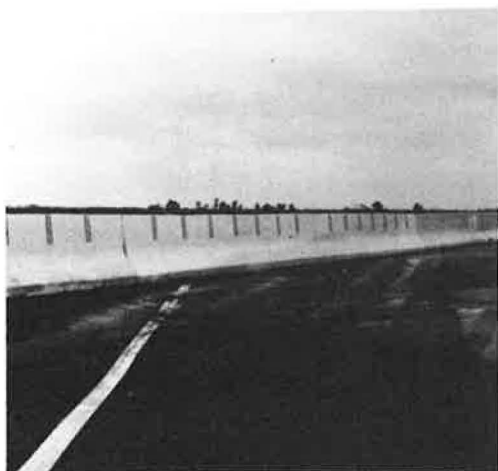
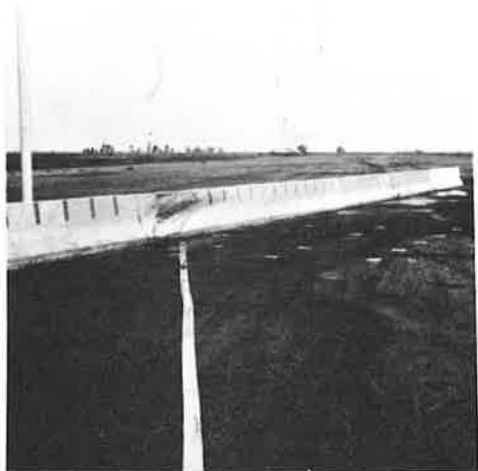
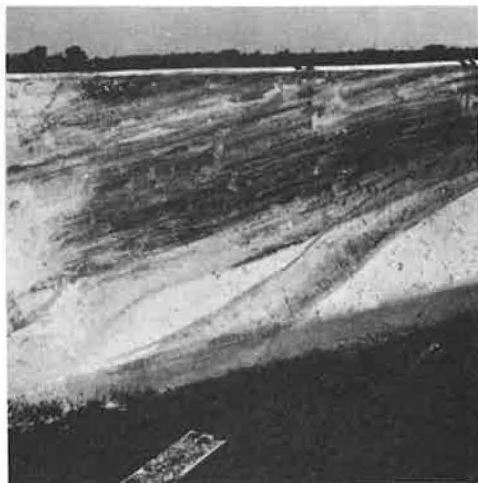
TEST 162. PLATE B.

The vehicle body contacted the barrier immediately at initial impact and for a distance of 12 ft. As the vehicle was redirected parallel to and away from the barrier, moderate damage was sustained by the left-front quarter panel and rear bumper, with minor scratches of the paint along the left side. The left-front-end sheet metal and undercarriage were damaged severely.

The barrier sustained no damage other than very slight spalling of concrete at the expansion joint immediately adjacent to the point of impact.
