# Factors Affecting the Durability of Concrete Bridge Decks

## Phase I: Construction Practices

C. F. STEWART and B. F. NEAL, California Division of Highways

Construction history was recorded on 28 concrete bridge deck placements incorporating planned variations in concrete slump, strike-off machine, finishing, texturing and curing.

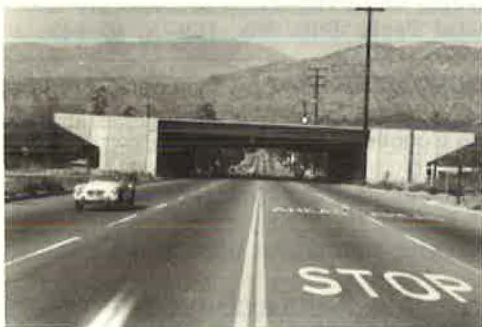
Figure 1. Typical structure.

The structures vary in length from 60 to 91 ft (Fig. 1) and in width from 146 to 170 ft. The excessive width necessitated each deck being placed in 4 separate units. This resulted in 28 placements available for study.

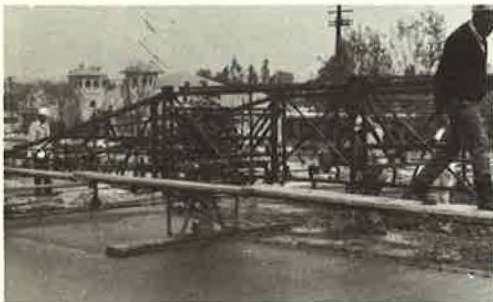
Figure 3. Bidwell strike-off machine.

The Bidwell strike-off machine (Fig. 3) was adopted as a control machine. Others included: Trueline (Fig. 4), Borges (Fig. 5), and Clarey (Fig. 6).

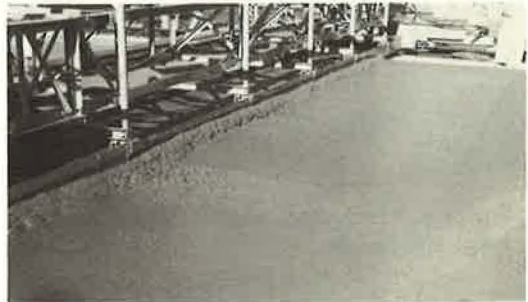
Figure 4. Trueline strike-off machine.

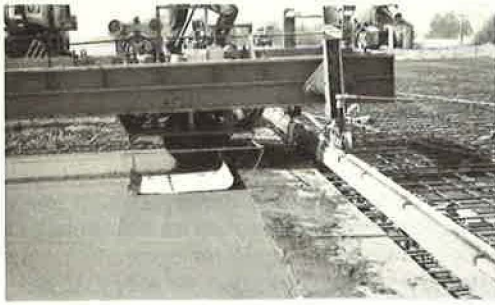
Figure 5. Borges strike-off machine.

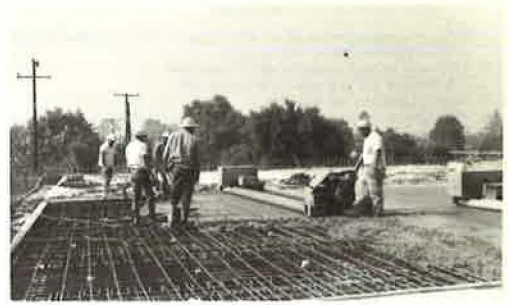
Figure 6. Clarey strike-off machine.

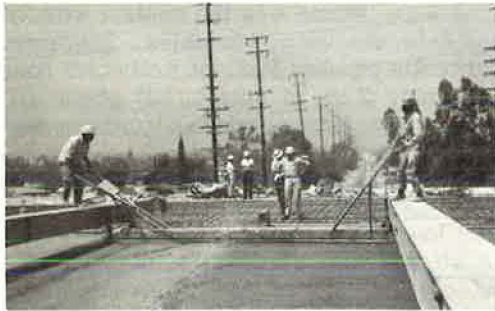
Figure 7. Sixteen-foot longitudinal plow handle float.

The control finishing float was a wooden 16-ft longitudinal plow handle float (Fig. 7) applied approximately 45 min behind the strike-off machine. Variables included one floating as close behind the strike-off machine as possible, one floating as late as the workability of the concrete would permit, and a combination of both an early and late floating, all with the wooden float; floating at the standard time with two 6-in. diameter, 10-ft long aluminum pipes in tandem (Fig. 8); and floating at the standard time with a single 4-in. diameter 10-ft long aluminum pipe equipped with a handle for full floating control (Fig. 9). All floating was transversely applied.

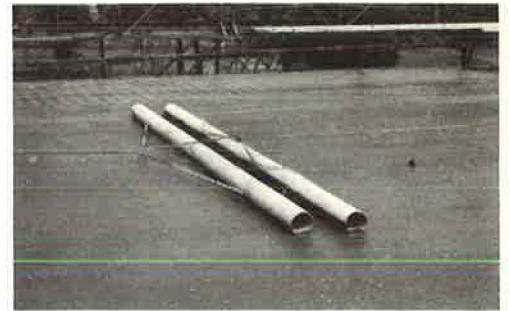
Figure 8. Aluminum pipes (6-in. diameter, 10 ft long) float in tandem.

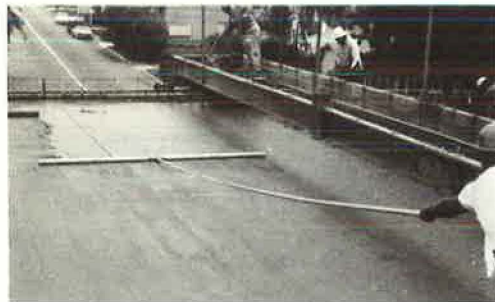
Figure 9. Aluminum float (4-in. diameter, 10 ft long) with handle.

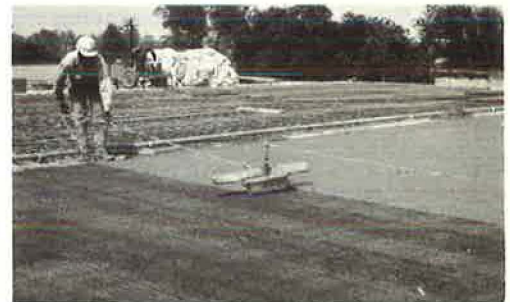
Figure 10. Surface texturing with stiff bristle broom.

The standard texturing was achieved with a stiff bristle broom (Fig. 10). The texturing variables were burlap drag (Fig. 11) and natural texturing by the longitudinal wooden float (Fig. 12). All texturing was transversely applied.

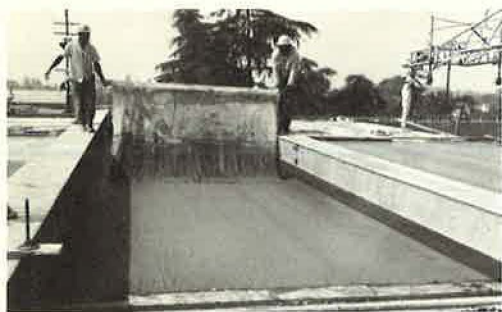
Figure 11. Surface texturing with burlap drag.

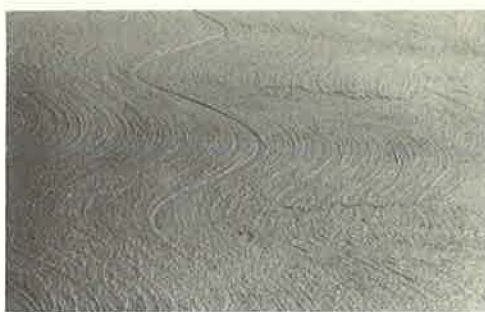
Figure 12. Natural texturing by longitudinal wooden float.

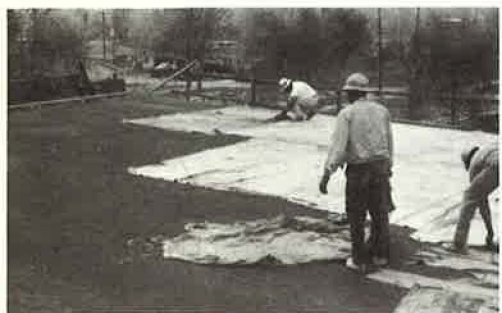
Figure 13. Placing rugs for a wet rug cure.

The standard 7-day cure was provided by wet rugs (Fig. 13) with variations of delayed cures and liquid membrane-type curing compounds (Fig. 14). The membrane cures were supplemented with the wet rugs the day after the cure began. A monomolecular film evaporation retarder was used on 4 placements before the standard cure.

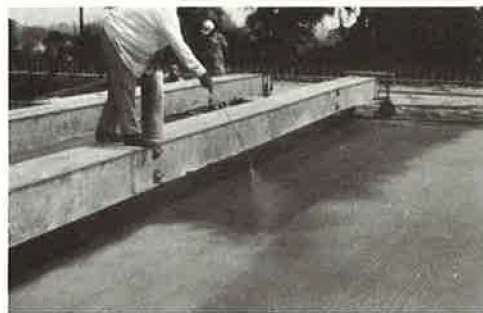
Figure 14. Applying liquid membrane-type curing compound.

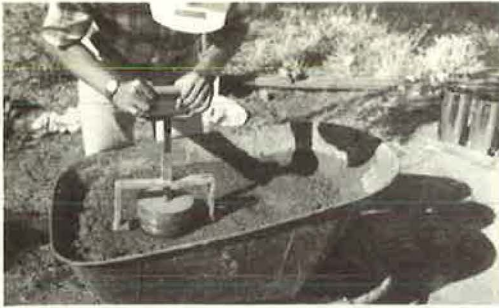
Figure 15. Measuring concrete slump with a Kelly ball.

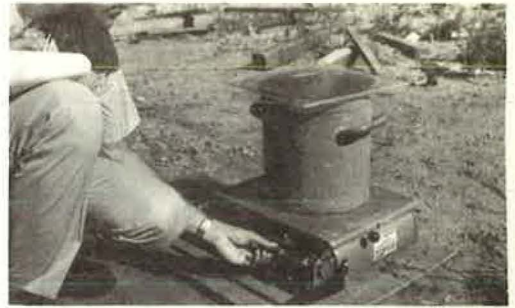
Figure 16. Making unit weight test.

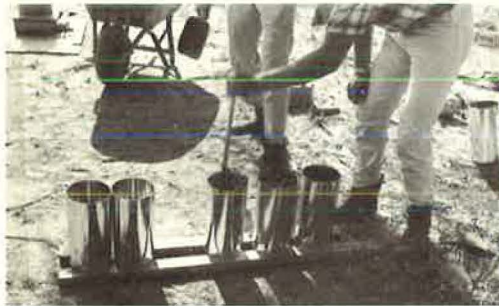
Figure 17. Fabricating concrete cylinder test samples.

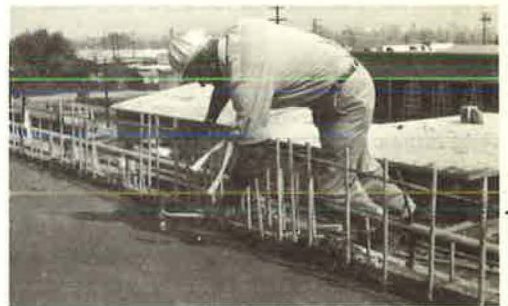
Figure 18. Placing grid reference points.

During each placement, a minimum of 7 men were engaged in either collecting data or assisting in maintaining construction control. Two men at the batch plant checked the batch proportions, obtained cement and aggregate samples, and recorded the quantity of water added to the mix from cleaning operations. One man at the job site controlled the water added to produce the desired slump, recorded slump (Fig. 15) and concrete temperature measurements, made unit weight tests (Fig. 16), and fabricated test specimens (Fig. 17). Two men conducted normal inspection duties, coordinated control of operational timing variables, and placed grid reference points in the finished concrete (Fig. 18).

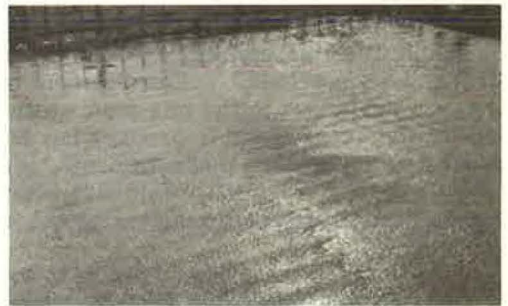
Figure 20. Excessive bleed water.

Visual evaluation of the properties and behavior of the fresh concrete did not always agree with the consistency as determined by Kelly ball "slump." Certain batches of concrete appeared extremely fluid when discharged from the placing bucket onto the deck forms. Other batches exhibited a large amount of free water at the front of the placing and finishing operation. In spite of this, slump recorded for these batches is about 4 in. No explanation for this anomaly is apparent; however, it is believed that variation in aggregate gradation or caliber of slump measurements could be factors.

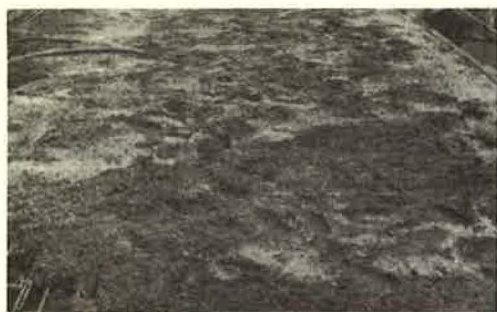
Figure 21. Excessive walking in the fresh concrete.

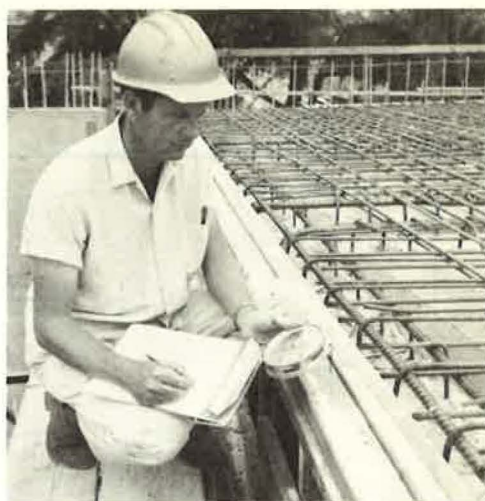
Figure 22. Recording climatological data.

1. Condition of forms, support and tying of reinforcing steel, and depth of cover over the steel.
2. The in-place location of each batch of concrete (Fig. 19).
3. A time history on each batch of concrete: total batch time, and the time when each batch was placed in the deck, vibrated, struck-off, finished, textured, and cured; also, the number of passes made by the strike-off machine and finish float was recorded.
4. Irregularities, such as over or under vibration, excessive bleed water areas (Fig. 20), premature drying areas, and areas where excessive walking in the fresh concrete occurred (Fig. 21).
5. Weather history of temperature, humidity, wind direction and velocity, and rate of evaporation (Fig. 22).

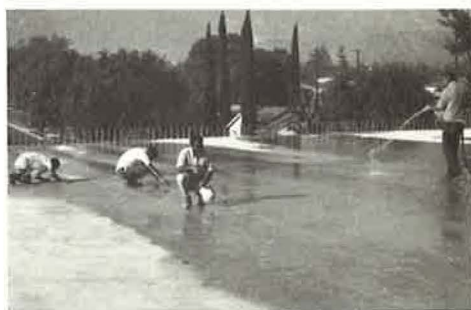
Figure 26. Conducting a deck crack survey.

Two crack surveys have been made: initial and pre-traffic. Age of the concrete varied from 21 to 202 days for the initial and from 295 to 492 for the pre-traffic. For each survey, the deck was thoroughly washed (Fig. 26), and a 4-man team systematically examined the deck for cracks. As cracks were found, a keel mark was placed alongside them. The larger ones were measured and coded according to their width. The location and width of each was later indicated on the respective grid sheet.
