HIGHWAY RESEARCH RECORD

Number 227

Snow
and
Ice Control

CORROSION OF AUTO-BODY STEEL AND THE EFFECTS OF INHIBITED DEICING SALTS

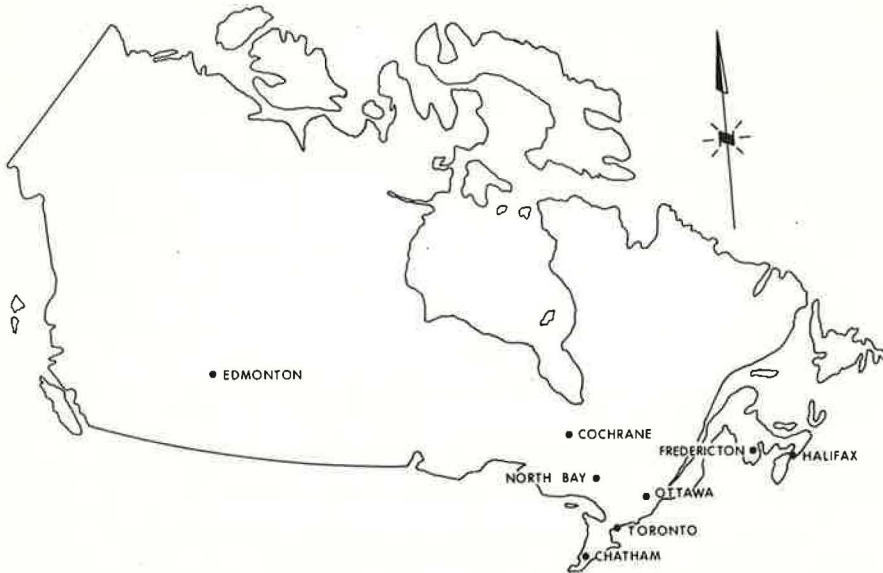
Figure 1. Vehicle and atmospheric test locations.

Phase 1: Vehicle Tests—Phase 1 was designed to determine the amount of corrosion to unprotected auto-body steel fitted to vehicles traveling on highways in eight representative areas of Canada (Fig. 1). The five Ontario areas were chosen to obtain results that were representative of conditions throughout the Province (they would also be applicable to the major part of Canada and a large part of the northern United States). The three areas outside of Ontario were included so that the results obtained would be representative of all of Canada and the northern United States. Although each area is designated by the major city or town, the test vehicles (light maintenance trucks or station wagons) ran largely on the highways of the particular area.

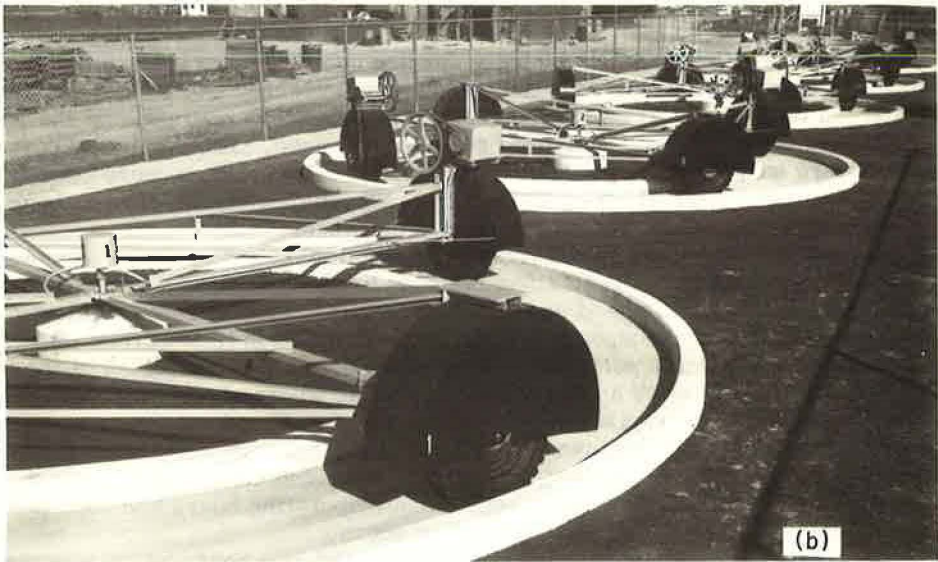
Figure 9. The traffic simulators (test rigs) showing (a) drive mechanism and (b) wheelpaths.

The test rigs were driven by electric motors mounted on two of the four wheels of each test rig and the power was transmitted to the wheels by a belt reduction drive (Fig. 9a). The wheels ran in three paths (Fig. 9b); wheel 1 ran in the outermost track; wheels 2 and 4, the drive wheels, ran in the center path while wheel 3 ran in the innermost path. This arrangement helped to move the snow back and forth and mix in the deicant in much the same way as traffic does on the highway. Later in the first winter, scrapers were added behind each wheel to assist further in mixing the snow and, in the interest of safety, guardrails were built around each track. These features are shown in the winter photographs in Figure 10. The building, shown at the right of Figure 9a, housed the automatic electrical controls for the test rigs and was also used as a small laboratory where the exposed coupons were cleaned and analyzed.

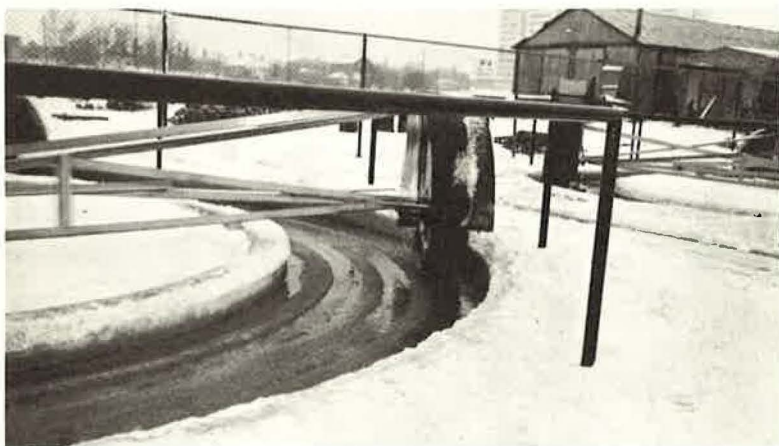
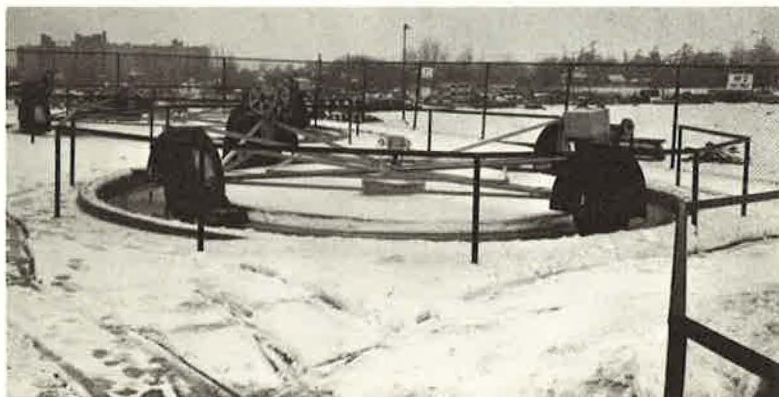
Figure 10. Views of traffic simulators in winter.

Each wheel of the test rigs was designed to contain 40 pairs of coupons (one flat and one crevice per pair) mounted beneath the fender (see Fig. 10). This was to minimize variations so that at each coupon withdrawal two coupon pairs could be taken from each fender, making a total of 8 pairs withdrawn from each test rig at every withdrawal period. It was expected that the average of 8 coupons of each type would result in smoother cumulative corrosion curves.

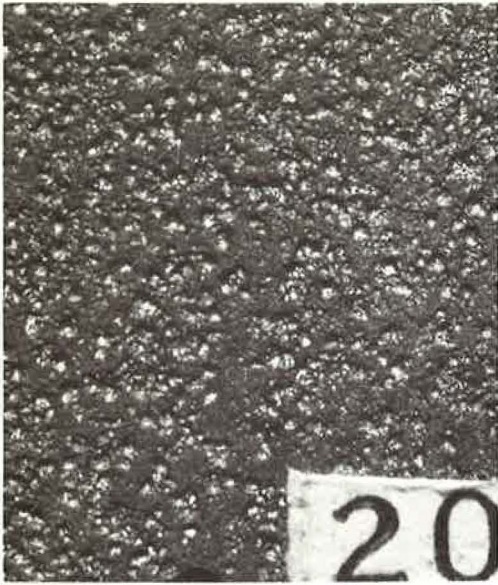
Figure 37. Example of light pitting in exposed portion of coupon—coupon exposed for 12 months in Test Rig No. 2.

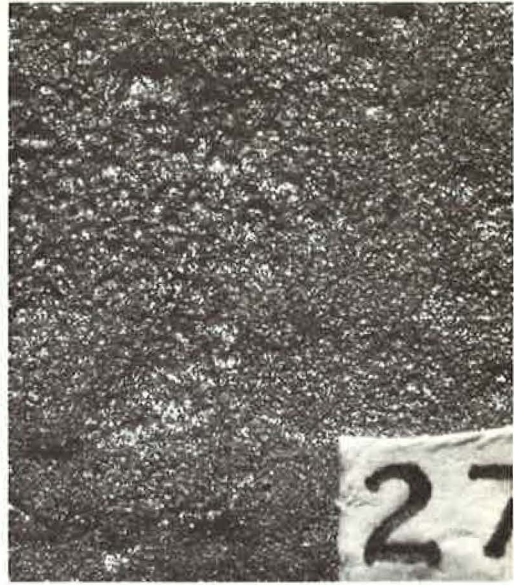
Figure 38. Example of deep pitting beneath protective lacquer—coupon exposed for 12 months on a test vehicle.

One of the deep pits which occurred under the lacquer in the vehicle corrosion test coupons is shown in Figure 38, taken after the coupon had been chemically cleaned. The pitted area is in the upper left-hand portion. The actual size of the pit diameters

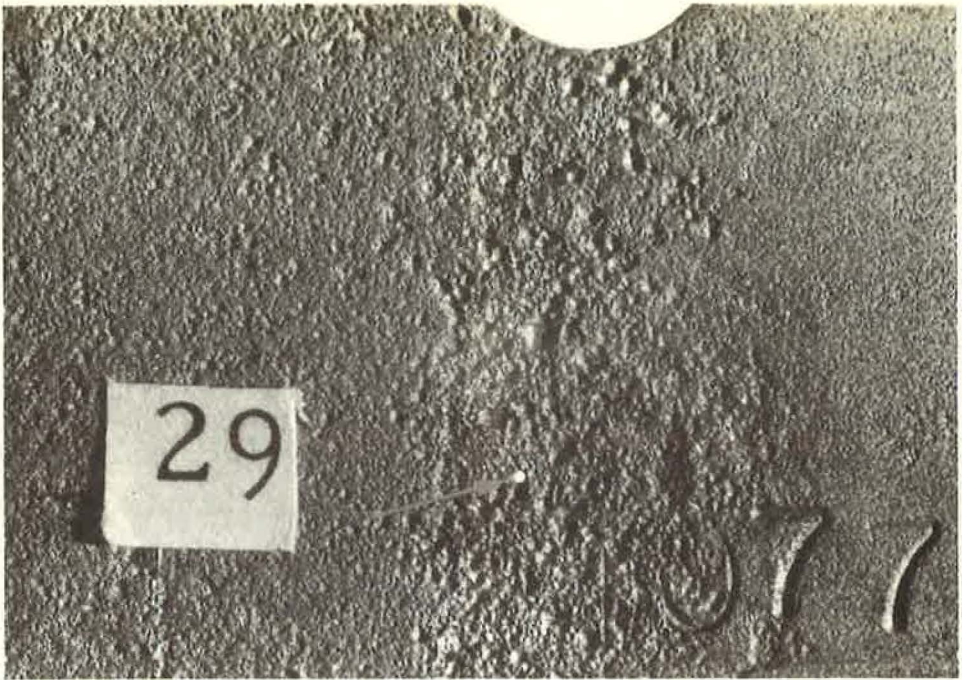
Figure 39. Example of deeply pitted area beneath protective lacquer, showing actual perforation—coupon exposed for 19 months in Test Rig No. 5.

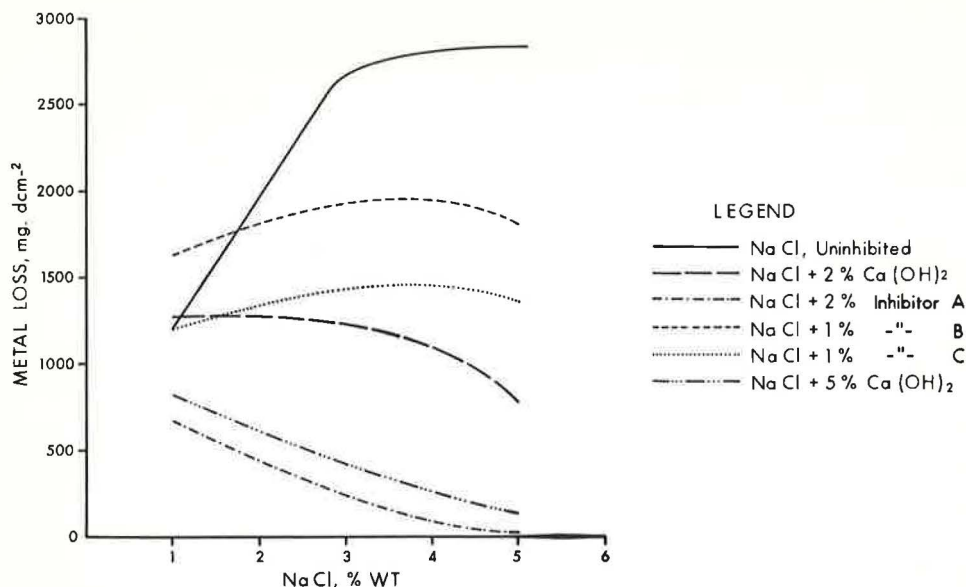
Figure 42. Results of third Dip-Dry test (7 Days at 70 F).

The next Dip-Dry test involved testing the same inhibitors again (dichromate omitted) at double the previous concentrations and also omitting the 10 percent salt concentration. Before this test was run, a new corrosion inhibitor was proposed. This material was crude calcium hydroxide extracted from residues obtained in the manufacture of acetylene. This material was proposed for use at a very high concentration which would have proved uneconomical. Technical grade calcium hydroxide was included in the test at two concentrations (2 and 5 percent) to represent this material. The results are shown in Figure 42 for 70 F and in Figure 43 for 32 F.

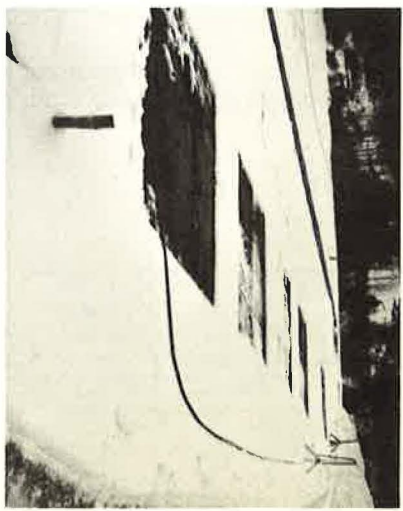
Figure 4. Test area following a 2 1/2-in. snowfall (December 13, 1965); 1 #2 test section is in foreground, and reading to right are the 1 #6, 1 #2, 1 #6, #6, (snow covered) and #10 sections.
