The Safety Factor in Excavations and Foundations

GEORGE F. SOWERS, Senior Vice President, Law Engineering Testing Company, Atlanta, and Regents Professor of Civil Engineering, Georgia Institute of Technology

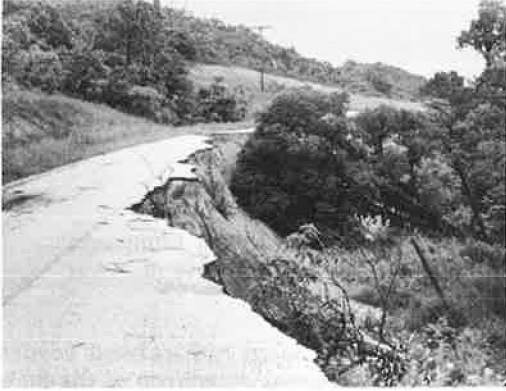
After several years of satisfactory performance with no indications of distress, the embankment suddenly failed (Fig. 1). The failure was the result of a chain of circumstances. Debris, from cutting undergrowth nearby, was eroded from the steep slopes of the ravine, and it accumulated at the culvert entrance. The embankment with its clogged culvert became a dam with water ponded behind it. The soil in the embankment became saturated, a condition that was never anticipated in the original design. The continuing saturation and seepage through the embankment weakened the soil enough so that a shear failure developed on the downhill side. More than half of the road was taken by this failure.

Figure 1. Slide of a highway embankment weakened by saturation caused by a clogged culvert.

The complex nature of the safety factor can only be understood by considering all the technical components that are involved. Essentially, it is a technical measure of the unknown or, in less elegant terms, of the ignorance of the designer. The most important of the components that influence the safety factor are listed in Table 1. The site conditions are among the most difficult components to evaluate quantitatively because of the extremely complex nature of the soils, rock, and groundwater conditions. Moreover, these site conditions are dynamic, changing with the seasons, and even changing as a result of the new construction. The saturation of the embankment in Figure 1 is an example of an environmental change that led to failure.

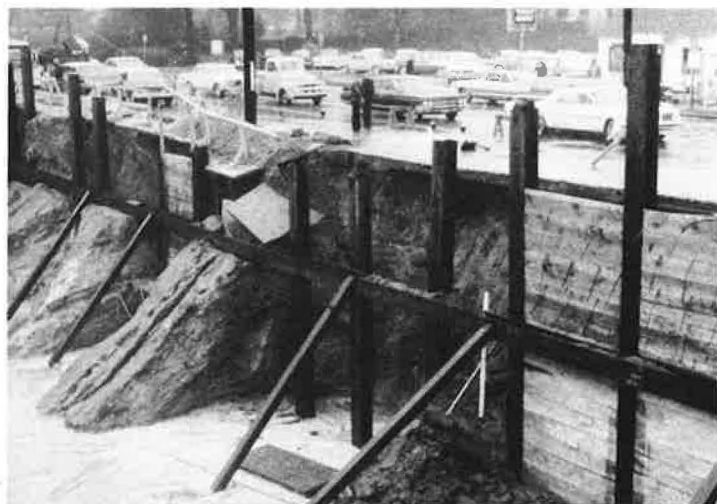
As stated, the immediate system consists of the soil and the structure directly involved in the project. Failure can occur independently in the soil, the structure, or in both. In a deep excavation for an office building, the bracing structure that supported the soil was properly designed and did not suffer damage, although the soil failed and nearly disrupted the entire system (Fig. 2). The bracing consisted of vertical H-piles acting as soldier beams, with horizontal steel beam wales supported by diagonal steel beam rakers. The design of the bracing system and the sequence of installation were shown on the contract drawings. They required driving all the H-piles and then excavating to the level of the first wale. Wood lagging was required to be installed between the soldier piles as the excavation progressed downward. At that level, the wale was to be installed followed by the diagonal rakers. Following the placing of the wale and rakers the next level of excavation would proceed. The contractor reasoned that he could change the bracing procedure and save money. He excavated a narrow slot at the location of each soldier pile and drove the soldier pile in the slot, thereby reducing the skin friction and easing the driving. He then excavated to the level of the first wale and installed the rakers. He omitted the wood lagging in this stage because it would be inconvenient and time-consuming to install it level by level. He then proceeded to excavate between adjacent soldier piles from the first wale to the bottom of the excavation. Because workmen installing the lagging would interfere with machine excavation, he planned to install the lagging after the excavation had been completed to the bottom between the adjacent soldier piles. The weather was reasonably dry, and the soil appeared to stand without the need of the lagging, which confirmed his optimism. However, after several such excavations had been made and no lagging was yet installed, a severe storm occurred. The soil adjacent to the excavation became saturated and weakened. Large chunks of earth fell between the soldier piles where the lagging should have been. Unfortunately, an 18-inch water main was supported by the soil only a few feet from the bracing system. The fallout of the soil left the water main unsupported, and it ruptured. The flow of water washed a large hole beneath the adjoining pavement of a main thoroughfare, making it necessary to close two traffic lanes.

Figure 2. Failure of soil face behind soldier piles where installation of the lagging had been delayed. The dropout destroyed the sidewalk and an 18-inch water main and undermined a 6-lane pavement.

At the same time, the flow flooded the building site to a depth of 20 feet. Nearly a month was lost in pumping the water from the site, removing the slime that had accumulated on the bracing system, and cleaning the power shovels, air compressors, and other mechanical equipment in the job. The direct cost to the contractor was nearly \$100,000. Moreover, more than a month's building occupancy was lost. Even more serious was the exposure of the public to potential loss of life from the undermined street and the potential loss of property due to interruption of fire protection in the adjacent area of the city. (Fortunately, the failure took place in the early morning hours before morning rush-hour traffic had commenced, and there was no loss of life or property except from the direct loss of the pavement support.) In this case, the safety factors of the bracing system design were adequate. Because of the omission of a portion of the system, the soil rather than the bracing system failed. The contractor had not considered the safety of the soil in his streamlined operation, and as a result nearly precipitated a disaster.
