# Construction Practices for Placing 48-Inch Precast, Prestressed Concrete Cylinder Piling in Deep Water

WALTER W. GRIMES, South Dakota Department of Highways

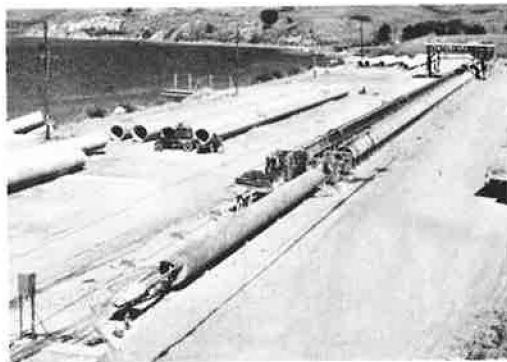
Figure 7. Casting yard: vibrating mandril, twin casting beds and gantry—pile storage at left.

In using the mandril as an internal form, a stiff no-slump concrete mix was required. Care in placing this dry mix at headers and on the ends was exercised to prevent the pile from collapsing and requiring patching. The pile was cured with a fog to maintain high humidity and kept at a temperature between 70 and 85 F.

After the concrete had cured to 5,000 psi, pick points were drilled through the pile shell and the pile extracted from the form. The pile was placed in a storage yard by the water. At this time, plugs were cast into one end of each pile. Two types of plugs were used: one was a 4-ft flush-end plug; the other was a tapered plug, having 3 ft of concrete in the end of the pile with a 45-deg 2 ft long taper (Fig. 8). Both plugs were epoxied into the pile at the time the plug was cast. At this time, the pick points were epoxied and filled with a stay-crete mixture. After the piles had cured to 7,000 psi, they were moved to the launching rail and taken to the stiffleg driving unit. For moving each pile, one end near the pick point was set on a flex float unit, and the other pick point was held by a small A-frame with a winch line attached.

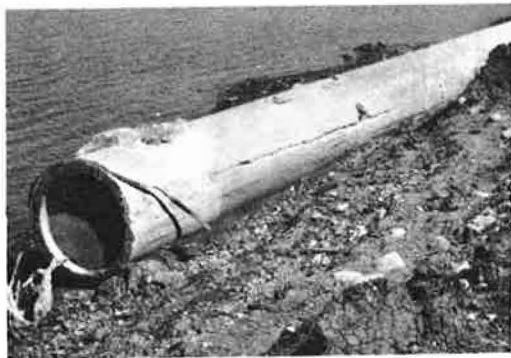
Figure 9. Test pile 2-24—113 ft long cast from 7300 psi concrete. Pile driven filled with water; seated with 1792 blows for 20-in. penetration. Pile shows plug in place, banding torn loose and a split 70 ft long in section where concrete was placed in the form.

per inch a pile would stand without damage during the driving operation. One pile was driven as a test pile to a total of 1,792 blows for 20 in., and then pulled (Fig. 9). Inspection indicated the pile had sustained a longitudinal crack approximately 70 ft in length and that the reinforcing ring on the end had been stripped off. However, this pile would have been acceptable if it had been backfilled properly. Later studies of driven piles revealed that many piles in the various bents had been driven over 5,000 blows to get acceptable bearing. For example, in Bent 20 the pile in position 5 was driven 1,251 blows to place it. Pile 9 was driven 5,237 blows to get acceptable bearing. Both of these piles sustained no visible damage at the time of acceptance. On the other hand, in Bent 24, pile 7 was driven 327 blows and on inspection it contained 30 ft of water. Pile 8 was driven 1,710 blows in a total of 77.5 in. and contained 75 ft of water at the time of acceptance. Both of these piles were inspected by divers and had longitudinal cracks in the area where concrete had been placed into the form. These piles were pumped dry and backfilled with Class C concrete to an elevation of 1358. In Bent 16, pile 2 was reported as having water gushing out of the pile hammer helmet during the driving operation. An attempt to pump this pile dry failed. On inspection by divers, it was discovered that a pick point patch had come loose admitting the water from the jets. Since these pick points were about 6 in. square, considerable water could be admitted to a piling under pressure when one failed.

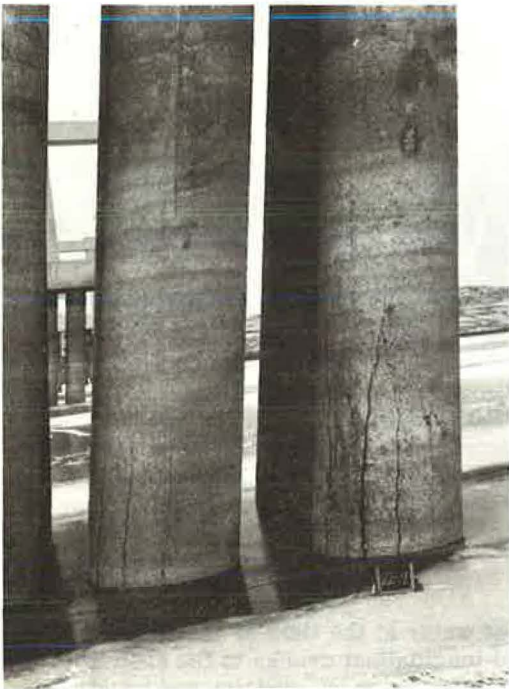
Figure 10. Bent 22 pile 4—cracks as found January 1964. Length 138 ft, 7000 psi concrete—driven a total of 6897 blows. Pile was pumped dry before filling with sand and Class C concrete.

In piling that required repairs, zones up to 14 ft thick consisting of segregated concrete, silt, sand, gravel, hay and even an 8 x 8 timber were removed. Typical of the piling repaired were the following: In Bent 22 pile 4, 14 ft of loosely cemented aggregate, neat cement, low-strength concrete and a void were cleaned from the pile shell and replaced with dry-packed concrete. After cleaning the exterior shell a steel reinforcing band of  $\frac{3}{8}$ -in. steel was epoxied and bolted into place (Figs. 10 and 11). Bent 26 pile 1 had 6 prestressing cables exposed with a 3-ft void where the water around the pile had washed out unconsolidated material. Ten feet of loose material including a straw tremie seal was removed and replaced with dry pack. The exterior of this pile was banded with a reinforcing unit, epoxied and bolted into place (Figs. 11, 12, and 13). All piles that were repaired were reinforced by banding to replace the steel that had been cut out to gain access to the pile core.

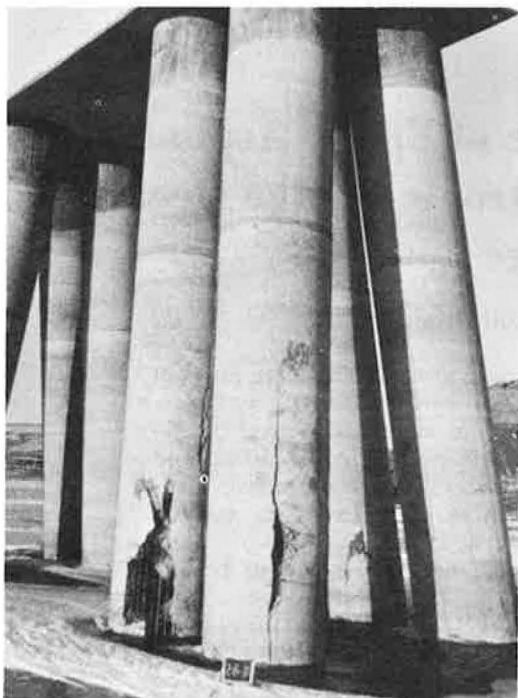
Figure 12. Cracked piling Bent 26. Large hole and crack in Position 7; pile in Position 1 was driven a total of 308 blows; dry when filled with sand and Class C concrete.

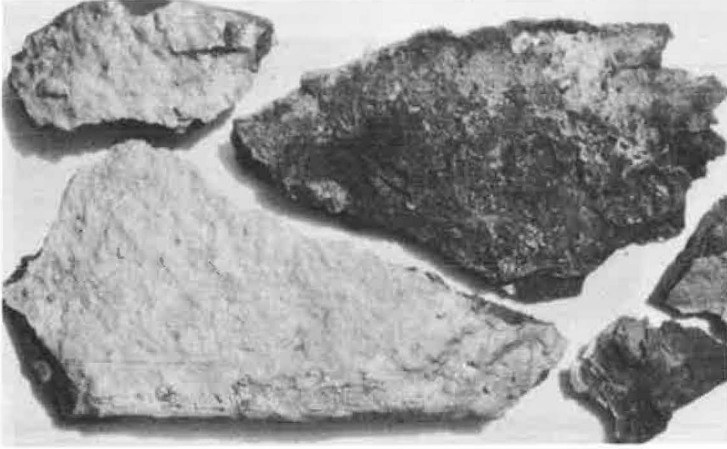
Figure 10. Mass rust buildup;  $\frac{4}{5}$  natural size.

Figures 10, 11, and 12 show massive slabs of "rust" up to  $\frac{1}{4}$ -in. thick formed on a railway station column built of 6 by 6-in. steel angles "protected" by aluminum paint. The hydrated oxide material is magnetic, but is seen to be entirely nonmetallic, and the structure of the "as polished" cross sections suggests how the progress of corrosion has varied with local differences in structure of the steel, even well below the immediate

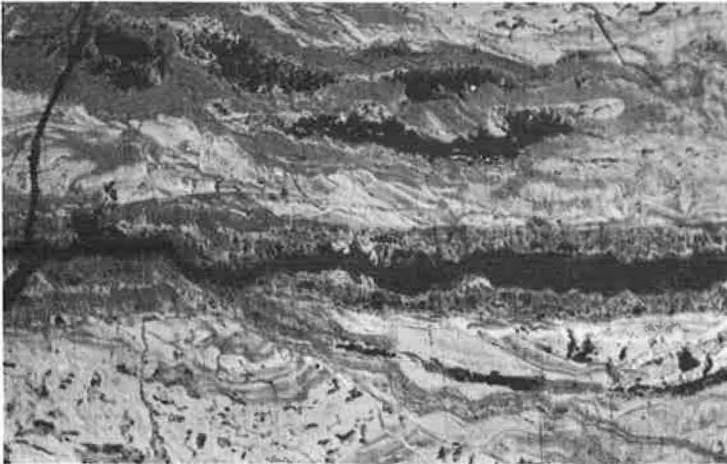
Figure 12. Rusty interior section, 100X.

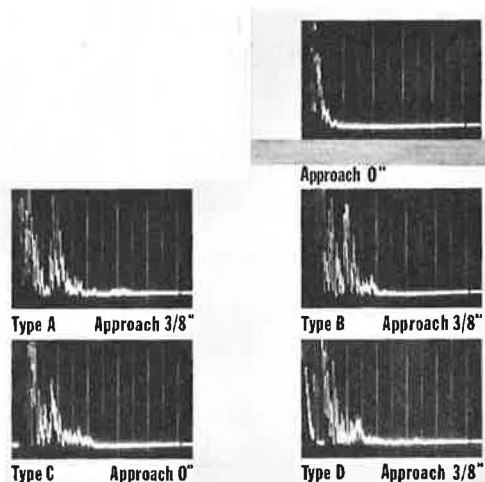
Figure 2. Wedge noise and weld bead approach.

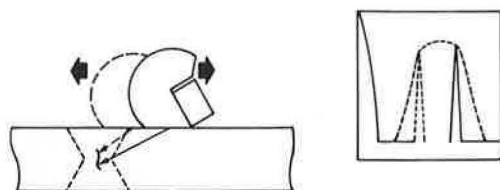
Figure 8. Travel to and from the weld reveals defect height.

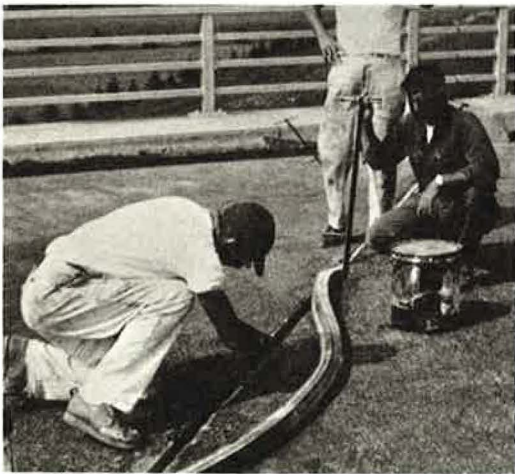
Figure 9. "Pogo Stick" inserter for bridge seals.

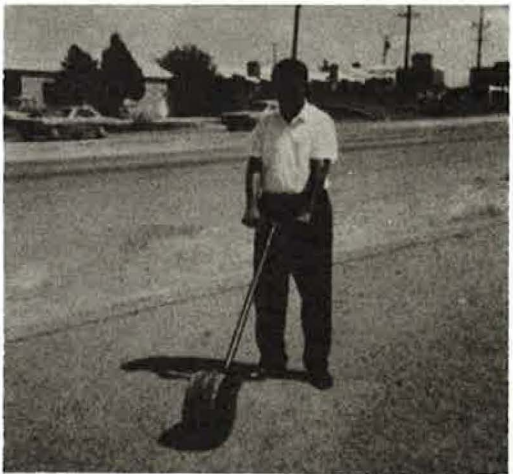
Figure 10. Roller (250 lb) for inserting bridge seals.

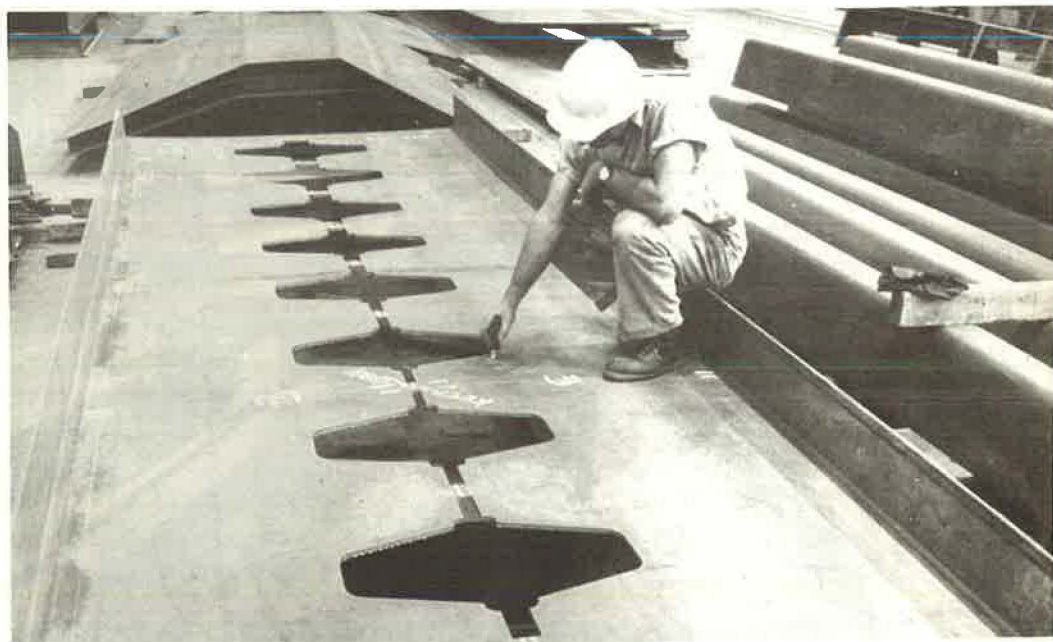
Figure 6. Cutting floor beams to fit the deck ribs.

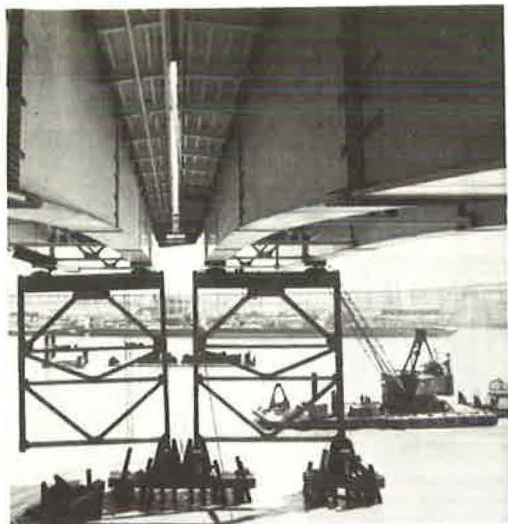
Figure 18. Damage caused by the barge accident that knocked one support from under a construction bent.
