Michigan's Experience With Different Materials and Designs for Skid Resistance of Bituminous Pavements

PAUL J. SERAFIN, Michigan Department of State Highways

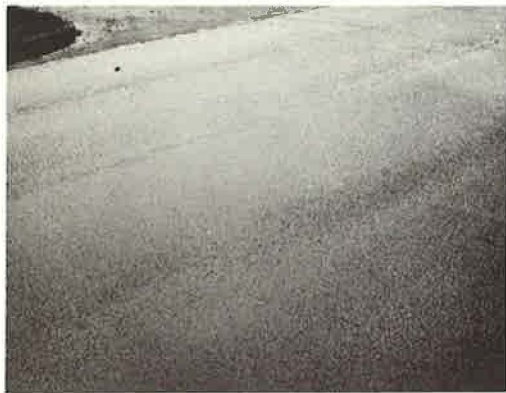
An example of a slippery pavement caused by polished coarse aggregate is shown in Figure 1. The reflection of light from the pavement surface is a good indication that it may be slippery. A close-up of a sawed pavement core taken from this surface is shown in Figure 2. The coarse aggregate particles have become oriented in such a way that their flat faces are exposed to the surface and subject to subsequent polishing by traffic. When this same specimen is turned at an angle, as shown in Figure 3, one can see the oily bitumen absorbed into the surface of the coarse aggregate particles. This adds to the problem under wet conditions.

Figure 1. Slippery pavement surface of polished limestone.

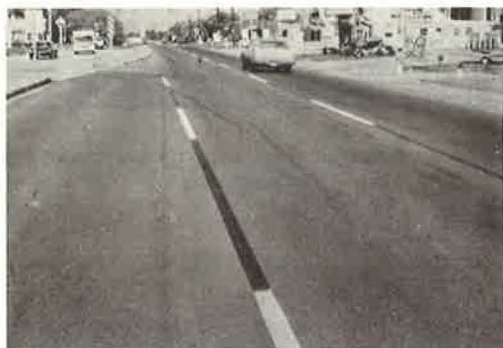
Figure 4. Crushed sandstone surface 4 years after construction.

Because the crusher-run material appeared to contain sufficient fines, no additional sand was added to the initial mix design. Several bitumen contents, varying from 8 to 10 percent, were tried, but the resulting mixture was tough to handle and produced a nonuniform, open-textured mat. After some experimentation, the mix design was changed by adding 1 part fine sand to 5 parts crusher-run sandstone and 9.5 percent 60 to 70 asphalt. Commercial mineral filler was not added to this mixture. This mixture produced a uniform-textured, skid-resistant surface and was used on 3 intersections in the Bay City area. Normally, a gradation of this type would use about 6.5 percent asphalt; however, because of the high absorption of this material (7.2 percent), it was necessary to raise the bitumen to about 9.5 percent in order to produce a serviceable pavement. Figure 4 shows a typical intersection after 4 years of service where this sandstone mixture was used, and Figure 5 shows a close-up of the sandpaper surface texture. After several months of wear, the larger sandstone particles began to show a dishing effect as shown in Figure 6. This has not detracted from the excellent service performance of this surface after 4 years of service under moderately heavy traffic; rather, it is felt that skid resistance characteristics have improved.

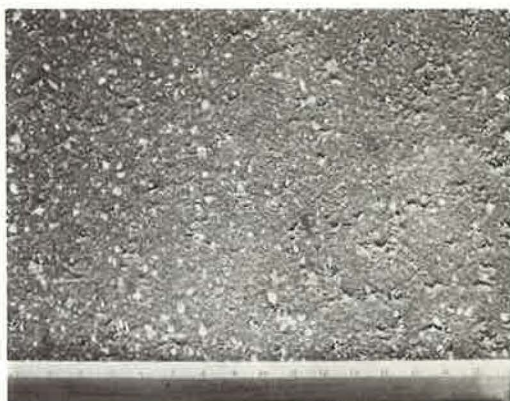
Figure 5. Close-up of sandstone surface 4 years after construction.

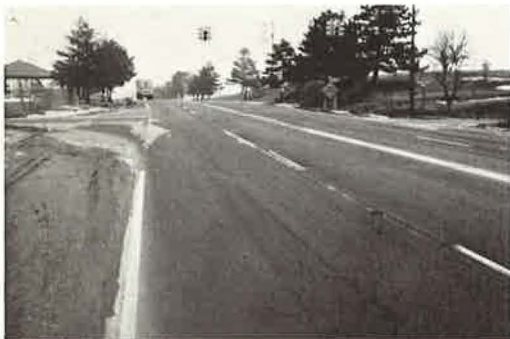
Figure 7. Crushed quartzite surface 3 years after construction.

percent 60 to 70 asphalt; 4.0 percent fly ash was added as mineral filler to make up for the fines lost through washing, and the remainder was quartzite crushings. No other aggregate was added for this mix design. Figure 7 shows a typical surface after 3 years of service in the Flint area. Some loss was experienced where traffic entered from a side gravel road causing considerable localized abrasion; however, the rest of the surface is in good condition. Figure 8 shows a close-up of this excellent skid-resistant surface.

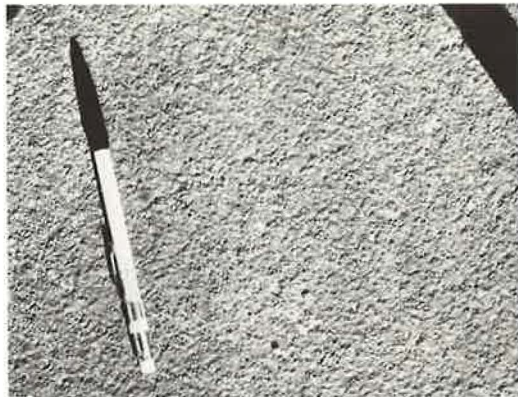
Figure 8. Close-up of quartzite surface 4 years after construction.

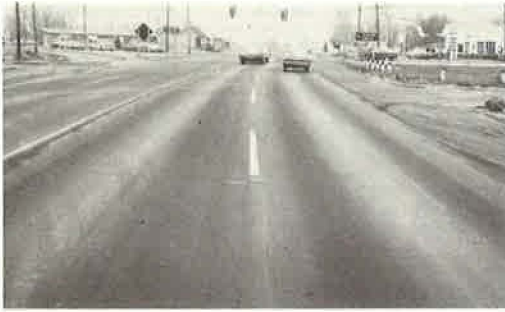
Figure 9. Crushed beach pebbles 3 years after construction.

The mix design used was 5.7 percent 60 to 70 asphalt and 2.0 percent fly ash mineral filler; the remainder was crusher-run beach pebbles. No other aggregate was added to this mixture. Figure 9 shows a typical surface 3 years after construction at an intersection south of Flint. Figure 10 shows a close-up of the surface after 4 years of service. This surface is in fair condition; however, because of relocation of the roads in this area, part of this project was resurfaced last year.

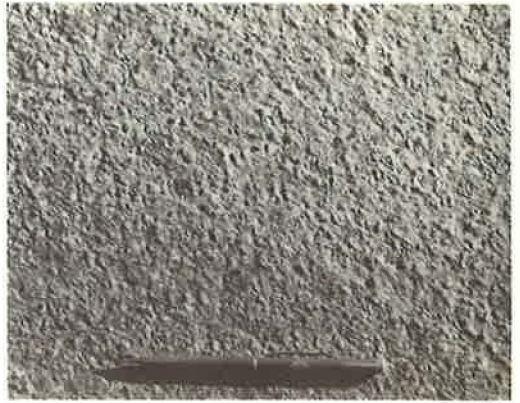
Figure 10. Close-up of beach-pebble surface 4 years after construction.

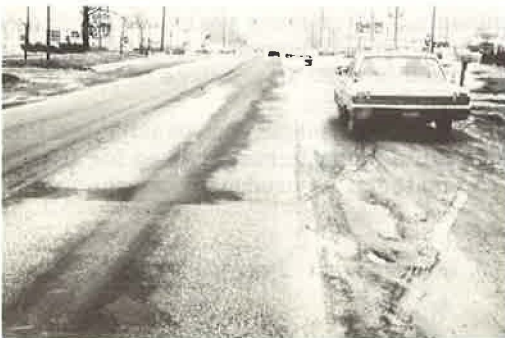
Figure 11. Crushed traprock 3 years after construction.

The mix design called for 6.1 percent 60 to 70 asphalt plus 3.5 percent added fly ash mineral filler; the remainder was crushed traprock. No other aggregate was added to this mixture, which was used at an intersection south of Flint. Figure 11 shows the

surface after 3 years of service. Considerable areas of the surface were worn completely through to the old pavement. No detour provisions were made, and heavy traffic was permitted to traverse the uncured, warm mat, resulting in premature wear that was evident within a few days after construction. I believe this mix would have proved more durable if traffic had not been permitted on the warm surface during construction.

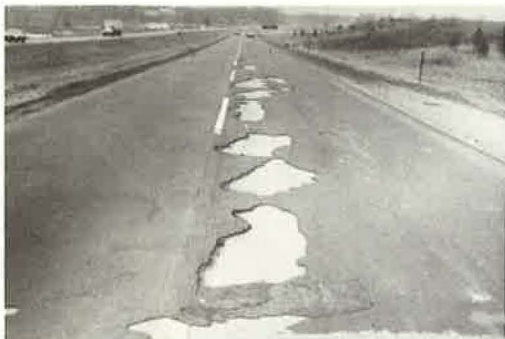
Figure 12. Synthetic bitumen and sand 1 year after construction.

sand, they exhibited promising skid resistance because of what appeared to be a noticeable rejuvenation of the sandpaper texture. This mixture was placed at a rate of 80 lb/sq yd on a section of I-96 about 50 miles west of Detroit. During the start of the first winter, sections of the pavement peeled off as shown in Figure 12. The rest of this surface was later bladed off. It was determined that considerable hardening of the bitumen occurred within a few months resulting in penetrations approaching zero. It is believed this contributed to the loss of adhesion between the thin bituminous mat and the underlying concrete pavement.

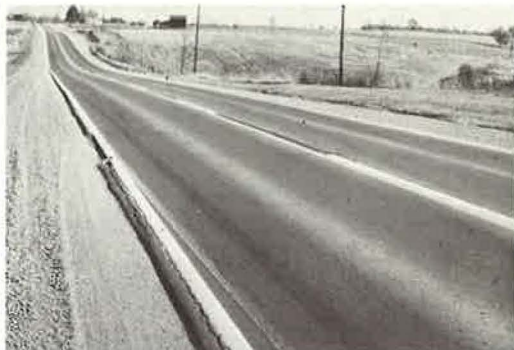
Figure 13. Sand-emulsion surface 4 years after construction.

In recent years the asphalt emulsion industry has promoted the use of hot emulsion sand mixtures for skid-proofing purposes, and other states have reported satisfactory service with these mixtures. A mixing grade emulsion was used for this purpose; the producer claimed that the bitumen residue has certain thixotropic characteristics, thus permitting higher bitumen contents to be used in the mixture without danger of flushing. A fine aggregate passing the No. 8 sieve was mixed with about 10.8 percent emulsion resulting in about 7.5 percent residue. The temperature of the mixture delivered to the street ranged between 245 and 270 F. Figure 13 shows a typical pavement section after 4 years of service, and Figure 14 shows a close-up of the fine sandpaper texture. This road is in good condition and offers a skid-resistant surface.

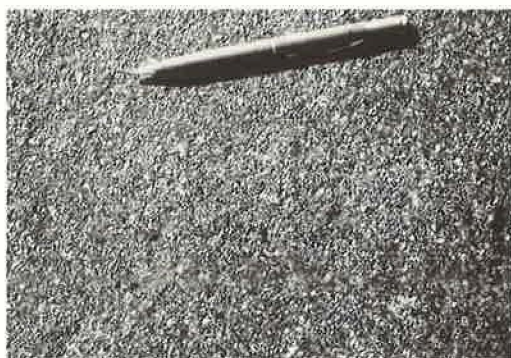
Figure 14. Close-up of sand-emulsion surface 4 years after construction.

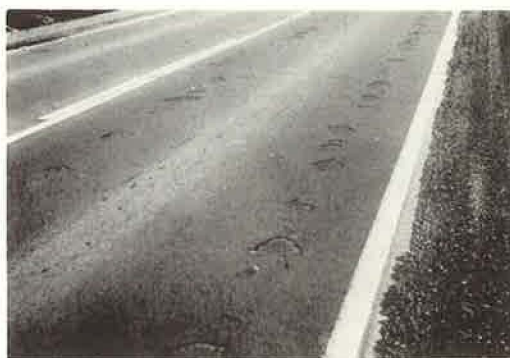
Figure 15. Delamination of sand-asphalt surface 1 year after construction.

At the beginning of the first winter season, some sand-asphalt surfaces showed delamination in the wheel tracks; that is, about $\frac{1}{8}$ -in. layers would separate from the rest of the mat. Figure 15 shows a typical example of such a road, and Figure 16 shows a detail of this phenomenon.

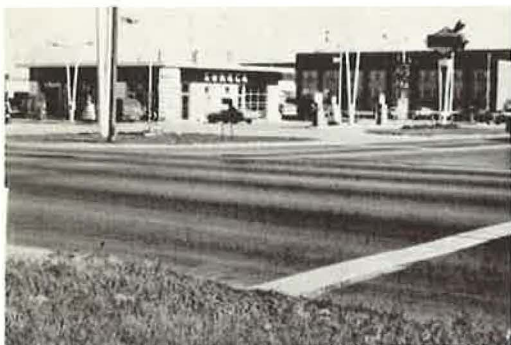
Figure 18. Stone-filled sand-asphalt surface 4 years after construction.

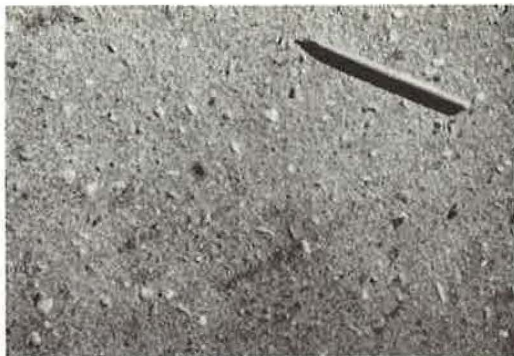
Figure 19. Close-up showing stones sticking out of stone-filled sand asphalt.

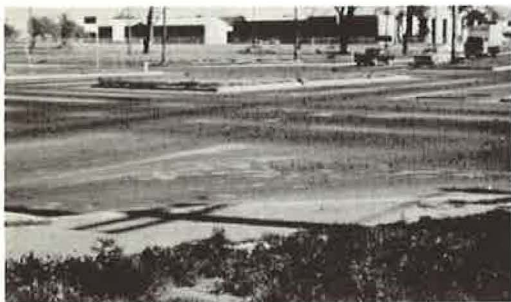
Figure 20. Raveled fillets of sand-asbestos surface 4 years after construction.

Figure 20 shows a typical area in Detroit after 4 years of service. It is generally in good condition except for the fillet areas that were manually placed and cooled before

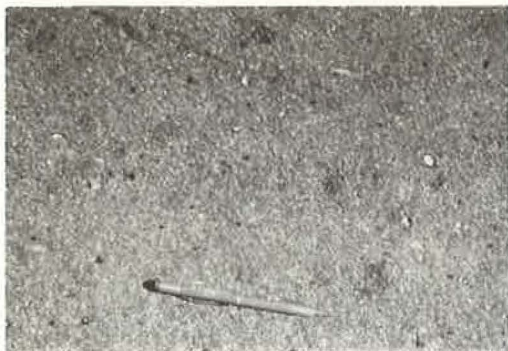
Figure 21. Close-up of sand-asbestos surface 4 years after construction.

they were properly compacted, resulting in some raveling. Figure 21 shows a close-up of the sand-asbestos-asphalt surface texture that exhibits satisfactory skid resistance.

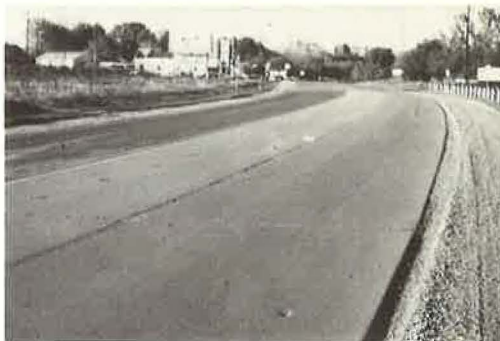
Figure 22. Sinopal-sand surface 4 years after construction.

Figure 22 shows this surface after 4 years of service. The lighter colored areas shown in the right 2 lanes have the Sinopal added, while the darker areas in the left 2 lanes are mixtures of sand asphalt without Sinopal. Figure 23 shows a close-up of the Sinopal surface; the white particles of Sinopal can be seen exposed at the surface. This surface, in general, is in good condition and exhibits good skid resistance.

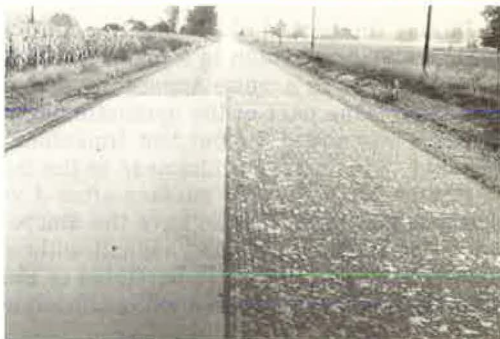
Figure 24. Freshly laid bituminous surface after rain.

Motorists are sometimes warned of freshly laid bituminous surfaces by a sign indicating "slippery when wet." Figure 24 shows a freshly laid bituminous mat constructed with MC-3000 liquid asphalt. The left foreground surface was laid the day before, while the rest of the surface, which appears spotted, had just been completed when it was rained on. After 1 day of curing and weathering, water wets the pavement. However, as shown by the close-up in Figure 25, water globules have formed on the mat of the

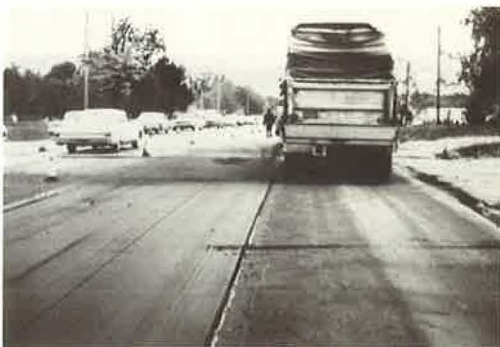
Figure 26. Spreading precoated sand on unrolled bituminous mat.

initial skid-resistant bituminous surface by applying hot sand, precoated with about 1 percent asphalt cement, on the unrolled mat behind the paver. This is then rolled into the surface and reduces the initial slickness. About 2 to 5 lb/sq yd of this precoated sand is sufficient; more may produce a ball-bearing effect, which can also be dangerous and may mar the pavement surface when bunched-up sand is rolled into the mat.

Figures 26 through 30 show some typical equipment used in this technique. The spreader shown in Figure 27 is not equipped with a deflector, thus allowing about $\frac{2}{3}$ of the precoated sand to be wasted on the shoulder. Using a seeder, as shown in Figure 28, sometimes leaves ridges that subsequently mark the pavement.

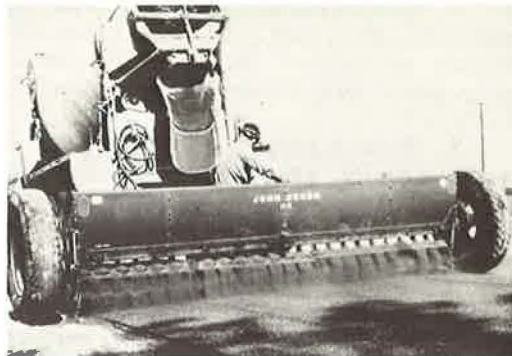
Figure 28. Seeder used for spreading precoated sand leaves ridges.

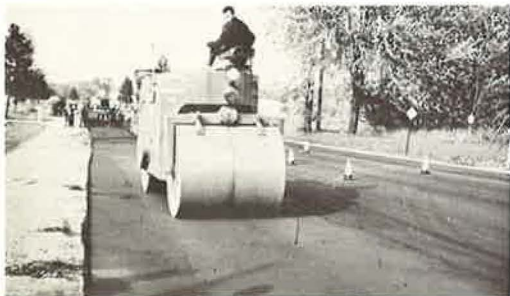
Figure 29. Rolling pavement after sand application.

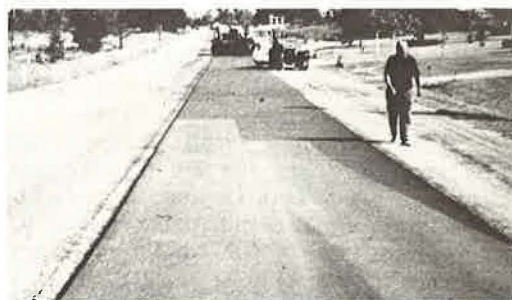
Figure 30. Precoated sand on mat of partly rolled surface.
