# Field and Laboratory Studies of the Effect of Subbase Type on the Development of D-Cracking

DAVID STARK, Portland Cement Association, Skokie, Illinois

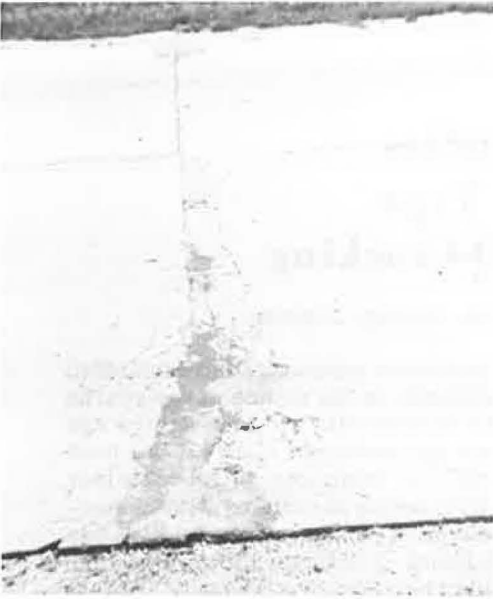
Figure 1. D-cracking along transverse joint of pavement.

•DURING the past several years, field studies of a large number of pavements have revealed the widespread occurrence of a type of deterioration known as D-cracking, in which distress develops along joints, structural cracks, and the outside edges of pavement slabs (Fig. 1). Further observations revealed that deterioration was initiated in the lower levels of the pavement slab (Fig. 2). These observations and associated laboratory studies indicated that distress was due to the freeze-thaw failure of coarse aggregate particles (Fig. 3), and that pavement design, or the environment into which the concrete was placed, was a decisive factor in the durability of the pavement (1). Recognition of this fact led to studies at the PCA laboratories in which various combinations of subbases and concrete slabs were placed in an outdoor test plot to simulate pavement exposures in a freeze-thaw climate. It was anticipated that the findings in this study would indicate the need for durability as well as other considerations in pavement design. Additional information from the field observations, together with interim results from the laboratory tests, are discussed.

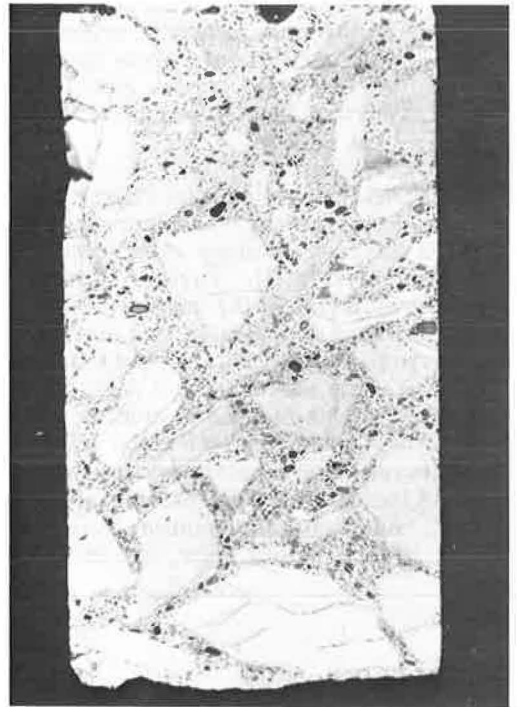
Figure 3. Vertical section of core taken through D-cracked pavement slab. Severe cracking in coarse aggregate particles extends into surrounding mortar.

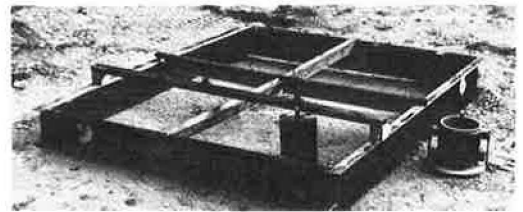
Figure 5. Form for casting test slabs and Y-shaped forms for making joints and cylinder mold used for concrete to be placed into cylindrical hole cast into slab.

In order to monitor moisture movements in the test slabs, a method initially reported by the California Division of Highways was used (2). Cylindrical steel molds, machined to an outside diameter of 5.550 in., were positioned at centers 12 and 15 in. from the outside edges of the slabs (Fig. 5). These were removed from the slabs after approximately 6 hours. The concrete cylinders to be inserted into the holes thus formed were cast in steel molds machined to an inside diameter of 5.500 in. and equipped with centrally located 0.500-in. diameter steel rods, which were required to form a hole through which another rod could later be inserted to clamp the discs together. Concrete was taken from each batch for the appropriate slab and externally vibrated into the mold. After 1 day, the concrete cylinder was removed from the mold, placed in a plastic bag, and cured under polyethylene with the slab for 13 days. Companion reference cylinders were made each day of casting and cured in a similar manner.

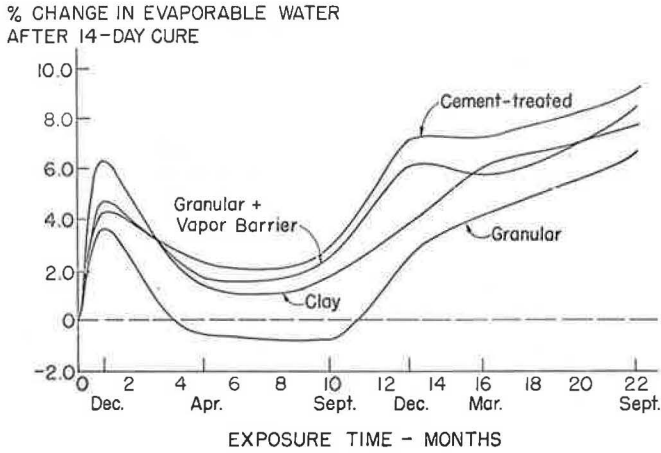
Figure 6. Moisture measurements for full depth of slabs on 4 subbases.

Figure 6 summarizes the results of measurements according to subbase type after exposure to 2 freeze-thaw seasons. Each curve represents the average for the full depth of slabs made with 3 different coarse aggregates. It should be pointed out that the curves were derived from data obtained only during the months specifically indicated on the abscissa, and do not include the extreme effects of summer drying. An initial moisture increase of 3.7 to 6.3 percent was recorded after a 1-month, late fall exposure. The greatest average increase occurred in concrete placed on the clay subgrade. By April following the first freeze-thaw season, moisture contents had dropped 2 to 5 percentage points for concrete placed on the clay, cement-treated, and granular + vapor barrier bases but still remained above that immediately following an initial curing period. Moisture contents of concrete placed on the granular subbase dropped more than 4 percentage points to a level somewhat below that immediately following the initial curing period. Average moisture contents were nearly the same for the spring and fall measurements but then increased greatly during the fall season. The greatest increase was recorded for concrete placed on the cement-treated base. By December preceding the second freeze-thaw season, moisture contents were higher than the previous December only for concrete placed on the cement-treated and granular + vapor barrier subbases. During the second freeze-thaw season, moisture contents increased for concrete placed on the granular and clay subbases and remained constant or decreased for the other concretes. Following the most recent summer season, moisture contents were at higher levels than at any previous time.

curves in Figures 6 and 7 shows that the bottom half of the slabs placed on the cement-treated and granular + vapor barrier subbases had smaller increases in evaporable water content compared with the full depth of these slabs.

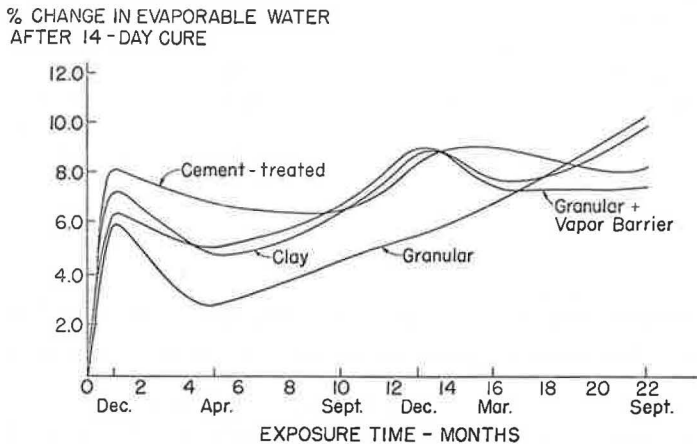
Figure 7. Moisture measurements for bottom half of slabs on 4 subbases.

Data for the bottom half of the concrete slabs are shown in Figure 7. It is seen that similar but less pronounced trends occur here compared with those for the full depth of the slab, except during the first month's exposure following the initial curing period. During this period, moisture increases were greater, as might be expected, because there was no direct exposure to atmospheric drying. Also, there was a slight change in the relative positions of the curves after 22 months' exposure. Comparison of the
