# DYNAMIC TESTS OF THE CALIFORNIA TYPE 20 BRIDGE BARRIER RAIL

Eric F. Nordlin, James H. Woodstrom, Raymond P. Hackett, and  
J. Jay Folsom, California Division of Highways

The results of five full-scale vehicle impact tests on the California type 20 bridge rail are reported. The type 20 bridge rail is a rigid barrier system that incorporates a 27-in. high reinforced concrete parapet with a traffic-side contour very similar to that used for the New Jersey type of concrete median barrier. A 2- by 6-in. by  $\frac{1}{4}$ -in. thick structural steel tube rail is placed 12 in. above the top of this parapet, thus giving an overall barrier height of 39 in. Five tests were conducted at speeds of from 45 to 66 mph and at impact angles of 7, 15, and 25 deg. The test results indicated that this system will retain and redirect a 4,900-lb passenger vehicle impacting at speeds up to 65 mph and at angles of from 7 to 25 deg with the barrier. Vehicle damage varied from negligible at a 7-deg impact angle to severe at a 25-deg impact angle. The test results indicated that the vehicular decelerations sustained during 25-deg, 65-mph impacts into this system will result in occupant injuries varying f

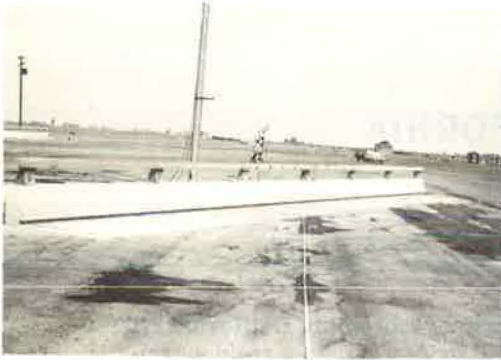
Figure 1.

•THE FIRST vehicle impact tests of bridge barrier rails were conducted by the California Division of Highways in the mid-1950's (1, 2). These tests were initiated because of the serious operational deficiencies, primarily structural, that were developing with the bridge barrier rails then in use in California as heavier, high-speed vehicles took to the highways. As a result of these tests, the California Division of Highways adopted a design designated as the California type 1 bridge barrier rail (Fig. 1).

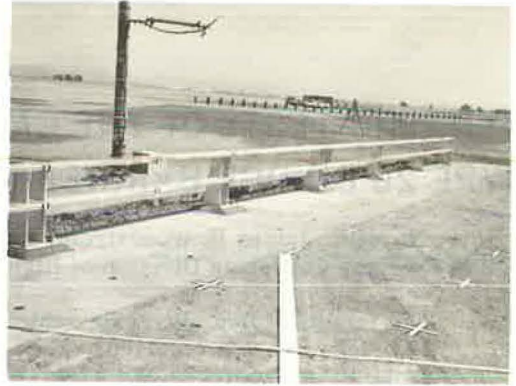
Figure 2.

Subsequent vehicle impact tests of California bridge barrier rails (3, 4) have resulted in the development and adoption of the California types 8 and 9 bridge barrier rails (Figs. 2 and 3). Although these barriers have proved to be satisfactory, reports from New Jersey (5) and subsequent tests by the California Division of Highways in 1966-67 (6) indicated that the New Jersey concrete median barrier (Fig. 20, Appendix) showed definite promise of reducing the damage sustained by vehicles striking it at the more prevalent flat angles of impact. This characteristic was also reported by General Motors (7) in tests conducted on a bridge barrier containing a parapet contour similar to the New Jersey barrier (Fig. 20). The effectiveness of the lower sloped surface in reducing vehicle damage and decelerations had also been observed operationally in several experimental installations of the New Jersey concrete median barrier in California.

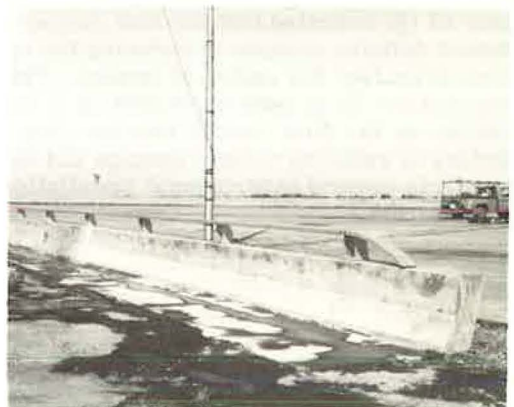
Figure 4.

Consequently, the Bridge Department of the California Division of Highways designed the California type 20 bridge barrier rail (Fig. 4 and Appendix Fig. 20). This design incorporates a single steel rail mounted 12 in. above the top of a 27-in. high concrete parapet. The rail is a rectangular tubing identical to that used in the type 9 design. The parapet wall has a traffic-side profile almost identical to the New Jersey median barrier.

The type 20 design provides better "see-through" characteristics than the General Motors design because the overall height is about 16 in. less, the concrete parapet is about 5 in. lower, and the steel rail is narrower. Visibility through the type 20 bridge rail is not as good as through the type 9 design. However, it appears to be adequate. Five full-scale vehicle impact tests of this type 20 bridge rail are reported herein.

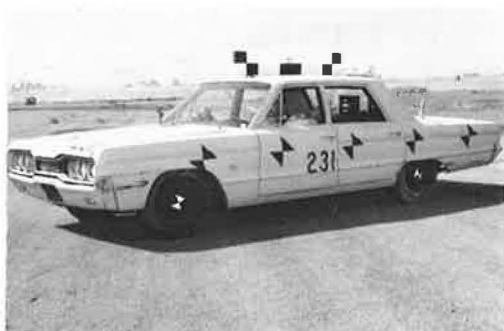
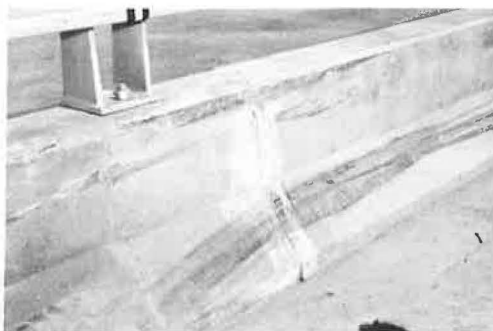
Maximum vehicular rise was approximately 16 in. There was minor sheet-metal damage sustained by the test vehicle and slight surface cracks sustained by the barrier (Figs. 6 and 7). No determination of the electronically measured deceleration could be made due to the poor quality of the instrumentation data.

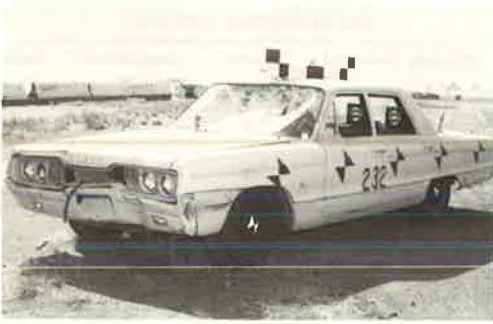
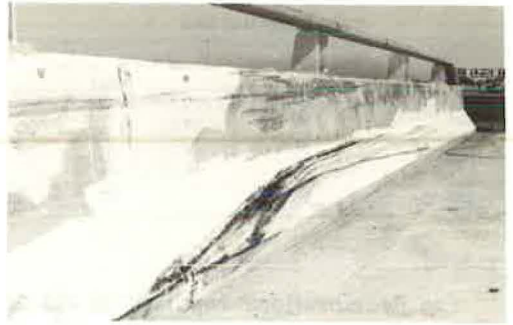
1 deg (Appendix Fig. 24). During this test the maximum vehicle rise was 16 in. Vehicle damage was very minor, and there was no significant structural damage sustained by the barrier (Figs. 8 and 9). The damaged windshield and grill were caused by a second collision with a section of scaffold. A maximum 50-msec average deceleration of 4.8 g laterally (average of 2 data channels) was measured on the floor of the passenger compartment. This deceleration did not exceed the tolerance level for a seat-belted occupant. None of the longitudinal deceleration data was considered accurate.

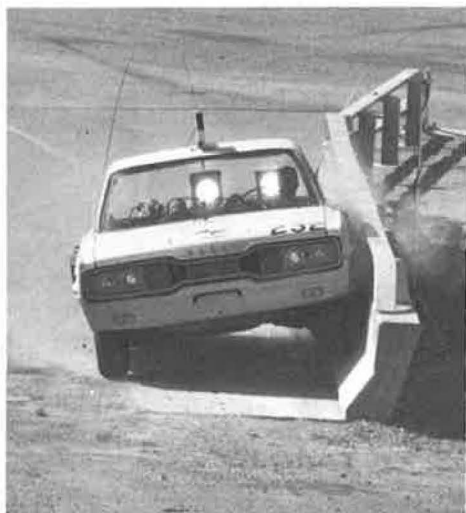
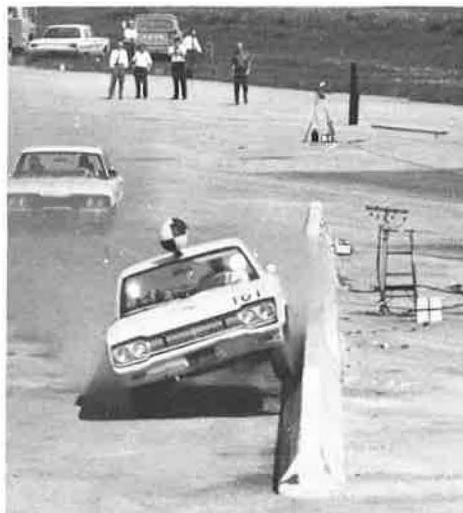
stantially less than that noted during a previous 7-deg, 65-mph test (test 161B) of the New Jersey type of concrete median barrier (6). The two tests are shown in Figures 12 and 13.

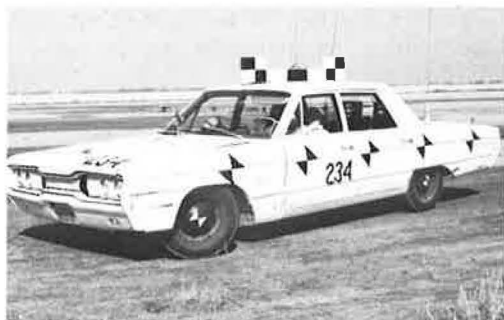
Figure 14.

Vehicle damage was limited to minor scrapes along the left side (Fig. 14). Barrier damage was very minor (Fig. 15). The maximum 50-msec average decelerations measured on the floor of the passenger compartment were 4.8 g laterally (average of two data channels) and less than 1 g longitudinally (average of three data channels). These vehicular decelerations did not exceed the tolerance levels for a seat-belted occupant. Thus, a belt-restrained occupant would have sustained little or no injury. The maximum 50-msec dummy decelerations measured were 6.5 g laterally and 2.3 g longitudinally.

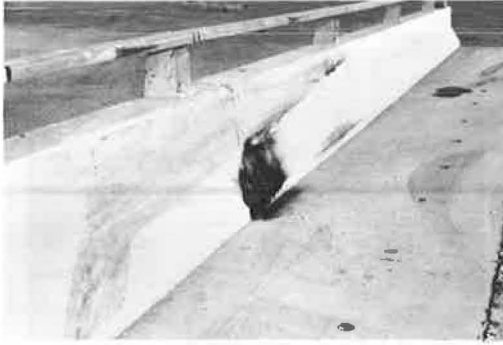
Figure 16.

Spalling of the concrete in the vicinity of impact and a slight permanent deflection (0.1 ft) of the steel railing indicated the severity of the impact (Fig. 16). The concrete portion of the barrier railing sustained a vertical crack approximately  $\frac{1}{16}$  in. wide that extended from the deck to the top of the parapet. This crack was at a point just upstream from impact. Displacement of the concrete parapet was approximately  $\frac{1}{8}$  in. at the top of the expansion joint. As could be expected with any 25-deg impact into a rigid barrier, vehicular damage was severe (Fig. 17).

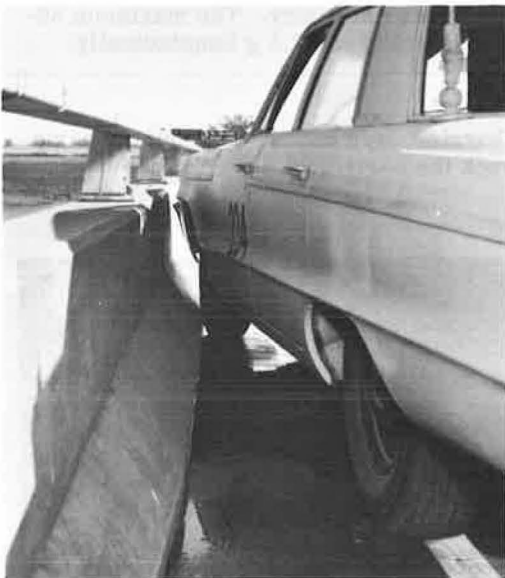
Figure 18.

The results of these tests indicated that the effectiveness of sloping the traffic side of the barrier parapet diminished as the angle of impact increased. This is not surprising in that the point of initial vehicle-barrier contact shifts from the tire sidewall at a 7-deg impact angle (Fig. 18) to the

Thus, at the greater angle, a smaller proportion of the vehicle kinetic energy is absorbed within the vehicular suspension system, and a proportionally greater amount is absorbed through deformation of the vehicle body and chassis, thus resulting in increased vehicle damage and passenger-compartment decelerations. As the impact angle approaches 25 deg, the vehicular damage sustained approaches that sustained when impacting the vertically faced type 1 bridge barrier rail. However, an excerpt in a recent study reported elsewhere (11) indicates that approximately 75 percent of the vehicles departing from the traveled way do so at an angle of 15 deg or less. Almost 60 percent depart at 10 deg or less; this indicates that, in a majority of the collisions that will probably occur with the type 20 barrier, the sloped parapet face will be beneficial.

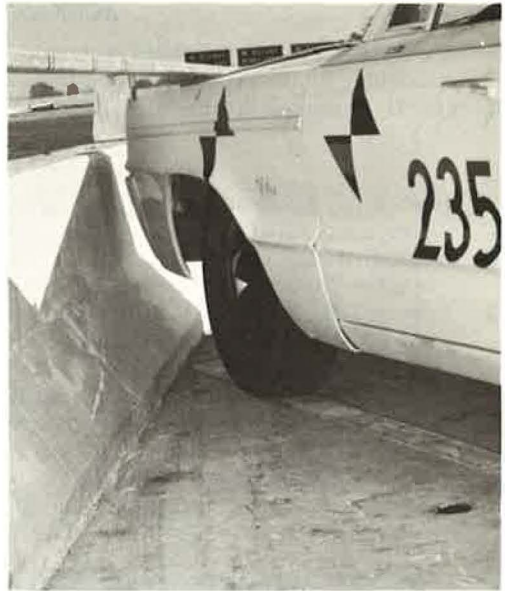
Figure 19.

body sheet metal at a 15-deg impact angle (Fig. 19).

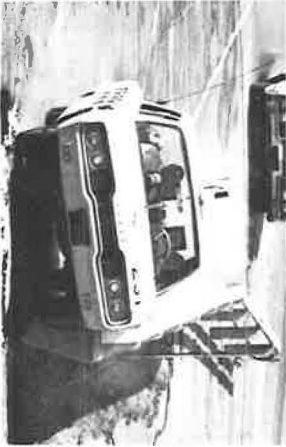
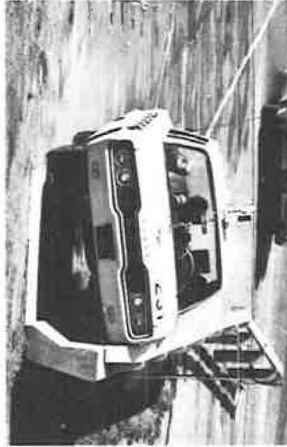
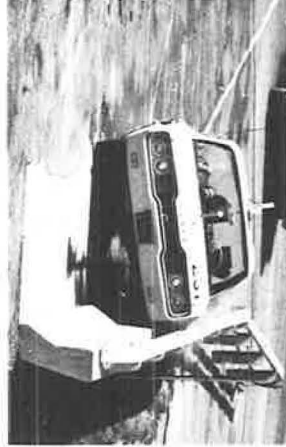
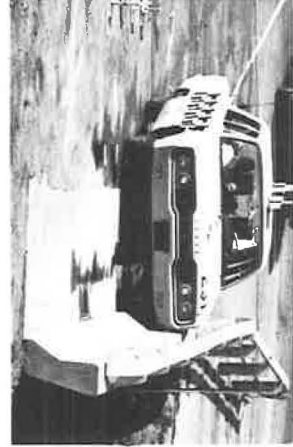
Figure 23.

BARRIER TESTED . . . . . Type 20 Bridge Rail  
 LENGTH OF INSTALLATION . . . . . 67' ±  
 PASSENGER COMPARTMENT DECEL. Long. \*  
 (Highest 50 ms average) Lat. \*  
 MAXIMUM VEHICLE RISE . . . . . 16"  
 EXIT ANGLE . . . . . 0°  
 BARRIER DAMAGE . . . . . Negligible  
 \*EXCESSIVE INTERFERENCE IN SIGNAL.

TEST NO. . . . . 231  
 DATE . . . . . 10-2-69  
 VEHICLE . . . . . 1966 Dodge Sedan  
 SPEED . . . . . 45 mph  
 IMPACT ANGLE . . . . . 7°  
 VEHICLE WEIGHT . . . . . 4980 Lbs  
 (Incl./dummies & instrumentation)  
 DUMMY RESTRAINT. . . . . Lap Belt

Test 231 was conducted to evaluate the effectiveness of the type 20 bridge barrier rail when impacted at a flat approach angle and a moderate speed. The vehicle impacted the barrier approximately 27.5 ft from the upstream end at a speed of 45 mph and at an approach angle of 7 deg. After impacting the barrier, the test vehicle was smoothly redirected parallel to the barrier. Vehicle barrier contact was maintained for the remaining 40 ft of barrier, after which the vehicle traveled an additional 150 ft before coming to a stop (Appendix Fig. 23).

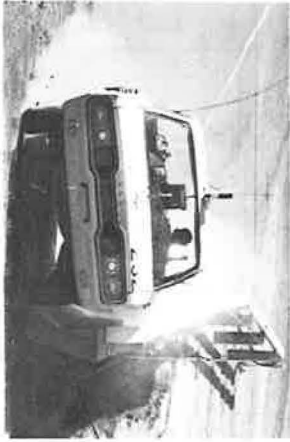
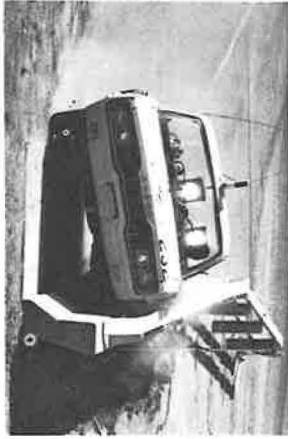
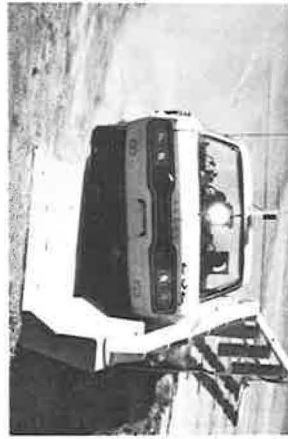
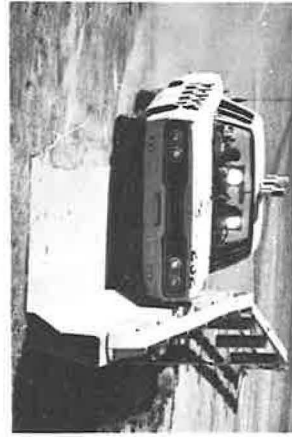
Figure 24.

BARRIER TESTED . . . . . Type 20 Bridge Rail  
 LENGTH OF INSTALLATION . . . . . 67' ±  
 PASSENGER COMPARTMENT DECEL. Long. \*  
 (Highest 50 ms average) Lat. 4.8 G's  
 MAXIMUM VEHICLE RISE . . . . . 16"  
 EXIT ANGLE . . . . . 1°  
 BARRIER DAMAGE . . . . . Negligible  
 \* ERRONEOUS DATA

TEST NO. . . . . 232  
 DATE . . . . . 10-2-69  
 VEHICLE . . . . . 1966 Dodge Sedan  
 SPEED . . . . . 66 mph  
 IMPACT ANGLE . . . . . 7°  
 VEHICLE WEIGHT . . . . . 4980 Lbs  
 (Incl./dummies & instrumentation)  
 DUMMY RESTRAINT . . . . . Lap Belt

The same vehicle used for test 231 was used for test 232 with no repairs. Test 232 also involved a 7-deg impact, but the impact velocity was increased to 66 mph. Impact was again about 27.5 ft from the upstream end of the test barrier. After impact, the vehicle traveled along the barrier for 27 ft and then left the barrier at an exit angle of

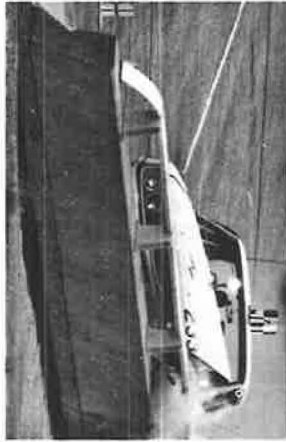
Figure 25.

BARRIER TESTED . . . . . Type 20 Bridge Rail  
 LENGTH OF INSTALLATION . . . . . 67'±  
 PASSENGER COMPARTMENT DECEL. . . . . Long. \*  
 (Highest 50 ms average) . . . . . Lat. \*  
 MAXIMUM VEHICLE RISE . . . . . Negligible  
 EXIT ANGLE . . . . . 10°  
 BARRIER DAMAGE . . . . . Negligible  
 \* INSTRUMENTATION MALFUNCTION  
 † VEHICLE GAS TANK REMOVED

TEST NO. . . . . 233  
 DATE . . . . . 10-8-69  
 VEHICLE . . . . . 1966 Dodge Sedan  
 SPEED . . . . . 64 mph  
 IMPACT ANGLE . . . . . 15°  
 VEHICLE WEIGHT . . . . . 4900 Lbs.†  
 (Incl./dummys & instrumentation)  
 DUMMY RESTRAINT . . . . . Lap Belt

The vehicle used for tests 231 and 232 was used again for test 233, a 64-mph, 15-deg impact. Impact occurred about 27.5 ft from the upstream end of the barrier. After maintaining contact with the barrier for approximately 19 ft, the test vehicle left the barrier at an exit angle of 10 deg (Appendix Fig. 25). Vehicle rise was small; it appeared that the steel railing held the test vehicle down during the redirection. This penetration underneath the steel railing is indicative of the decreasing effect of the contoured concrete surface at larger impact angles. There was no tendency for the vehicle to roll or jump. The left front end and undercarriage of the vehicle were severely damaged (Fig. 10). Minor spalling of the concrete parapet also occurred (Fig. 11). No measurement of vehicular or dummy deceleration was obtained because of an apparent instrumentation malfunction.
