PERFORMANCE OF THE HI-DRO CUSHION CELL BARRIER VEHICLE-IMPACT ATTENUATOR

Gordon G. Hayes, Don L. Ivey, and T. J. Hirsch, Texas Transportation Institute, Texas A&M University

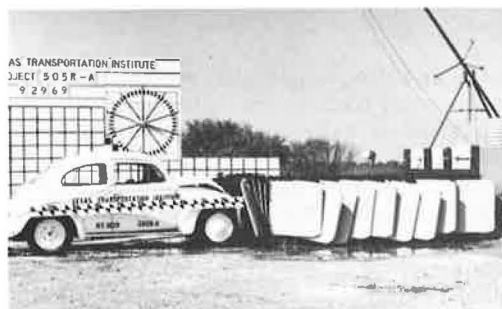
Figure 4. Vehicle and barrier after Test A.

Table 2 gives the pertinent test data. In the first test, a Volkswagen sedan weighing 1,820 lb impacted the barrier head-on at 42 mph. The vehicle was stopped in 13.2 ft with an average deceleration of 4.5 g and a peak deceleration of 14.6 g. The vehicle damage was not severe (Figs. 3 and 4).

Test A—No parts were replaced.

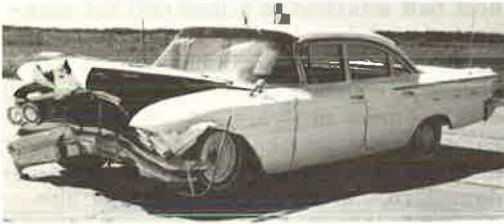
The second test used a Pontiac sedan weighing 4,650 lb that impacted head-on at an initial speed of 64 mph. The average deceleration over 17.3 ft and 0.34 sec was 7.9 g, while the maximum deceleration of 13.4 g was lower than that of the first test (Figs. 5 and 6).

Figure 6. Vehicle after Test B.

Test B—25 cartridges were replaced, 19 of which were repairable.

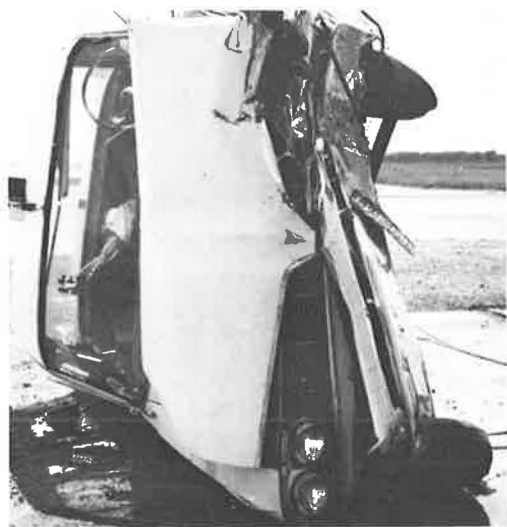
In the third test, a Pontiac sedan weighing 4,410 lb struck the cushion at 54 mph and at an angle of 20 deg with the barrier centerline. The vehicle had begun to redirect and had rotated approximately 5 deg when the main restraining cables pulled out of their front anchorage connections. The left front of the vehicle went head-on into the rigid barrier, and the vehicle rolled over on its right side (Figs. 7 and 8).

Figure 8. Vehicle after Test C.

Test C—Failure of anchorages caused damage that necessitated replacement of several fender panels, diaphragms, and interior panels. (Some replacements were made in the course of the previously mentioned modification of the barrier structure.)

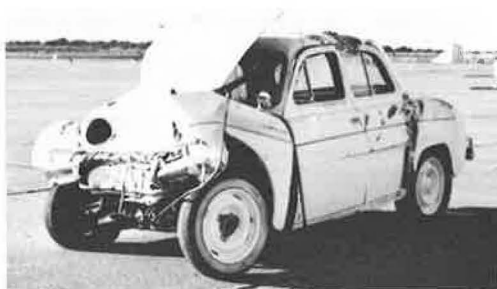
The vehicle apparently struck the front of the barrier about 1 ft off-center and started a yaw and roll motion, finally rolling over on its top after most of the kinetic energy had been absorbed (Figs. 9 and 10).

Figure 10. Vehicle after Test D (righted).

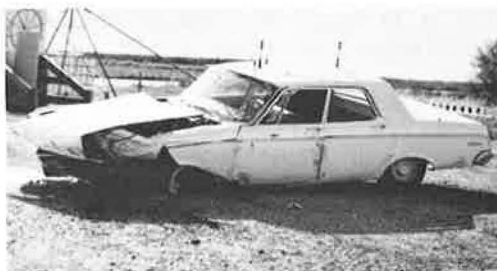
The final test was another 20 deg impact. A 3,710-lb Dodge sedan traveling at 59 mph was used. This was the only test in which the vehicle left the barrier with significant speed. The average longitudinal deceleration of 4.9 g was calculated over the distance in contact of 19.4 ft by noting the speeds at the beginning and end of this contact. The maximum deceleration was 8.9 g. Figure 11 shows the vehicle after the test.

Figure 11. Vehicle after Test E.

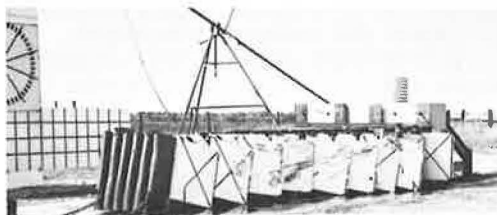
In this last test, the vehicle began to ramp or climb up the side of the barrier. It became completely airborne by as much as 1.5 ft for about 20 ft and, upon recontacting the ground, rolled over on its left side before coming to rest upright. Examination of vehicle and barrier indicates that a slight contact was made with the upper corner of the rigid steel wall. The path of the vehicle contact up the side panels is shown in Figure 12.

The steel barrier in front of the concrete wall was pulled away from the concrete about 6 in. at the bottom and about 2 in. at the top. The restraining cables were fastened to this steel barrier so this could allow as much as 2 ft of additional localized lateral movement to the cushion.

Figure 12. Barrier after Test E.

Test E—Damage occurred to fender panels only. No replacements were made because no further tests were planned.
