THE EFFECT OF GOOD VIBRATION ON THE DURABILITY OF CONCRETE PAVEMENT

Laurence C. Bower and Burrell B. Gerhardt, Colorado Department of Highways

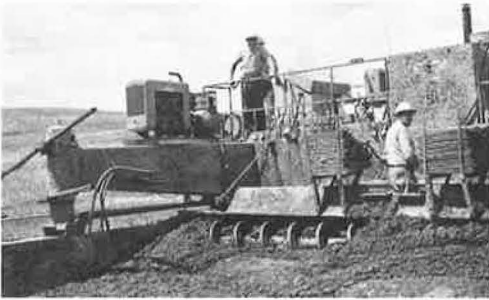
Figure 4. Paver used on project I80S with 15-kw, 180-cycle generator on right front leg of paver.

Occasionally the passing lane became the experimental lane and the driving lane was designated as the control section. The base course for this project was a 4-in., 3 percent SS-K emulsified asphalt-treated sand. The paver and vibrator mounting are shown in Figures 4 and 5.

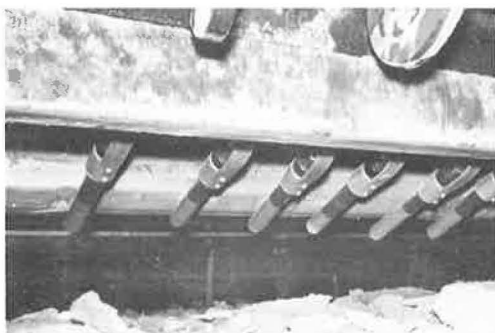
Figure 5. Internal vibrator mounted on paver.

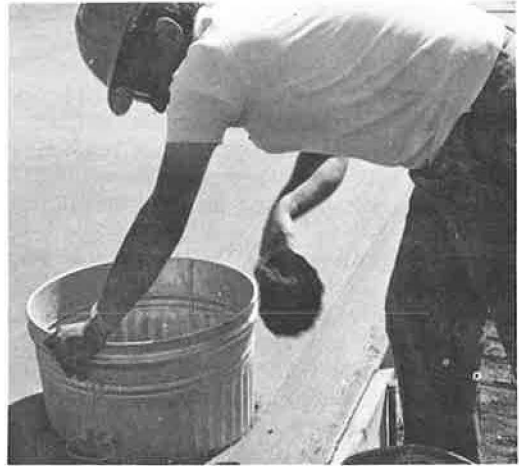
Figure 9. Sampling procedure for particle size analysis.

In addition to the regular tests for control of the construction, special tests recommended by the Federal Highway Administration officials were performed for segregation of particles, density, air content, and pressure around the vibrators. Selection of the sample for the particle size analyses was made in the finished pavement by pushing a 21-in. diameter cylinder (bottomless garbage bucket) into the mix and scooping out the top third, middle third, and bottom third of the concrete into separate containers for separate tests.
