# USE OF SILICONE ADMIXTURE IN BRIDGE DECK CONCRETE

H. L. Patterson, Michigan Department of State Highways

This report is the third in a series that resulted from a cooperative study, originally started in 1963 and sponsored jointly by the Dow Corning Corporation of Midland, Michigan, and the Michigan Department of State Highways, to determine the effects of using a silicone admixture in bridge deck construction. The previous reports dealt with the construction and initial inspection of the Scotten Avenue bridge over Michigan Avenue in Detroit and of the Coe Road bridge over US-27 in Isabella County.

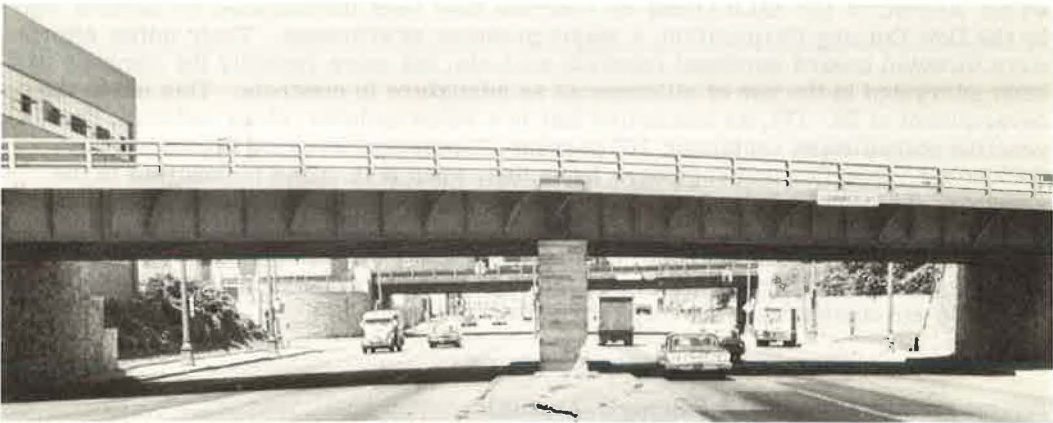
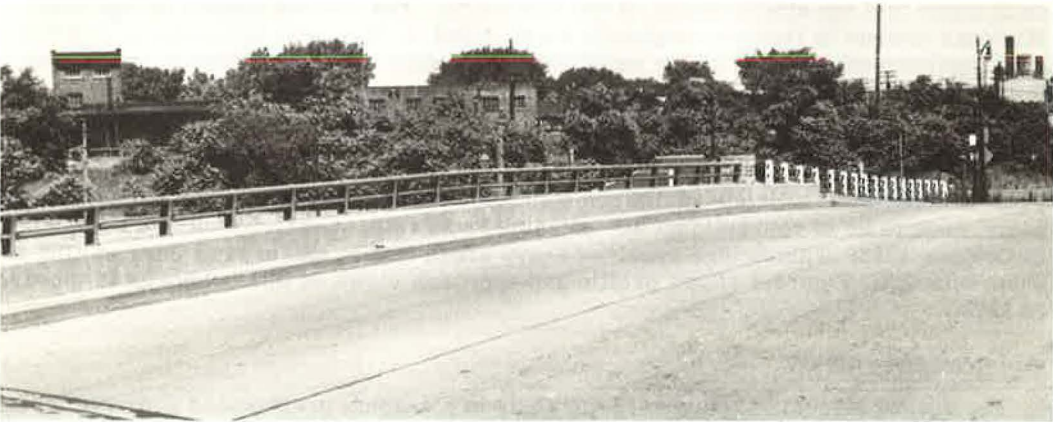
Figure 1. Scotten Avenue bridge over Michigan Avenue: (a) general view of bridge deck looking northwest and (b) profile view looking west along Michigan Avenue.

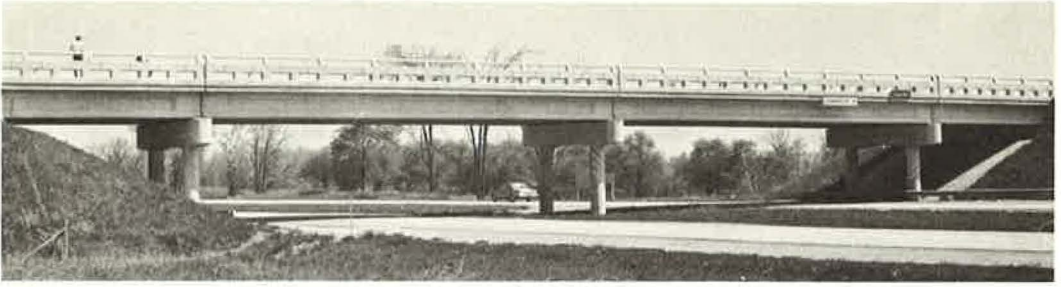
Figure 2. Coe Road bridge over US-27 south of the village of Shepherd: (a) general view of bridge deck from the west approach and (b) k profile view looking northwest.

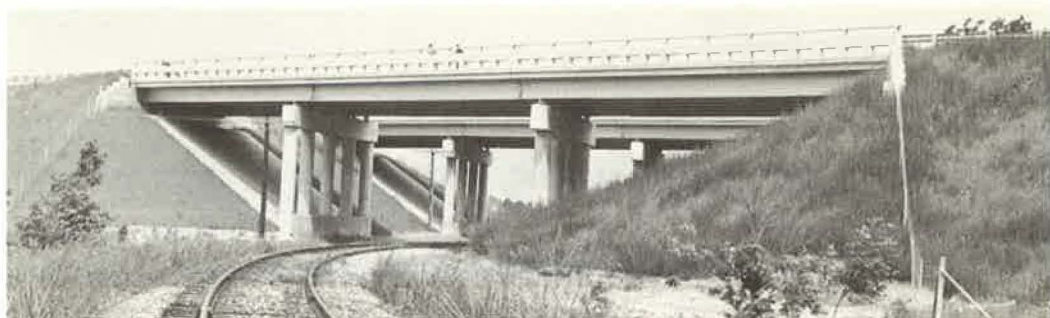
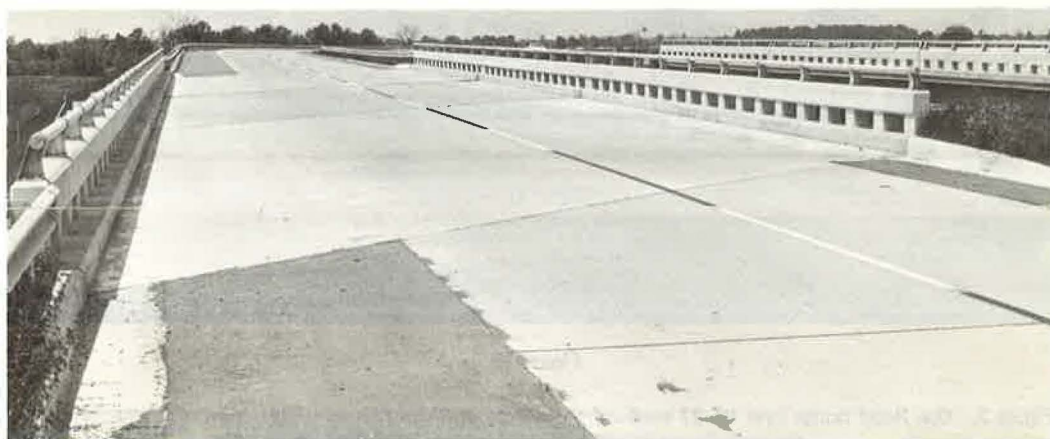
Figure 3. Eastbound M-78 bridge over the Grand Trunk and Western Railroad, southwest of the city of Flint: (a) general view of bridge deck looking west and (b) profile view looking northeast.

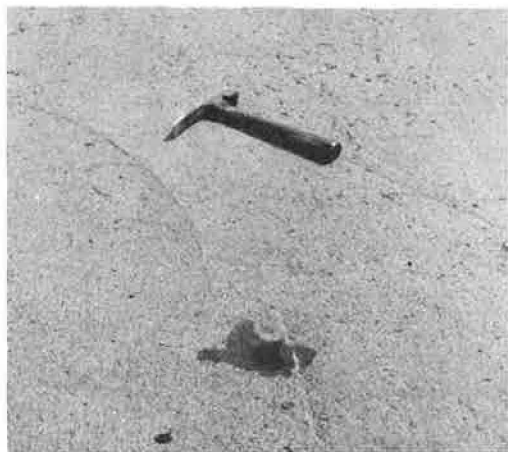
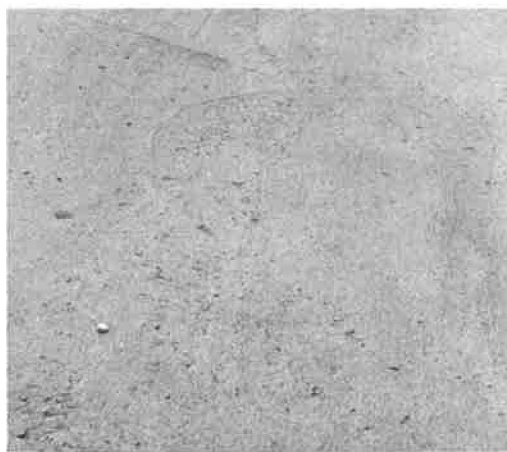
The plastic shrinkage cracks in the silicone developed within 36 hours after finishing and were prominently visible at that time. Three known conditions could have contributed to their formation: (a) the silicone concrete took 36 hours to set; (b) the slag aggregate, with its great absorption potential, had adequate time to absorb a significant amount of mix water; and (c) the polyethylene sheeting, with which the deck was cured, could have allowed air movement underneath if it was not properly sealed around its perimeter. The first 2 factors are considered to be the most critical on this project.

The pitted areas seem to have been produced by traffic abrasion, to which slag aggregate appears to be vulnerable. On successive annual inspections, it was noted that surface features photographed the first year could not be identified the second year. Although this abrasion was by no means confined to the silicone concrete, it was more distinct there because of the unfavorable location it occupied on the bridge deck with respect to traffic. That is, the bridge was on a vertical curve and the nature of the traffic pattern was such that vehicles would be braking as they left either end of the bridge deck where the silicone concrete was located.

The few small scaled areas and scattered iron pop-outs on the bridge appeared to be confined to the normal concrete pours. This would indicate that the silicone was effective in preventing these types of deterioration. Figure 5 shows some of the most prominent deterioration features found on the deck.

Figure 5. Deterioration on the Scotten Avenue bridge: (a) typical plastic shrinkage cracks found in silicone concrete, (b) light pitting to which slag aggregate appears vulnerable, and (c) 3- by 5-in. scale spot caused by volume expansion of rusting iron.

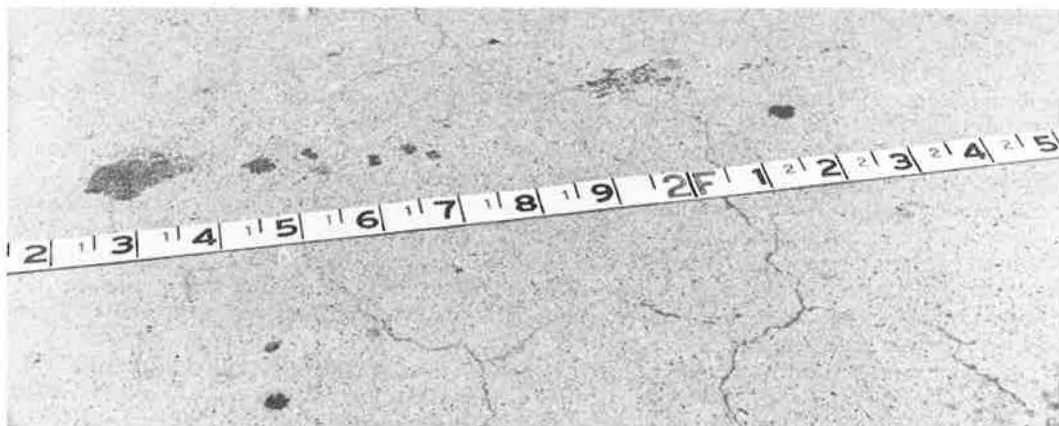
Figure 11 shows a diagram of the deterioration features that were visible at the time the deck was inspected; included are pop-outs and craze cracking in all 3 spans and light scale in span 3. The most prominent of these were the numerous pop-outs that developed uniformly over the entire deck surface; they developed in a pattern consistent with laboratory observations and suggested that the silicone admixture provided little protection for the frost-susceptible particles in the gravel lying close to the top surface of the concrete. Figure 11 also shows that both types of concrete developed large areas that were craze cracked. This type of cracking is generally the result of early surface shrinkage and could be caused by conditions similar to those that produce plastic shrinkage cracks.

Scaling is minor on this deck, being confined mainly to the south curb line in span 3 where the longitudinal screeding machine left the heaviest concentration of laitance. Because this thin layer of silt and cement was weak and brittle, it was soon removed by weathering and traffic abrasion and now gives the specious impression that the rapid destruction of the concrete is imminent; however, the concrete below laitance generally presents a more formidable surface. Figure 12 shows some of the prominent deterioration features described previously.

Figure 12. Deterioration on M-78 bridge included (a) pop-out concentration in traffic lane of span 2 and typical across entire deck, (b) distinct craze cracking area in traffic lane of span 2, and (c) light scaling of thin laitance coat along south curb line in span 3.
