HIGHWAY RESEARCH RECORD

Number | Loading History of Bridges
382 |
7 reports
prepared for the
51st Annual Meeting

BRIDGE STRESS-RANGE HISTORY

P. P. Christiano, L. E. Goodman, and C. N. Sun,
Department of Civil and Mineral Engineering, University of Minnesota

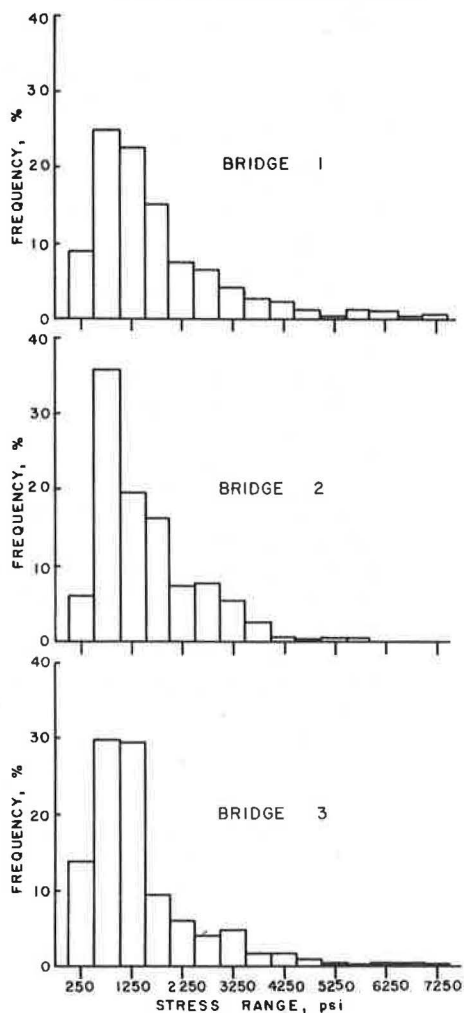
Figure 4. Distribution of stress range at end-of-cover-plate point on interior stringer.

Summaries of the stress-range frequencies for the most critical point, insofar as fatigue is concerned, on each bridge are shown in Figure 4. These stress-range frequency distributions were determined from the strain events recorded during the 24-hour sampling period for each bridge.

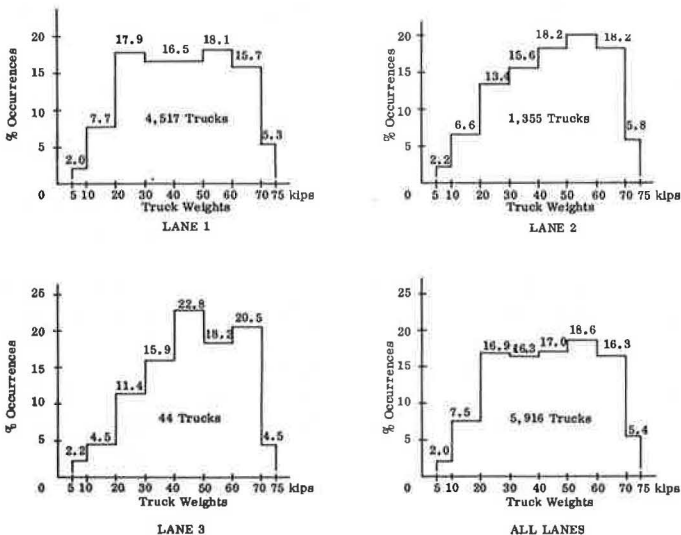
Figure 3. Percentage of trucks by weight range on I-95 bridge.

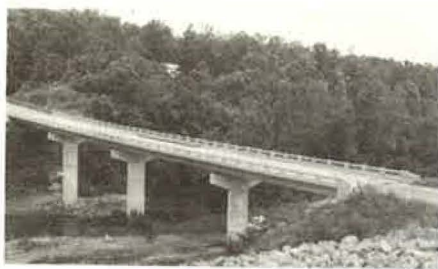
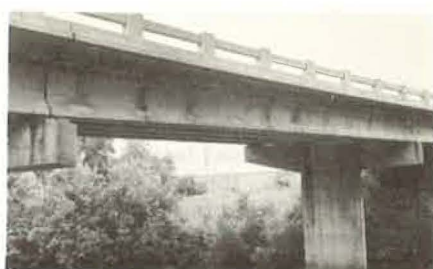
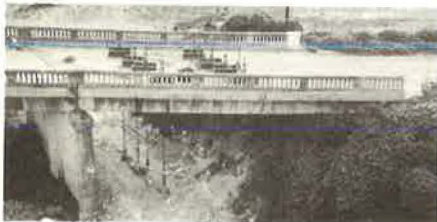
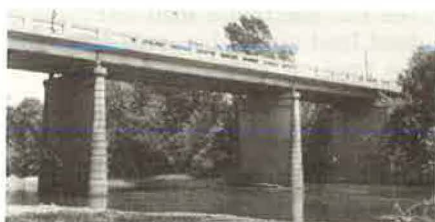
Figure 1. Test bridges.

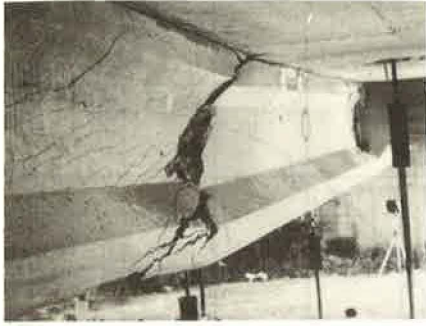
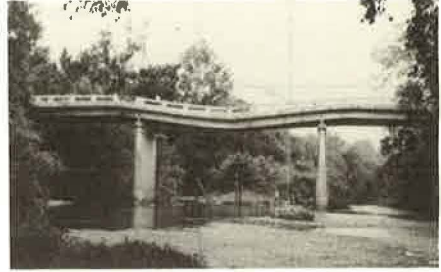
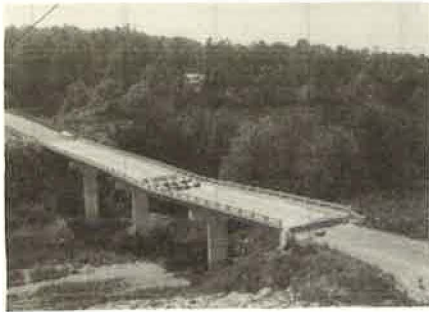
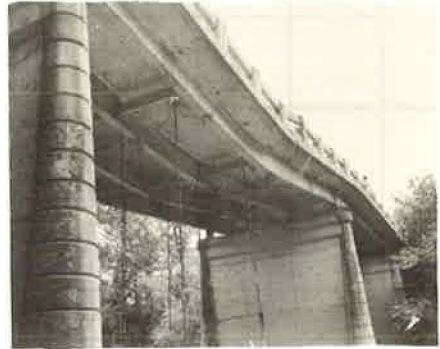
Figure 6. Mode of failure.

Bridge 1—The behavior of this bridge was almost linearly elastic up to yielding at the section under the applied loads nearest the center of the span. As the load was increased, there was considerable rotation at this section and, in turn, considerable deflection. Shortly after yielding began and the load was increased further, the bridge "lifted off" the abutment nearest the applied load, thus making it impossible to develop more moment at the first pier. The bridge continued to experience increasingly large deflections for each load increment until, after a very large deflection, yielding occurred, and a plastic hinge formed at a section near the center pier at the end of the cover plates on the side of the pier away from the loaded span. Shortly after this hinge formed, a secondary compression failure of one of the curbs occurred at the section of maximum positive moment, and the test was terminated.

Bridge 2—This bridge behaved in a predictable way up to a load of approximately 950 kips. However, there was considerable "dishing" of the bridge at this point, and the interior girders were deflected considerably more than the exterior girders. The result of this dishing was a tendency for the bridge deck to separate from the interior precast girders. At a load of approximately 950 kips this separation occurred, and composite action of the interior girders was lost as the vertical stirrups crossing the interface between girder and deck were sheared. After composite action was lost, the behavior of the bridge was radically changed. Almost immediately there was crushing of the extreme top fibers of the interior precast sections at the section of maximum moment. This crushing and accompanying rotation resulted in a redistribution of moments at the section and an increase in the moment in the exterior girders. As the load was increased further, the interior girders failed in shear, and the test was terminated.
