HYBRID BARRIER FOR USE AT BRIDGE PIERS IN MEDIANS (MODULAR CRASH CUSHION PLUS CONCRETE MEDIAN BARRIER)

Gordon G. Hayes, Don L. Ivey, and T. J. Hirsch, Texas Transportation Institute,
Texas A&M University; and
John G. Viner, Federal Highway Administration

A traffic safety barrier for use at bridge piers in roadway medians has been designed and crash-tested. The hybrid system consists of steel drum crash cushions that have smooth transitions to concrete median barriers. The system is narrow enough to allow installation in relatively restricted median areas under highway overpasses. The crash cushions, which are located in front of the outermost bridge piers, act as energy absorbers for frontal impacts and as redirection barriers for angle impacts. The concrete median barrier serves as a redirection barrier for "interior" angle impacts. Two vehicles were directed into the side of the crash cushion at 10 and 20 deg to test the system in the crash cushion median barrier transition area. The vehicles were redirected smoothly and showed no spin-out or overturning tendency. Without structural repairs to the barrier after the 10-deg test, a lightweight vehicle was directed head on into th

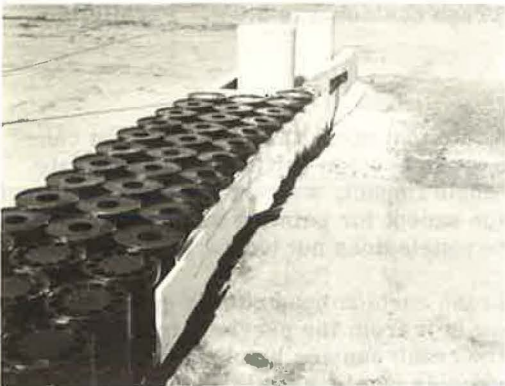
Figure 5. Barrier after Test B (oblique view).

Figure 5 shows the barrier after the test, and Figure 6 shows sequential photographs of the test. The damage to the crash cushion was slight. The redirection was very smooth, with only a slight ramping of the left front end of the vehicle observed. The vehicle left the barrier at an angle of about 5 deg to the centerline of the crash cushion; the tracks of the vehicle as it left the barrier can be seen in Figure 5. The damage to the vehicle is shown in Figure 7. The vehicle was driven away from the site after the test, which indicates, along with the small angle of departure, that a driver could have maintained control after the impact.
