# EVALUATION OF CRASH CUSHIONS CONSTRUCTED OF LIGHTWEIGHT CELLULAR CONCRETE

Don L. Ivey, Eugene Buth, and T. J. Hirsch, Texas Transportation Institute,  
Texas A&M University; and  
John G. Viner, Federal Highway Administration

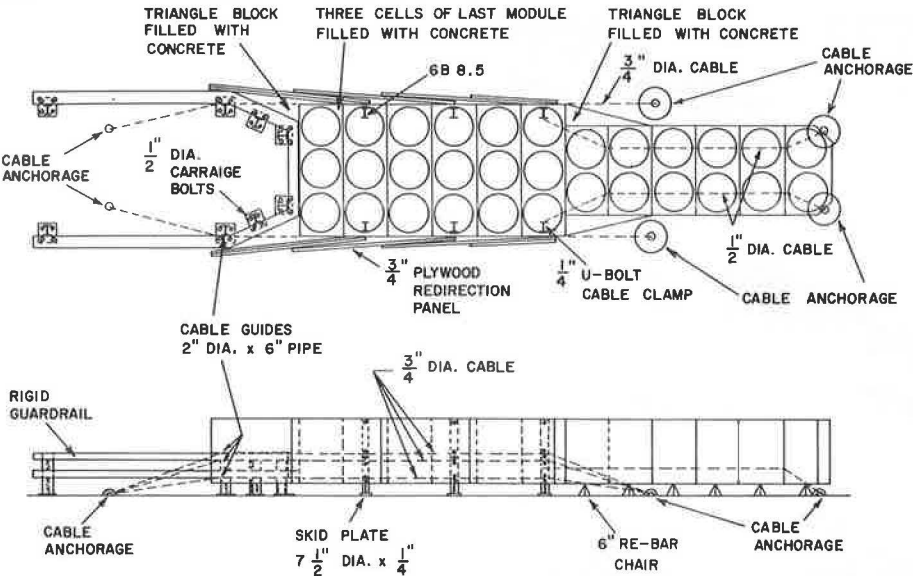
Figure 3. Florida Tests 1 and 2, Mod II concrete crash cushion.

•THE feasibility of vehicle crash cushions constructed of lightweight cellular concrete was demonstrated by a series of three head-on vehicle impacts on prototype installations (1). The concrete crash cushion is one of a group of first-generation devices that include the barrel crash cushion, the Fitch inertia barrier, and the Hi-Dro Cell barrier. The evaluation sequence that was followed with all of these systems is (a) feasibility testing, (b) full-scale head-on testing, and (c) side-angle testing. Because of the excellent performance of the concrete cushion in the first three tests conducted, several states were interested in applying the concept to some of their potentially hazardous areas. The basic cushion (2) that was tested under the Federal Highway Administration's 4S Program (Fig. 1, Mod I) and the side-fender panels previously tested as part of barrel crash cushion designs (3) were incorporated in a concrete cushion designed for Florida. The results of two side-angle tests of the system constructed for Florida (Fig. 1, Mod II) were reported to Florida in November 1970 (2).

It was decided that additional tests would be conducted to further evaluate the concrete cushion for both side-angle impacts and head-on impacts involving small vehicles. Further modifications of the cushion were made prior to the final series of tests that resulted in the design shown as Mod II in Figure 1. The most significant concrete cushion designs that have been tested are shown in Figures 2 through 4. This report describes in detail the three tests that were conducted on the Mod III concrete crash cushion.

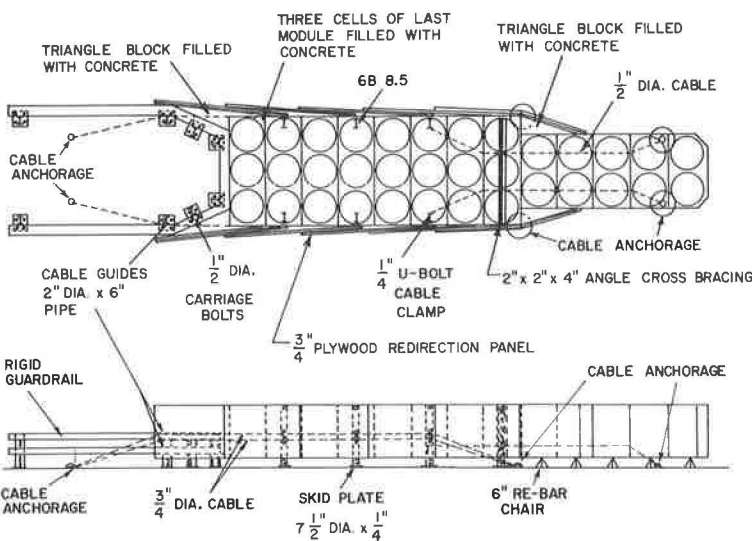
Figure 4. Tests D, E, and F, Mod III concrete crash cushion.

Three full-scale vehicle crash tests (designated D, E, and F) of the Mod III concrete crash cushion (Fig. 4) were conducted in this final test series; the results are given in Table 1. Properties of the concrete used in the various cushions tested are as follows,

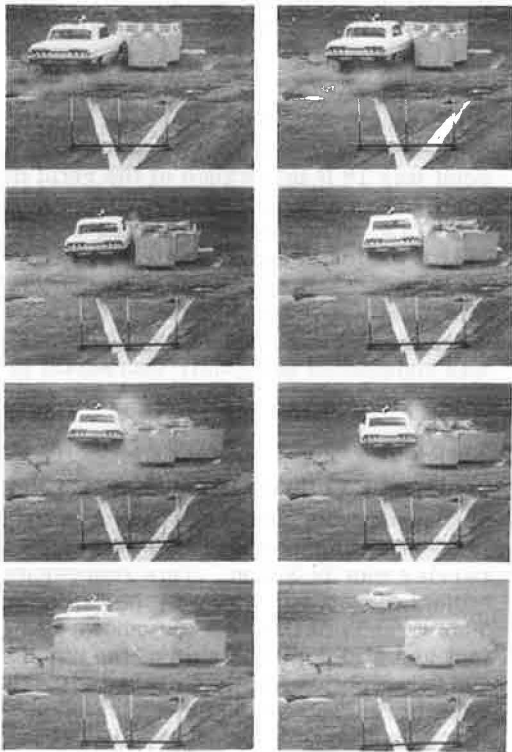
Figure 5. Test D sequential photographs (view parallel with barrier).

In this test a 1963 Chevrolet weighing 3,790 lb was impacted into the cushion at a 10-deg angle from the longitudinal axis of the cushion (Fig. 5). The contact point was 18 ft in advance of the rigid backup rail. The speed at contact was 57.2 mph, and the speed at loss of contact was 49.6 mph. The average longitudinal deceleration was 1.3 g. The distance that the vehicle was in contact with the barrier was 20.4 ft over a period of approximately  $\frac{1}{3}$  sec. The vehicle laterally penetrated the barrier a maximum distance of about 2 ft. The vehicle was smoothly redirected, and damage was relatively light (Fig. 6). Figure 7 shows that only five modules were significantly damaged and that the cushion could probably still sustain a head-on impact. The test was considered extremely successful in regard to both passenger safety and vehicle damage.

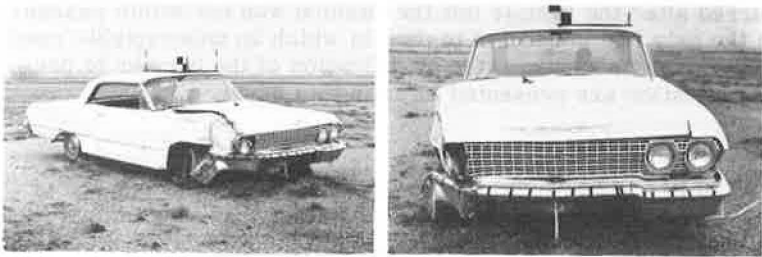
Figure 6. Vehicle after Test B.

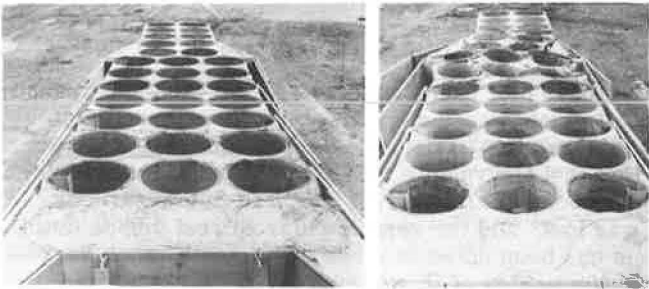
Figure 7. Barrier before and after Test D (end view).

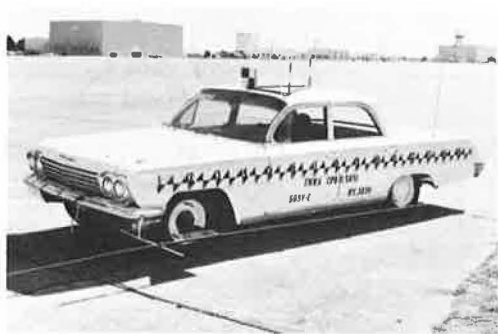
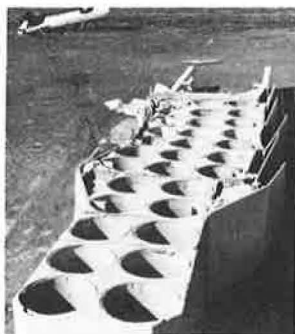
Figure 8. Vehicle before Test E and in final position.

In this test a 1962 Chevrolet, weighing 3,820 lb was impacted into a Mod III barrier at a 20-deg side angle. The point of contact was 16 ft in advance of the rigid backup rail. The impact speed was 59.7 mph, and vehicle speed at loss of contact with the barrier was 29.3 mph. This represented an average deceleration of 5.6 g in the longitudinal direction. The vehicle was in contact with the cushion for approximately 16 ft. Photographs of this test are shown in Figures 8 through 10. As the vehicle made contact and slid down the side of the cushion, a slight ramping tendency was observed. This interaction finally culminated in the generation of a high roll-initiating force as the vehicle reached the end of the cushion. The vehicle rolled in a counterclockwise direction (when viewed in the direction of vehicle travel); ramped on the rear of the cushion near the end of the backup rail; traveled beyond the cushion installation, skidding on its left side; rolled clockwise to an upright position; and continued to roll over onto its top. It came to rest approximately 80 ft past the barrier. Although the decelerations, which were caused by vehicle-cushion interaction, were within the range of human tolerance, the roll condition that occurred after the vehicle left the cushion was not within passenger safety limits. This is the only test conducted to date in which an unacceptable reaction of the vehicle occurred. Recommendations for modification of the barrier to preclude the recurrence of this situation are presented later in this paper.

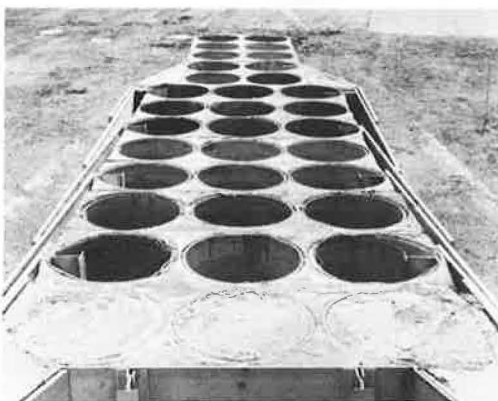
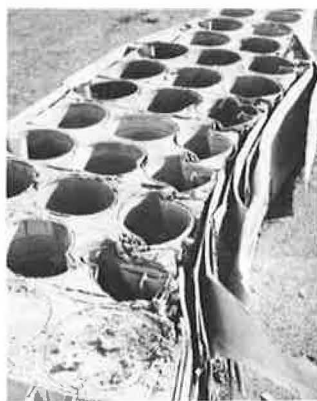
Figure 9. Barrier before and after Test E.

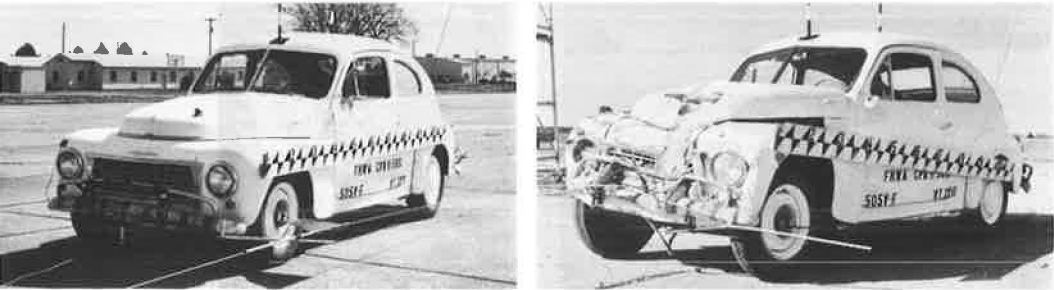
Figure 11. Vehicle before and after Test F.

A 1957 Volvo weighing 2,210 lb was impacted into the cushion head on at a speed of 61 mph. The average longitudinal deceleration was 10.2 g, with a peak longitudinal deceleration of 19 g. The interaction of the vehicle and cushion was considered acceptable. The damage done to the vehicle and cushion is shown in Figures 11 and 12.

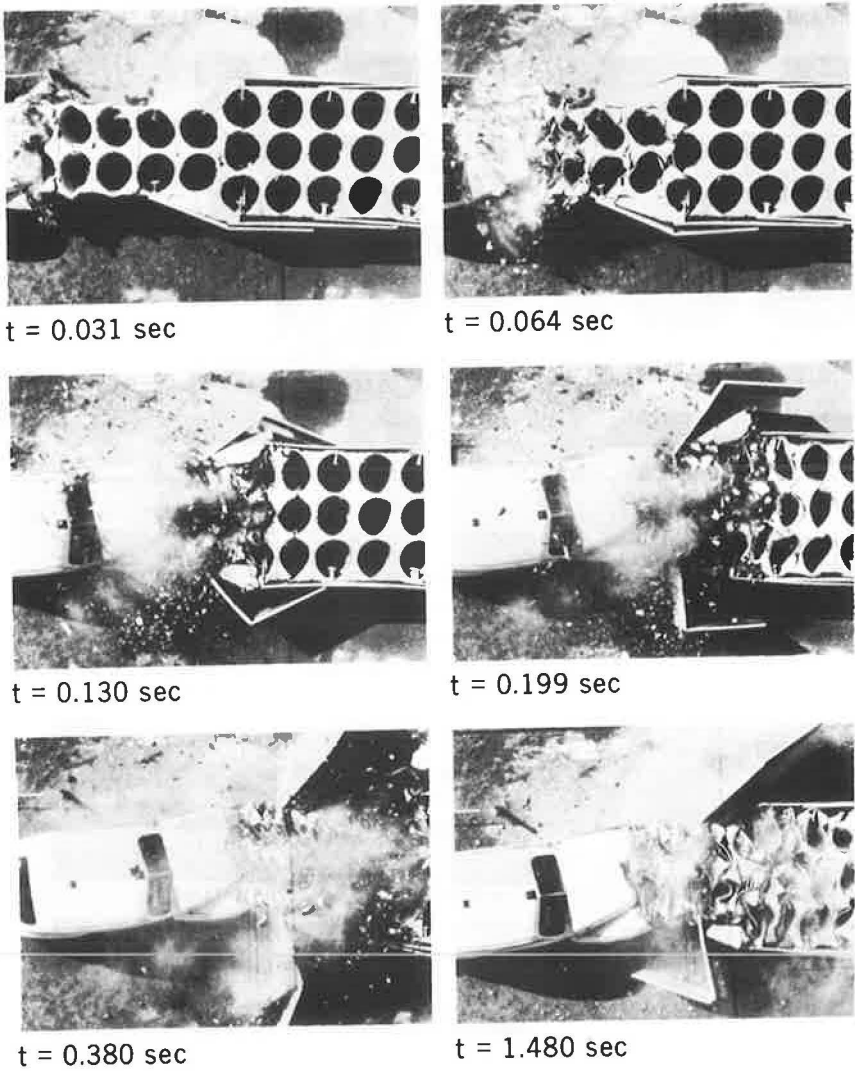
Figure 12. Test F sequential photographs (overhead view).
