DYNAMIC TESTS OF AN ENERGY-ABSORBING BARRIER EMPLOYING SAND-FILLED PLASTIC BARRELS

Eric F. Nordlin, J. Robert Stoker, and Robert N. Doty,
California Division of Highways

The results of three full-scale tests of vehicles impacting energy-absorbing barriers employing sand-filled frangible plastic barrels are reported. The barriers were designed for placement in front of fixed objects located in freeway gores. They were composed of an array of 15 to 17 barrels 36 in. in diameter by 30 and 36 in. high. The barriers were 21 and 25 ft long and tapered from a 9-ft width at the rear to a 3-ft width at the nose. The barrels were not attached to the ground. Sedans weighing approximately 4,700 lb impacted the nose of the barrier head on at a speed of approximately 60 mph and at a 15-deg angle. A small sedan weighting about 1,900 lb also impacted the nose of the barrier head on at 59 mph. The barrier was judged acceptable in the areas of cost, ease of construction and maintenance, aesthetics, simplicity, and versatility and is recommended for use in operational trial installations.

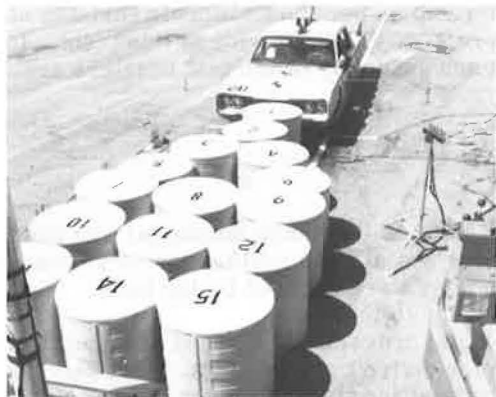
Figure 3.

The initial barrier (Test 241) was constructed using barrels containing 400 lb of sand at the nose and 2,100 lb of sand at the rear (Figs. 3 and 4 and Appendix, Fig. 22). This mass distribution was designed to obtain a relatively uniform rate of deceleration during impacts. The tapered barrier was 3 ft wide (one barrel) at the nose and 9 ft wide (three barrels) at the rear.

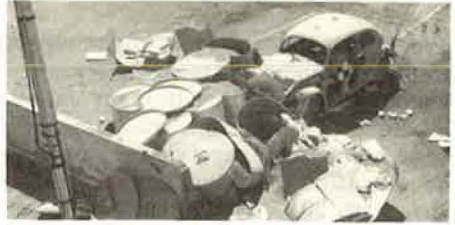
Figure 11.

Vehicle Behavior and Damage—The VW hit the barrier nose head on with its axis about 9 in. to the left of the barrier centerline. The impact velocity was 59 mph. The vehicle came to rest 19 ft beyond the nose of the barrier with all its wheels on the ground (Figs. 11 and 12). During impact there was a 16-in. rise at the rear of the vehicle (measured at a target on the right rear fender). (See Fig. 27 in the Appendix for a summary of the test results.)

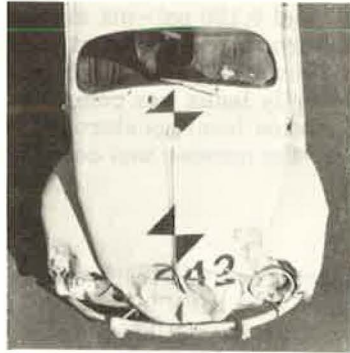
Figure 13.

The front truck lid remained closed and was moderately buckled, as were the front fenders. Maximum crush at the forestructure of the VW was only 8 in. (Appendix, Fig. 24, and Fig. 13). The impact from the dummy's head caused the entire windshield to pop out. The substitution of a pulley for the standard VW steering wheel (required for radio control of the VW) prevented measurement of any steering wheel deformation.

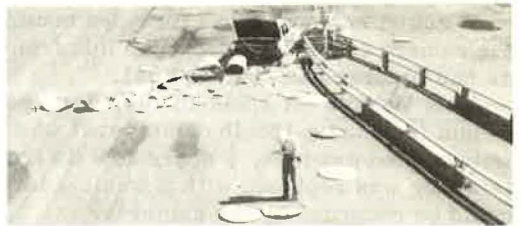
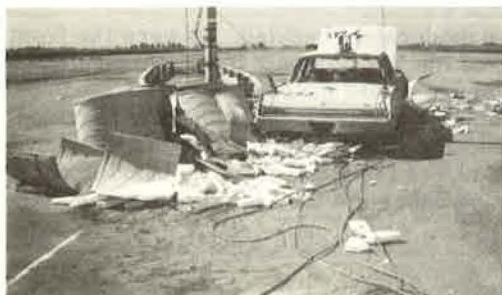
Vehicle Behavior and Damage—The crash vehicle hit the nose of the barrier about a foot to the right of the planned point of impact at a speed of 57 mph and an angle of 15 deg with the barrier axis. It ramped up midway into the barrier, continued on through it, narrowly missed the right corner of the Type 8 bridge approach guardrail nose, and stopped with the rear of the vehicle even with the last row of barrels in the barrier. It came to rest with all wheels on the ground on a thin layer of sand (Figs. 17 and 18). (See Fig. 29 in the Appendix for a summary of the test results.)

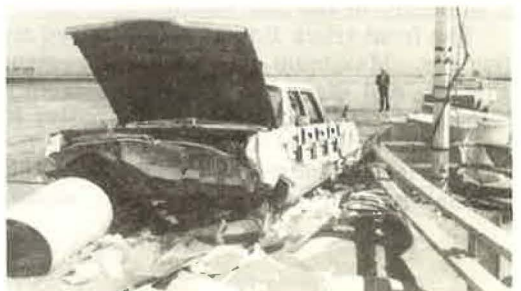
Figure 19.

Damage to the vehicle forestructure was quite severe (Fig. 19). The front end, including fenders, was uniformly crushed back against the engine. The maximum crush was 21 in. (Appendix, Fig. 24). The engine was not displaced. The lower longitudinal front frame members and the bumper were sharply buckled down to the ground and back against the front wheels. The hood was undamaged because of the relatively low height (30 in.) of the first four rows of barrels. A crimp in the roof was observed on the driver's side above the doorpost. The rest of the car was undamaged. Maximum deformation of the steering wheel was $2\frac{3}{4}$ in. The collapsible steering column was shortened $\frac{3}{4}$ in. by the dummy's impact.

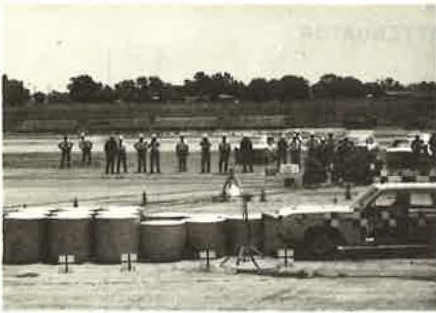
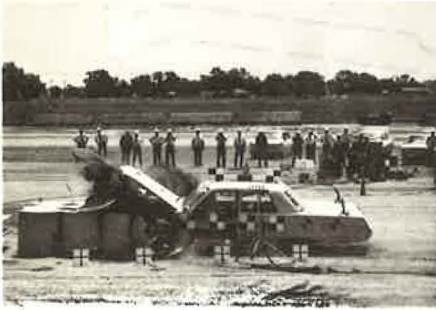
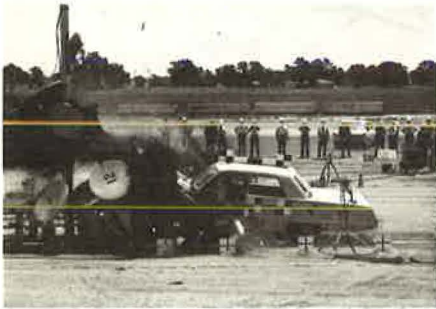
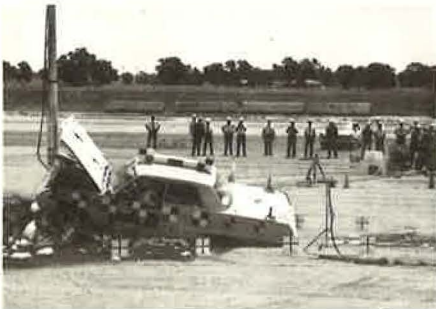
Figure 25.

Impact + 0.027 Sec.

Impact + 0.231 Sec.

Impact + 0.435 Sec.

Impact + 2.373 Sec.

Test No.	241
Date of Test	May 21, 1970
Vehicle	1968 Dodge
Vehicle Weight (w/dummies and instrumentation)	4690 lb.
Impact Velocity (V_0)	58.0 mph
Impact Angle	Head-on
Dummy Restraint	Lap Belt
Barrier Depth	2'1"-10"
No. of Plastic Barrels	15

Deceleration Distance of Passenger Compartment	24'-0"
Maximum Vehicular Deformation at Forestructure	1'-8"
Passenger Compartment Deceleration - Highest 50 ms. avg. - accelerometer record, 100 Hertz	10.7 G's
Vehicular Deceleration - Avg. value based on $V_0^2 = 2as$ where $s = 24.0'$ (stopping distance)	4.7 G's
Gadd Severity Index (Dummy's head)	185

Vehicle damage was confined mainly to the front end. Maximum significant crush at the center of the vehicle forestructure was $1\frac{2}{3}$ ft. The crush was fairly uniform across the front of the vehicle but slightly less on the left side (Fig. 8 and Appendix, Fig. 24). The lower frame member, bumper, and front fenders were all severely buckled, and the radiator was shoved back against the engine. On the passenger side, the front windshield was cracked where the sun visor came down and was struck by the dummy's head. No crimp in the roof over the doorpost was observed. The doorpost on the driver's side was torn loose from its roof connection and displaced back $\frac{1}{2}$ in. Immediately after impact, the hood flew open; however, it sustained no damage because the level of the hood was higher than the $2\frac{1}{2}$ -ft-high barrels at the nose of the barrier. The steering wheel deformation was $2\frac{1}{2}$ in.; the collapsible steering column was foreshortened 0.7 in. when hit by the dummy. (See Fig. 25 in the Appendix for a summary of these results.)

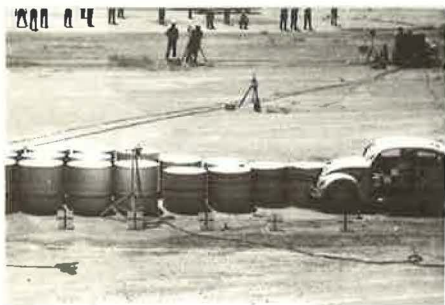
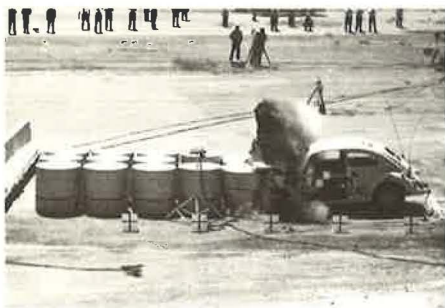
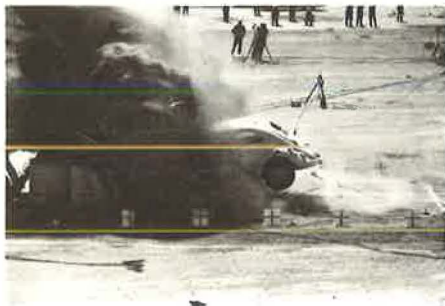
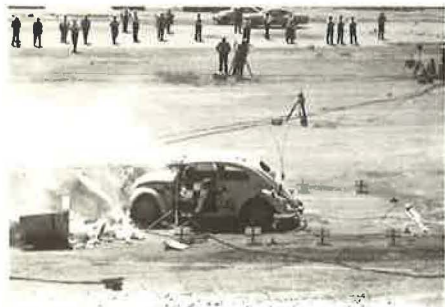
Figure 27.

Impact + 0.022 Sec.

Impact + 0.163 Sec.

Impact + 0.586 Sec.

Impact + 4.536 Sec.

Deceleration Distance - Passenger Compartment	19'-0"	Test No.	242
Maximum Vehicular Deformation at Fcstructure	8"	Date of Test	September 4, 1970
Passenger Compartment Deceleration - Highest 50 ms. avg. - Accelerometer Record, 176 Hertz	8.7 G's	Vehicle	1957 Volkswagen Sedan
Vehicular Deceleration = Avg. value based on $V_0^2 = 2as$ where $s = 19.0'$ (stopping distance)	6.1 G's	Vehicle Weight (w/dummy & Instrumentation)	1940 lbs.
Gadd Severity Index (Dummy's head)	1280	Impact Velocity (V_0)	59.0 mph
		Impact Angle	Head-on
		Dummy Restraint	Lap belt
		Barrier Depth	25'-3"
		No. of Plastic Barrels	17

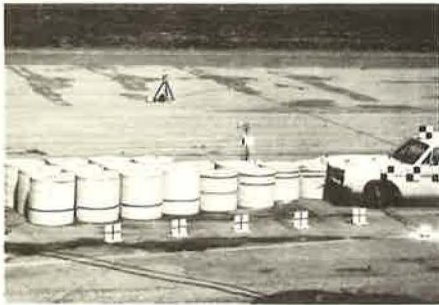
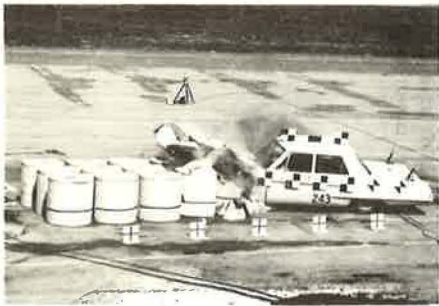
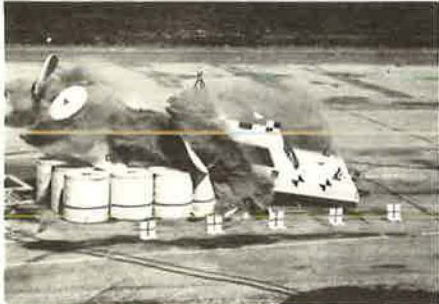
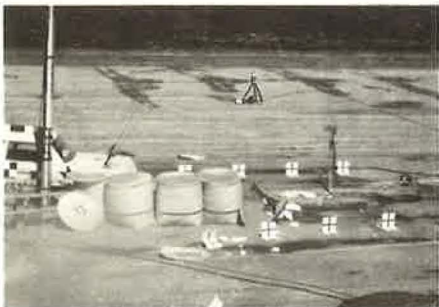
Figure 29.

Impact + 0.012 Sec.

Impact + 0.180 Sec.

Impact + 0.348 Sec.

Impact + 8.880 Sec.

Deceleration Distance - Passenger Compartment	39'-0"	Test No.	243
Maximum Vehicular Deformation at Forestructure	1'-9"	Date of Test	September 24, 1970
Passenger Compartment Deceleration - Highest 50 ms. avg. - accelerometer record, 176 Hertz	7.9 G's	Vehicle	1968 Dodge
Vehicular Deceleration - Avg. value based on $V_0^2 = 2as$ where $s = 39'-0"$ (stopping distance)	2.8 G's	Vehicle Weight (w/dummy & instrumentation)	4770 lbs.
Gadd Severity Index (Dummy's head)	580	Impact Velocity (V_0)	57 mph
		Impact Angle	15° nose
		Dummy Restraint	Lap belt
		Barrier Depth	25'-3"
		No. of Plastic Barrels	17
