CRASH TEST EVALUATION OF STRONG-POST, ENERGY-ABSORBING GUARDRAIL USING A LAPPED W-BEAM FOR TRANSITIONS AND MEDIAN BARRIERS

Grant W. Walker, Dynamics Research Manufacturing, Inc.; and
Charles Y. Warner, Brigham Young University

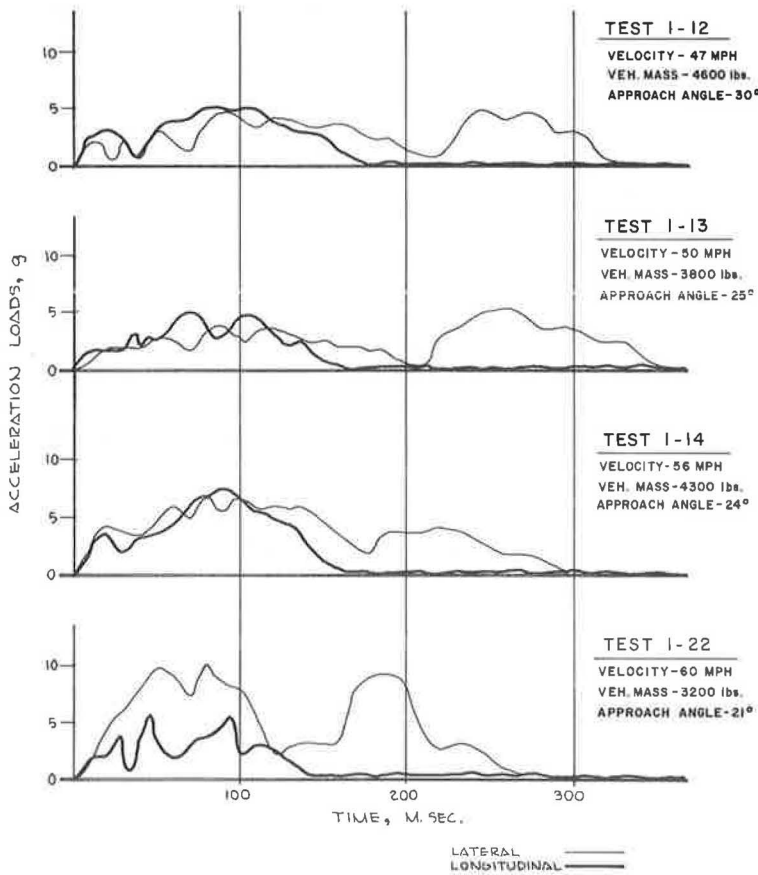
Figure 6. Lateral and longitudinal load comparisons.

Table 1 summarizes the important parameters and results for this series of tests. Figure 6 shows acceleration-time histories as measured on the floor pan of the test vehicles. Figures 7 and 8 show vehicle and guardrail damage after a 57-mph, 24-deg impact (Test 1-14). A description of each test follows.

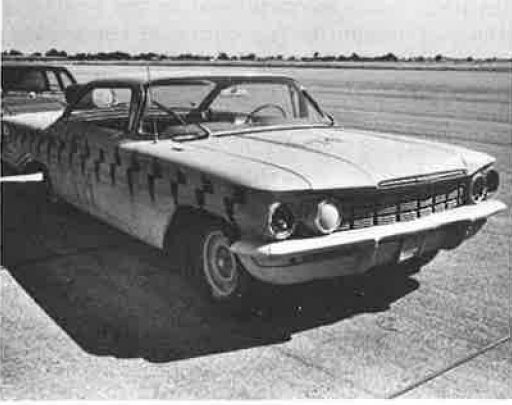
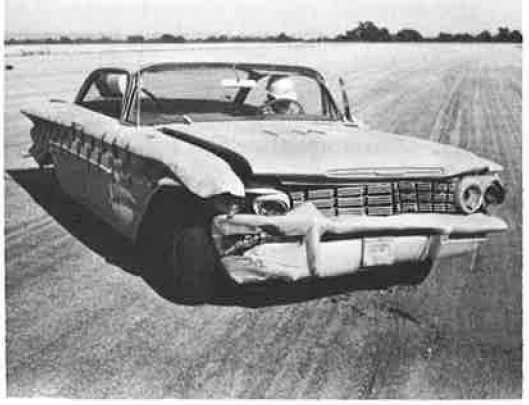
Figure 7. Test vehicle before and after impacts.

In this test, a 1960 Oldsmobile hardtop convertible weighing 4,300 lb impacted the rail at a speed of 56 mph and an angle of 24 deg. Again, damage to the vehicle was limited to moderate suspension bending and sheet metal deformation, at both front and rear of the car, with no discernible frame damage. The vehicle left the rail at a 10-deg angle and rolled freely on all four tires. Six rail bolts were snagged during impact. Both longitudinal and lateral average g loads, were approximately 4 g during impact.
