DYNAMIC TESTS OF THE CALIFORNIA TYPE 15 BRIDGE BARRIER RAIL

Eric F. Nordlin, J. Robert Stoker, Raymond P. Hackett, and Robert N. Doty,
California Division of Highways

The results of two full-scale vehicle impact tests of the California Type 15 bridge barrier rail are reported. The Type 15 bridge rail is a semirigid system consisting of two 3½-in. square structural steel tubular rails mounted 14 and 27 in. above the pavement on 6-WF-25-steel posts bolted to the edge of the reinforced concrete bridge deck. The post spacings tested were 6 ft 3 in. and 9 ft 4½ in. This bridge barrier rail was designed for use on secondary California highways with maximum bridge widths of 32 ft. The tests were conducted at impact velocities of approximately 60 mph and approach angles of approximately 15 deg. The test results indicate that the bridge rail designs tested will retain and redirect a 4,500-lb passenger vehicle impacting at a speed of 60 mph and an angle of 15 deg. Tolerable deceleration rates, moderate vehicle damage, and minor to moderate barrier damage will be sustained. However, it was concluded that a post spacing of 8 ft 0 in. would provide an effective, economical, and aesthetically

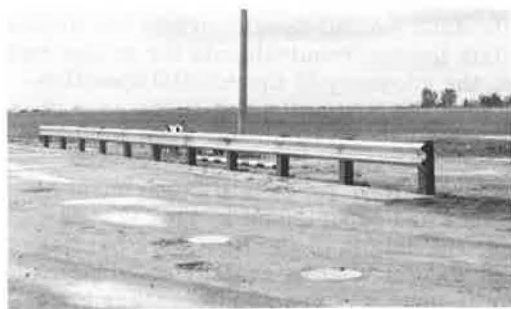
Figure 1.

The metal beam bridge railing frequently used on California's secondary roads in the past was developed and tested in 1959 (1) as part of a test series to investigate existing and proposed bridge rail designs. This metal beam bridge railing consisted of a single steel W-section beam mounted 24 in. high on steel H-section posts bolted to the outside edge of the concrete bridge deck at 6 ft 3 in. on centers (Fig. 1).

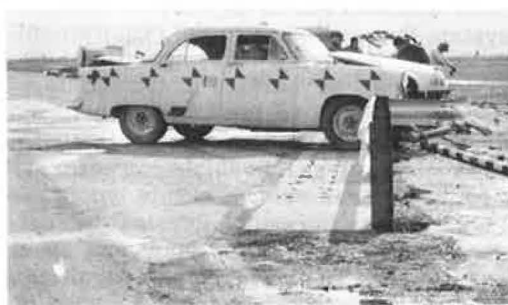
Figure 2.

In the 1959 tests, a 4,000-lb passenger vehicle was impacted into the bridge railing at a speed of 55 mph and an angle of 30 deg. The crash produced severe wheel-post entrapment and excessive rail deflections (Fig. 2). Although this design was not judged adequate for freeway use, it was considered suitable at that time for placement on federal-aid secondary highways and certain California state highways where only lower speed, flat, oblique-angle collisions were expected. It proved to be an economical and effective barrier under these conditions. However, as heavier, higher speed vehicles became more prevalent on these secondary highways, failures began occurring even at low, oblique impact angles. These failures were attributed to the inability of the single W-section beam to adequately distribute the larger impact loading outside the immediate impact area. Thus, only the posts very close to the impact area were being loaded, and failures were occurring at the post-to-deck connections in much the same manner as had been observed in the 1959 test series.

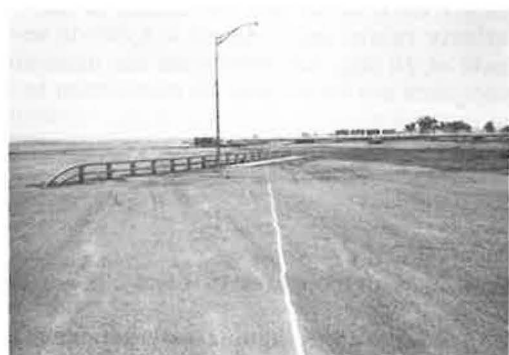
Figure 3.

The test installation consisted of 67 ft of Type 15 bridge barrier rail and 52 ft of Type 15 bridge approach guardrail (Fig. 3).

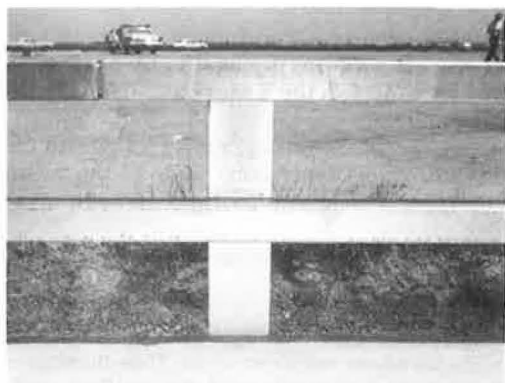
Figure 5.

The rails were 3½-in. square, 10½-lb structural steel tubing that conformed to the requirements of ASTM Designation A 500, grade B. The interior sleeve-type rail splice (Fig. 5) and the ¾-in. welded stud rail-to-post connectors that proved effective in a previous test series (4) were again used.

One problem encountered during construction or reconstruction of the bridge barrier installation was with the interior sleeve rail splice. It was reported by construction personnel that the lateral sliding tolerance between the sleeve and the interior of the tubular rail was too great; thus rail alignment at the splices was not as close as was desired. However, it should be noted that this clearance must be adequate to permit the splice sleeve to slide readily inside the tube for ease of barrier construction and rail replacement.

Another point of concern was the dimensional tolerances for the slotted hole in the tubular rail. When repairs were made the splice sleeves were not readily interchangeable, particularly when a tube that had been bent from the previous impact was used. This, however, could easily be remedied by increasing the slot width from 7/16 in. to 1/2 in. This should provide the needed tolerance for interchangeability.

Also, some method of sliding the sleeve other than hammering on the bolt head should be devised. The use of either a slot in the adjoining tube, with a corresponding hole in the splice sleeve, or a slot and corresponding hole on the opposite side of the

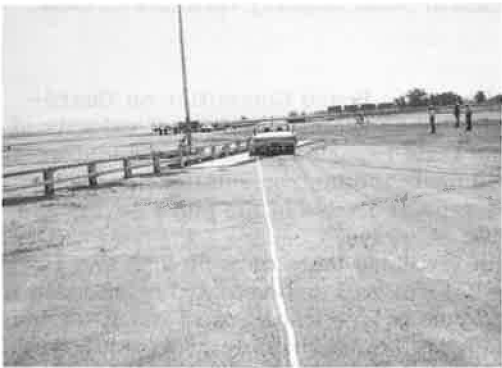
Figure 6.

Test 251 was conducted to test the ability of the initial Type 15 bridge barrier rail design (6-ft 3-in. post spacing) to redirect a passenger vehicle impacting at a moderate velocity and approach angle (Fig. 6).

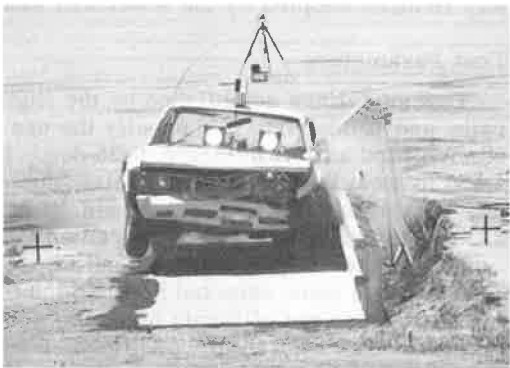
Figure 8.

Barrier damage was relatively minor. Two rail sections and three posts were deformed and would have required replacement for aesthetic reasons. However, all the barrier components were intact structurally and the barrier was still functional. The maximum residual lateral rail deflections occurred at post B-5, approximately 3 ft downstream of initial impact. The permanent deformations of the upper and lower rails were 0.21 ft and 0.14 ft respectively (Fig. 8).

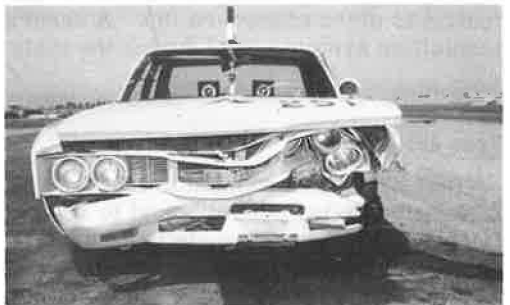
Figure 9.

Vehicle damage was moderate, consisting of paint scratches and sheet metal deformation at the left front corner, along the left side, and at the left rear fender. The grill, headlights, and fender at the left front end were extensively deformed, a portion of the front bumper was torn away, and the bumper mounting brackets and leading frame members were distorted back toward the front wheel. However, the deformation was essentially superficial, and, except for the possible rubbing of distorted sheet metal against the front tire, the vehicle appeared to be operable (Fig. 9).

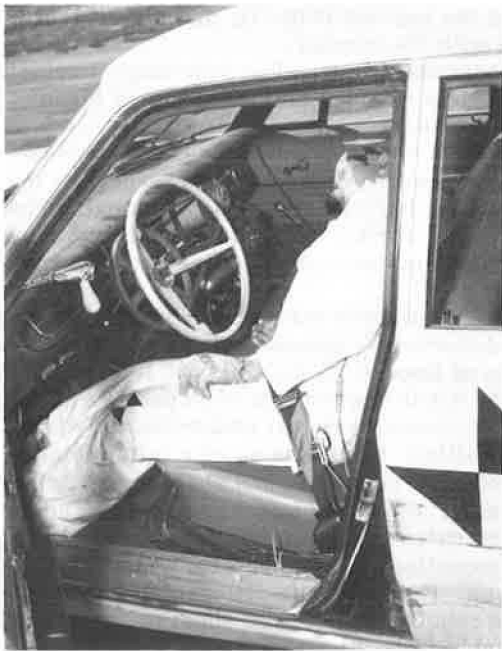
Figure 10.

Inside the passenger compartment, there was no appreciable deformation of the steering wheel rim or of the left front door frame to indicate that the dummy had been subjected to high deceleration forces (Fig. 10). However, deceleration recording instrumentation indicated that the deceleration forces, particularly in the lateral direction, were higher than anticipated or desired. Records of the instrumentation data are contained elsewhere (6). A summary of these data is as follows:

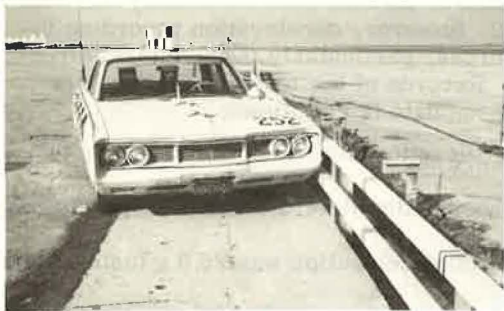
Figure 11.

Analysis of the results of Test 251 led to the modification of the test barrier installation to provide a post spacing of 9 ft 4½ in. The post spacing was increased to introduce more flexibility into the barrier rail system, thereby lessening the severity of a collision with the barrier. To achieve this modification, seven posts were removed and 2-ft square sections of the cantilevered bridge deck were removed at three locations. New post anchor bolts were installed at these locations, the deck edges within the removed sections were coated with epoxy, and new concrete was cast using a 6 sack mix. The 28-day compressive strength of the concrete was 4,540 psi. The steel rail sections from the original barrier were modified to provide stud bolts and rail splices at the new locations as required. This resulted in a discontinuity in the lower rail. However, this discontinuity was far enough from the location of impact such that it did not affect the test results. The height of the upper and lower rails was identical to that tested in Test 251 (Fig. 11).

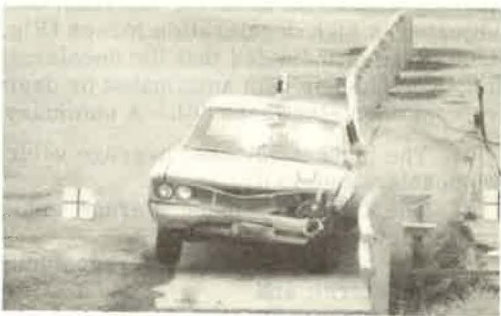
Figure 12.

Again, vehicle dynamics through impact were good. A 7-deg roll toward the barrier occurred (Fig. 12) and the vehicle was effectively redirected to an exit angle of 2 deg with the barrier. The total vehicle-barrier contact was approximately 14 ft. The maximum vehicle rebound into the traveled lanes was 22 ft. In view of the low 2-deg exit angle, the overall post-impact vehicle trajectory was considered satisfactory.

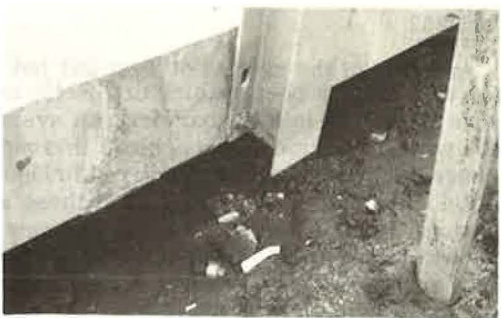
Figure 14.

Concrete damage was limited to minor spalling at the lower anchor bolts and on the underside of the bridge deck at post B-6 (Figs. 14 and 15). The failure of the upper post-to-deck connector at this post transferred impact loading to the lower connector and contributed to the concrete damage. However, it should be noted that post B-6 was at one of the rebuilt sections of the bridge deck. During reconstruction it was not always possible to install the new lower post-to-deck connectors above the existing lower longitudinal deck reinforcing steel as specified on the plans. If this had not been the case, the load transfer capability of the deck reinforcing may have precluded some of the concrete spalling.

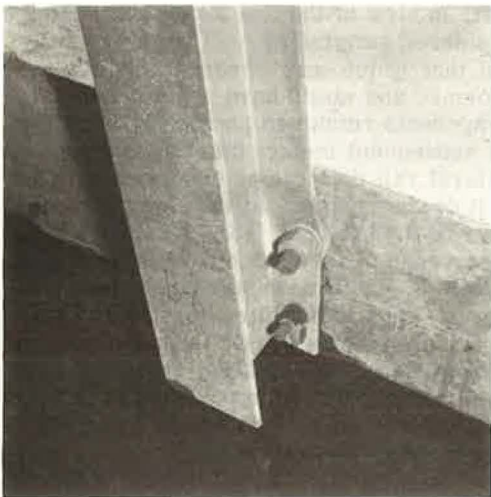
Figure 15.

The barrier damage was more severe than that which was observed after Test 251. Two rail sections and two posts were deformed and would have required replacement. Although all of the principal barrier components remained physically intact, it is doubtful that the barrier could have sustained a subsequent impact into the damaged section without failure. The maximum residual lateral rail deflections occurred at midspan between posts B-5 and B-6, approximately 7.4 ft downstream of initial impact. Deflection of the top rail was 0.56 ft and of the bottom rail 0.43 ft (Fig. 13). Maximum residual lateral post deflections, measured from the upper edge of the deck, were (a) post B-5, 2.7 ft downstream of impact, 1⅞ in. and (b) post B-6, 17.1 ft downstream of impact, 1⅞ in. Although the post deflections are numerically equal, thus indicating similar loadings, at post B-6 the downstream upper post-to-deck connector (high-strength threaded rod 1 in. in diameter) failed in tension and, consequently post flange deformation was absent at that point. Minor post flange deformation did occur on that side of the post just above the lower connector (Fig. 14). On the upstream side, post flange deformation occurred above the upper post-to-deck connector, which remained intact (Fig. 15).

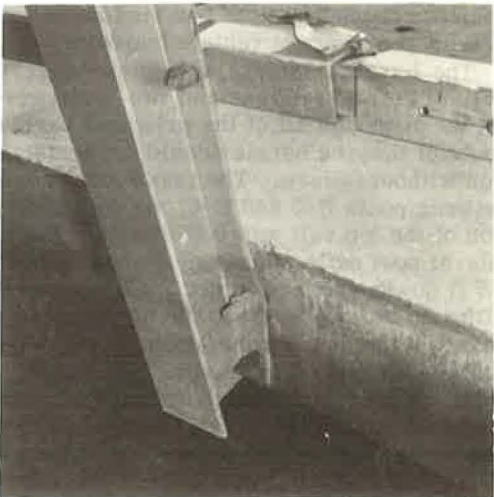
Figure 16.

At post B-5, all post-to-deck connectors were intact and both post flanges deformed above the upper connectors (Fig. 16). However, a flange-web fracture (0.1-in. by 3-in.

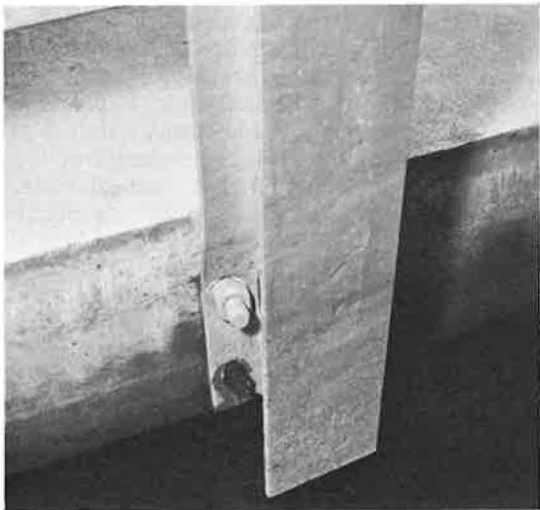
Figure 17.

separation) occurred adjacent to the downstream upper post-to-deck connector (Fig. 17). There was no damage sustained by any of the rail stud bolts or splice sleeves.

Laboratory tests of the failed barrier components from Test 252 were conducted to check on the possibility of defective material. A hardness test was performed on the sheared-off end of the failed post-to-deck connector from post B-6. This produced an average Brinell reading, with a $\frac{1}{16}$ -in. ball, of 94 on the B scale. This value approximates a tensile value of 100,000 psi, which is comparable with the minimum specified tensile strength requirement for the anchor bolts of 105,000 psi. However, because it was both an approximate value and slightly below specification, the remainder of this connector was jackhammered from the bridge deck for further testing. A standard tensile test resulted in values of 108,700 psi ultimate and 91,300 psi yield. Both values are well above the specified minimum strength for this material. A tensile specimen was also cut from the failed post (B-5). The test results were 67,400 psi ultimate and 41,400 psi yield. Both of these values were well above the minimum specified values for the post material. The failures were therefore attributed to the inability of the rails to transmit the impact loading to a sufficient number of posts due to the greater post spacing in this design.
