HIGHWAY RESEARCH RECORD

Number | Traffic Safety Barriers,
386 | Lighting Supports,
and Dike Slopes

11 reports
prepared for the
51st Annual Meeting

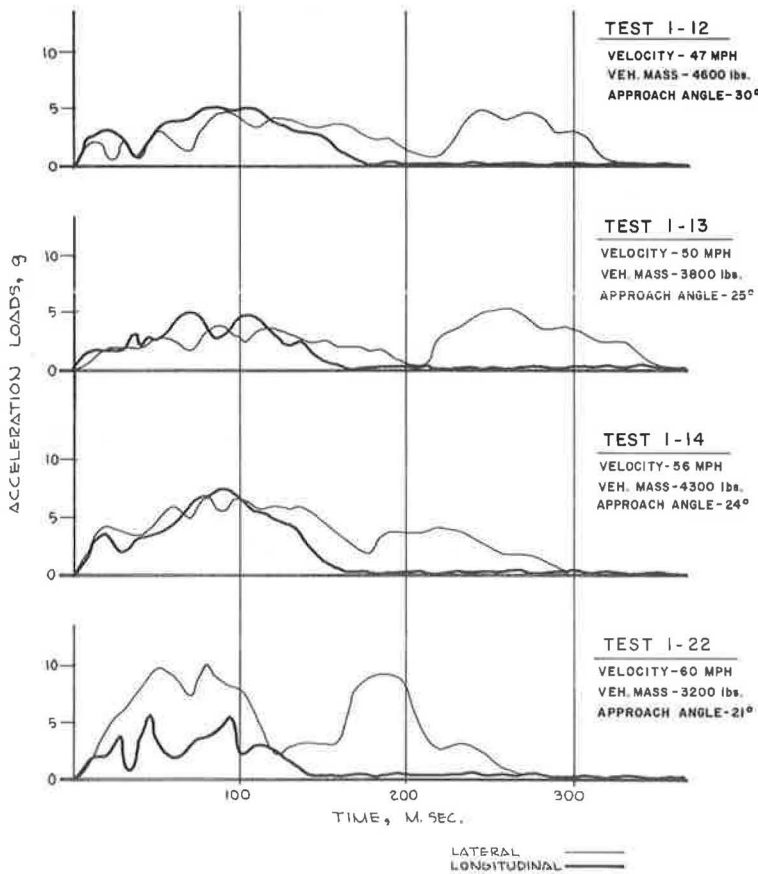
Figure 6. Lateral and longitudinal load comparisons.

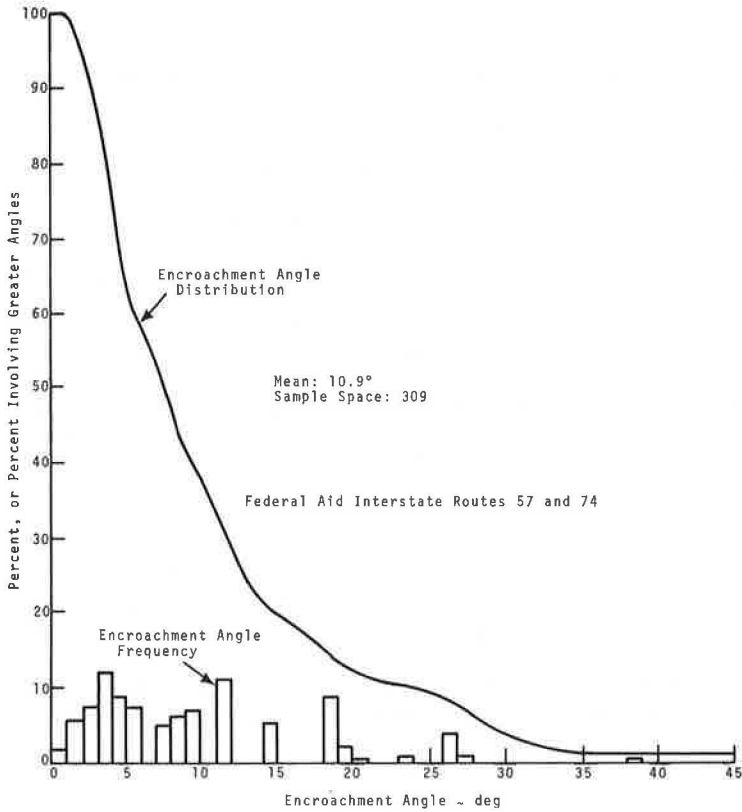
Figure 5. Encroachment angle distribution and frequency.
