HIGHWAY RESEARCH RECORD

Number | Bridge Design,
400 | Construction,
and Repair

10 reports
prepared for the
51st Annual Meeting

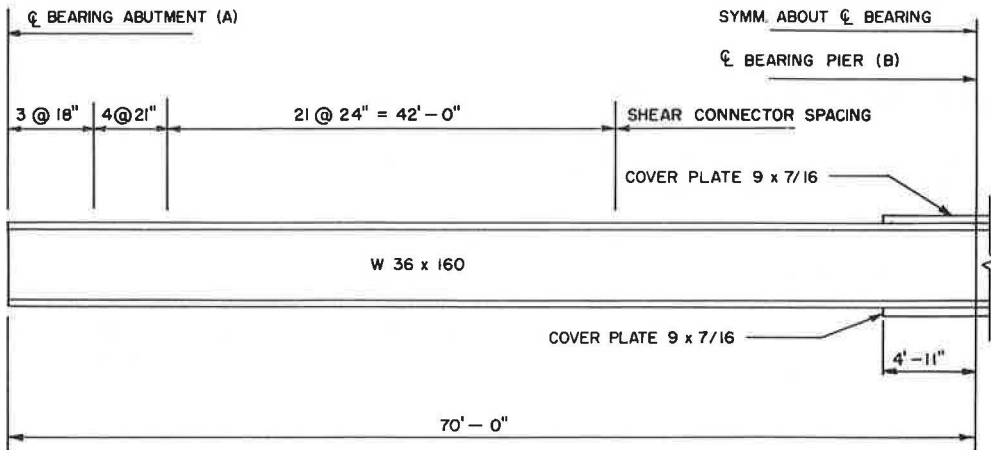
Figure 1. Computer optimum design for sample problem.

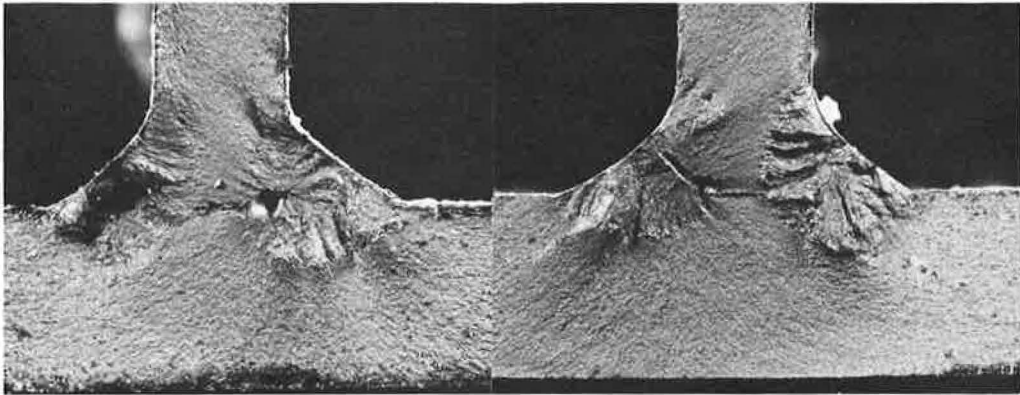
Figure 1. Examples of porosity from the root of the longitudinal fillet weld.

(a) Typical gas pore (x2.5)

(b) Pore elongated and perpendicular to the weld surface (x2.5)

It was observed that cracks in the welded beams always originated from a discontinuity (flaw) in the web-flange fillet weld unless a severe notch existed at the flame-cut flange tip. More than 180 cracks were found in the plain-welded beams reported on elsewhere (4, 9). Seventy-five of these cracks were cut open for fractographic examination. It was found that about 80 percent of the cracks had originated from porosity caused by the entrapment of gas. In general, these cavities were completely inside the weld. The gas pores appeared on the fracture surface as rounded cavities with a smooth and shiny surface as shown in Figure 1. A few pipe or blow holes extended to the surface of the weld.

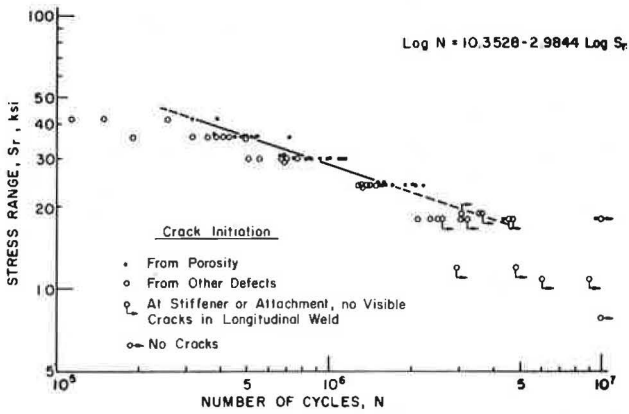
Figure 2. Comparison of welded beams failing from porosity in the fillet weld with beams failing from other defects.

All test data for beams failing from porosity in the longitudinal fillet weld are plotted by the solid circles shown in Figure 2. The equation of the mean line resulting from a least squares fit to these test data is

The open symbols shown in Figure 2 represent plain-welded beams that failed from defects other than porosity. This included beams failing from weld repairs, stop-start positions, other weld defects, and severe notches in the flame-cut flange tips. Generally, these beams yielded shorter lives than did beams failing from porosity.

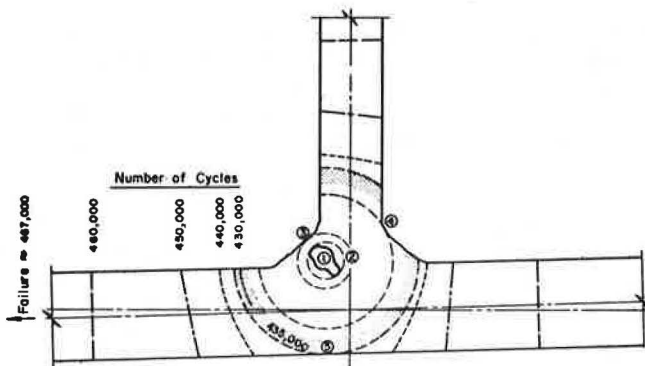
Figure 3. Stages of crack growth from a pore in the fillet weld.

elastic cross section. Based on this photographic evidence, a circular disc-like crack was assumed to model the actual crack during growth inside the flange-web connection (Fig. 3).

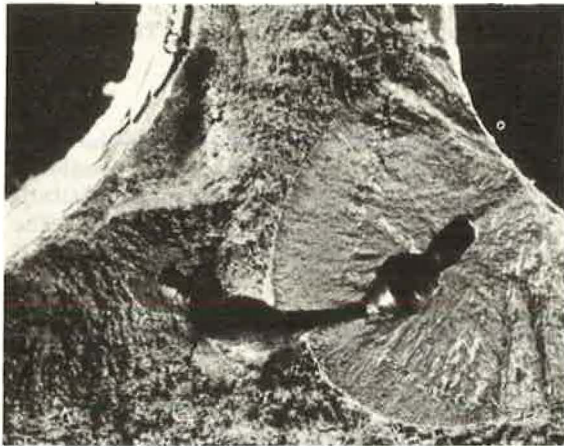
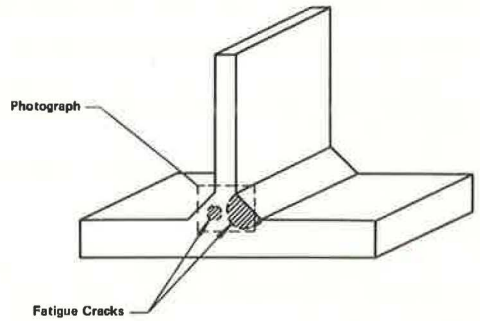
Figure 4. Two small fatigue cracks that initiated from pores in the longitudinal fillet weld and grew perpendicular to the axis of the weld (~x5.5).

One of the smallest cracks was discovered during an examination of a crack in the fillet weld. A tiny crack about 0.07 in. in diameter had originated from a very small pore in the left weld as shown in Figure 4. The extent of the circular crack is seen from the smooth crack surface surrounding the pore, as compared to the rough appearance caused by static tearing when the cross section was opened for inspection. The small crack on the left was completely inside the flange-to-web junction and could not be detected by inspection of the weld surface.

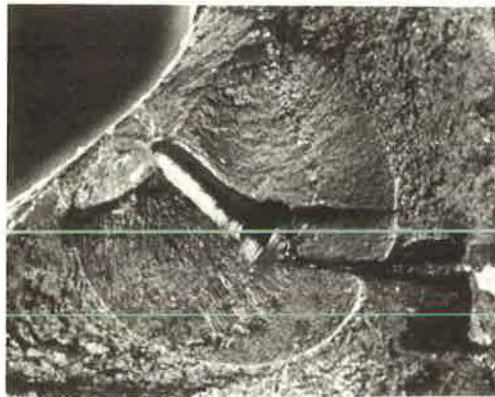
Figure 5. Small crack with penetration to the fillet weld surface (~x6.3).

A small crack discovered by the magnetic particle inspection method is shown in Figure 5. The crack had initiated from the elongated pore and grown to the surface of the fillet weld. Almost no deviation from a circular shape is visible. This crack is about 0.26 in. in diameter and could not be detected on the weld surface with the aid of a magnifying glass even under favorable circumstances and under sustained loading.

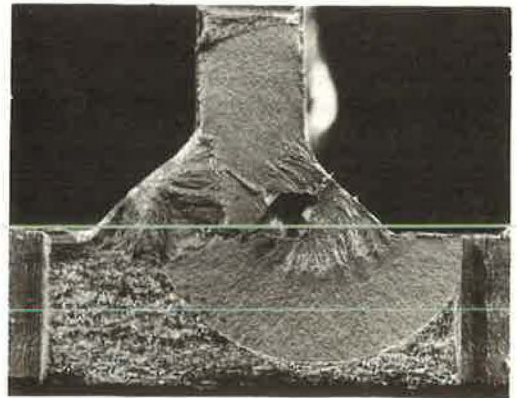
Figure 6. Crack in flange-to-web junction approaching the extreme fiber of the tension flange (~x2.1).

A crack that has nearly penetrated the extreme fiber of the tension flange is shown in Figure 6. Again, no significant disturbance of the circular shape is apparent at either side of the web or at the front approaching the surface of the flange. This crack, although quite sizable, is not easily detected on a structural element under applied loading. The linear dimension of the crack visible on the surface of the flange-to-web junction is somewhat less than 1 in.

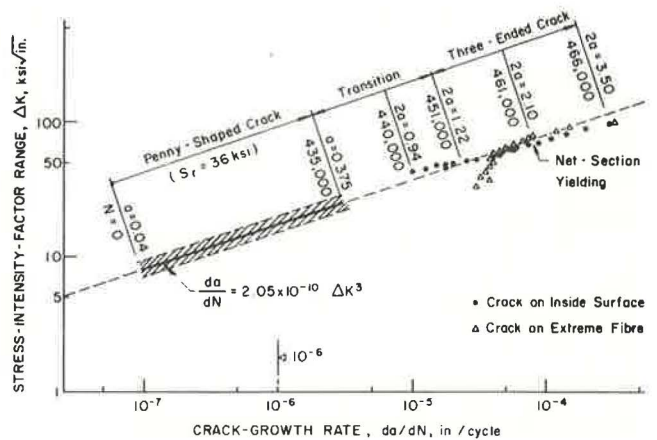
Figure 7. Stages of crack growth and corresponding growth rates for a crack in a plain-welded beam.

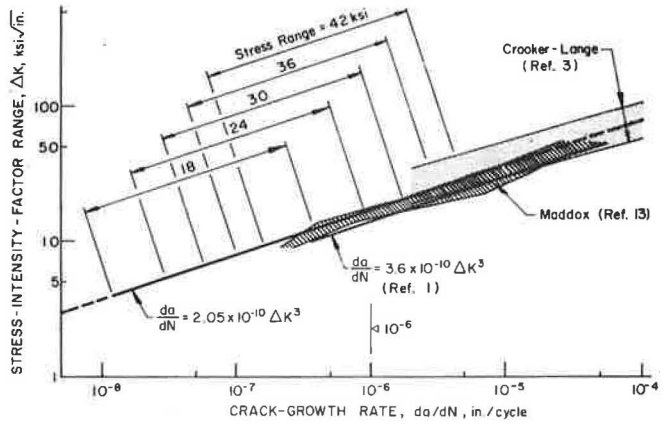
Figure 8. Ranges for crack growth as a penny-shaped crack.

ranges as shown in Figure 8. The ΔK -regions applicable to growth as a penny-shaped crack are indicated for the test beams subjected to the stress ranges used in this study. Crack initiation took place at ΔK -values below $10 \text{ ksi} \sqrt{\text{in.}}$ in all test beams. Most of the life was spent at growth rates smaller than 10^{-6} in. per cycle.

The derived crack-growth relationship given by Eq. 8 is also compared with data from crack-growth specimens (Fig. 8). It was necessary to extrapolate the curve into the higher growth-rate region to compare it with available growth-rate data. The extrapolated curve falls within the scatterband reported by Crooker and Lange (3). This scatterband contains data from tests on carbon and low-alloy steels with yield strengths comparable to the yield strengths of the steel beams. A conservative upper bound for growth rates on ferrite-pearlite steels was proposed by Barsom (1) as

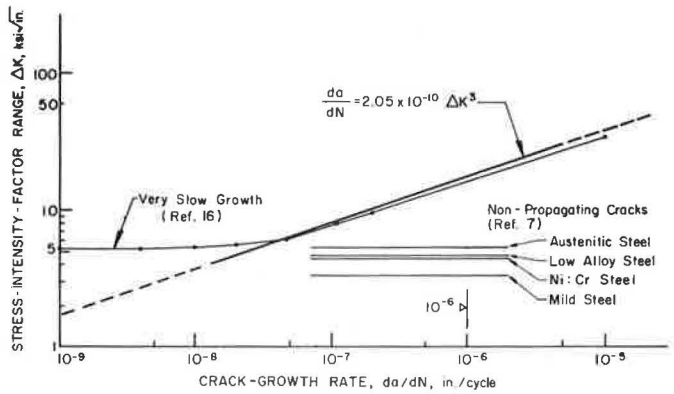
Figure 9. Approximate mean line of Paris' data for very slow growth and Harrison's limiting ΔK -values for nonpropagating cracks.

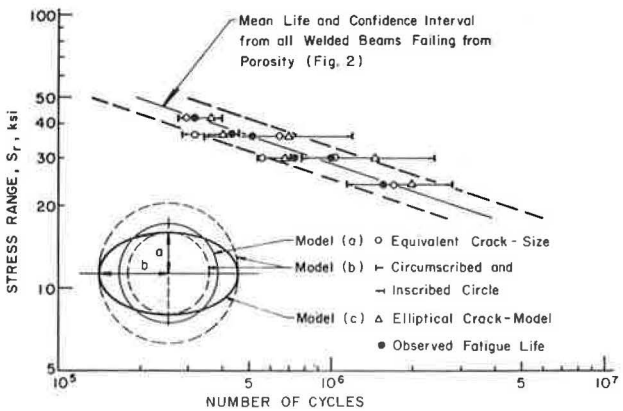
Figure 10. Prediction of fatigue life using crack models.

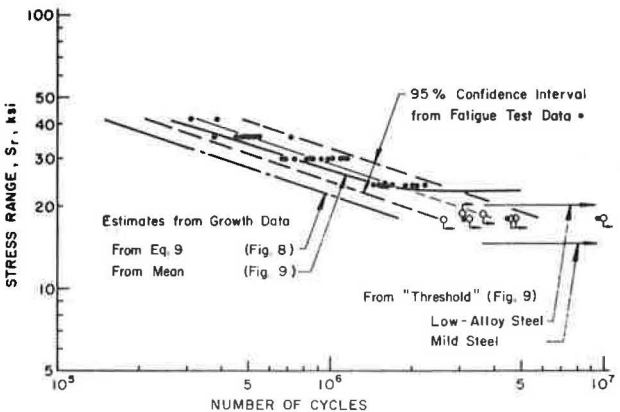
Figure 11. Comparison of a predicted low bound and a mean line with mean life and scatterband from test data.

The scatter in the test data shown in Figure 11 was previously related to the variation in shape, size, and severity of the porosity. Other factors contribute to the variation in test data. Beams with seemingly equal defects still experience variation in the fatigue strength because of variation in the crack-tip radius, crack-growth rates, and other uncontrolled variables.

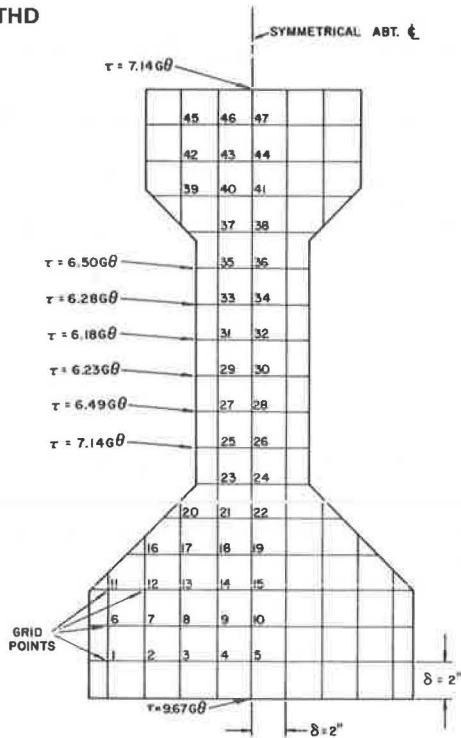
Figure 1. Cross section of THD Type B prestressed beam.

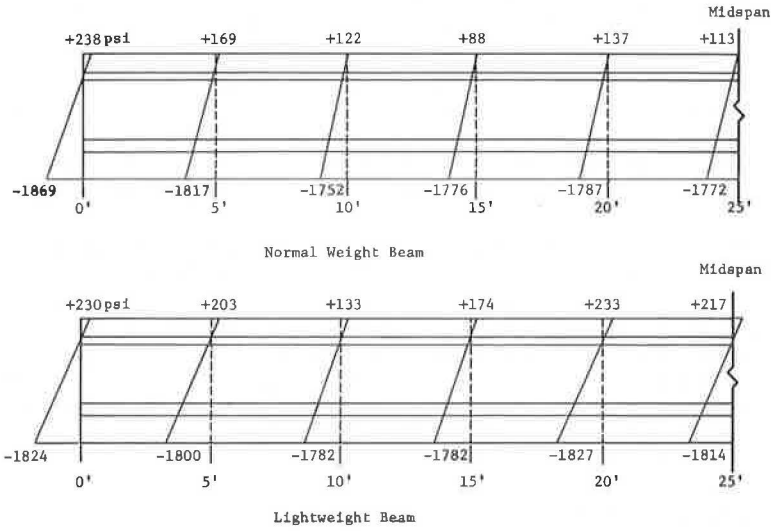
Figure 3. Stresses due to dead load plus prestress.

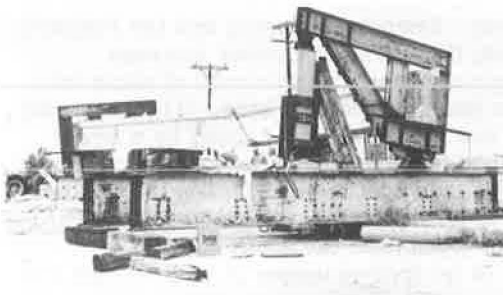
Figure 4. Testing frame with failed specimen.

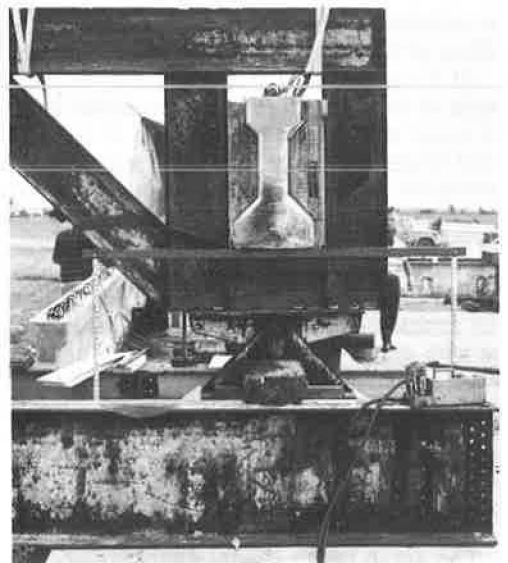
Figure 5. Testing frame showing scales used to determine rotational displacements of end of specimen.

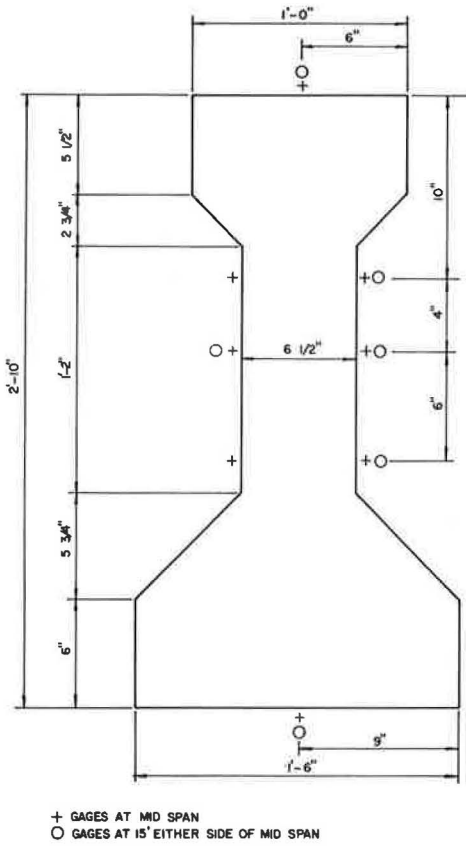
Figure 6. Cross section of THD beam showing dimensions and locations of strain-gauge rosettes.

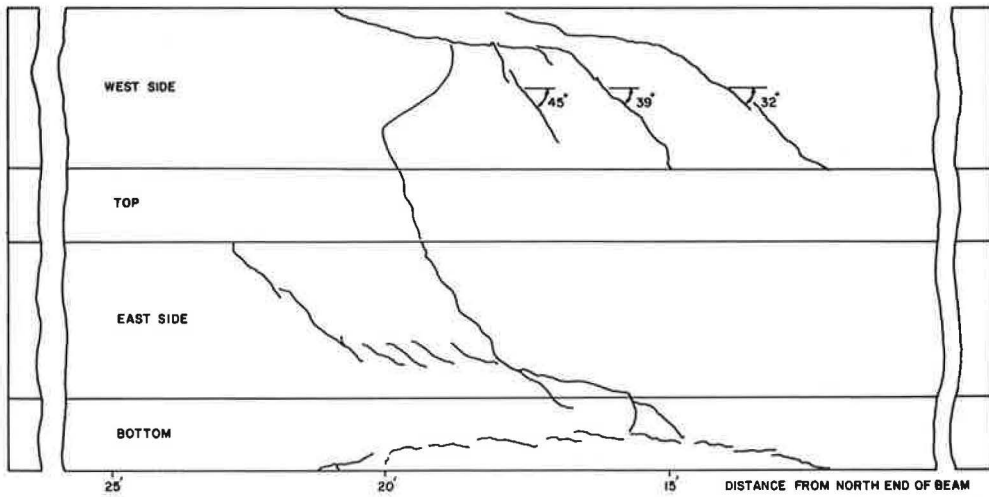
Figure 7. Cracking pattern in normal-weight beam.

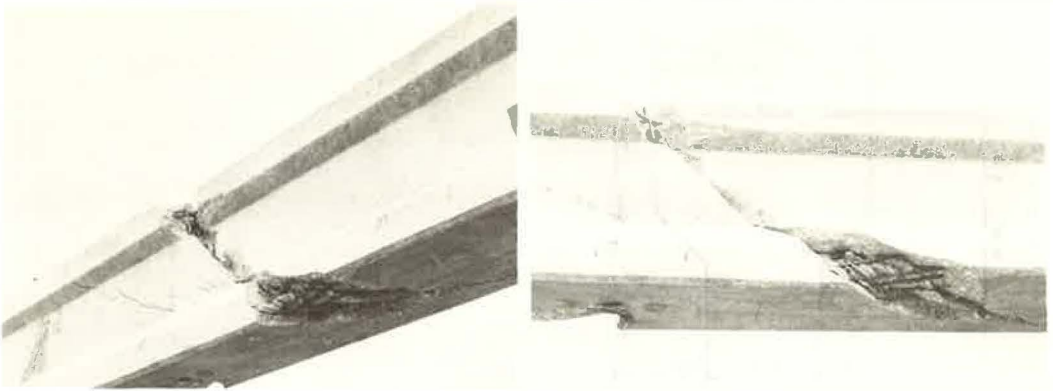
Figure 8. Failure crack in normal-weight beam.

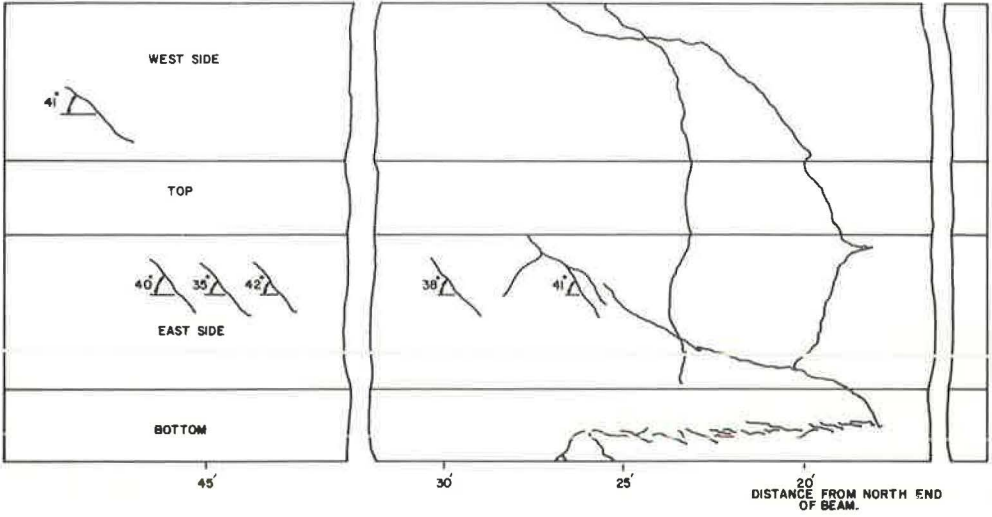
Figure 9. Cracking pattern in lightweight beam.

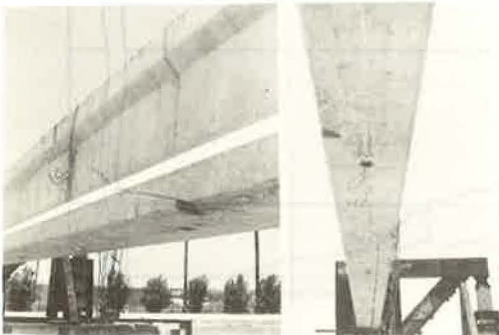
Figure 10. Failure crack in lightweight beam.

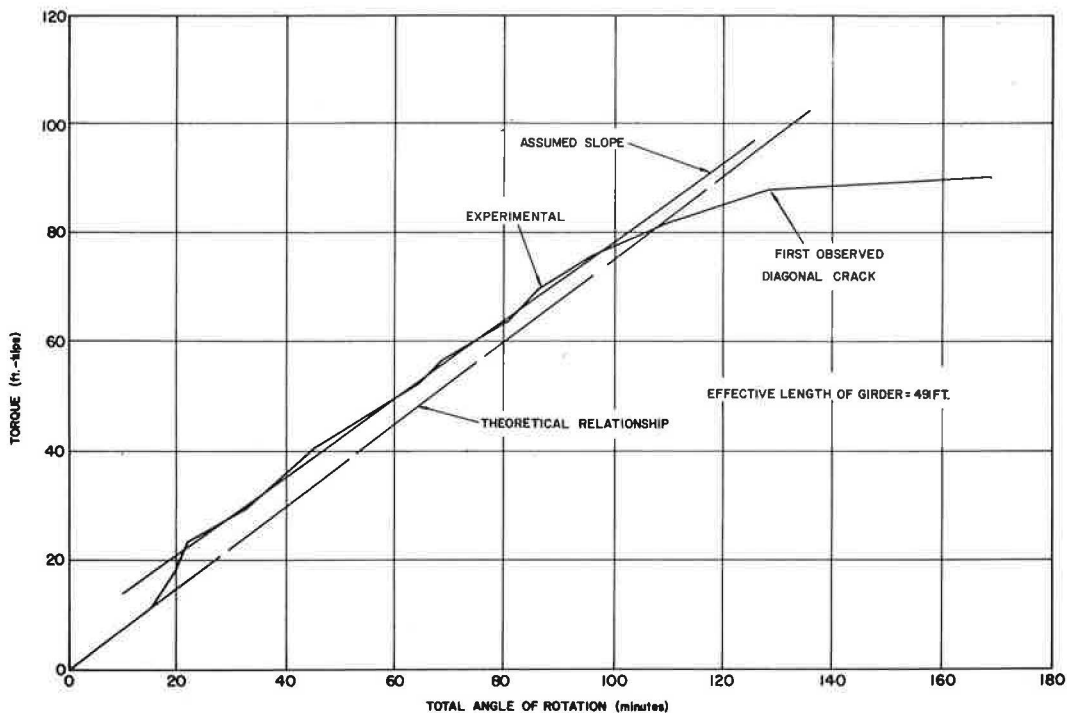
Figure 13. Torque-rotation relation for normal-weight beam.

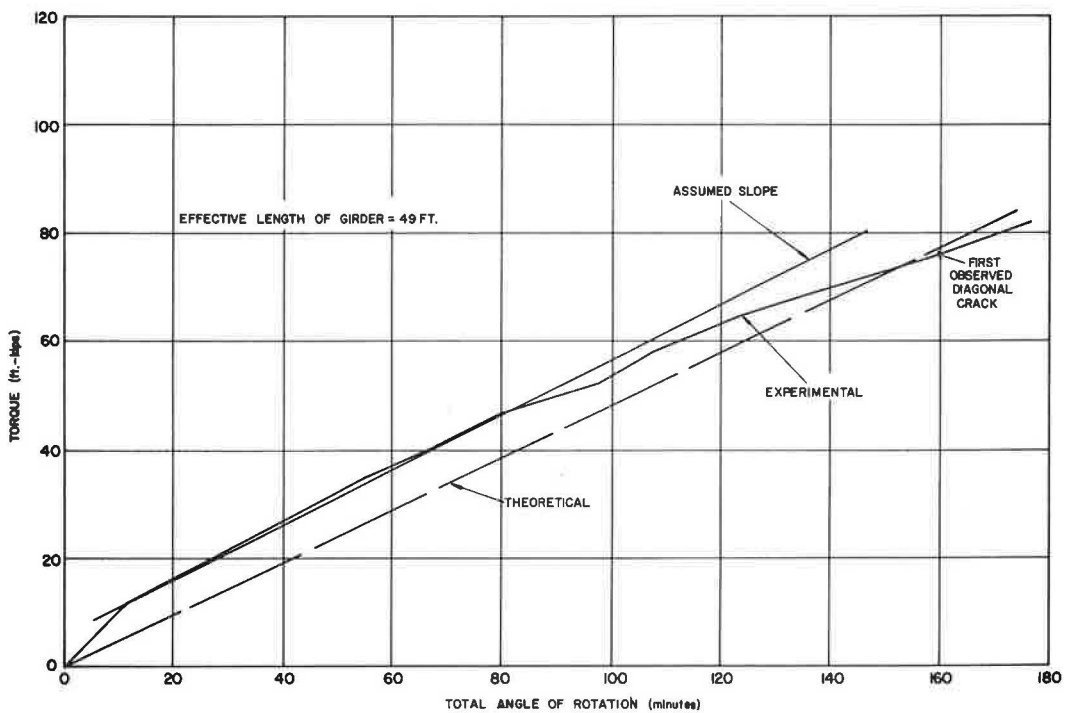
Figure 14. Torque-rotation relation for lightweight concrete beam.

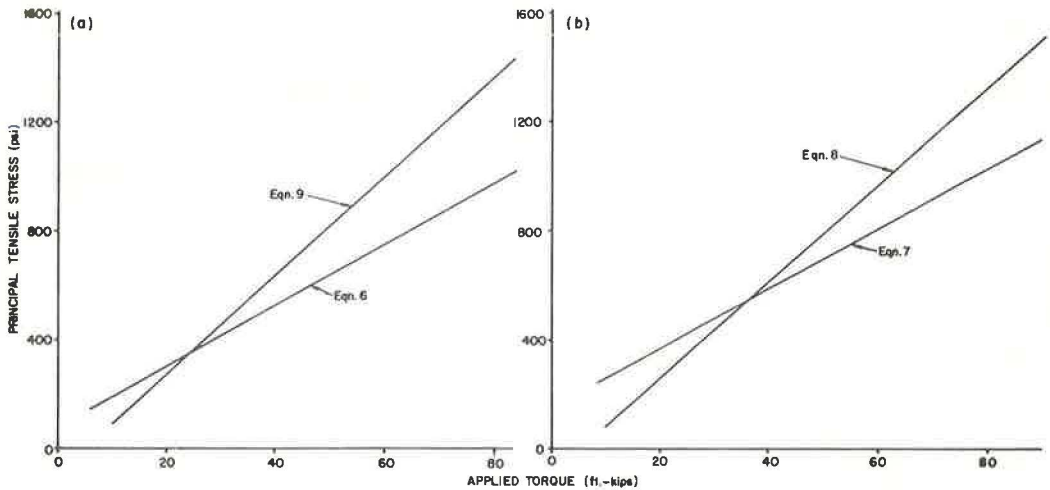
Figure 15. Comparison of stress at reentrant corner with stresses in top flange.

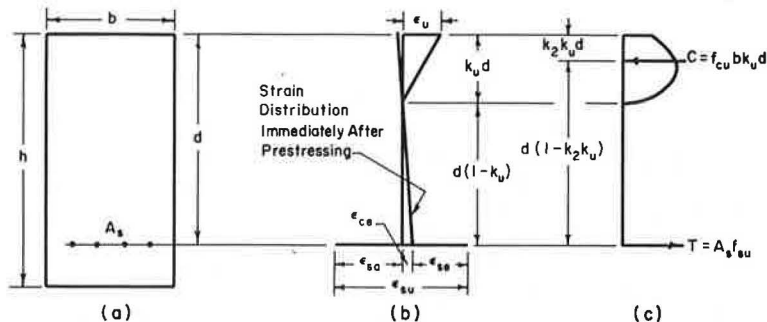
Figure 1. Conditions of strain and stress at failure for beams reinforced in tension only.

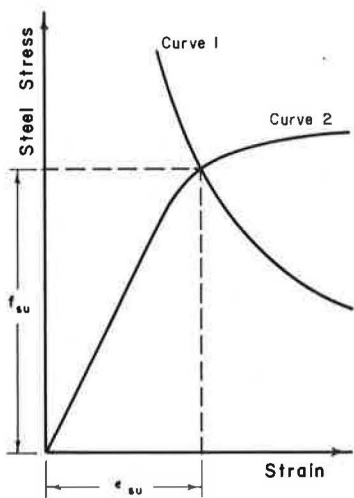
Figure 2. Graphic solution.

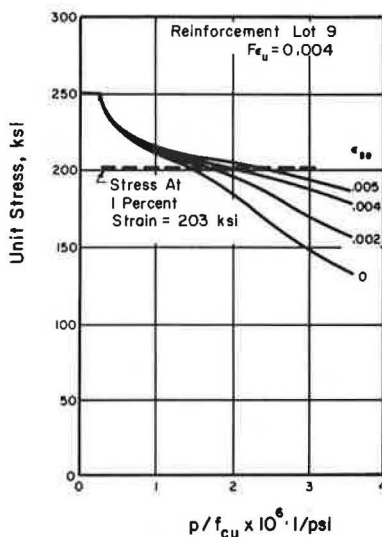
Figure 3. Effect of ϵ_{s0} on reinforcement at failure.

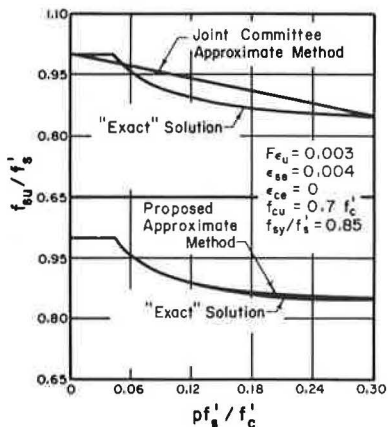
Figure 4. Comparisons of "exact" values of $f_{s u}$ with those derived from the joint committee approximate method and the proposed approximate method.

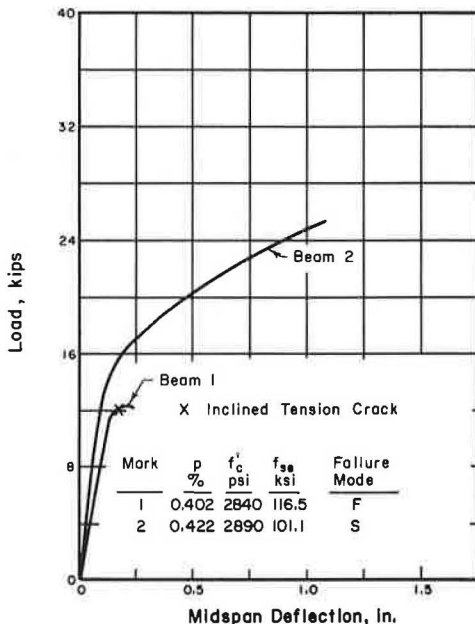
Figure 5. Load-deflection curves for beams failing in flexure and shear.

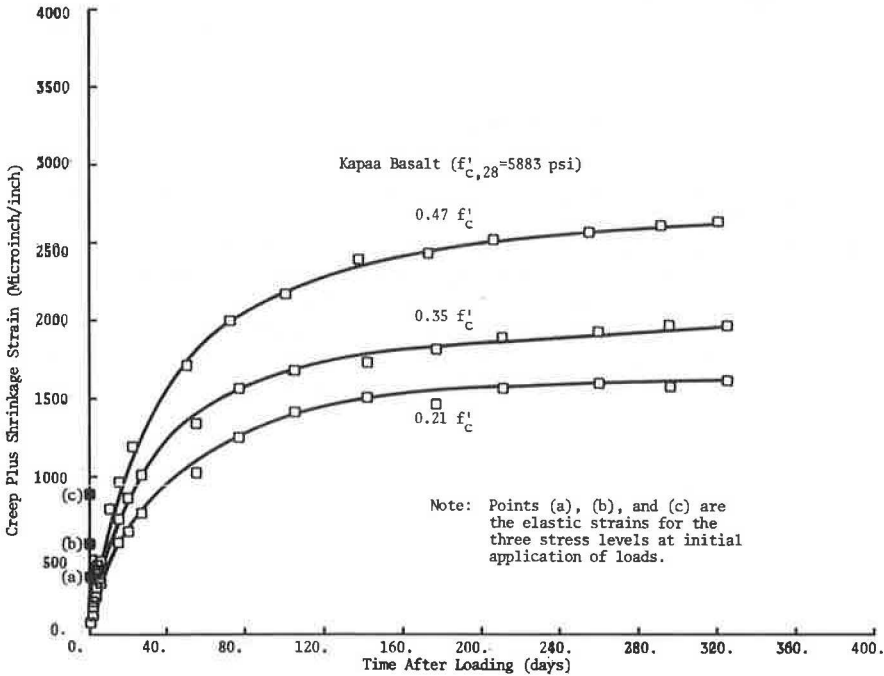
Figure 1. Creep plus shrinkage strains versus time after loading for basalt concrete.

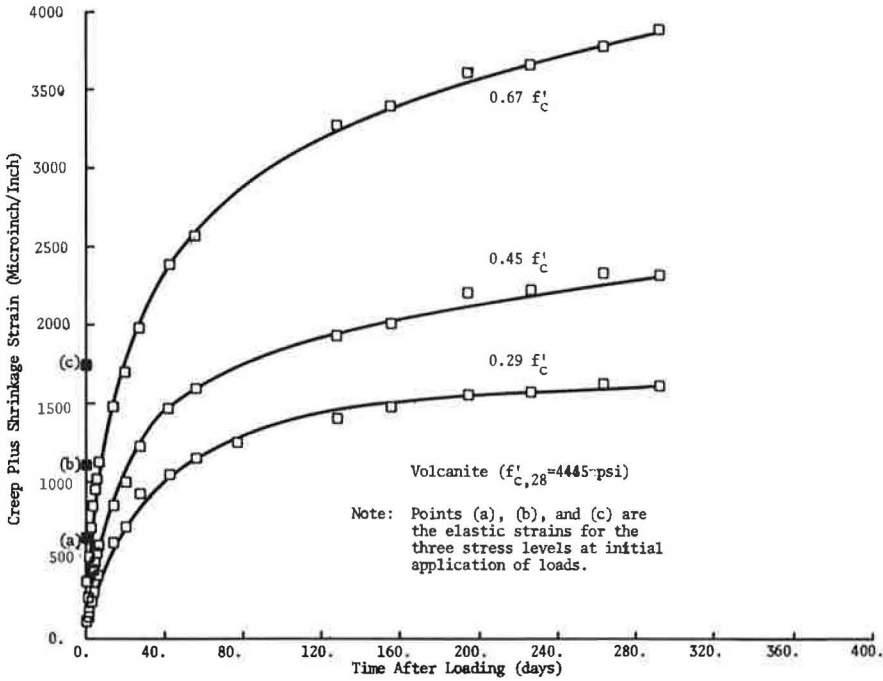
Figure 2. Creep plus shrinkage strains versus time after loading for volcanite concrete.

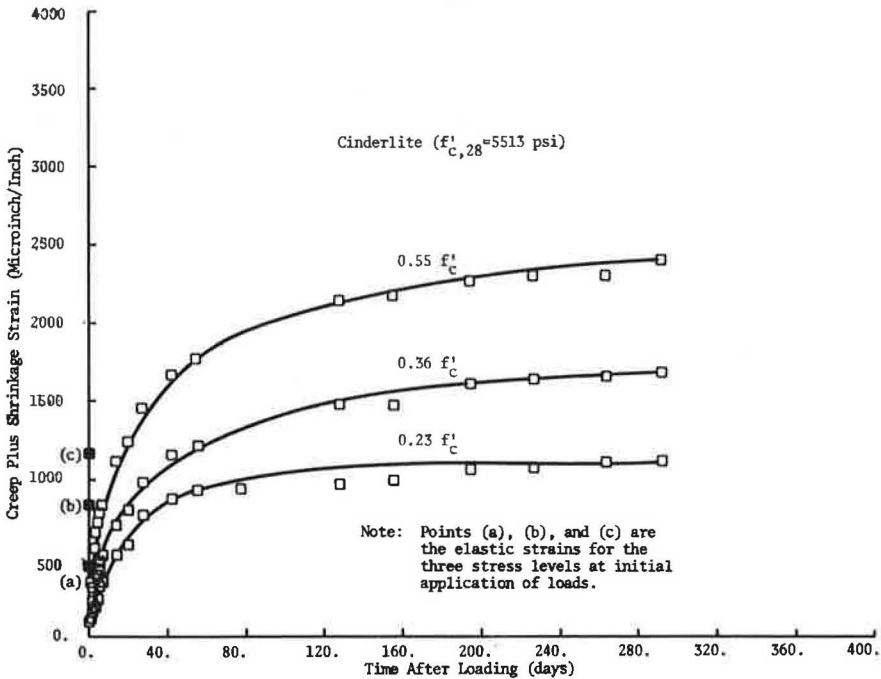
Figure 3. Creep plus shrinkage strains versus time after loading for cinderlite concrete.

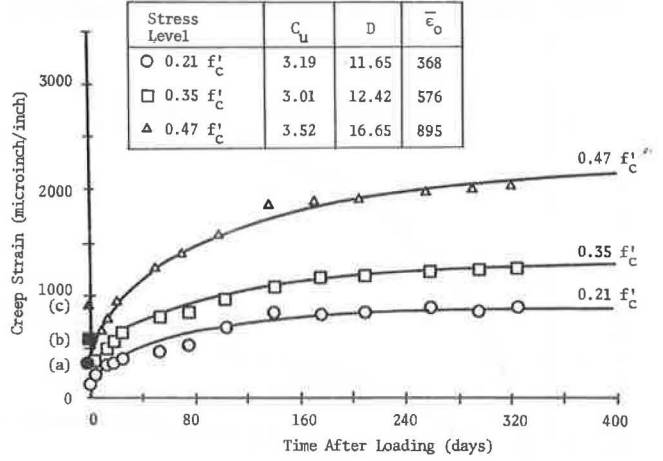
Figure 4. Creep strain versus time after loading for basalt concrete.

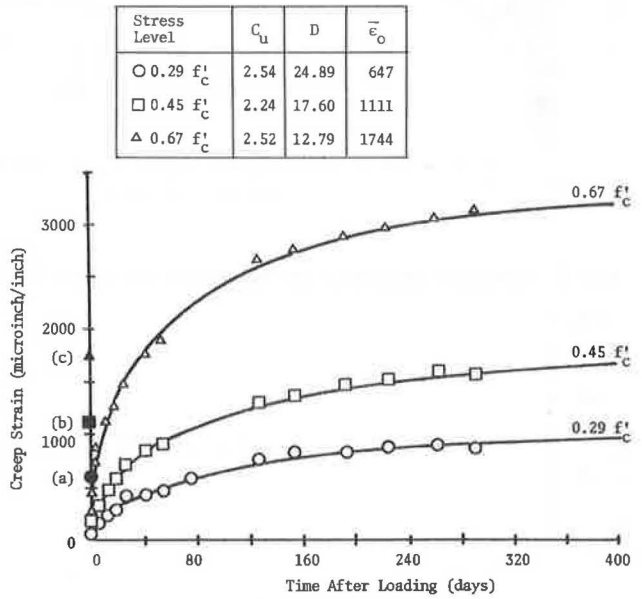
Figure 5. Creep strain versus time after loading for volcanicite concrete.

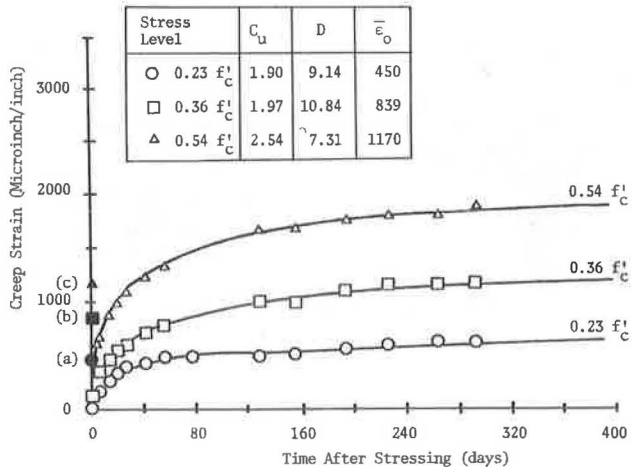
Figure 6. Creep strain versus time after loading for cinderlite concrete.

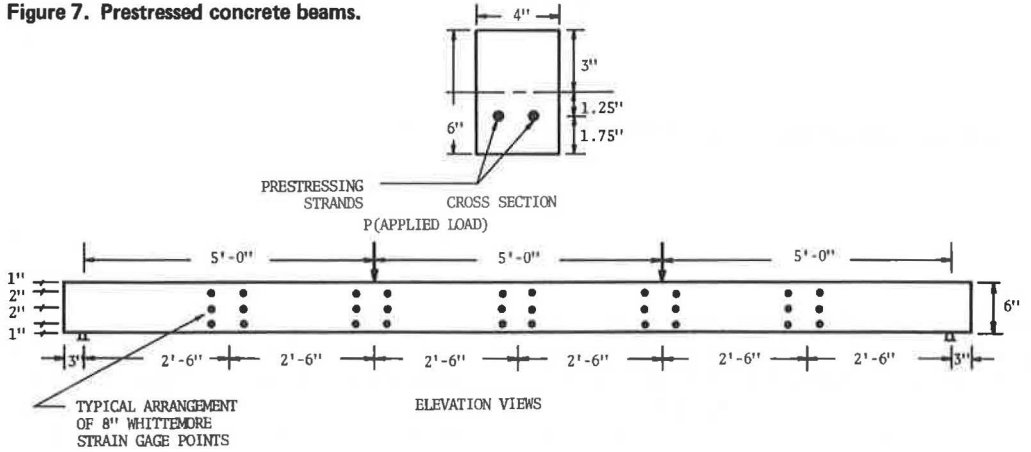
Figure 7. Prestressed concrete beams.

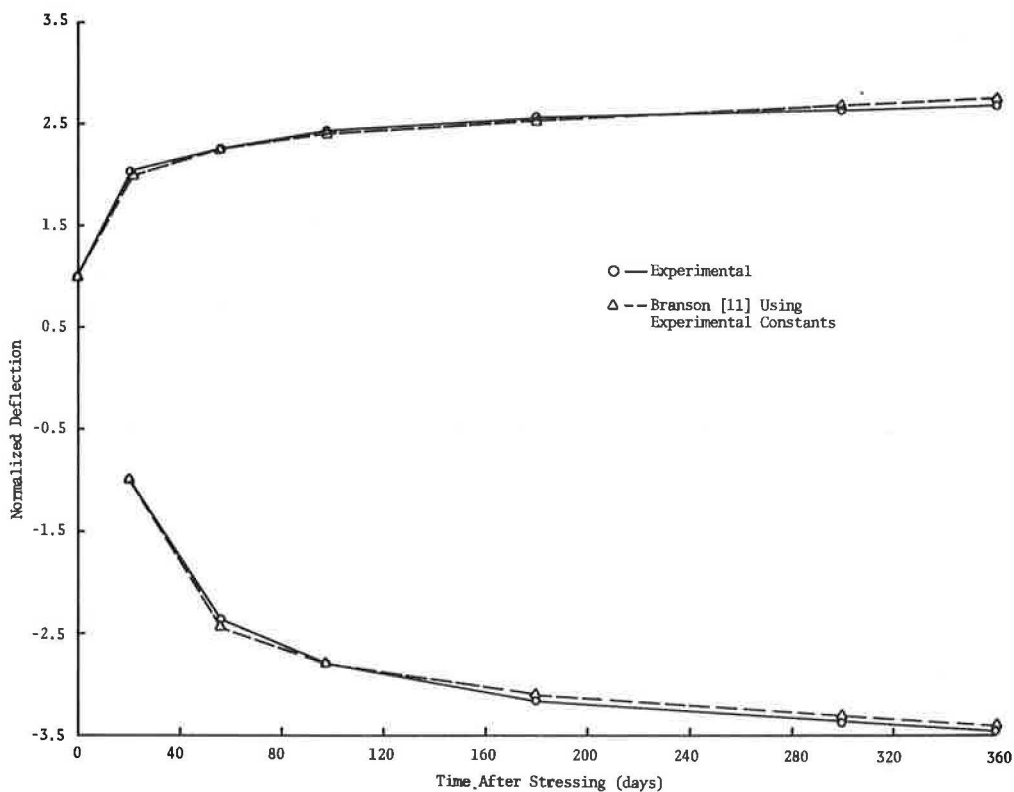
Figure 10. Comparison of normalized camber and normalized effects of subsequently applied loads with suggested values (basalt).

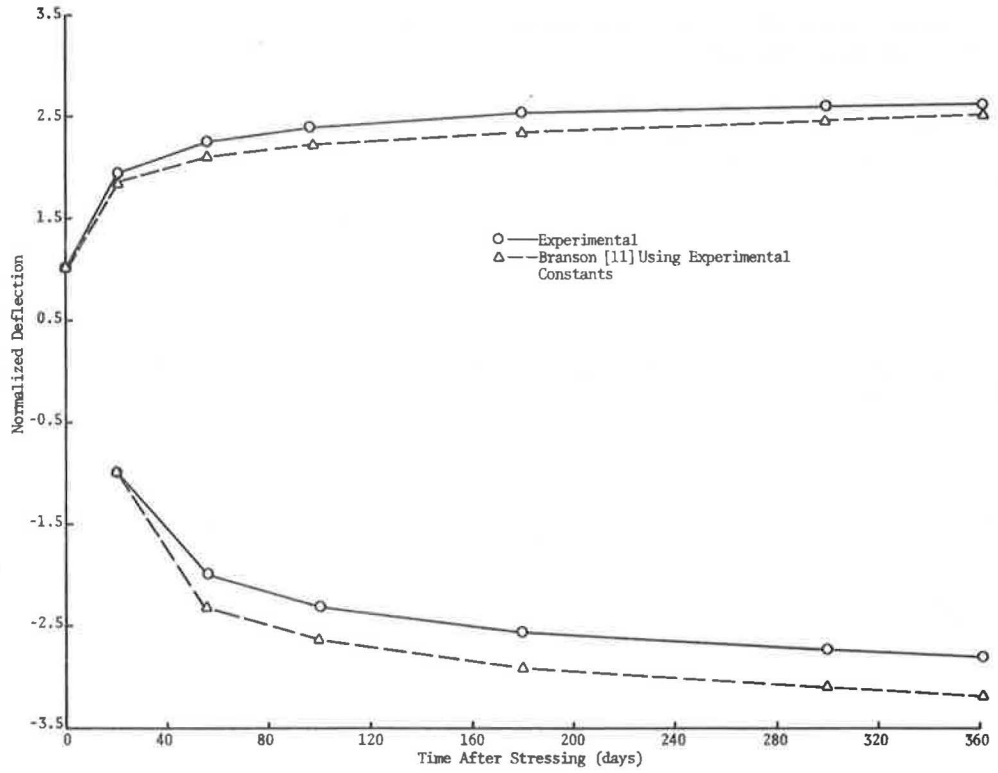
Figure 11. Comparison of normalized camber and normalized effects of subsequently applied loads with suggested values (cinderlite).

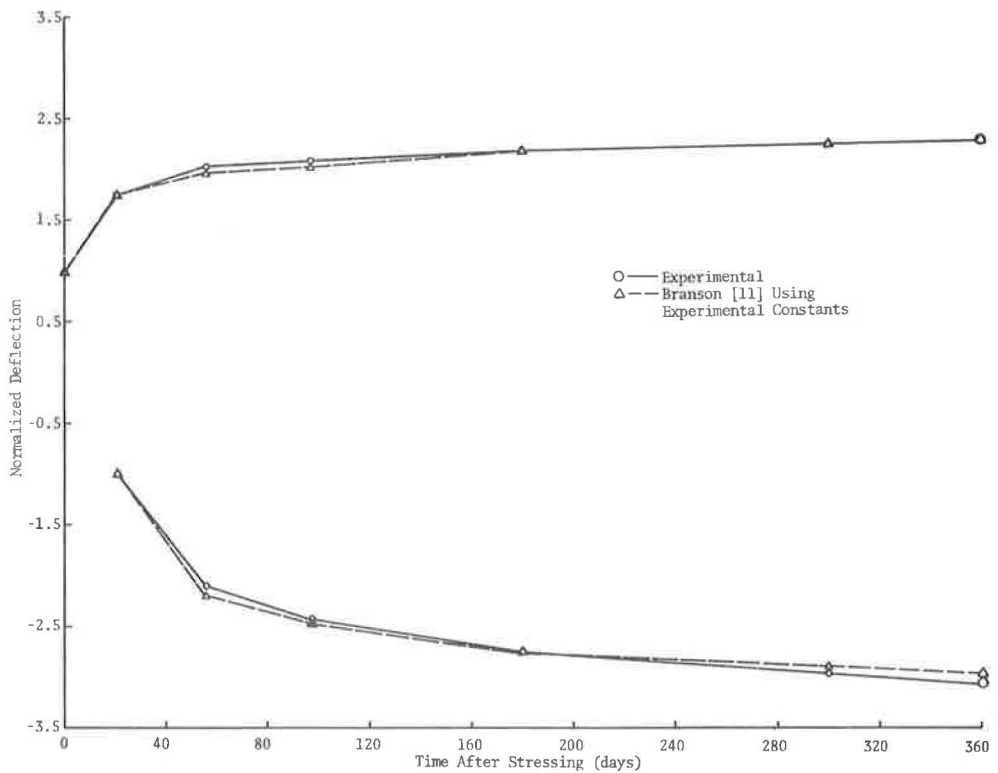
Figure 12. Comparison of normalized camber and normalized effects of subsequently applied loads with suggested values (volcanite).

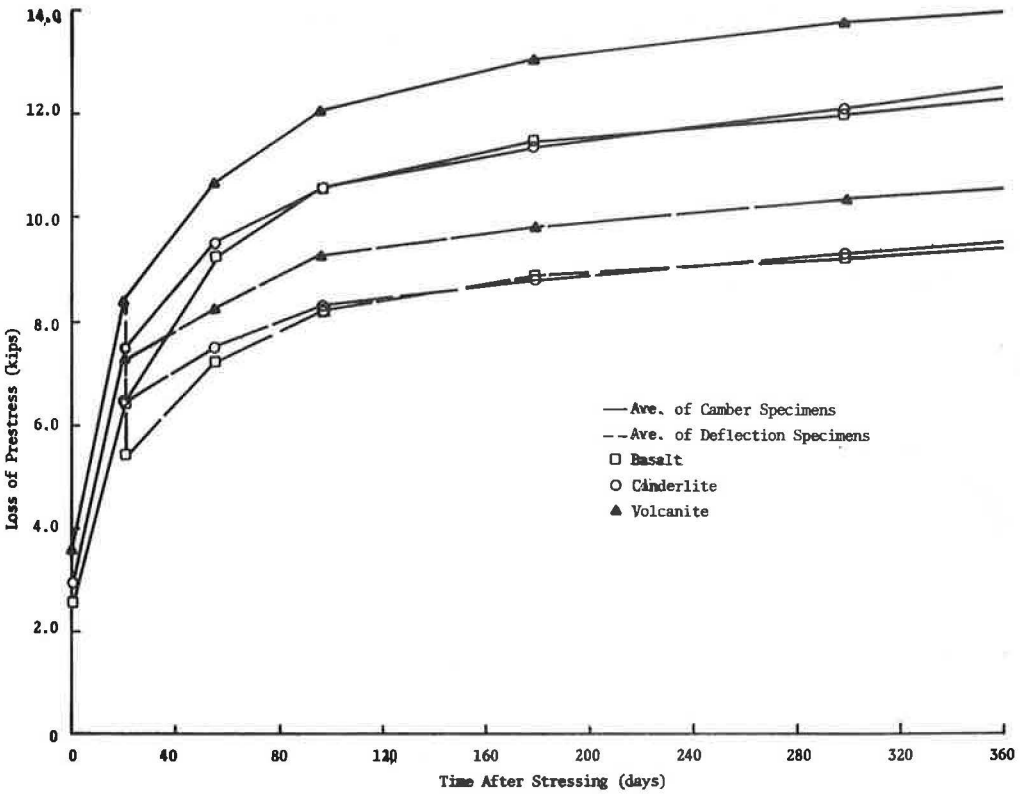
Figure 14. Experimental loss of prestress at midspan for each concrete mix.

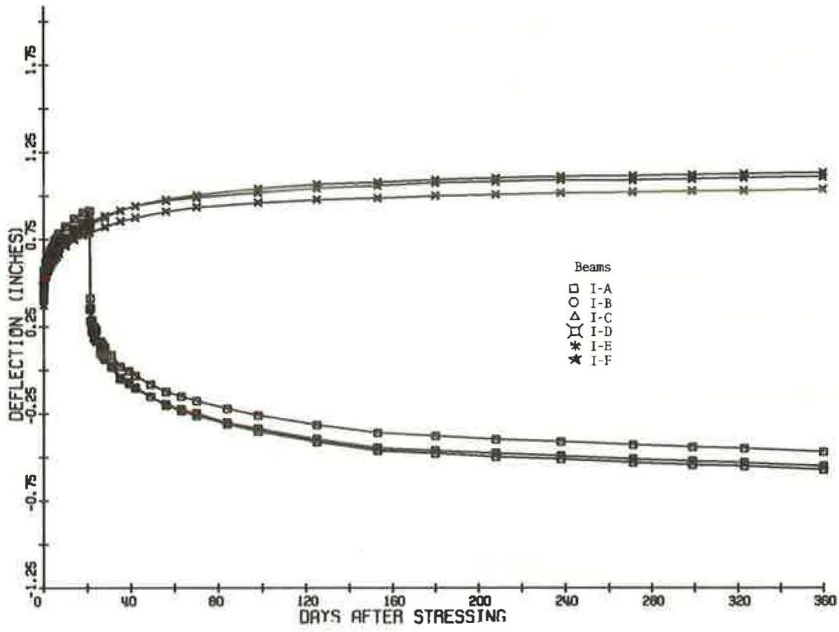
Figure 15. Measured deflection at midspan (basalt).

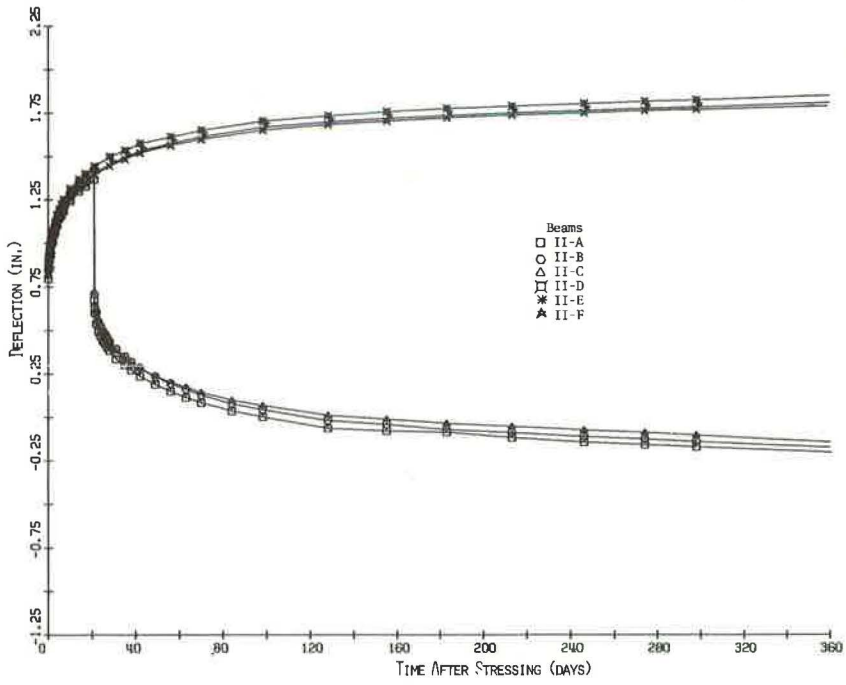
Figure 16. Measured deflection at midspan (cinderlite).

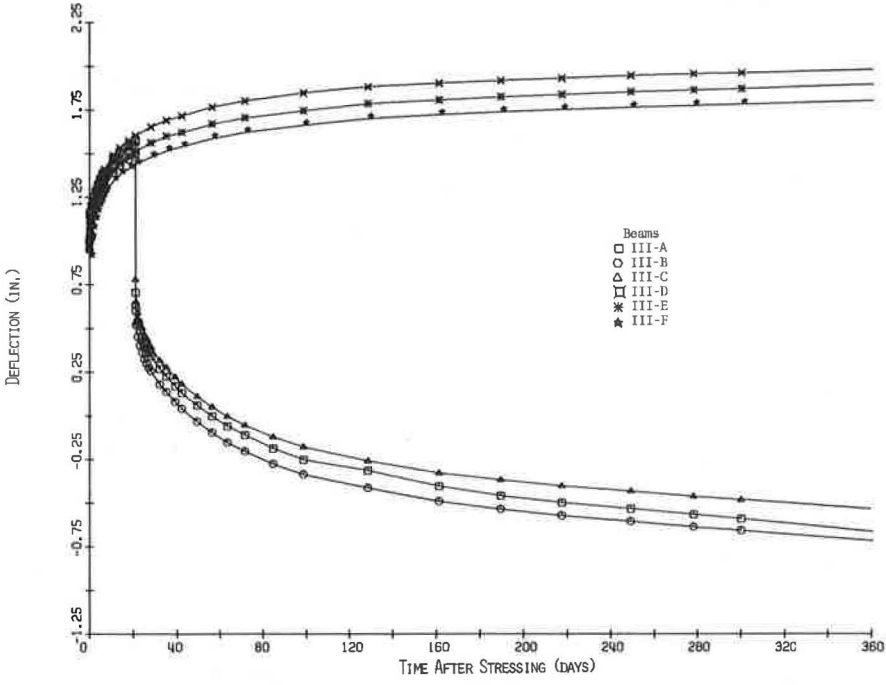
Figure 17. Measured deflection at midspan (volcanite).

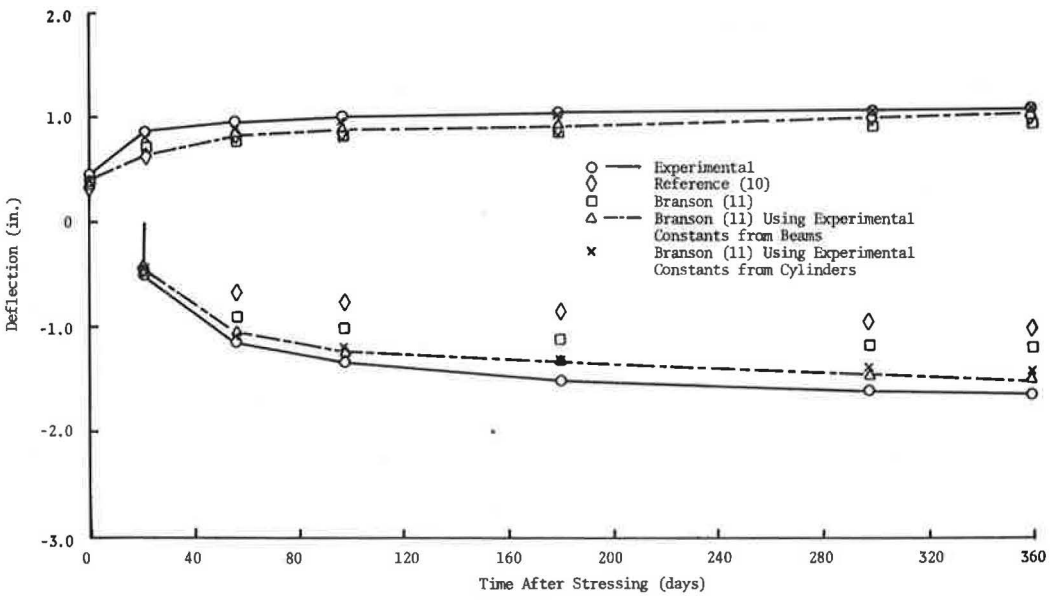
Figure 18. Comparison of camber and effects on deflection due to subsequently applied loads with suggested values using experimental strength (basalt).

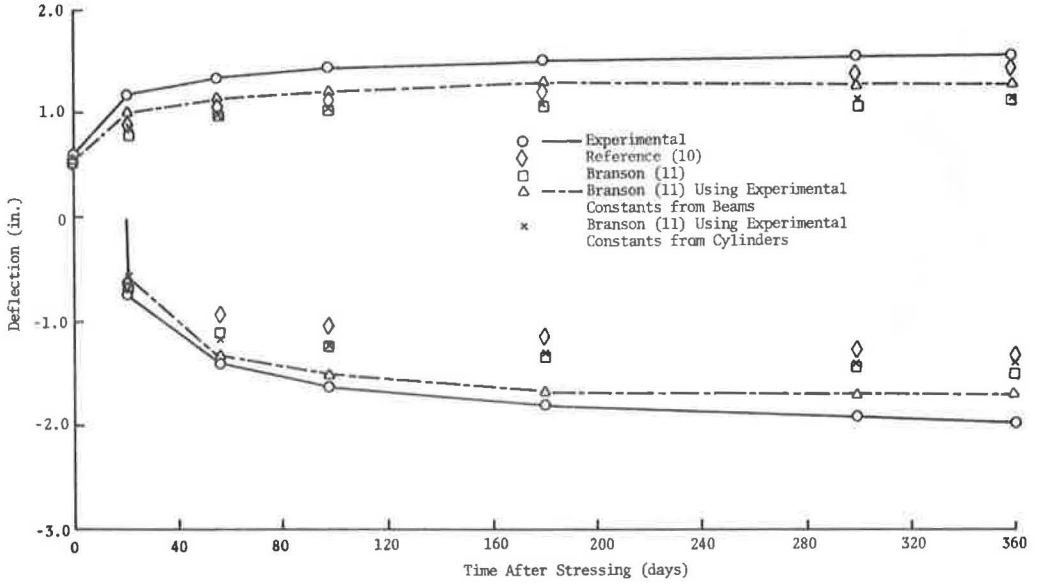
Figure 19. Comparison of camber and effects on deflection due to subsequently applied loads with suggested values using experimental strength (cinderlite).

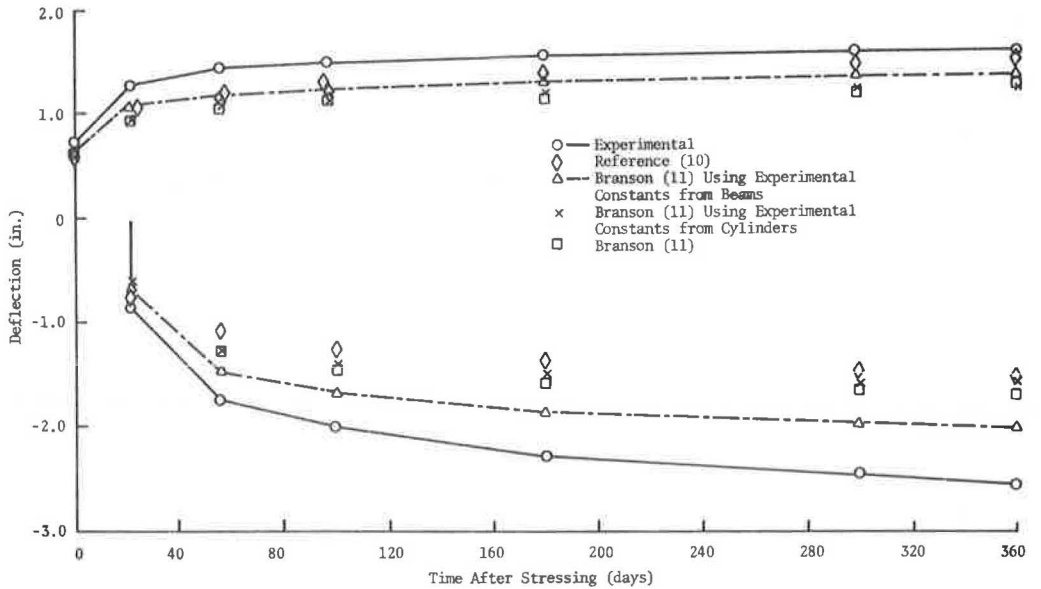
Figure 20. Comparison of camber and effects on deflection due to subsequently applied loads with suggested values using experimental strength (volcanite).

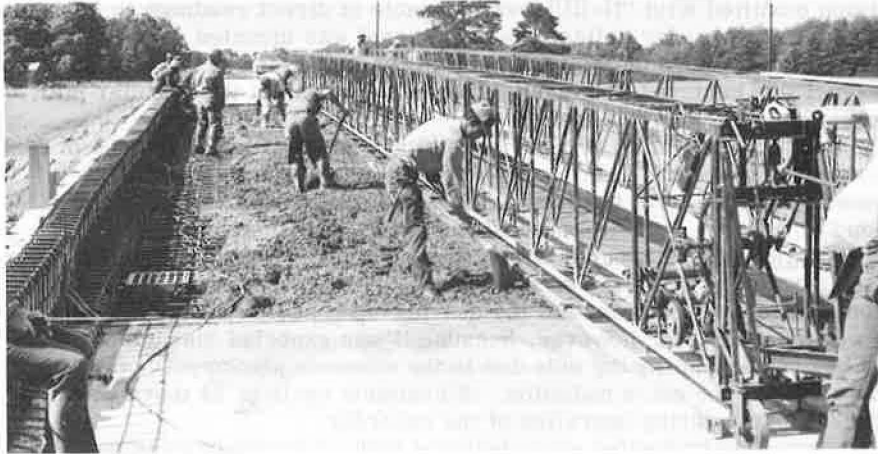
Figure 1. Longitudinal bridge deck screeding machine.

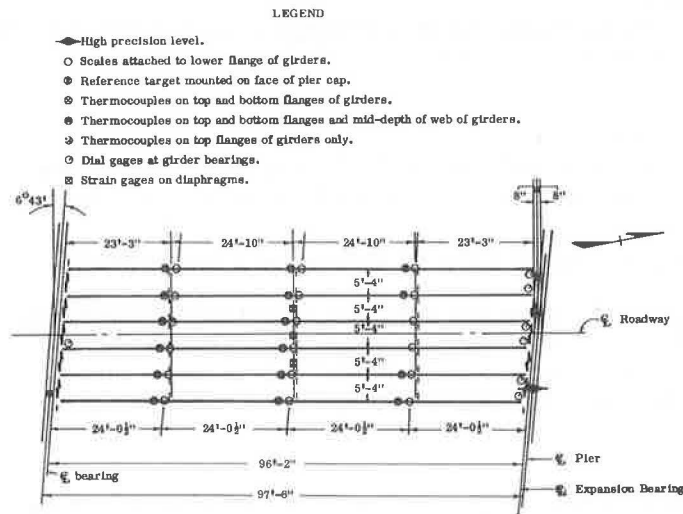
Figure 2. Locations and dimensions of test instrumentation for Route 607 span.
