HIGHWAY RESEARCH RECORD

Number | Bridge Design,
400 | Construction,
and Repair

10 reports
prepared for the
51st Annual Meeting

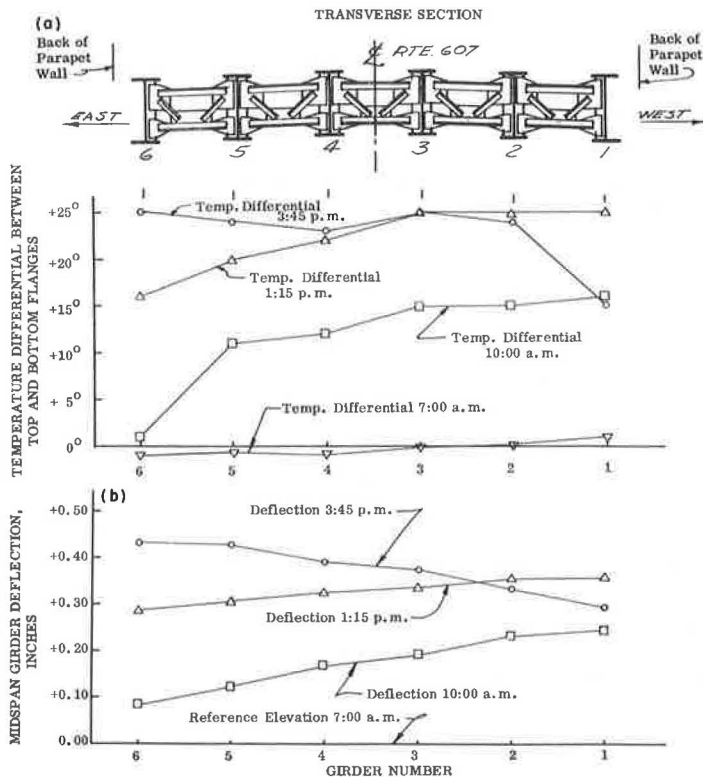
Figure 4. Upward midspan girder deflections due to differential temperatures between the top and bottom flanges of each girder.

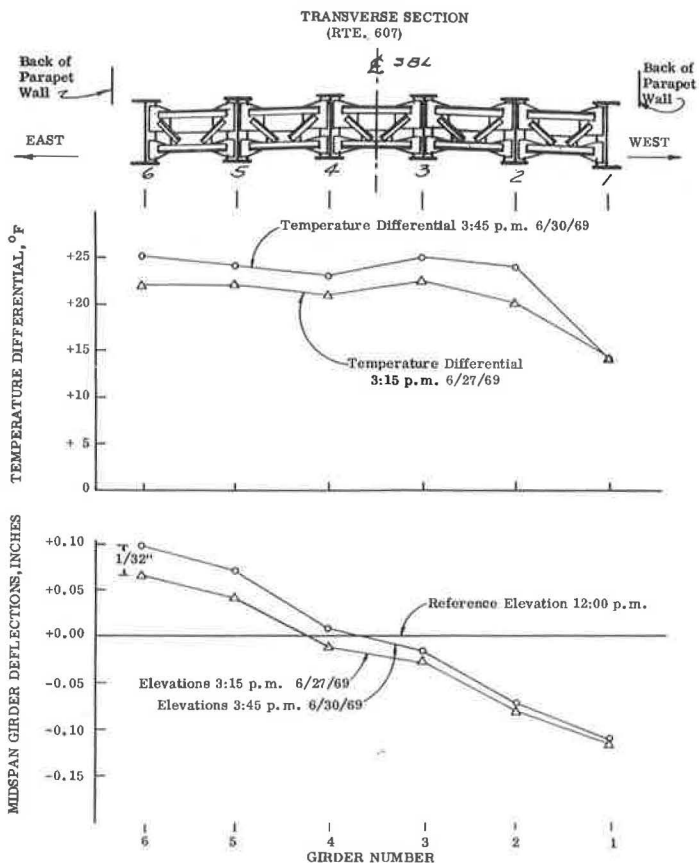
Figure 5. Midspan girder deflections and temperature differentials.

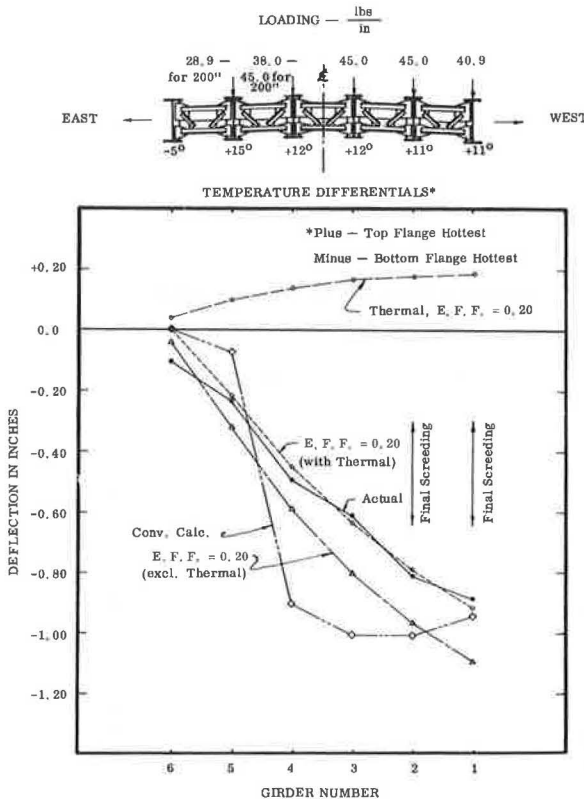
Figure 8. A comparison of actual field midspan deflections with computed deflections (loading interval 3, 9:15 a.m., Route 607, span 3).

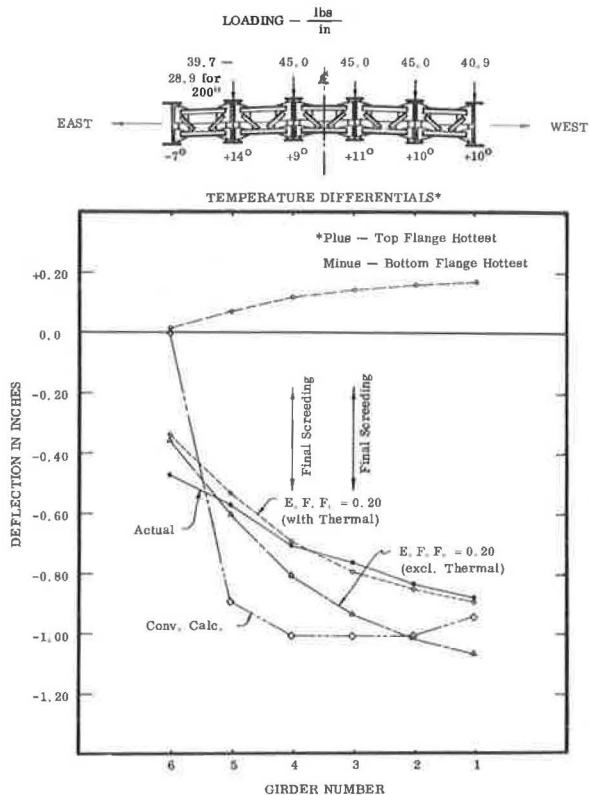
Figure 9. A comparison of actual field midspan deflections with computed deflections (loading interval 4, 9:45 a.m., Route 607, span 3).

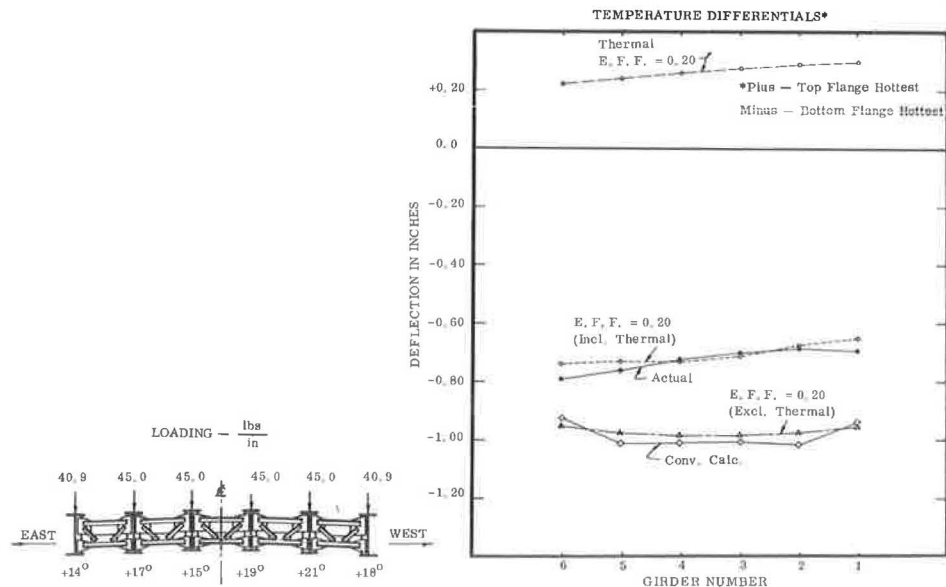
Figure 10. A comparison of actual field midspan deflections with computed deflections (loading interval 5, 2:50 p.m., Route 607, span 3).

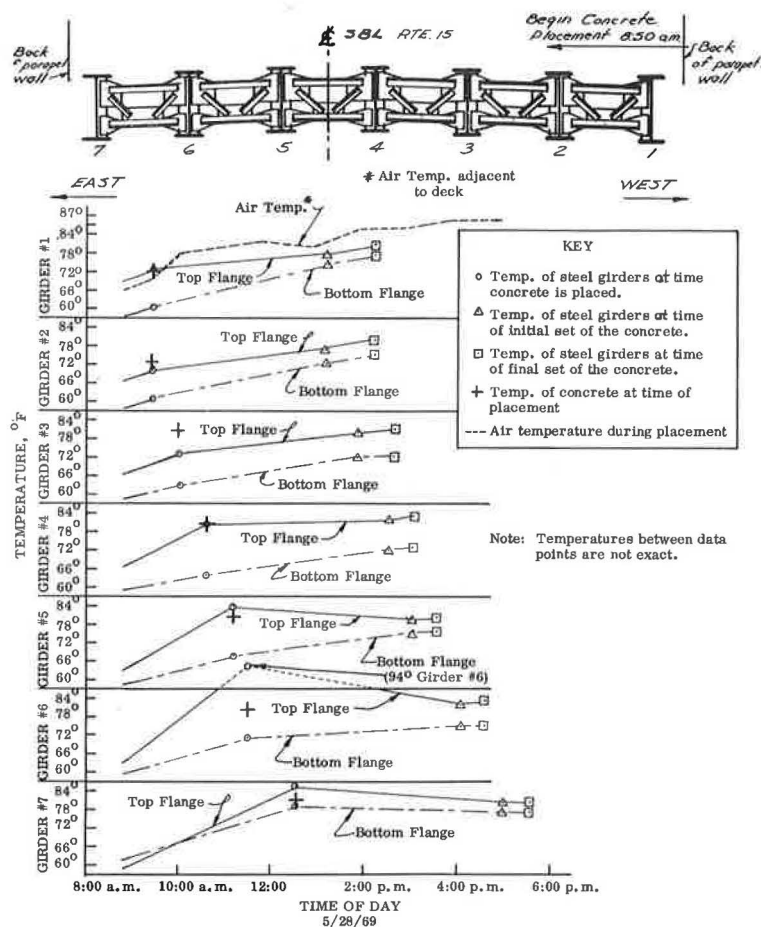
Figure 11. Temperature conditions during bridge deck placement (Route 15, span 4).

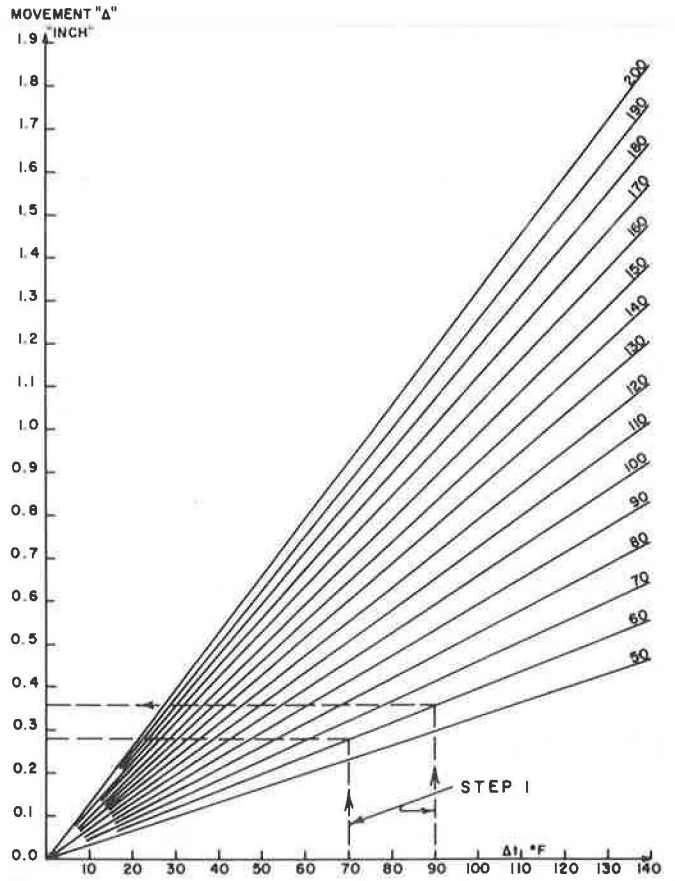
Figure 1. "Δ" movement for $S_L = 50$ to 200 ft and $t = -20$ to 120 F.

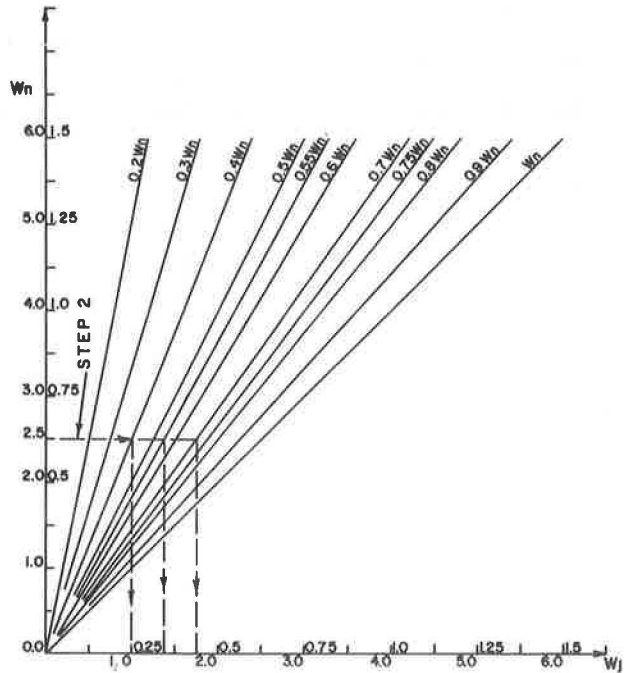
Figure 2. Joint sealer efficiency chart.

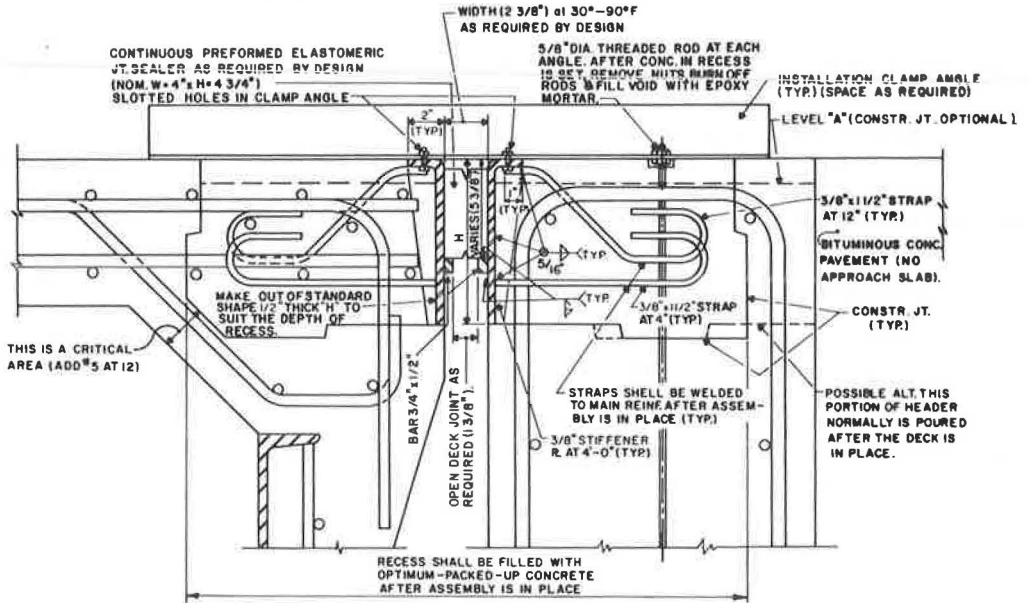
Figure 3. Armored joint detail, section A-A.

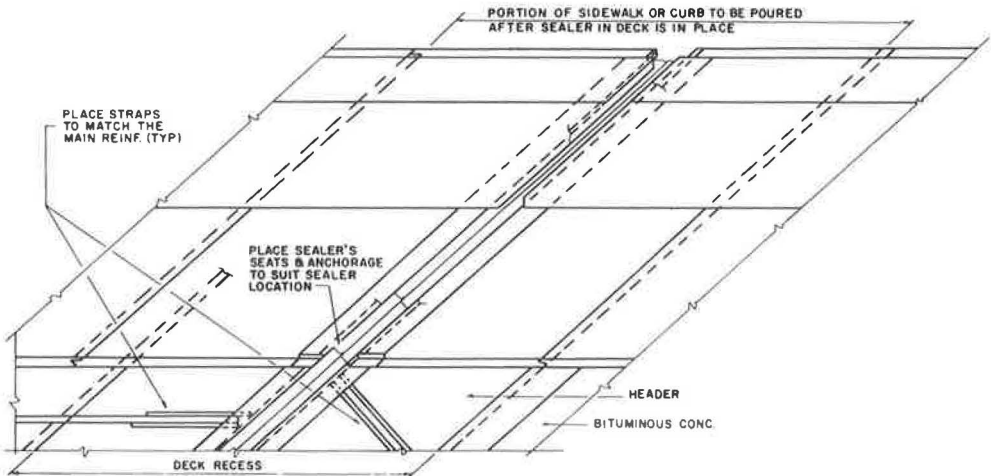
Figure 5. Typical joint detail at sidewalks and curbs.

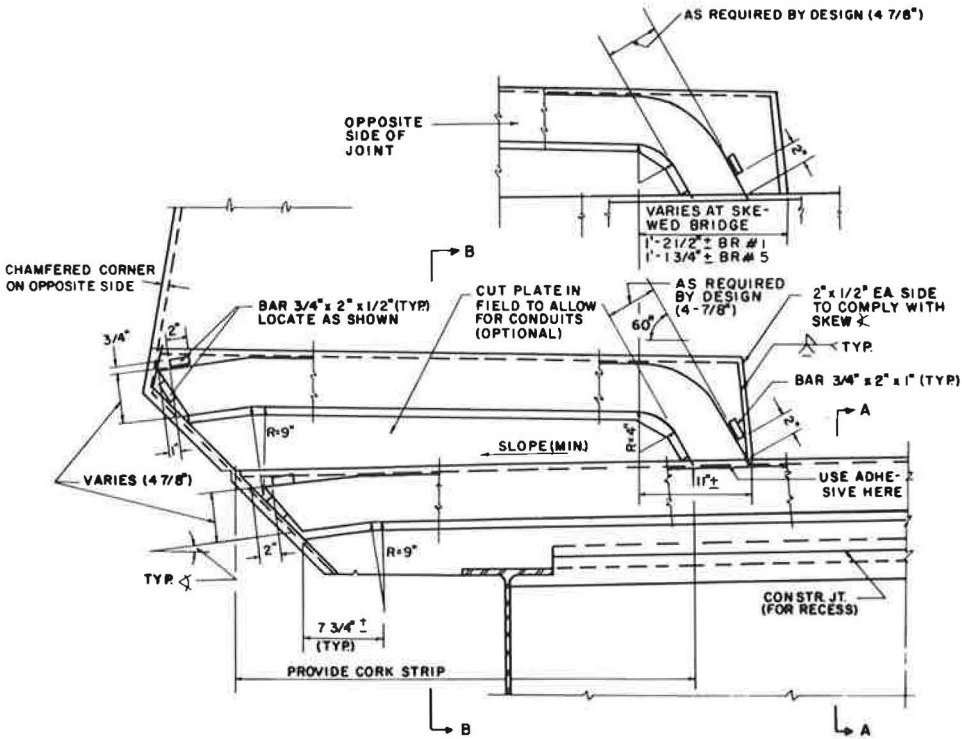
Figure 6. Armored joint detail, safety walk and curb location.

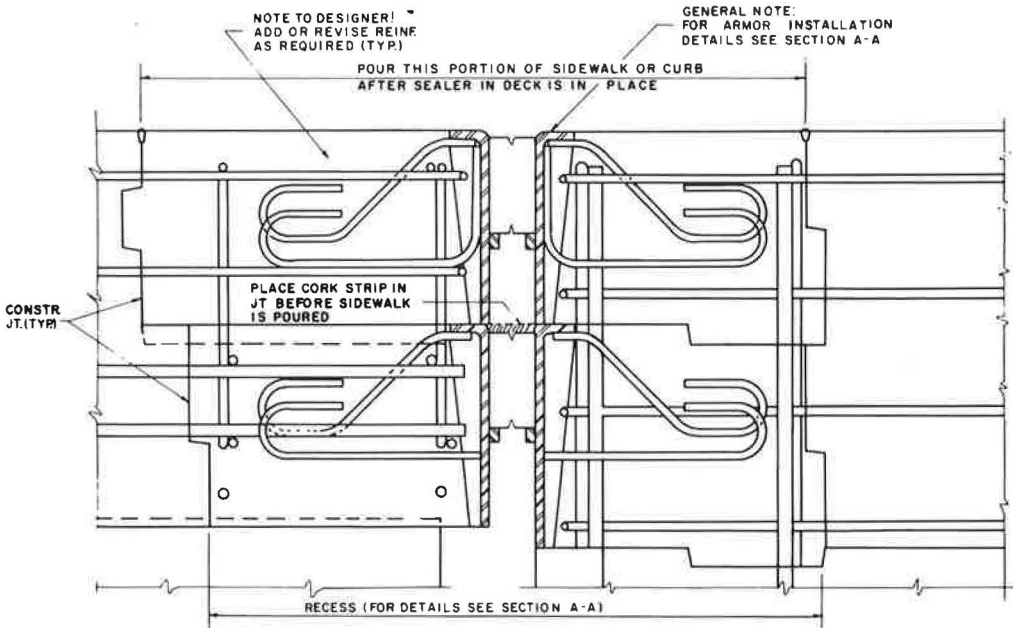
Figure 7. Armored joint detail, section B-B.

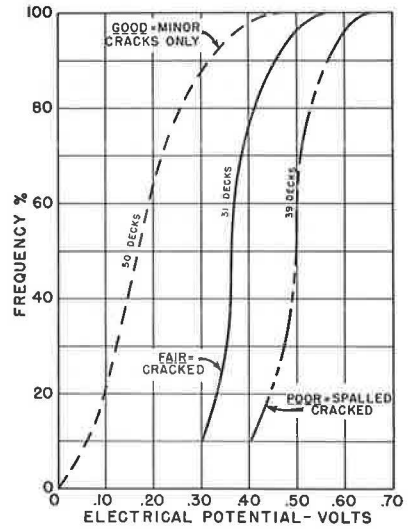
Figure 2. Bridge deck condition classification versus electrical potential.

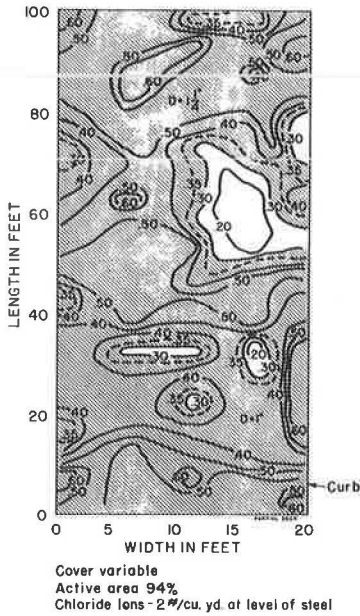
Figure 3. Bridge deck condition classification 1.

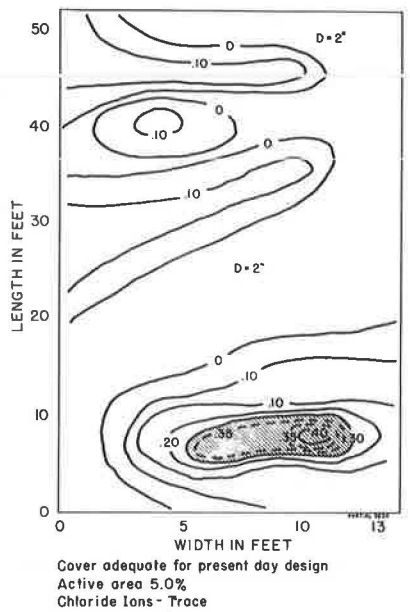
Figure 5. Bridge deck condition classification 3.

A deck in this classification is recommended for a more elaborate patching procedure. All concrete should be removed to a 0.3-V reading or to clean steel and to a depth below the steel, which is adequate to accommodate the maximum aggregate size. The concrete must be replaced with a chloride-free mix. The old concrete and the exposed steel should be coated as explained previously. We believe a membrane can be placed on this deck with satisfactory results. An example of a deck in this classification is shown in Figure 5.

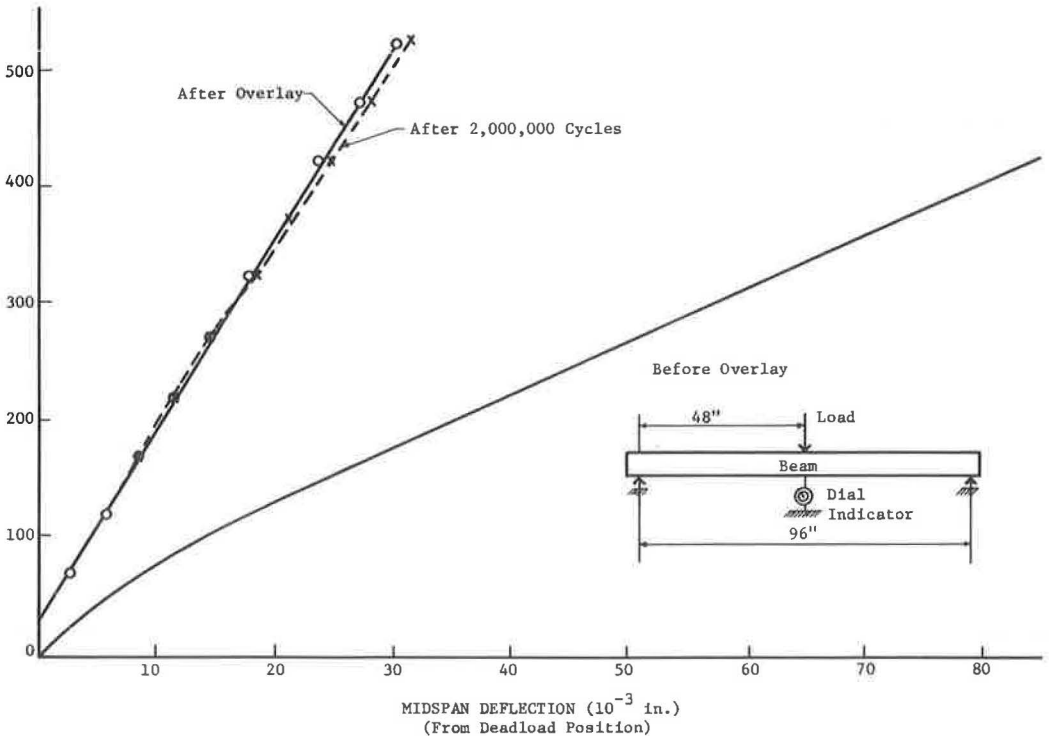
Figure 2. Typical static load-deflection curves.

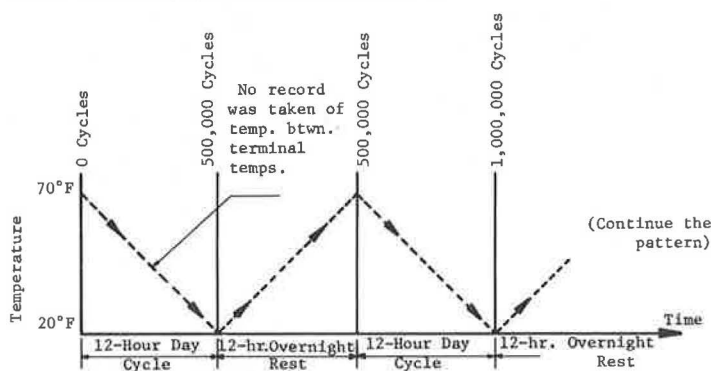
Figure 3. Loading cycle temperature and time.
