SOME CASE STUDIES OF HIGHWAY BRIDGES INVOLVED IN ACCIDENTS

M. H. Hilton, Virginia Highway Research Council

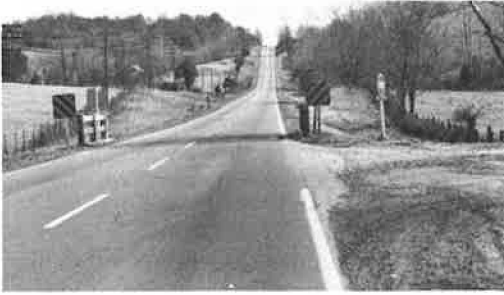
Figure 2. A narrow bridge located within a passing opportunity section of two-lane highway with intersection to the right adjacent to the structure.

Case Study 1—The first case study bridge has had a history of accidents, one fatal, and was recently involved in a sequence of collisions. When a bridge with a narrow roadway width is located within a passing opportunity section of a two-lane highway such as that shown in Figures 2 and 3, collisions involving the bridge railings appear to occur more frequently than when this situation does not exist. This 22-ft long, 23-ft clear roadway bridge was involved in a passing accident in August 1969 when a westbound vehicle met an eastbound vehicle passing another eastbound vehicle. The westbound vehicle went into a skid to avoid the eastbound vehicles, crossed to the opposite side of the road, knocked out the east end of the bridge railing, and went over the edge of the structure. The railing was rebuilt, but in March 1970 an eastbound vehicle, forced over by a passing vehicle, knocked out the west end of the same rail. Subsequently the rail was rebuilt, but in May 1970 an eastbound tractor-trailer, after being forced off the edge of the approach roadway, struck the same rail knocking it out entirely. The rail was again rebuilt, and in November 1970 the east end of the railing on the opposite side of the road was knocked out by an out-of-control eastbound vehicle. The last two accidents were single-vehicle property damage types in which the driver lost control after running off the edge of the pavement in the area of the intersection adjacent to the bridge. Note also that there is no pavement edge striping across the intersection. Under certain circumstances this could be a contributing factor and is discussed further in a later case study.

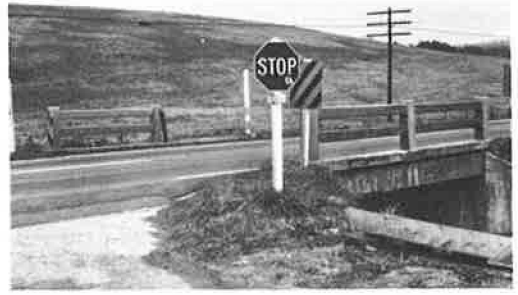
Figure 3. Same bridge shown in Figure 2 with east end of north rail knocked out.

It is difficult to determine the total economic losses from the series of accidents described because property damages are only estimated by the reporter, some damages are not reported at all, and medical expenses are unknown. A reasonable estimate of the property damages, which occurred during a 15-month period, can be made as follows:

<u>Item</u>	<u>Cost (dollars)</u>
Personal property damages on two reported accidents	3,000
Personal property damages on two unreported accidents	1,000
Four repairs of handrail at average cost of \$432 each	<u>1,728</u>
Total	5,728

The handrails were repaired by state forces. If medical costs, lost wages, etc. were included in this estimate, the total economic losses would, of course, have been higher.

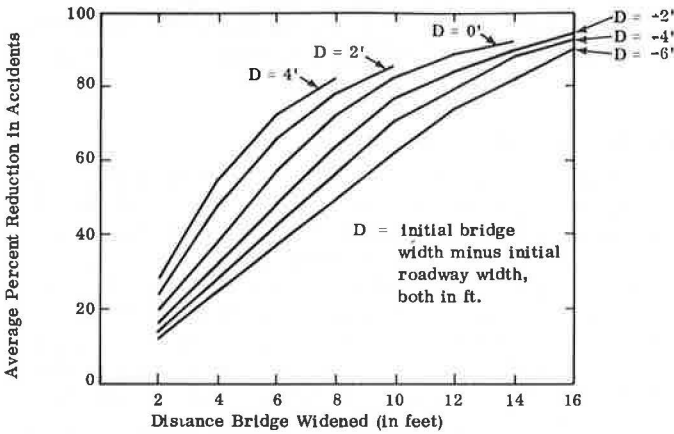
Figure 4. Forecast chart of accident reduction through bridge widening (12).

Curves that can be used to forecast accident reductions and fatality-injury and property damage reductions through the widening of bridges have been developed by Jorgensen and Associates (12) and are shown in Figures 4 and 5. By extrapolating the curve D = 0 of Figure 4, we can estimate that an average reduction in accidents of approximately 95 percent can be expected from the 17-ft widening of the second case study structure. A similar reduction in property damages and injuries could be expected by extrapolation of the curves shown in Figure 5. Benefit and cost estimates can be calculated for the widening improvement by using the methodology presented by Jorgensen (12). Thus, for an annual cost of \$985 (based on a 30-year service life), widening of the bridge will yield estimated average annual benefits of \$11,350 for a benefit-cost ratio of 11.5 (1). Inasmuch as these two case study structures are quite similar, the first bridge could be widened for approximately the same cost as the second. The annual cost of such an improvement to the first structure would be less than one-fifth of the \$5,728 property-damage estimate for the recent series of accidents.

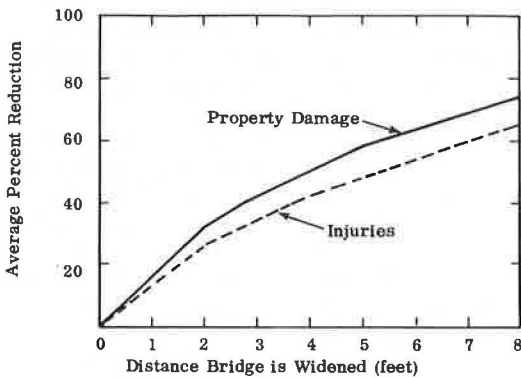
Figure 5. Forecast chart of fatality-injury and property damage reduction through bridge widening (12).

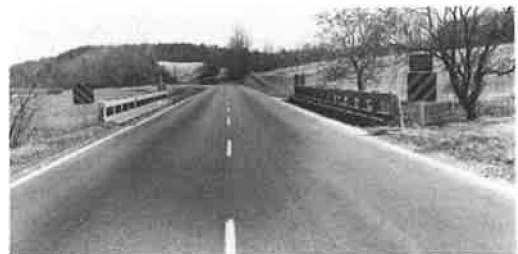
Figure 6. Restricted roadway width and exposed ends of rigid concrete railing.

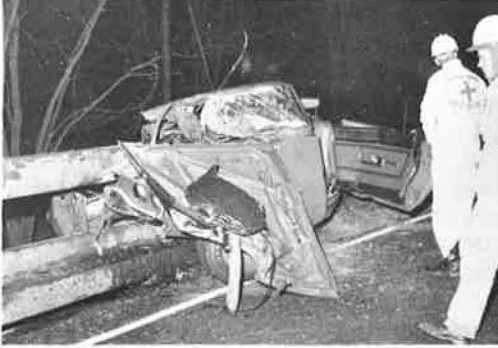
Figure 7. Head-on collision with right end post of bridge shown in Figure 6.

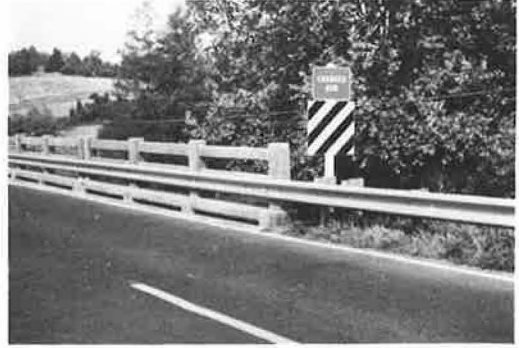
Figure 8. Approach guardrail continued across a bridge.

Progress toward meeting these requirements can be made. In Figure 8, for example, structural continuity between the approach rail and bridge rail has been obtained by a closer spacing of the approach rail posts adjacent to the bridge rail and by continuing the guardrail across the length of the bridge. In addition, the ability of the rail system to laterally restrain a vehicle and to remain intact after a collision is enhanced when the continuous guardrail is anchored to the existing bridge rail. Similar rail systems have been described by Tutt and Nixon (13).

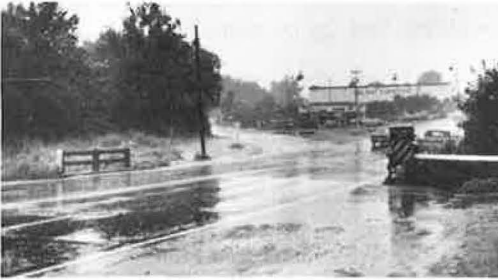
Figure 9. Bridge with narrow roadway located adjacent to intersection (center) and business entrance (right foreground).

Case Study 3—Slowing, stopping, or turning traffic at intersections, business entrances, and so forth increases accident potential. When bridges happen to be located adjacent to points of high accident potential, their potential for involvement also appears to be increased. A typical example is shown in Figure 9 in which a bridge with a narrow roadway is located adjacent to an intersection where traffic slows or stops for left turns. Collisions with the right bridge rail have resulted from situations in which a vehicle has maneuvered to avoid collision with other vehicles making turning or lane-change maneuvers. A business entrance adjacent to the right approach to the bridge probably adds to the traffic conflicts at this particular location.

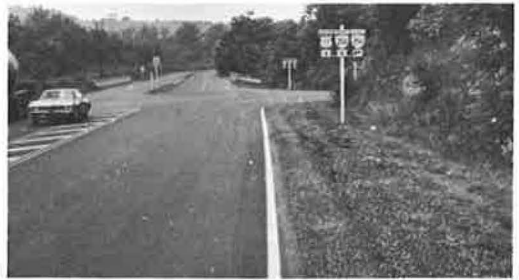
Figure 10. Bridge located at end of pavement transition from two to four lanes.

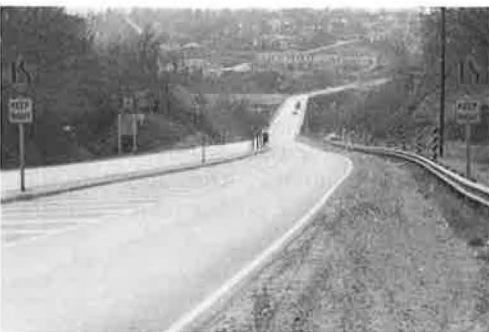
Figure 11. Transition from four to two lanes on approach to major bridge crossing.

Case Study 5—Each approach to this case study bridge (Fig. 11) has a transition from four lanes to two lanes. It might be expected that transitions of this type would tend to have an effect similar to that of widening the roadway but not the bridge. This

type of practice, as prior studies have shown (9, 12, 14), results in increased accident rates. Many of the accidents at the structure in question have been related to passing maneuvers on the bridge or its approaches. In a recent accident of this type, a truck went through the steel railing and off the bridge; the driver was killed. Although the bridge is now marked as a no-passing zone, it appears that the four-lane highway on each side of the bridge creates a psychological "freedom to pass" attitude that prevails on the two-lane bridge as well. The rail penetration incident might also suggest that reinforced concrete parapet walls should always be used on the larger, higher, major structures such as the one illustrated.

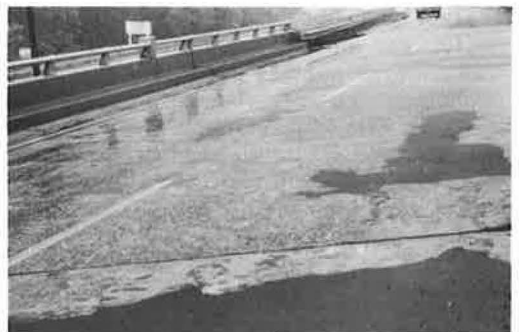
Figure 12. Site of several skidding accidents on downhill, superelevated deck treated with epoxy surface treatment with no initial deslicking sand applied.

Case Study 6—Inspection of the scene of an accident can sometimes reveal contributing roadway factors that are more related to maintenance or construction than to design and obsolescence. An example of such a case is shown in Figure 12, a bridge on which several skidding accidents occurred during wet surface conditions. Significant portions of the deck had been repaired with an epoxy surfacing material that had not been treated with a deslicking grit (sand) during the initial application. McKeel (15) has found that epoxy overlays lose their skid resistance rather rapidly as the initial grit application is lost due to wear. An epoxy surface with no initial deslicking treatment could thus be expected to polish rapidly under traffic wear and to become very slick.
