LONG-TERM PERFORMANCE OF AN EXPERIMENTAL COMPOSITE PAVEMENT

J. Ryell and J. T. Corkill, Ministry of Transportation and Communications, Ontario

The report presents an evaluation of an experimental pavement constructed on Highway 401 near Milton, Ontario, in 1959. The experiment consisted of 7 sections of composite pavement and a section of continuously reinforced concrete pavement. The control section is normal reinforced concrete pavement (1959 design). Data on transverse and longitudinal cracking, road ridability, and skid resistance are presented; each pavement section is rated on present performance and economic aspects. Conclusions are that (a) the most satisfactory pavement section in the experiment consists of a 3 $\frac{1}{4}$ -in. bituminous overlay on an 8-in. unreinforced concrete base, (b) mesh reinforcement in the concrete base has no beneficial effect on the overall performance of the composite pavement, and (c) the best composite pavement in this experiment performed significantly better than many comparable rigid and flexible pavements that are located elsewhere on Highway 401 and are of approximately the same age and subjected to a similar traffic volume.

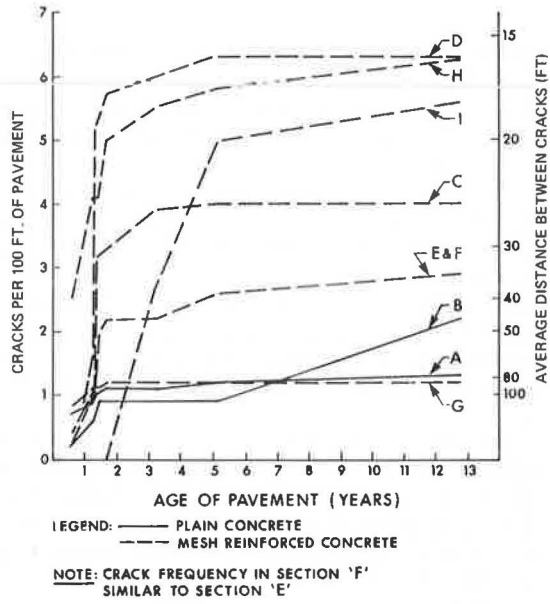
Figure 2. Transverse cracks as a function of pavement age.

The number of transverse cracks expressed as a function of pavement age and the distribution of cracks in each section after 13 years are shown in Figures 2 and 3 respectively. Measurements of road ridability are given in Table 4, and skid resistance is given in Table 5.

Each section of the pavement is affected by transverse cracking; little change occurred in either number or width of cracks after the first 2 winters. The exceptions are section B, where the number of cracks has more than doubled during the past 8 years because of a breakdown of the macadam asphalt binder course, and section I, where most cracks became visible in the reinforced concrete pavement after 3 to 5 years. Because of edge raveling, with subsequent loss of paving material, the cracks in the asphalt surface course are generally considerably wider than the cracks in the concrete base. Although the cracks vary in width and spacing within and between each section of experimental pavement, each of the 7 sections of composite pavement contains a number of wide cracks.

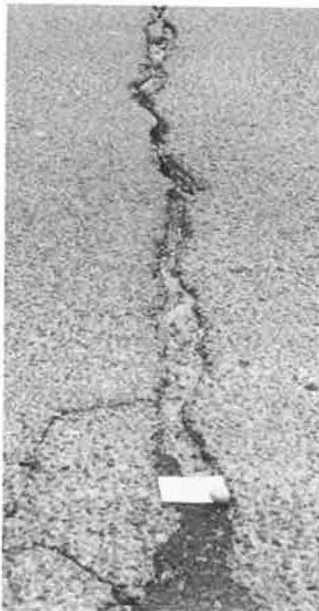
Cracks are least frequent but widest in sections having an unreinforced base or a reinforced base with formed joints (A, B, and G). Those are shown in Figures 4 and 5. Cracks are most frequent and generally the narrowest on sections with concrete base or concrete pavement having the greatest weight of reinforcing mesh (C, D, and H). Several cracks in the concrete slab of section H are very wide and faulted (Fig. 6). The longitudinal steel area provided in that section (0.38 percent of concrete) is considerably less than that normally recommended (0.60 percent) for continuously reinforced concrete pavement (3).

Figure 4. Wide transverse crack in asphalt pavement on unreinforced concrete base (section A).

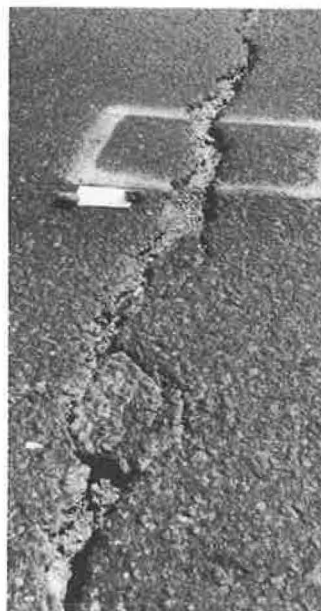
Figure 5. Wide transverse crack in asphalt pavement over contraction joint in reinforced concrete base (section G).

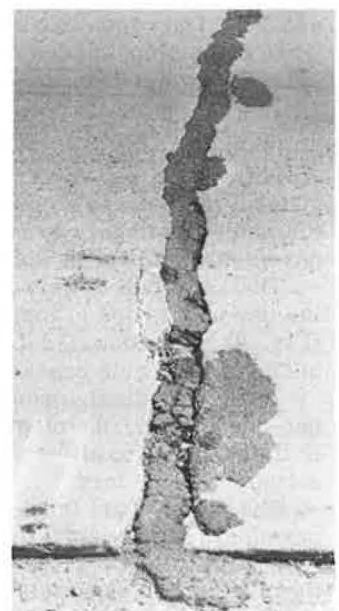
Figure 6. Wide stepped transverse crack, about 3 1/2 in. wide, in continuously reinforced concrete pavement (section H).

It is considered that section B, due to pronounced random cracking and loss of shape of the bituminous overlay, and section H, due to the stepping of numerous cracks, will need to be resurfaced in the near future.

6. The continuously reinforced concrete pavement (0.38 percent longitudinal steel) in section H had the poorest rideability characteristics of all the sections because of stepping at many of the transverse cracks.

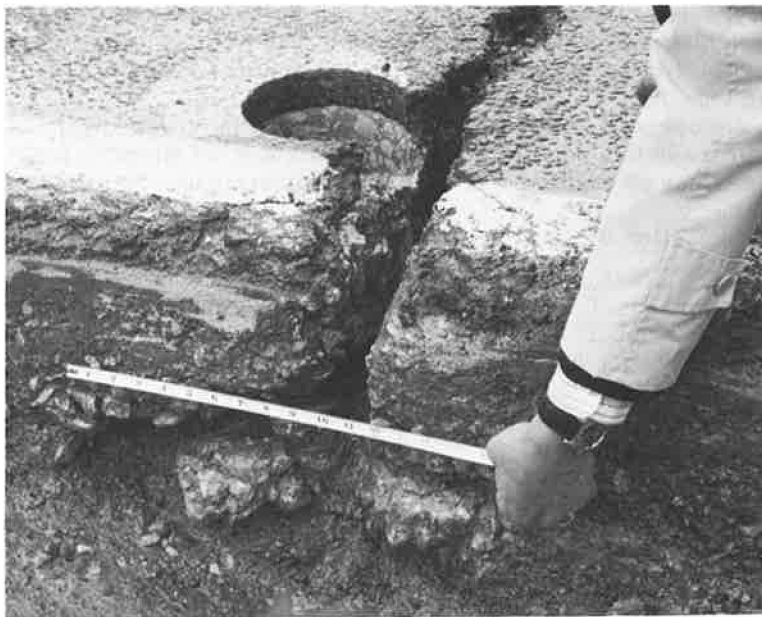
Transverse cracking in bituminous pavements placed directly on a granular base course has been identified as a serious problem in the northern parts of Ontario, where the freezing index is high (4). Such cracks permit the ingress of water and salt solutions, which lead to stripping of the bituminous mix, pumping of fine granular base material, and local weakening of the pavement structure. The transverse cracking occurring on the sections of composite pavement is seemingly less of a problem; if properly maintained, it will not seriously affect the riding qualities of the pavement, unless vertical faulting of the crack occurs. Many of the wider cracks in the pavement are faulted. In sections D and H, where about half of the transverse cracking exhibits faulting, it is undoubtedly a major cause of the relatively high R values as determined by the roughometer trailer. Most "steps" are in the range of 1/8 to 1/4 in.; the highest one measured was 3/4 in. at a wide crack in section D. Removal of the shoulder material adjacent to a wide faulted crack in section D indicated severe spalling of the bottom half of the 7-in. thick concrete slab (Fig. 7). The crack width in the concrete slab was 1¾ in. The 4-0 gauge longitudinal wires of the reinforcing mesh were "necked" and broken at the crack. Less severe spalling was also observed at narrower cracks in the concrete base (Fig. 8).

Figure 7. Severe spalling in bottom half of concrete base slab at wide crack (section D).

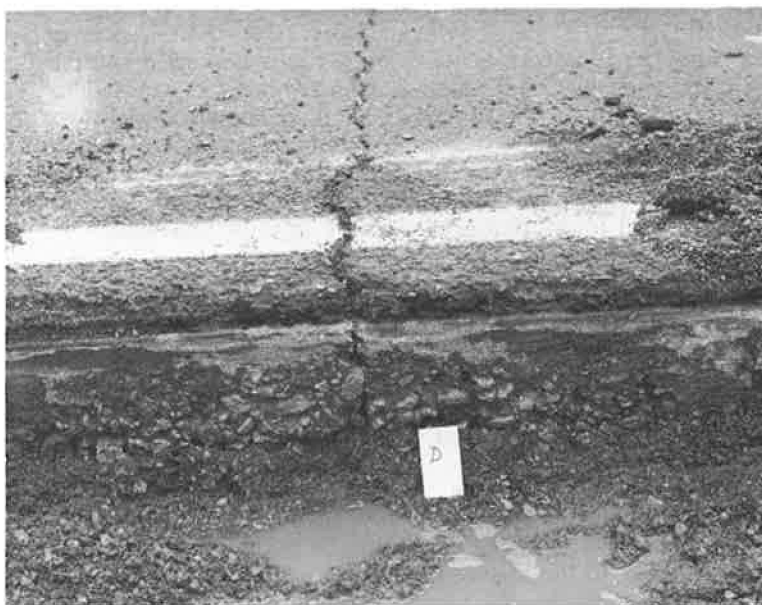
Figure 8. Less severe spalling near base of concrete slab at narrow crack (section D).

pooled at the surface of the excavation (Fig. 13). That surface water is also visible in Figure 8. Rainfall during the 7 days prior to this work was 1.1 in.

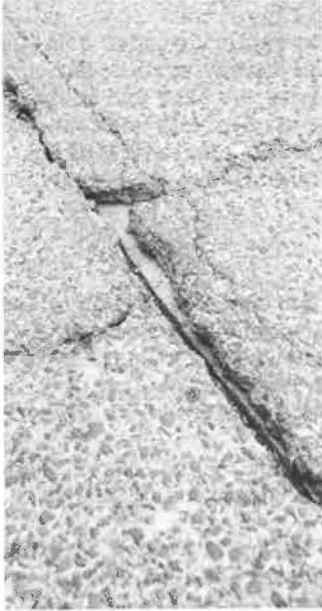
The hook-bolt dowels in 3 of the 7 bituminous-covered sections had little effect on the severity of the cracking. Both doweled centerline joints with 1½-in. thick asphalt (Fig. 9) and undoweled centerline joints with 8-in. thick asphalt (Fig. 10) are associated with wide cracks and loss of bituminous pavement.

It is apparent that the longitudinal joint in the concrete base is open (Fig. 9) and that the hook-bolt dowels (5/8-in. diameter at 2½-ft centers) have not held the two 12-ft wide slabs together. A core taken through the pavement at the location of a hook-bolt

dowel indicated that the assembly had failed and that 1 hook bolt had pulled out from the threaded coupling because of partial fracture and distortion of the coupling. A $\frac{3}{8}$ -in. wide gap exists between the 2 vertical faces of the concrete. Laboratory tests on a sample of hook-bolt dowel assemblies similar to those used in the pavement indicated that under tension the assembly failed at a load of 8.06 tons. The fracture occurred in the coupling connecting the 2 hook-bolt dowels. The $\frac{5}{8}$ -in. diameter hook bolts failed in tension at a load of 9.15 tons.

Figure 9. Loss of asphalt pavement due to cracking at centerline joint (section D).

The purpose of hook-bolt dowels in single-lane paving is to hold the longitudinal joint tightly closed. It appears in this pavement that the dowels are not adequate for that purpose and should be either strengthened or used at closer centers in future work.

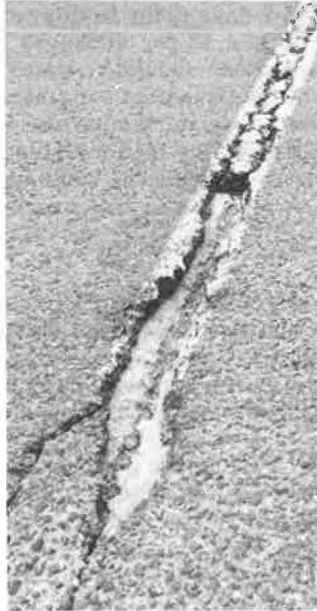
Figure 10. Loss of asphalt pavement due to cracking at centerline joint (section F).

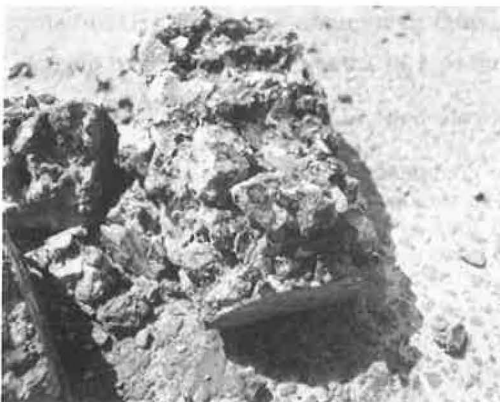
Samples of the bituminous mix cut out of the pavement revealed that the random cracks were confined to the HL1 surface course and did not occur in the concrete base. The macadam bituminous mix is badly stripped (Fig. 12). The stripping has advanced to the point that, near cracks, the mix has lost most of its structural strength and can be readily broken with the fingers. Stripping was first observed during a sampling program when the pavement was 6 years old. At that time, the stripping had not adversely affected pavement performance, and the cracks in the asphalt were almost all reflection cracks from the concrete base. The macadam mix sampled at several locations was quite wet and contained a lot of dirt and fines in the matrix. Because very little water will normally penetrate through the HL1 surface course, it is probable that water in the uncracked sections of the pavement has penetrated from adjacent cracks, particularly the centerline crack. One sample of bituminous pavement taken the day following a heavy rainfall revealed the macadam mix to be saturated, and water was pooled on the surface of the concrete base.

The widespread random cracking and some of the transverse cracking in section B are due to stripping and breakdown of the 3-in. thick macadam binder course. That type of macadam binder course has been used as part of an asphalt overlay on several miles of concrete pavement on Highway 401 near the experimental pavement and after 4 years of service appears to be in excellent condition. Nevertheless, the condition of the macadam in section B indicates that ways must be found to keep the material in a relatively dry condition if successful long-term performance is to be attained.

Figure 12. Breakdown of macadam mix binder course due to stripping of asphalt film from coarse aggregate particles (section B).

4. Unless ways can be found to reduce the stripping of the asphalt cement film from the coarse aggregate particles, the macadam bituminous mix used in section B is not a satisfactory binder course for this type of pavement.

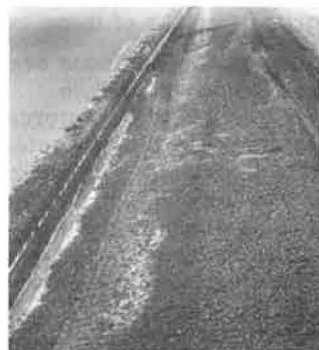
An examination of the concrete base in November 1972 involved the removal of shoulder material down to the underside of the concrete slab along 200 ft of roadway. The granular material near the edge of the pavement was saturated, and water rapidly

It is apparent that, in spite of a 12-in. thickness of granular material under both the concrete slab and the crushed-stone shoulder, water from the roadway surface is not drained from the structure of the pavement but collects readily in the base and subbase. Pavement damage to composite or concrete pavements from frost heave is not common in southern Ontario; nevertheless, the high moisture content of the subgrade with the possibility of ice-lense formation during the wintertime is potentially a cause of pavement faulting, particularly at wide transverse cracks.

Figure 13. Surface water in granular shoulder at edge of pavement.
